## Quebec Overpass Collapse Juxtaposed to Deteriorating Infrastructure in Canada

**Nemy Banthia**

The University of British Columbia  
Vancouver, Canada

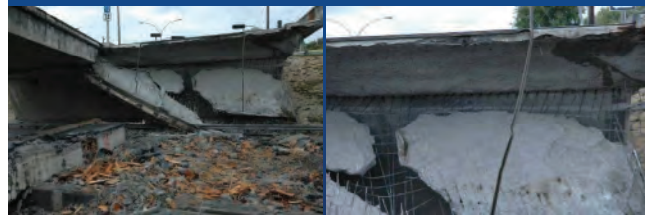
Rupture surface – South-East corner

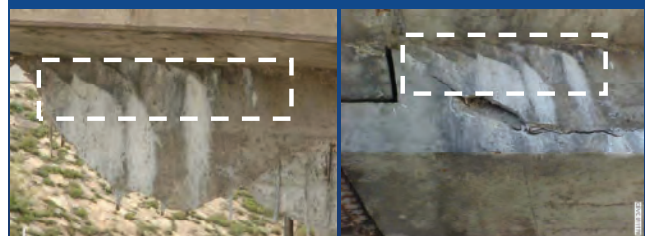
South-East corner

Right after the collapse

Before the collapse

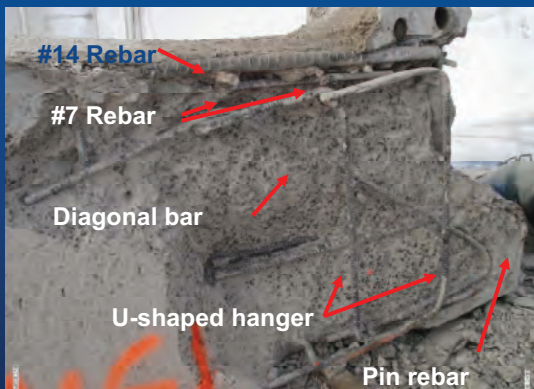
## Reinforcing Bar Location - East

### 1. Improper rebars installation during construction

The incorrect placement of the U-shaped hangers and diagonal bars created a zone of weakness that extended deep inside the thick slab.

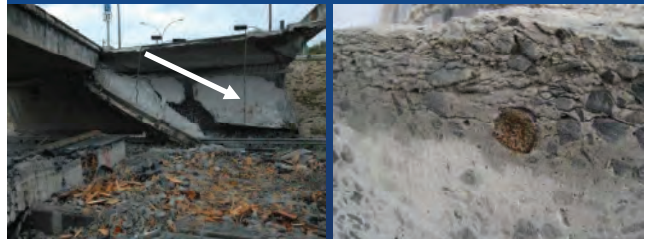
## Concrete Degradation – South-East Corner

Frost attack was identified as the main cause of concrete degradation at the vicinity of the rupture plane.

The concrete used for the construction of the abutments did not have the necessary characteristics to resist freezing and thawing cycles in presence of de-icing chemicals.

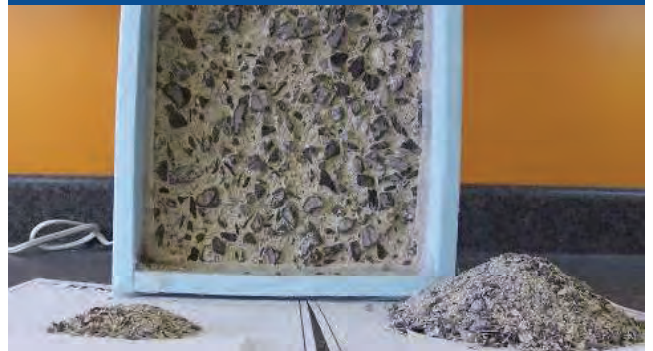
## Scaling Resistance

**Permissible limit**  
0.5 kg/m<sup>2</sup> after 56 cycles

**Results**  
7 kg/m<sup>2</sup> after 21 cycles
