# Damage of Bridge Structures during Recent Earthquakes and the Effectiveness of Seismic Retrofit

## ABSTRACT

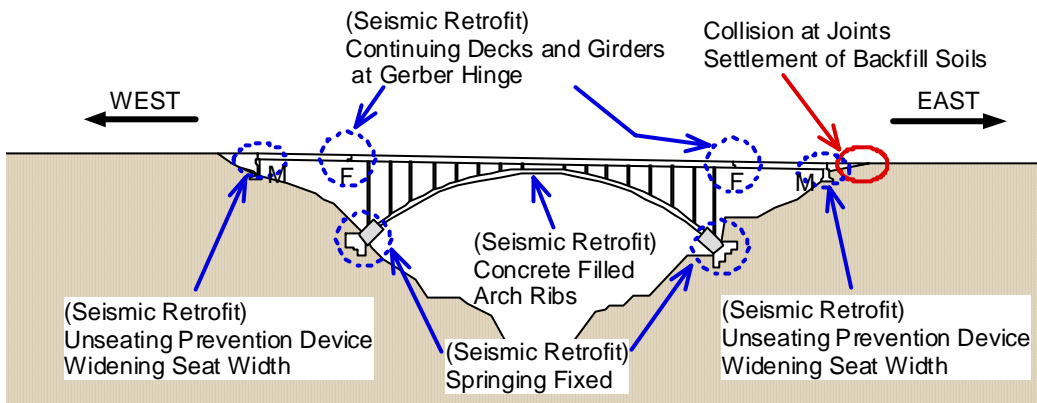
By the earthquake, some movement was found at the both joints and abutments, but no remarkable damage was found at the main members such as arch ribs. Some buckling and deformation was found at connection section of the lower lateral beam. Although it is necessary to investigate more in detail, the seismic retrofit to increase the strength and ductility of the ribs was estimated to work effectively to resist the seismic inertia force.

**Fig. 4** Seismic Retrofit and Damage to Agewa Bridge

The bridge was already made retrofitted as shown in **Fig. 4**. The bearings at the both ends of arch section were made to be fixed. The light weight concrete was filled in the arch rib to increase strength and ductility of ribs. And the unseating prevention devices were installed.

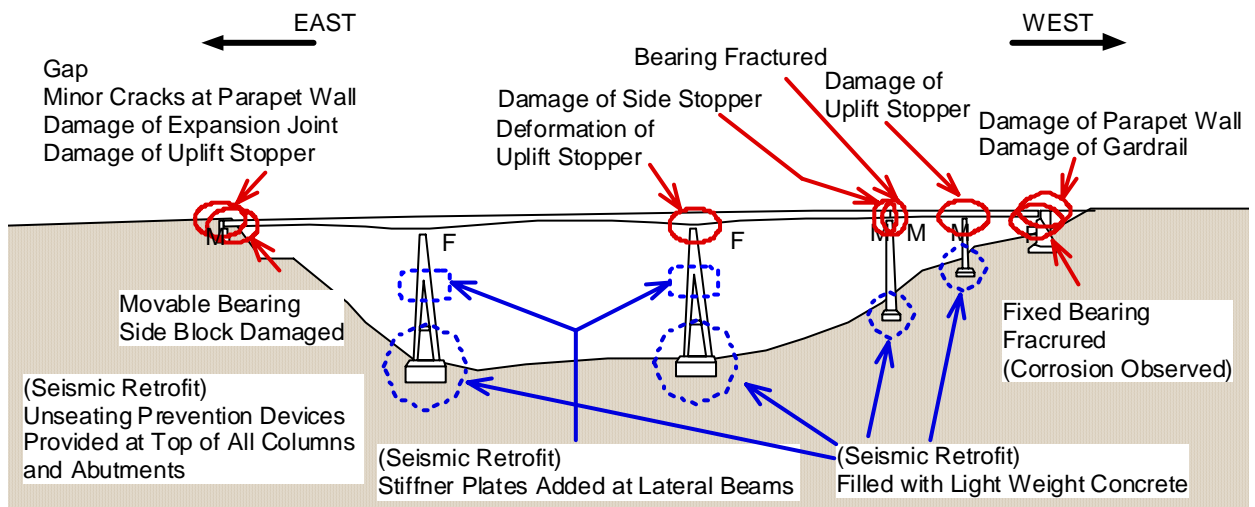
During the earthquake, the bearings were damaged as the deformation of shear keys as shown in **Photo 12**. No damage was found at the columns and other main members. Although it is necessary to investigate more in detail, the seismic retrofit to increase the strength and ductility of the steel piers was estimated to work effectively to resist the seismic inertia force.

**Fig. 5** Seismic Retrofit and Damage to Yoneyama Bridge

Superstructures were 3-span continuous steel box girder and 2 span continuous steel girder as shown in **Photo 11**. The bridge length was 279m. Abutments are wall type with spread type and caisson foundations. Piers were steel frame structures with height of about 44m. The bridge was retrofitted by the strengthening the bottom of steel piers, concrete infill to the steel columns, and added stiffeners to the lateral beams of piers, and the installation of the unseating prevention devices, were made as shown in **Fig. 5**.

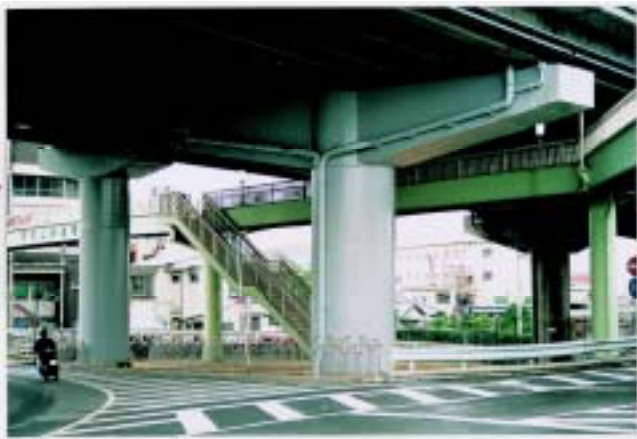
Before the earthquake, P714 was already retrofitted using steel jacketing with steel plate of 12mm thickness at the column section. P715 was planned to be retrofitted, but was as-built without any retrofit at the time of the earthquake.

On the other hand, at pier P714, no damage was recognized from the outside view. No peeling of the coating paint of the steel jacketing was found. After the earthquake, the connection between steel plate and inside concrete was checked by hammering test, then

the some separation was found at the some location. Based on the detailed investigation, no crack was found in the core concrete. This shows the effectiveness of the seismic retrofit for the column to prevent the bending and shear failure by the steel jacketing.

**Photo 1** Retrofitted Pier P714 of Hanshin Expressway [6]

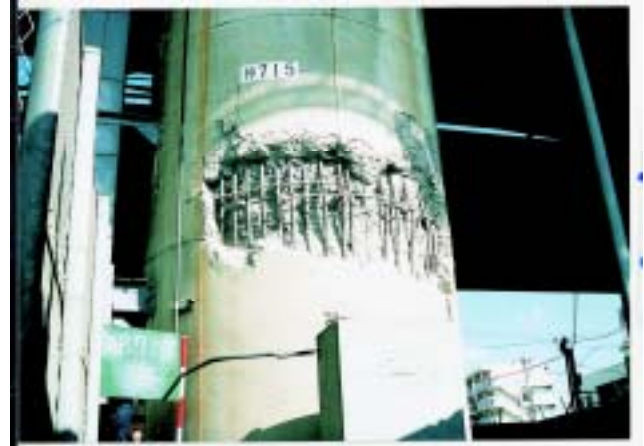
**Photos 1** and **2** show two piers taken after the earthquake. No damage was found at superstructures and/or bearings, and other effects including the sand boiling caused by the liquefaction was not found. At P715, the cracks and spall of cover concrete and the buckling of longitudinal re-bars at mid-height section of columns, which was the termination section of the some on the longitudinal re-bars, was found. The pier was not collapsed but the damage was serious and significant. The bottom of the column was investigated after the earthquake by removing the surrounding soils but no damage at the bottom was found.

**Photo 2** Pier P715 of Hanshin Expressway [6]

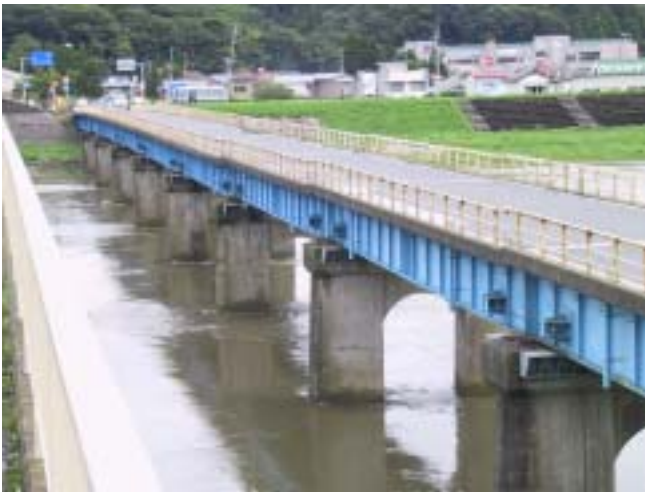
The effectiveness of the unseating devices was recognized at Ono bridge as shown in **Photo 3**. Ono bridge was constructed in 1935 and relatively old bridge. Superstructure was simply supported steel girder, and the bearing was simple steel plate and anchor bolts. Substructures were RC two column bents with caisson foundations. The bridge was located about 2 km from the epicenter. The strong motion observed at the nearest MLIT strong motion observation station, which was located 1km from the bridge, was the peak acceleration of 440gal and SI value of 51kine.

**Photo 3** Ono Bridge

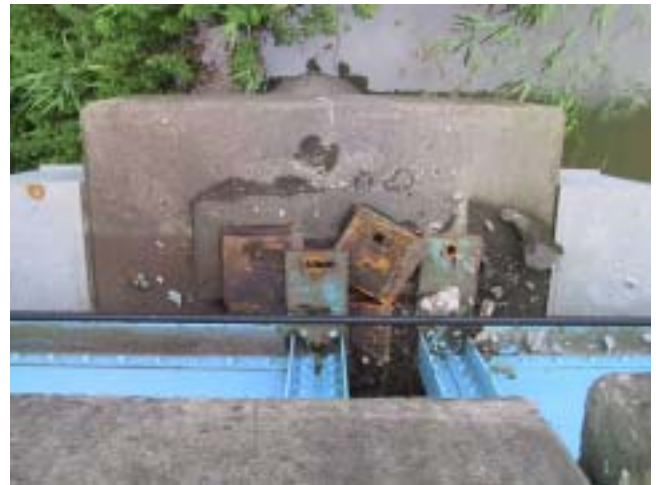
By the earthquake, all of the bearings at piers and abutments were damaged. Anchor bolts were failed in shear or pulled-out, and some of the steel plates of bearings were fractured at the welded section as shown in **Photo 4**. Some deterioration at the bearings was also found.

**Photo 4** Damage of Bearings

Ono bridge was damaged in the 1978 Miyagi-ken-oki earthquake as well. As the same as this time earthquake, the bearings were failed at 9 of 13 spans and the girder was displaced by 65cm in the transverse direction and 10cm in the longitudinal direction. The damage was repaired by installing the steel plates and anchor bolts. Then the unseating devices connecting the adjacent girders by steel plates and PC cables, and the steel bracket to increase the seat width to prevent falling down of superstructures by excessive displacement were installed.

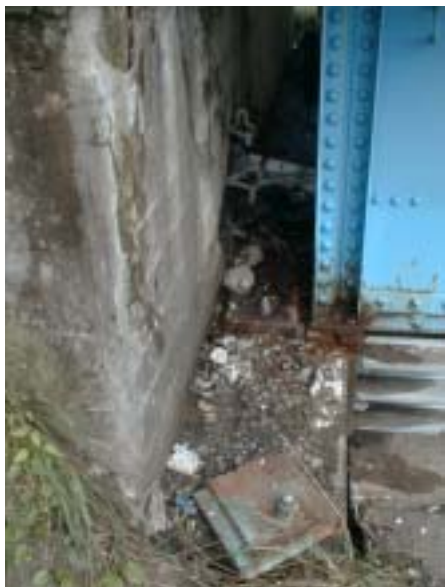
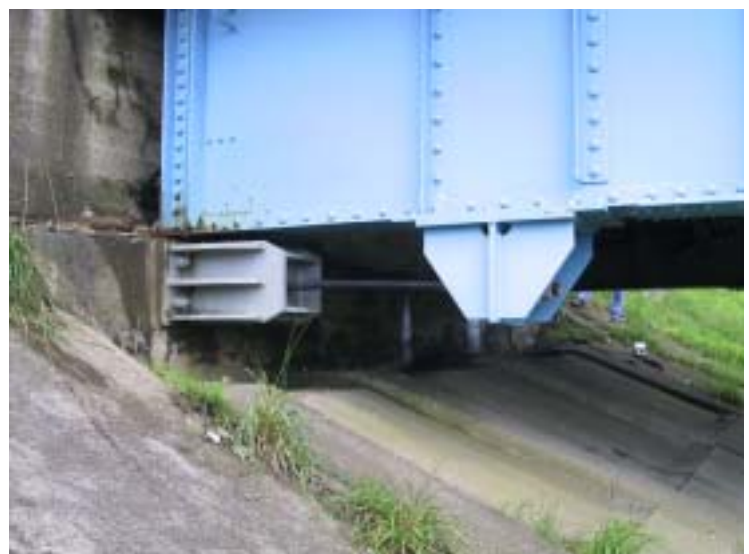
During the earthquake, all girders moved in the longitudinal direction by about 20cm. The gap of about 10cm in the vertical direction at the expansion joints was developed. The largest displacement was found at the abutment but the unseating devices by PC cables worked effectively to restrain the excessive displacement as shown in **Photo 5**.

**Photo 5** Effectiveness of PC Cable Type Unseating Prevention Devices

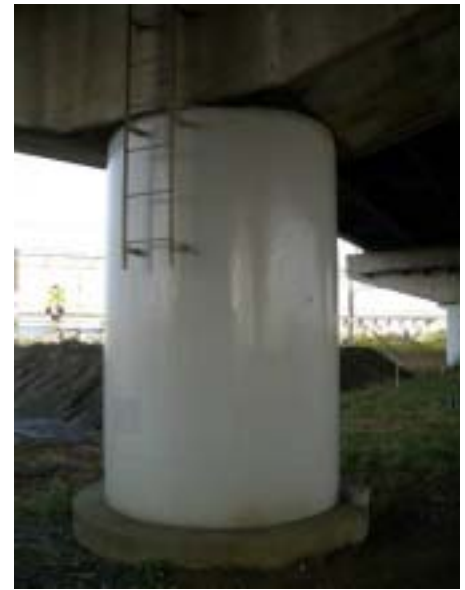
The effectiveness of the seismic retrofit at Shinkumi bridge is shown here. Shinkumi bridge was constructed in 1989 to overpass the railway as shown in **Photo 6**. The superstructures were of 2-span simply-supported steel girders and 3-span continuous steel girder. The substructures were RC columns with a circular section and supported by the pile foundations. Bearings were a steel plate type. The bridge consisted of two same but completely separate bridges, which had two inbound and down bound lanes, respectively. The columns of one bridge were already retrofitted by steel jacketing as shown in **Photo 7**. For the other bridge, the retrofit works were planned to be made in near future.

**Photo 7** Retrofitted Columns with Steel Jacketing (No damage)

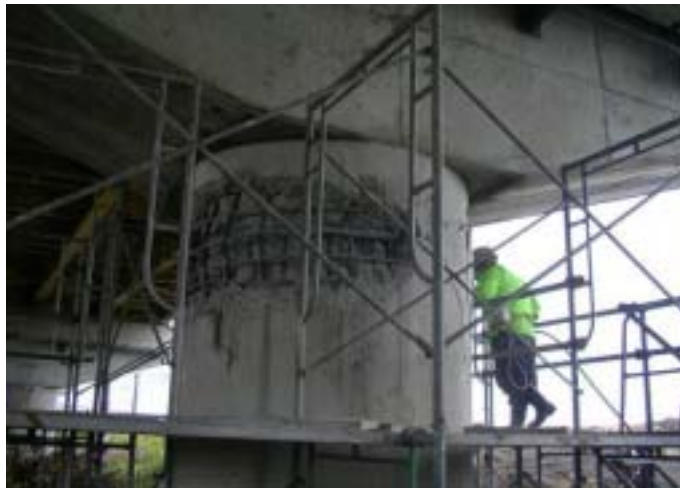
The damage was found at the bridge columns without retrofit works. The heaviest damage was found at the mid-height section of pier P5. That was the termination section of some of the longitudinal re-bars at mid-height. The cracks, spall-off of cover concrete, and buckling of re-bars were found as shown in **Photo 8**. At other piers of the same bridge, bending and shear cracks were observed. However, there were no damage at the retrofitted bridge and the retrofit works by the steel jacketing worked effectively.

**Photo 8** Damaged Pier P5 (Before Retrofit)

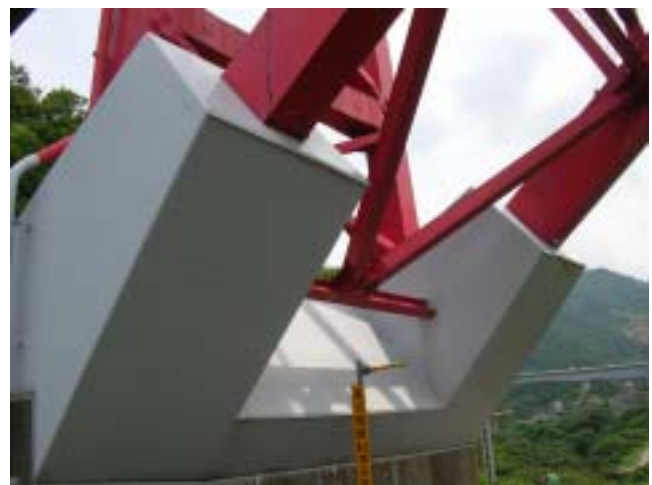
**Photo 10** Retrofitted Springing Section of Arch Rib (Concrete Jacketing)

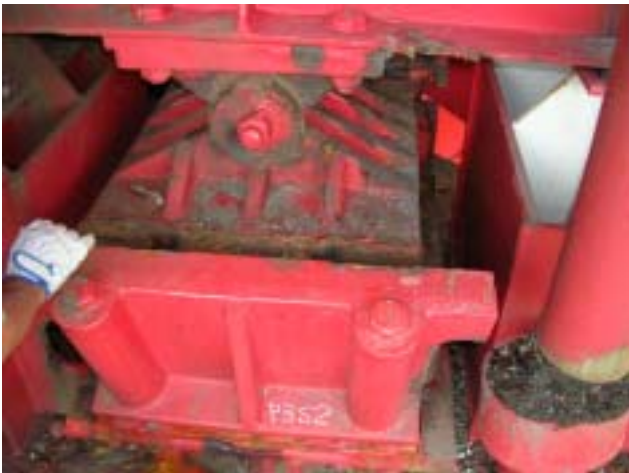
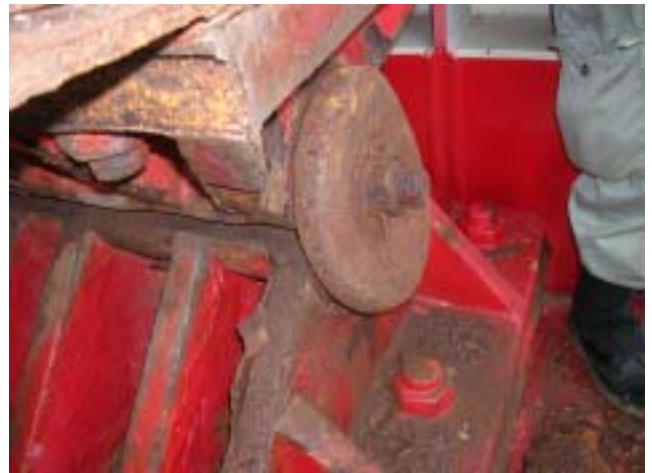
**Photo 12** Deformation of Shear Keys and Pin Caps of Bearings

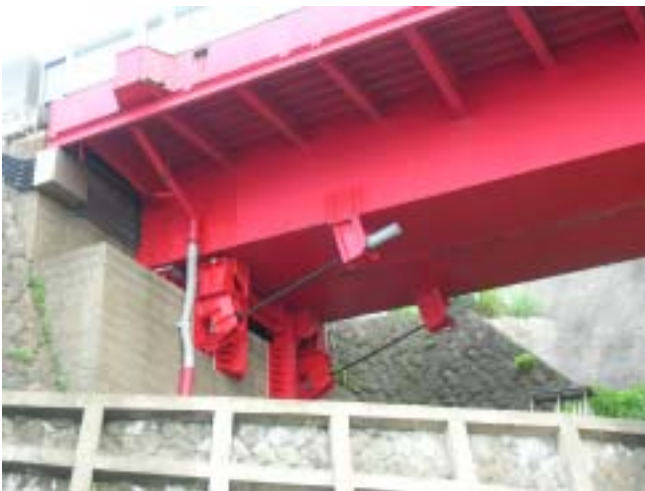
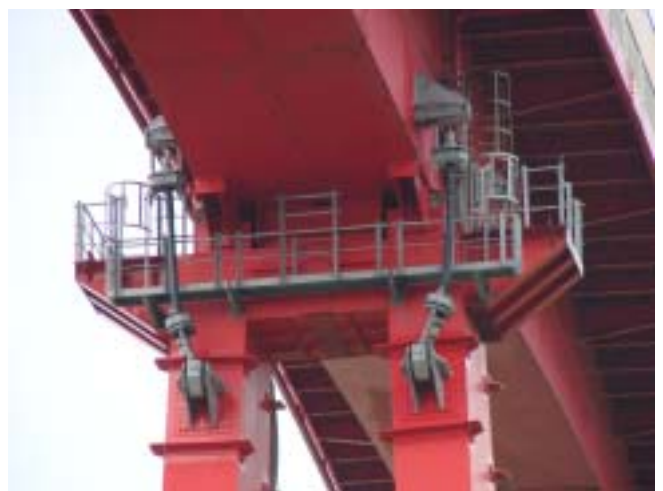
**Photo 13** Unseating Prevention Devices (Cable Restrainers in Longitudinal and Uplift Directions)
