# Lessons Learned from Bridge Performance of the 1999 Turkish & Taiwan Earthquakes

This paper presents preliminary findings concerning bridge performance and lessons learned from the three large earthquakes that struck Turkey and Taiwan in 1999. These findings seek to associate types of damage with fault types.

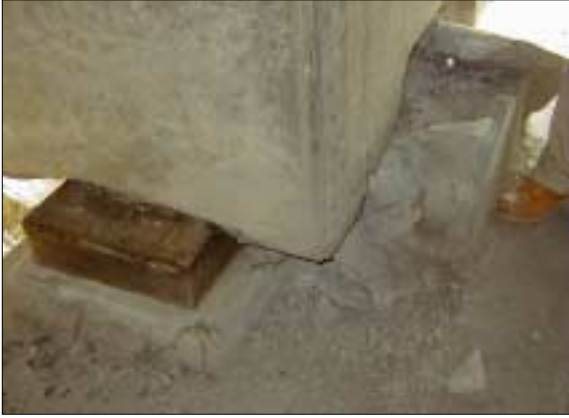
In the Kocaeli earthquake, shear key failures due to lack of proper detailing and construction allowed a large offset on the Sakarya Viaduct of the TEM (see Figure 3).

If the shear keys were able to provide adequate lateral resistance, much of the associated damage might have been avoided. However, the shear keys should not be designed stronger than the bridge pier to avoid incurring damage in the bridge foundations or piers, since foundation damage is more difficult to repair.

**Figure 3.** Shear keys failure in Sakarya Viaduct

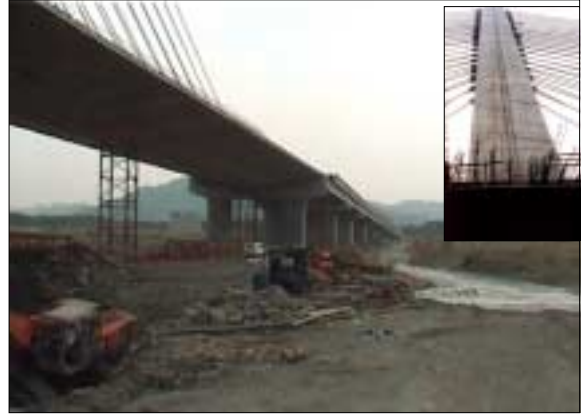
- *Long-span bridges, especially those still under construction, are vulnerable to near-fault effects.* The Ji-lu Bridge, located near Chi-Chi town, is a cable-stayed bridge. The structure was almost complete at the time of the earthquake; only one section under the tower and the guardrail were not completed. Damage to the bridge includes a cable fracture, cracking

and spalling in the concrete tower, pot bearings failure due to structure pounding and approach spans offset in the transverse direction. Ground motion, with a high pulse in the longer natural period, recorded in the near station have also indicated that bridges with a longer natural period might be vulnerable to strong ground motion. Figure 6 shows the Ji-lu Bridge with almost complete superstructure by missing one section adjacent to the pylon.

**Figure 6.** Cable fracture of a cable-stayed

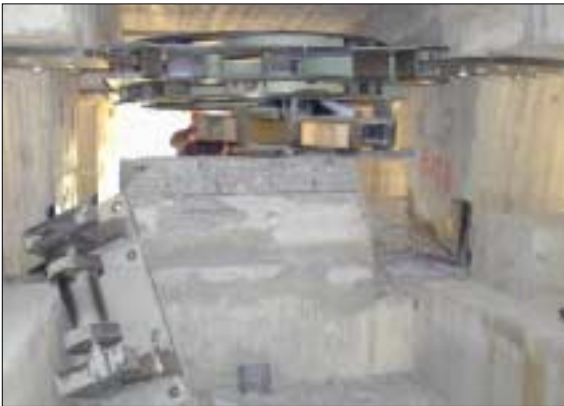
- *The shear capacity of connection details needs to be consistent with the design of other components.* The majority of the energy absorbing "C-elements" of the EDUs used in Viaduct #1 did not absorb much energy during the Duzce earthquake, since the shear failure of the connecting bolts to the pier prevented the EDUs from

functioning properly. Thus, balanced design between all components is needed to prevent malfunction of the whole system (Figure 4 shows the premature EDU failure)

**Figure 4.** EDU failure

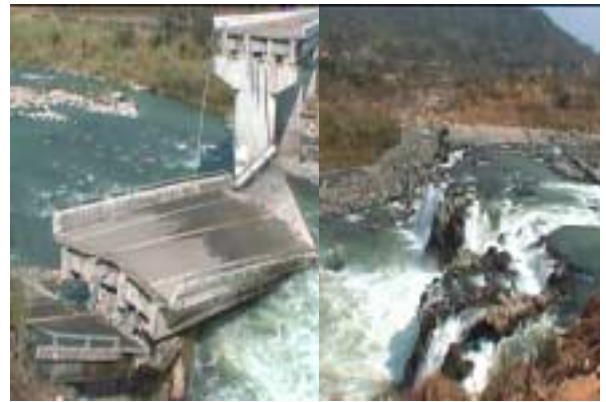
- *Ground failures may cause structural failure.* The ground failure of the Bei-feng bridge is located near the Shi-kan Dam (lifted up about 10 m). This bridge's spans collapsed due to a fault rupture underneath the bridge. The rupture lifted the upper stream by 5-6m, and created a new waterfall. This reverse-slip fault also shortened the bridge length and may have pushed the second pier to fail. Please Figure 7.

**Figure 7.** Spans Collapsed due to Fault Rupture

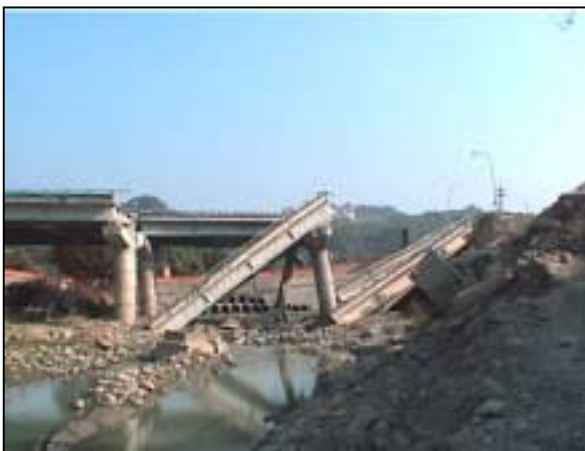
- *Generous seat width to accommodate unexpectedly large movements caused by ground failure or strong tremors is a very sound investment.* Bridges with irregular geometry, such as those with skewed or curved alignment, are more vulnerable to loss of support failure, and to bearing damage due to rotational moment. Extra seat width will prevent unseating of the superstructure in many cases. However, fault rupture, directly crossing or immediately adjacent to the bridge, is a catastrophic event and span collapse is inevitable if the displacements are large. (Figure 5 shows the Shi-wei Bridge that collapsed due to superstructure unseating. The surface fault rupture crosses their piers.

**Figure 5.** Spans collapsed of Shi-wei Bridge

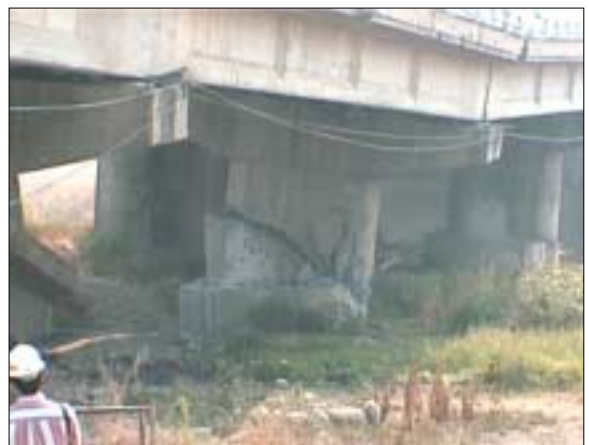
- Bridge pier shear failures should be prevented. Figure 8 shows the South-Bound bridge piers of the U-Shi bridge had severe shear cracks and failed. Shear reinforcement design needs to be considered in resistance of all directions. If the shear failures of this bridge were prevented through proper design, damage to the newer bridge would have been very limited.

**Figure 8.** Pier shear failure of U-Shi Bridge

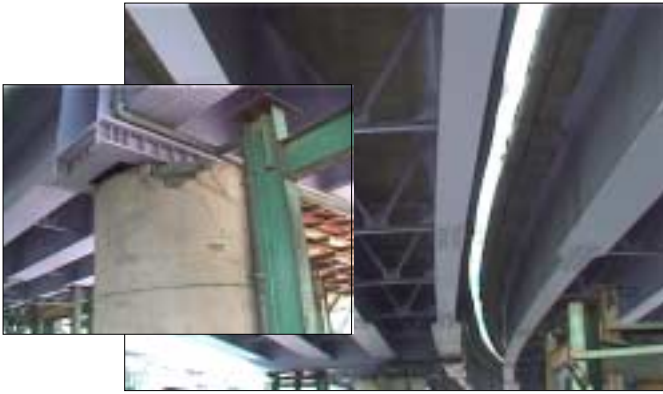
- *Cantilever overhang connections are vulnerable to shear failure, particularly for curved or skewed bridges.* Figure 9 shows shear cracks of a horizontal curved viaduct with a steel superstructure supported on the single concrete column piers. Some of these are "C – shaped with steel pier-caps cantilevered off the column resulting in an eccentric connection to the column. Although the bridge did not collapse, it had serious shear cracks. Most of the eccentric connections showed distress in the concrete columns. Those shear cracks could have contributed

through the vertical acceleration component for this cantilever overhang superstructures by amplifying the dead loads (see Figure 9).

**Figure 9.** Shear racking on eccentric connections

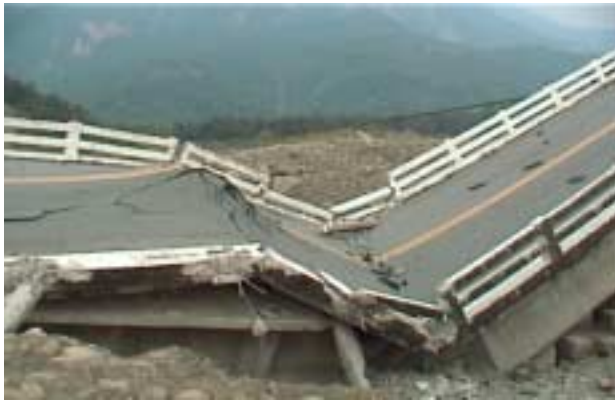
- *Near faults ground motion was intense and its effects need to be studied in combination with the vertical acceleration component.* This was shown by the detailed inspection of the Tong-tou bridge, which was near the epicenter of the Chi-Chi earthquake. The first and fourth spans collapsed. The second span tilted and rotated horizontally in transverse direction. There was severe substructure failure because the pier column bents sheared out completely. Large movements due to the fault rupture underneath the bridge contributed to this failure. It is very unusual to have a right-bridge collapse because its superstructure rotated completely off its supports.. Figure 10 shows the collapsed spans of the bridge.

**Figure 10** Spans collapsed of Tong-tou Bridge
