# Behavior of Dams due to The Western Tottori Prefecture Earthquake in 2000

## ABSTRACT

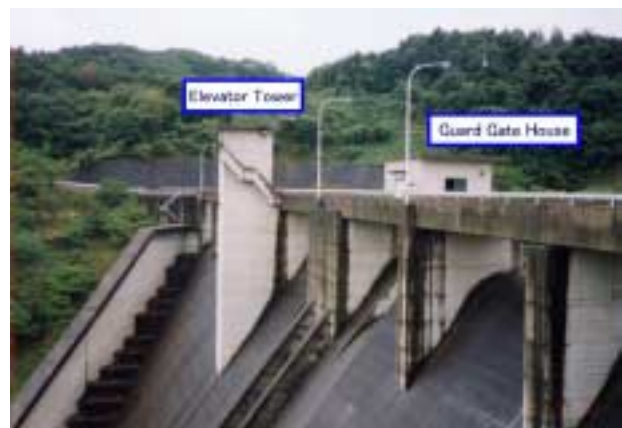
At the Kasho Dam (Photograph 1), the earthquake caused peak accelerations at the lower inspection gallery of 529 gal (north/south direction), 531 gal (east/west direction), and 485 gal (vertical direction). At the elevator tower at the crest elevation (Photograph 2), the peak accelerations were 2,051 gal (north/south direction), 1,406 gal (east/west direction), and 884 gal (vertical

Photograph 2 Elevator Tower and Guard Gate House of the Kasho Dam

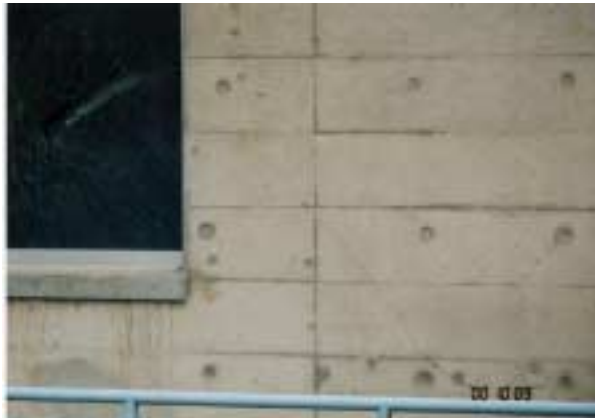
direction). The stream direction is 20 degrees east from north. At this dam, the wall (Photograph 3) and the foundation of the guard gate house that was a cantilever structure projecting upstream from the dam crest were cracked. But the drainage from the foundation, dam body leakage, and displacement of the dam body had stabilized so that there were no problems threatening the dam's safety. The water level in the reservoir dropped abruptly by 6 cm immediately after the earthquake. The level measurement, conducted at a later time, revealed that the upper end of the reservoir subsided about 20 cm as compared with the dam by the quake. It would be a possible reason for the dropping of water level of the reservoir.

Photograph 3 An Example of Cracks on Wall of Guard Gate House of the Kasho Dam (exterior wall surface on the right bank side)

The repairing works are planned to come into force shortly by Tottori Prefecture.

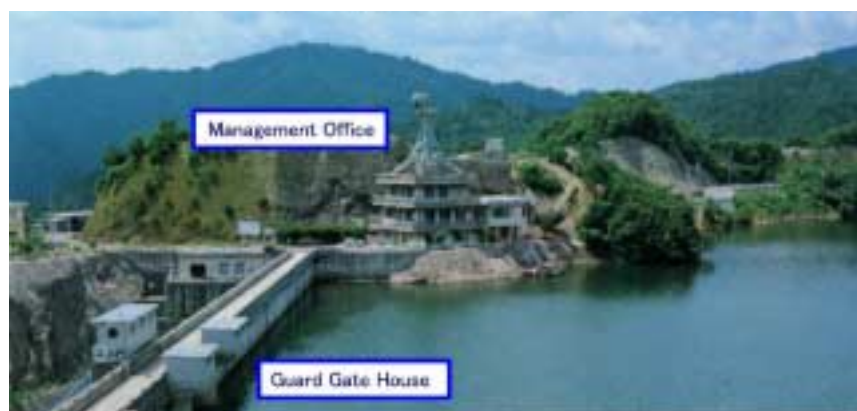
At the Sugawara Dam (Photograph 4), in the lower inspection gallery of the dam, the peak accelerations were 158 gal (downstream/upstream direction), 126 gal (right bank/left bank direction), and 109 gal (vertical direction). On the walls and the floor of the guard gate house that is a cantilever structure projecting upstream from the dam crest (Photograph 5), there were cracks that appeared to be extensions of the transversal joints of the dam (Photograph 6), and concrete on the dam's downstream surface was partially chipped (Photograph 7), but the no trouble of dam body was observed. Although the drainage from the foundation increased slightly immediately after the earthquake, it later stabilized. Near the dam and in the natural ground surrounding the reservoir, ground deformation caused cracking (Photograph 8). The Chugoku Regional Construction Bureau

Photograph 5 Upstream Surface and Guard Gate House of the Sugawara Dam

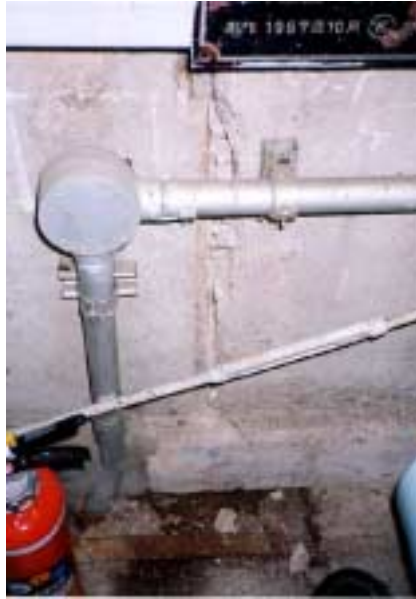
Photograph 6 Cracking on Wall of Guard Gate House of the Sugawara Dam  
(interior wall surface on the downstream side)

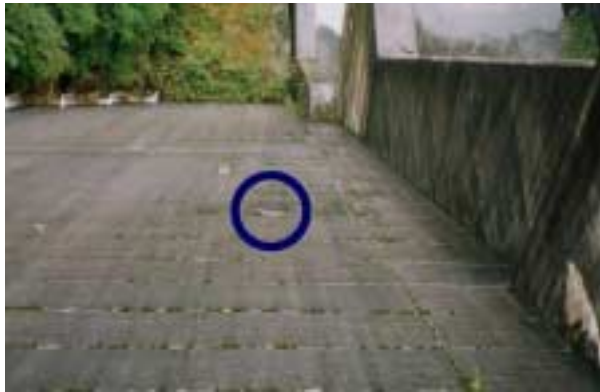
Photograph 7 Chipped Concrete on  
Downstream Surface of the Sugawara Dam

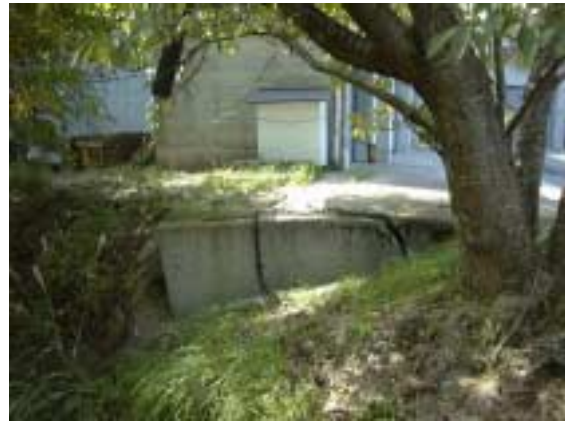
Photograph 8 An Example of Cracks in  
Ground Near the Sugawara Dam  
(near the garage on the downstream right  
bank)

has been monitoring the situation and counter-measures will be conducted by the end of this year.

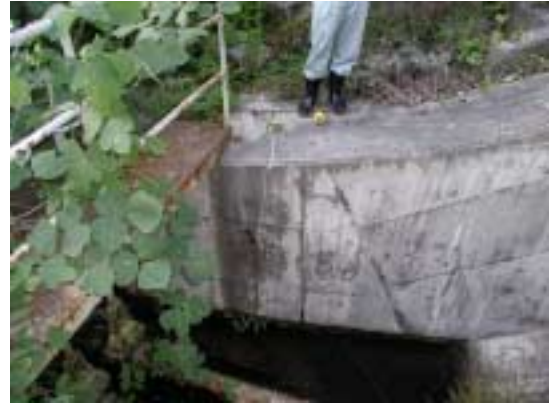
The Uh Dam (Photograph 9) is a regulating reservoir for the Ohmiya Dam that is for power generation and owned by the Chugoku Electric Power Co. and located upstream from the Sugawara Dam. This dam is a concrete gravity dam with a height of 14 m and a crest length of 34 m. Figure 2 shows its standard cross section. It is located about 1 kilometer from the fault estimated by the Geographical Survey Institute, Japan<sup>1)</sup> (hereafter called the "earthquake source fault"). During the earthquake, its reservoir water level was about 2 m below the full water level. The Hino Observation Station of the Digital Strong-Motion Seismograph Network (KiK-net)<sup>2)</sup> owned by the National Research Institute for Earth Science and Disaster Prevention is located 20 m from the Uh Dam. At this location, seismographs installed at the surface (S wave velocity of 210 m/s) and the underground (100 m below the surface, S-wave velocity of 790 m/s) recorded earthquake motion with a peak accelerations (combination of 3 constituents) of 1,135 gal and 607 gal respectively. Although the dam was subjected to this strong earthquake motion, the only damage to the dam was cracking with a width of 1 to 2 cm on the spillway channel near the foot of the downstream slope (Photographs 10). The embankment along the lakeside had slips caused small cracks. In addition, because of damage to the water supply facilities for power generation, after the earthquake, the water supply from the Ohmiya Dam to the Uh Dam was shut off and discharged into the reservoir of the Sugawara Dam.

Photograph 11 Cracking on the Spillway Channel Wall of the Uh Dam

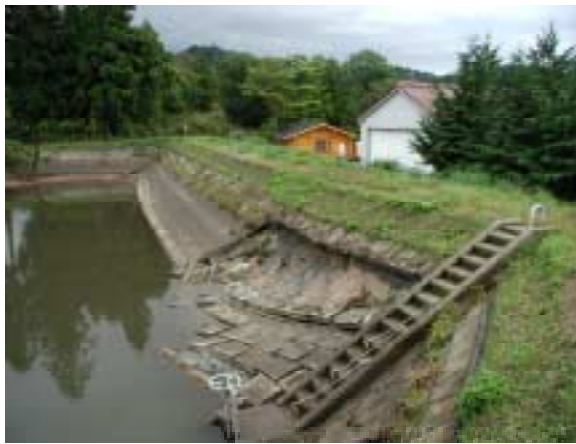
| # | Name of Earth Dam | Location | Distance from Source Fault (km) | Bedrock geology | Topography | Dam height (m) | Dam length (m) | Crest width (m) | Upstream slope gradient | Downstream slope gradient | Dam body material | Direction of the dam axis (right abutment) | Year constructed | State of damage |
|---|---|---|---|---|---|---|---|---|---|---|---|---|---|---|
| 14 | Kanayatani | Mizokuchi Town | 14.1 | Diluvial volcanic rocks | Flat land | 4 | 40×50×40 | 2.2 | 1:1.6 | 1:1.4 | Decomposed weathered granite | N8°E | | - Longitudinal crack over the full length of the crest, collapse of concrete blocks, bulging of the upstream slope, and breakage of the inclined sluiceway caused by the slippage of the dam body towards the reservoir |

Photograph 12 Damage to the Kanayatani Dam
