# Applicability of Seismic Design in Mitigating Progressive Collapse

## ABSTRACT

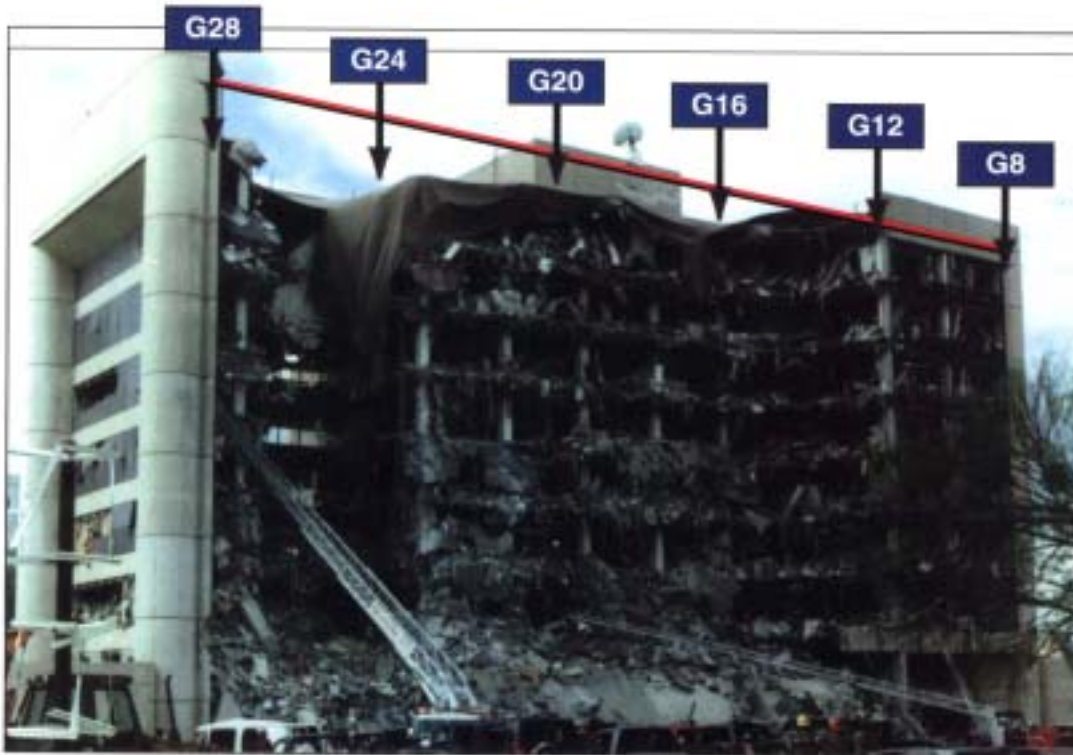
Figure 2. Damage to North and East Sides of Murrah Building

Focus of this report is performance of the nine-story portion of the Murrah Building and on use of seismic detailing to provide improved resistance to bombing. The nine-story portion of the building sustained significant damage and progressive collapse as a result of the April 19, 1995 bombing as shown in figure 2. Remaining portions of the nine-story and one-story buildings were demolished shortly after completion of the investigation. The parking structure sustained little damage and was not immediately demolished.

A forensic investigation of damage to the Murrah Building disclosed that failure occurred in three columns supporting a transfer girder on the north side of the building. One of these columns was destroyed by brisance or shattering while the adjacent two failed in shear. After losing support from the three columns, approximately 50 percent of the floor area of the building collapsed, producing a large number of casualties.

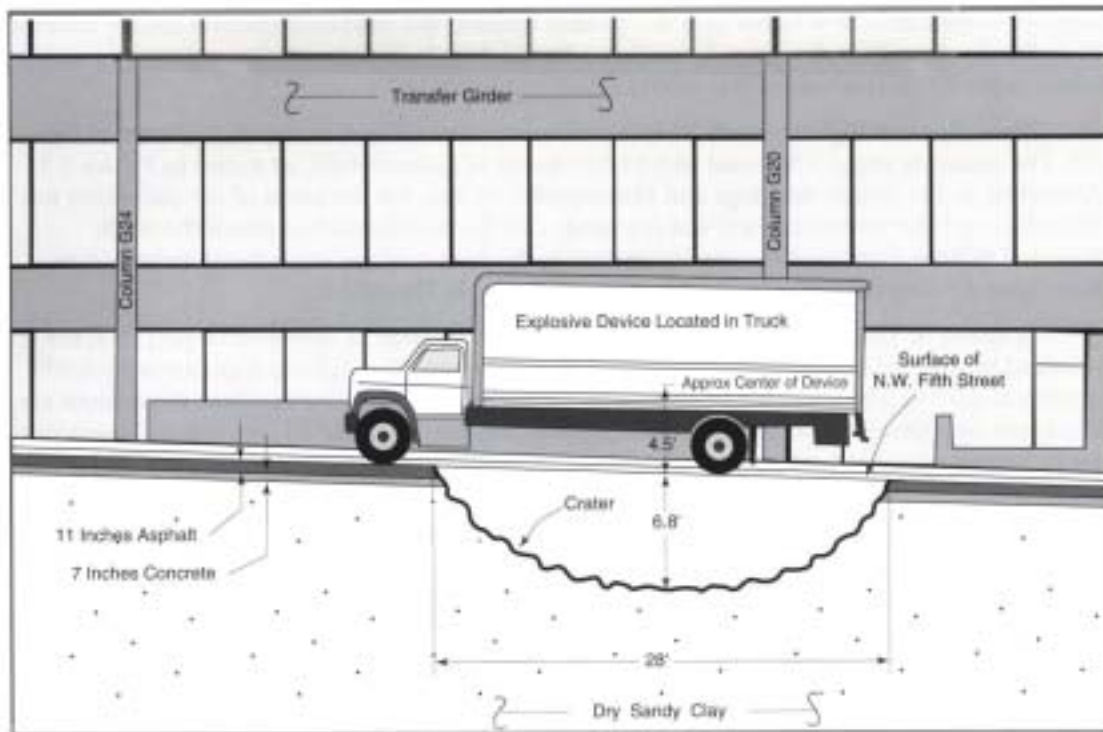
Fig. 3 Approximate Dimensions of Crater at North Face of Murrah Building

Based on observations made of the crater and other damage, the blast that damaged the building had a yield equivalent to approximately 1814 kg (4,000 lb) of TNT [2]. This extremely large explosion was centered approximately 4.8 m (15.6 ft) from Column G20 (see fig. 2 and fig. 3). The blast caused a crater approximately 8.5 m (28 ft) in diameter.

Figure 3 shows a drawing of the building north elevation with the explosive-laden truck parked in the street beside it. Also shown in the figure is the resulting crater. Figure 4 shows a plan view of the crater and location of the column nearest the truck. As reported in reference 1, a bomb having an explosive power equal to approximately 1814 kg (4,000 lb) of trinitrotoluene (TNT) was detonated in the truck.

Analysis of damage in the field and calculation of effects of the explosion determined that the nearest column, G20 as identified in figure 2 and figure 3, would have been destroyed by brisance or shattering. Approximately 12.2 m (40 ft) each side of the column that was destroyed, adjacent columns were found to have exceeded their shear strength, but been approximately at their flexural capacity. As a result, the adjacent columns failed in shear, thereby leaving the spandrel beam without

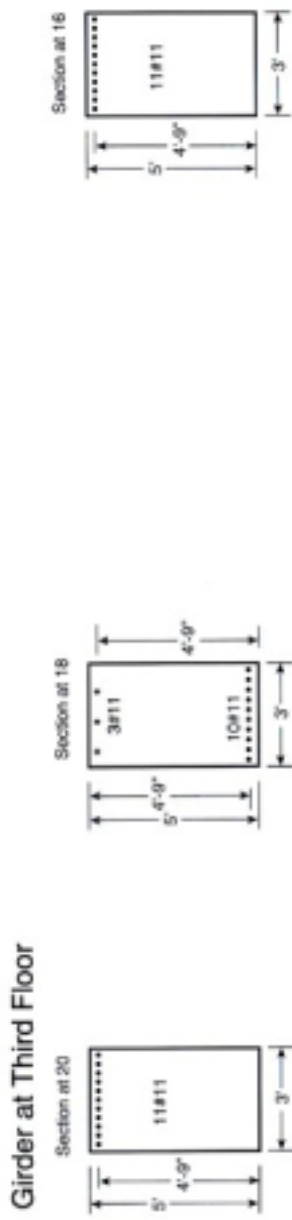
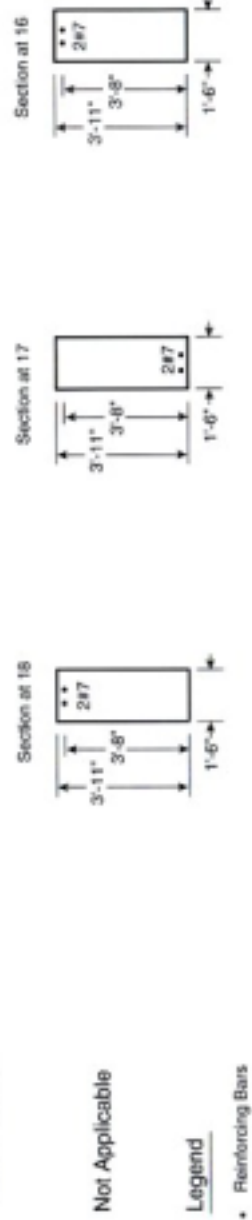
*Fig. 5 Cross-Sectional Distribution of Girder Reinforcing Bars.*

Transfer girder reinforcement is shown in figure 5. Three of the transfer girder top bars were continuous but none of the bottom bars were. A similar pattern was present in spandrel girders above the third floor as shown in figure 5. Consequently, there was no effective integrity reinforcement in the spandrels of this building. It must be noted that at the time the building was built, no integrity reinforcement was required. Analyses show that this building met or exceeded code requirements in every way that was checked.

If integrity reinforcement in the spandrel beams of the Murrah Building was maximized by making all of the bars continuous with full capacity mechanical butt splices, significant increase in the capacity of Mechanism 2 of figure 6 would be realized [5]. Using Mechanism 2 with 100 percent of the bars spliced with full capacity mechanical butt splices, calculated capacity of the building would be at least 6.7 kPa (140 psf). Unit weight of the building, including some live load, is approximately 5.3 kPa (110 psf). Consequently, even if one column had been removed the building would not have collapsed.

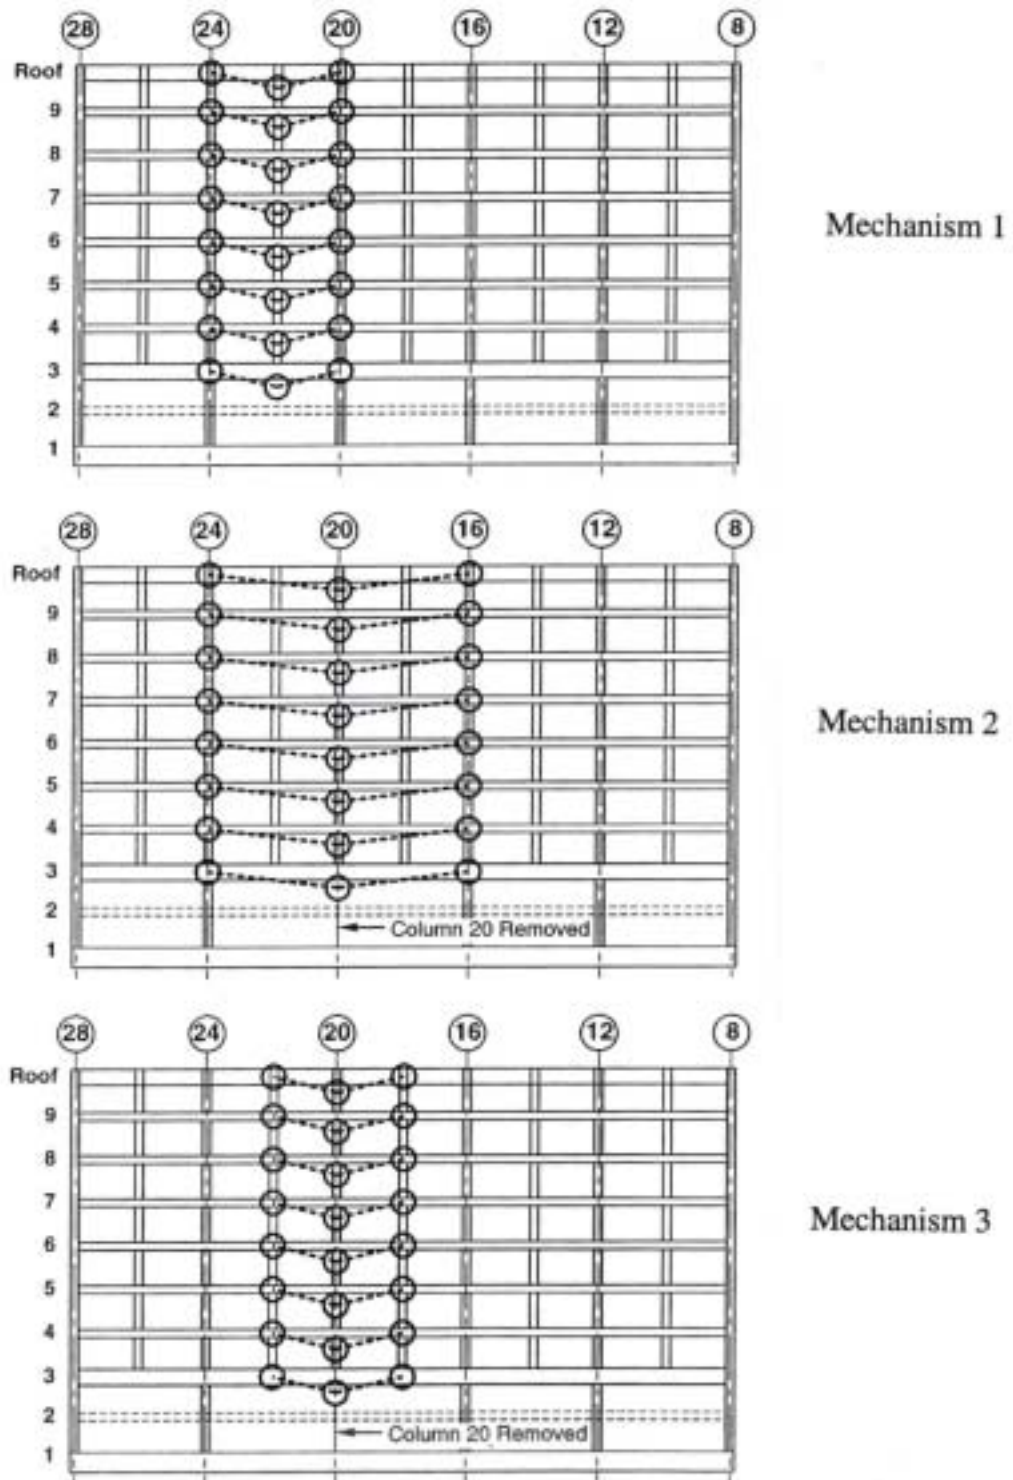
Figure 6. Possible Mechanisms with No Columns Removed and One Column Removed.

In reference 1, an analysis is made with one column removed. The three mechanisms that could develop after removal of one column are shown in figure 6. Calculations indicate that Mechanism 2 results in a capacity of approximately 2.9 kPa (60 psf) to 3.4 kPa (70 psf) floor above the spandrel beam. This is significantly less than the approximately 5.3 kPa (110 psf) of self-weight plus live load that existed in the building. Consequently, removal of any one column supporting the as-built transfer girder would cause failure of all of the floors above over a length of about 24.4 m (80 ft).
