**UJNR Panel on
Wind and
Seismic Effects**

Panel Update

Volume 1, Number 4, December 2003

REPORT ON THE 26 SEPTEMBER 2003 TOKACHI-OKI EARTHQUAKE, JAPAN

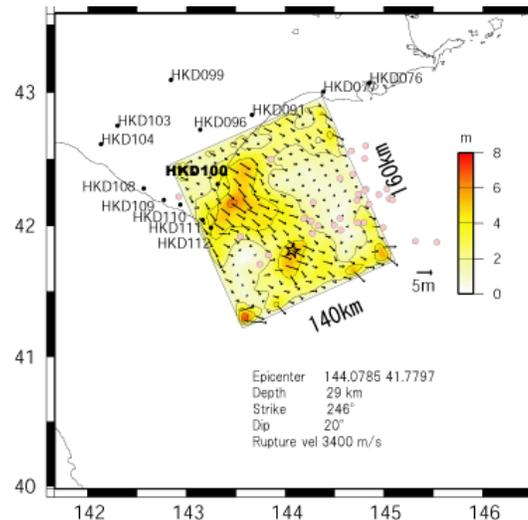
Figure 1 Estimated slip distribution on the fault plane. Colored circles are thrust type aftershocks. The star shows the epicenter. Arrows indicate the amplitude and direction of slip.

Figure 1 shows the estimated total slip distribution, which consists of two major slip areas; (a) around epicenter and (b) the north-west part of the fault with the maximum slip of 7.1 m. Relatively small slip velocity (~ 0.75 m/s) and long slip duration (nearly 13 sec) are obtained at region (a). This corresponds to the fact that onsets of direct waves were obscure in many observed seismograms.

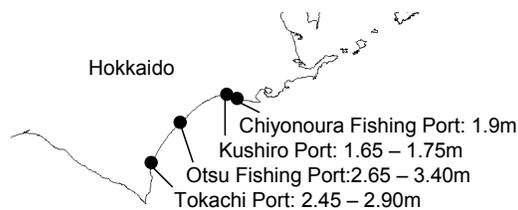
The Tokachi-oki Earthquake in 2003 generated a series of tsunamis. The main shock occurred at 4:50 (JST) on 26 September. The tsunamis were observed on the Pacific coasts from Hokkaido to the Tohoku region in Japan. Many researchers including members of PARI conducted tsunami field survey started at the same day, when the main shock occurred. The highest evidence of tsunami run-up was found at Cape Erimo and it was 4.0m. The tsunami height of 2.5m was observed at the tide station in the Tokachi Port at 5:24 (JST) about 30 minutes after the main shock. After the tsunamis arrived at the coasts in Hokkaido, they propagated along the coasts like edge waves and a number of tsunami attacked the coasts. At the Kushiro Port, the first tsunami of 1m arrived at 5:06 (JST), the maximum tsunami of 1.2m observed at 9:03 (JST) and a 1m tsunami attacked again at 14:20 (JST). At that time tsunami inundation occurred because the tsunami added to the normal high tide and the resultant sea level became high. At the Tokachi River, the tsunamis ran up 11km from the river mouth.

Figure 2 Tsunami run-up measured by PARI

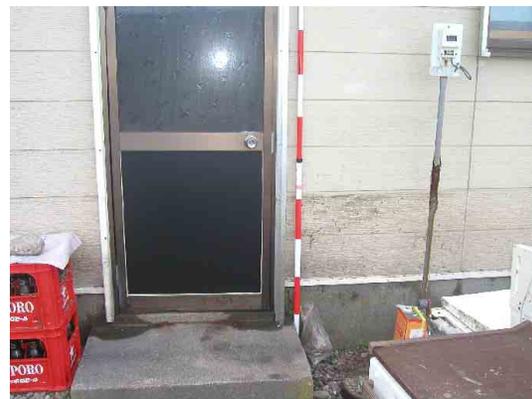
Photo 1 Evidence of tsunami run-up at Tokachi Port

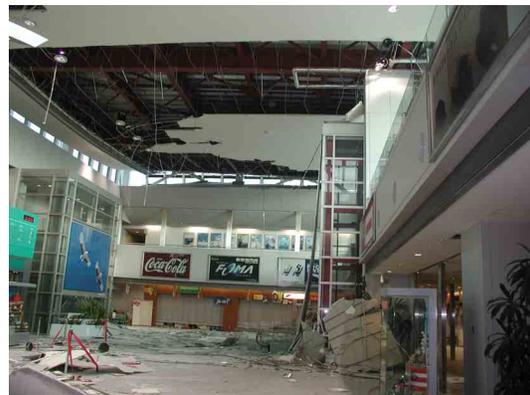
The three edges (north, south and east) of the ceiling were separated from surrounding structural elements and only the west edge was rigidly connected to the structure. Due to the pounding of the ceiling to the west structural frame, a large area of the ceiling fell down. No one was injured due to the early morning shock.

Photo 3 Damaged ceiling

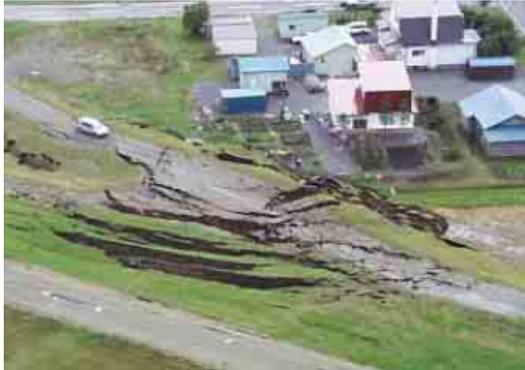
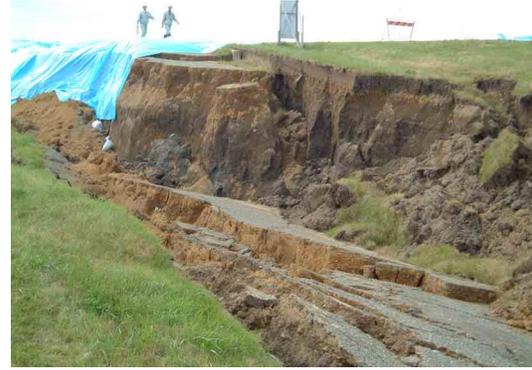
River dikes in Obihiro area including Tokachi river, Urahoro-Tokachi river and Usikubibetsu river were severely damaged during the earthquake. The total length of the damaged dike adds up to more than 25 km. Typical layout of the dikes in the area, particularly for the dikes of Tokachi river, has geometry of 5-10 m wide crest, 4-8 m height and gentle slope angle of 1:5. The observed damage to the dikes is mostly longitudinal crack and settlement of crests and lateral spreading of the gentle slopes as shown in Photo 4. The similar damage to the dikes in this particular area was observed during the 1993 Kushiro-oki earthquake.

In this area, extremely soft peat soil prevails the ground surface and ground water table are close to the ground surface. The dikes in this area, which were constructed using sandy soils, have significantly settled, causing the base of the dikes penetrated into the foundation soil. The mechanism and the main cause of the damage to the dikes is presumed to be liquefaction of the dike material blow the ground water table, which is similar to that during the 1993 event.

Photo 4 Collapse of slope of Tokachi river dike (right bank, 3.5 km from river mouth)

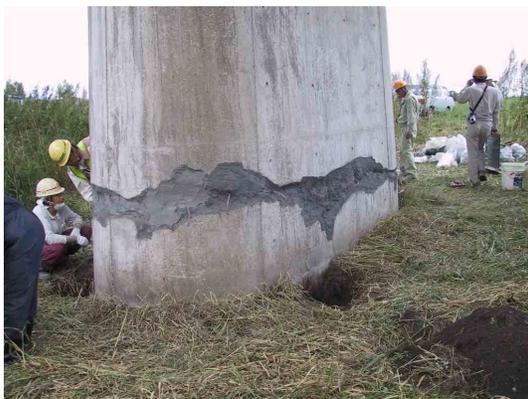
Chiyoda Bridge (Photo 5)

Chiyoda bridge was constructed in 1966 and has 15-span simply-supported girder/truss bridge with total length of 706m. The substructures are wall-type RC columns. The damage was developed at the mid-height sections of RC columns where some of the longitudinal reinforcement is terminated. Photo 5 shows the damage of Pier #13 in which the heaviest damage was found. The cover concrete was spalled-off, and some of the longitudinal reinforcement was buckled at the section. The columns was repaired and strengthened by concrete injection and steel jacketing.

Photo 5 Damage of wall-type reinforced concrete columns (Chiyoda Bridge). Spall-off of cover concrete was repaired by concrete injection.)

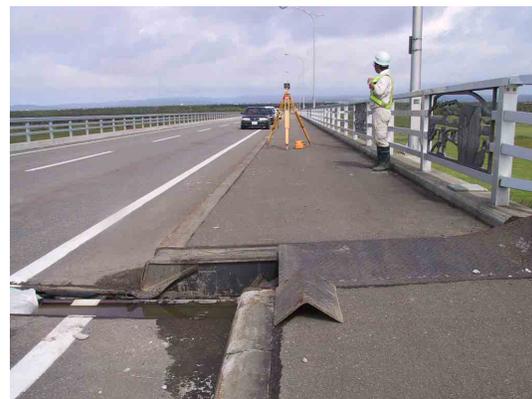
Tokachi River Bridge (Photo 6)

Tokachi river bridge with total length of 926m was completed in 1992. The bridge consists of 3 superstructures with 3-span continuous PC box girders and 3-span PC frame bridge. The substructures consist of wall-type RC columns and pile foundations. The bridge is located close to the fault zone where very strong ground motion was observed. The bearings were failed and the residual displacement of about 70cm in the transverse direction was developed at the continuous box girders as shown in Photo 6. Damage to substructures was not found.

Photo 6 Damage of bearings and transverse residual displacement of deck (about 70cm) (Tokachi River Bridge)

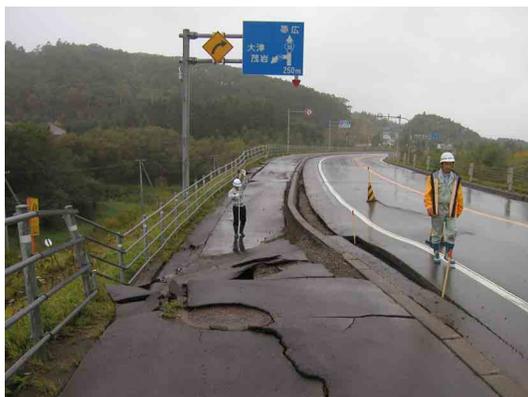
This part of the highway is an approximately 10m high embankment that connects with the dike of Tokachi River. A longitudinal crack was observed on the slope of embankment, and the road surface was settled over approximately 15m long (Photo 7).

Photo 7 Approach of Toyokoro Bridge,
National Highway Route 38 (Photo by
Hokkaido Development Bureau)

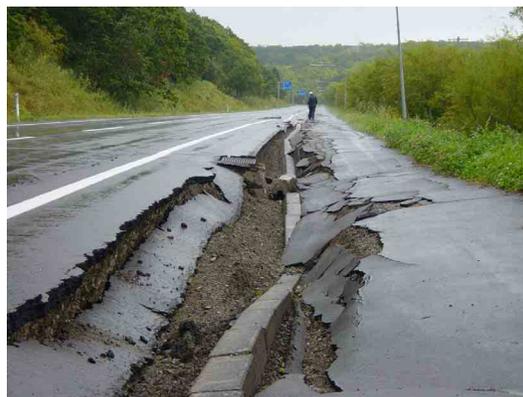
This portion of the highway is a half-bank and half-cut. The valley-side of embankment is a swamp, and the groundwater level seemed to be high. The sidewalk was collapsed over more than 100m and the roadway was partially damaged (Photo 8).

Photo 8 Chobushi, National Highway Route
336

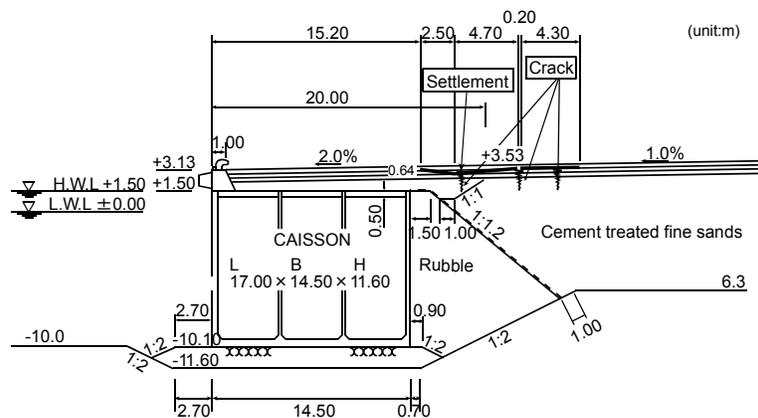
The major damage of port facilities during the 2003 Tokachi-oki Earthquake is No.4 pier caisson type quay wall (-10m, $k=0.2$) of Kushiro port moved toward sea 10cm to 20cm and large settlement (roughly 0.5m) of apron occurred as shown in Figure 3. The reclaimed material is cement treated dredged fine sands (SPT $N=10$), the PGA at Kushiro port were 575 Gal in EW, 347 Gal in NS and 149 in UD respectively. The key point of the damage mechanism is behavior

of backfill rubbles and cement treated soils during the earthquake as follows, 1) the confining pressure of backfill rubbles should be suddenly decreased due to movement of the caisson, 2) then re-arrangement of rubble particles occurred, 3) cement treated fine sands could not follow the deformation of backfill rubbles, 4) large settlement occurred just behind the caisson body.

Figure 3 Cross section of -10m caisson type quay wall at Kushiro port No.4 pier

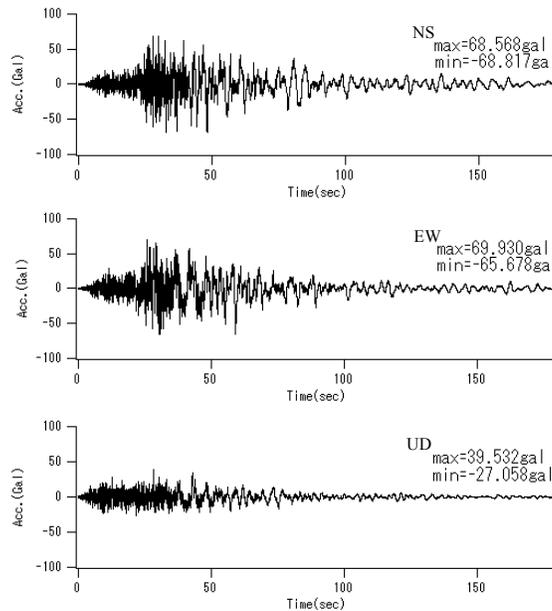
During the earthquake, Tomakomai Port was shaken with 70 Gal in EW, 69 Gal in NS and 40 Gal in UD respectively, long period component of 5-8 second and around 180 seconds duration as shown in Figure 4. The cylindrical oil tank (a diameter of 43m, oil depth of 18m and the natural period of first mode of sloshing is 7.1 sec) having floating roof burned due to the earthquake. From the results of back analysis of tank during the earthquake, the maximum uplift of the floating roof occurred 3m at 48sec in EW and 2.3m at 80sec in NS respectively.

Figure 4 Strong motion records at Tomakomai port during 2003 Tokachi-oki Earthquake

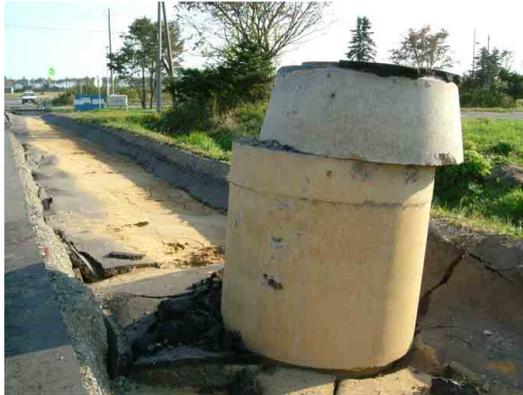
Sewer facilities in Obihiro area and Kushiro area were severely damaged during the earthquake. The amount of damage to sewer facilities is up to 5 billion yen. The observed damage to the sewer facilities is mostly uplift of pipes and manholes and settlement of road surface above the damaged pipes as shown in Photo 9. The damaged pipes were constructed by the open-cut method, in which sandy soils were used for backfill. The similar damage to the sewer pipes in Kushiro city and Kushiro town was observed during the 1993 Kushiro-oki earthquake and the 1994 Hokkaido-Toho-Oki earthquake. The most of the damaged pipes were located in wetland, where extremely soft peat soil prevails the ground surface and the ground water levels are shallow. Liquefaction of the backfill soil blow the ground water level was considered to be a major cause of the damage, while amplification of the ground motion at the peat layer was considered to affect the extent of the liquefaction of backfill soil.

Photo 9 Ejected manhole and settlement of road surface
