# **CARBON COMPOSITE SEISMIC RETROFIT OF REINFORCED CONCRETE COLUMNS WITH CORRODED REINFORCEMENT**

**Wilkins Aquino, Assistant Professor, Cornell University, Ithaca, NY**  
**Neil M. Hawkins, Professor Emeritus, University of Illinois at Urbana-Champaign**

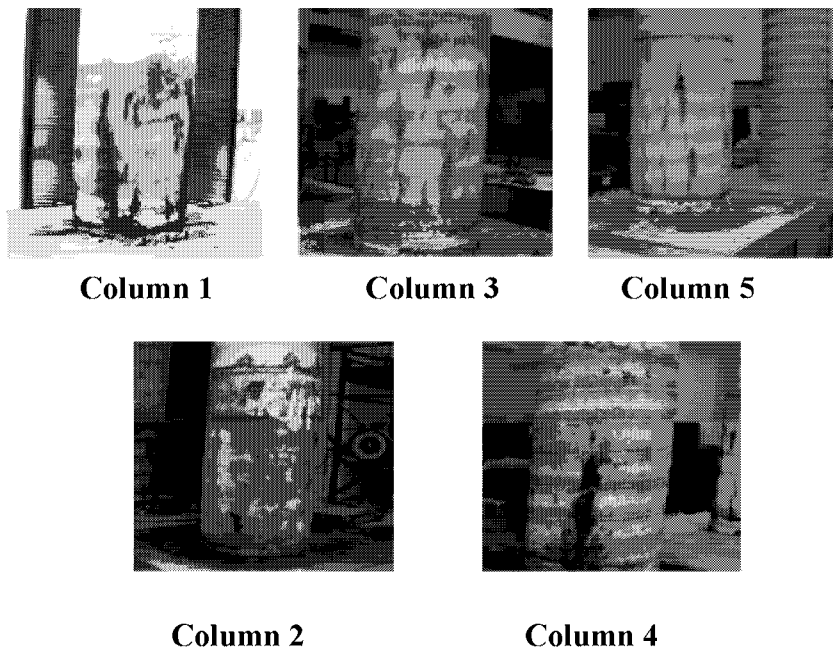
**Figure 4. Columns at Completion of Accelerated Corrosion**

At termination of the corrosion process no spalling of the concrete cover had occurred. However, the level of corrosion in terms of width and extent of splitting cracks, and of corrosion products, duplicated the extant conditions for many field columns.

**Visual assessment of corrosion-damaged columns.** Figure 4 shows the appearance of the columns at the end of the corrosion process. In every case vertical cracks formed on the column surfaces along the lines of the longitudinal reinforcing bars. In some cases horizontal cracks also delineated the positions of the lateral steel hoops. The amounts of dark corrosion products deposited on column surfaces varied noticeably from specimen to specimen, despite each specimen having been subjected to the same corrosion level.

For repair, the reinforcement in the columns was exposed and a visual assessment was made of the uniformity and extent of corrosion damage. The amount of reinforcing steel deterioration was similar in all columns. Column bar material losses were concentrated on the parts of their surfaces closest to the exterior of the column. Dowel bars showed far less corrosion damage than column bars. This result was expected because dowel bars were not connected directly to the circuit and could interact electrically with column bars only through metal spacers left during construction and through the lateral steel hoops. In every column, the lateral steel hoops were severely damaged with entire cross sections lost at localized points in several cases.

**Repair Process.** The repair process consisted of removing deteriorated concrete to a depth of 25 mm (1 in) beyond the dowel bars, cleaning the corroded reinforcing steel, casting repair material, and wrapping the columns using CFRP. Due to the confinement provided by the composite wraps, it was not considered necessary to replace deteriorated hoop bars many of which had corrosion fractures. The repair material was a normal strength concrete with a 28-day

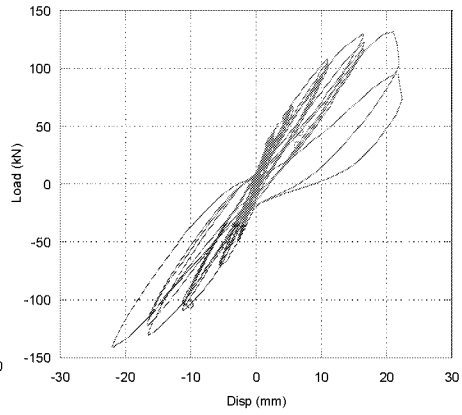
**(b) Column 4 –Corroded and Unretrofitted**

**Column 4- Unrepaired Corroded Column.** Figure 5(b) shows the load-displacement response. The hysteretic behavior was stable up to a load of 133 kN (30 kip) and a maximum displacement of 21 mm (0.8 in). Subsequent cycles to the same displacement resulted in a marked decrease in load capacity in the positive direction, while capacity in the negative direction remained unchanged. At that peak displacement corrosion cracks parallel to the column steel opened significantly. The column was declared to have failed in spite of the residual capacity for one direction of loading.

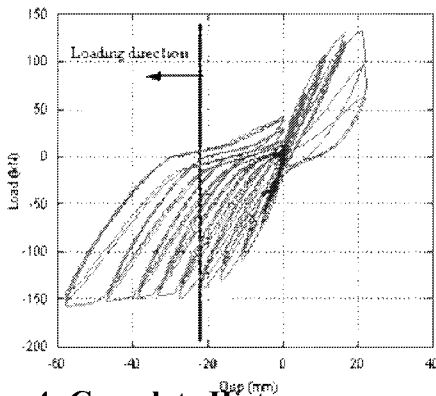
**(c) Column 4- Complete History**

Because the load in the negative direction could still be increased, the residual capacity of the column for that loading direction was investigated. Additional displacement increments were applied according to the standard load history, but in the negative direction only. Figure 5(c) shows a load-deformation plot for the full loading history of the column. A clear yield plateau occurred for the negative half of the load-deformation plot at a load of 142 kN (32 kip) and a displacement of 25 mm (1 in.). The maximum load was 150 kN (34 kip) at a displacement of 58 mm (2.3 in). Failure during cycling in the negative direction occurred due to rupture of the deteriorated lateral hoops and subsequent buckling of the column bars.

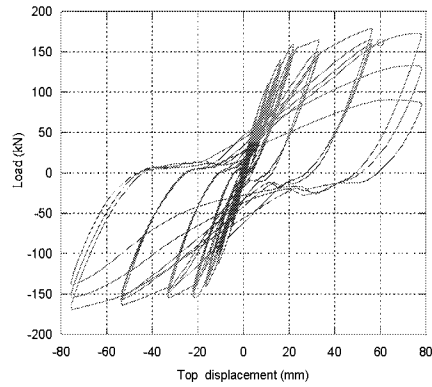
**(d) Column 2-75mm Bands**

**Column 2 – Retrofitted with 75 mm Bands.** The load-displacement plot for this column is shown in Figure 5(d). Well-defined yielding and stable hysteretic loops in both directions of loading characterized its behavior. The maximum load was 169 kN (38 kip) and the corresponding displacement and displacement ductility ratio were 78 mm (3.1 in) and 3.5, respectively. The hysteretic response of Column 2 shows pinching in the form of strong convexity of the load-deformation curve near the horizontal axis after the yield load was attained. The pinching was attributed to partial bond-slip failure of the dowel bars because rigid body motions between the column and foundation beam as measured by the cable transducers were negligible.

Although Columns 2 and 3 both had yield and ultimate load capacities exceeding those of the control Column 6, their ductility capacities differed significantly. Column 2 exhibited marked pinching, signifying bond-slip degradation, shortly after reaching its yield load while Column 3 exhibited little pinching throughout the test. This is a surprising result since repair was performed similarly for both columns. In addition, the FRPC theoretically provided the same degree of confinement for all columns. However, inspection after testing was completed of the repair concrete used in Column 2 revealed poor compaction around the reinforcing steel, providing the reason for the marked pinching observed in its load-displacement response.

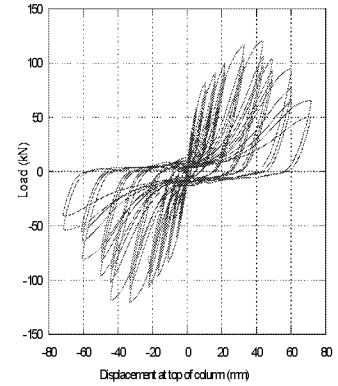
**(g) Column 1-Full Jacket**

**Column 1 – Retrofitted with Continuous Jacket.** The load-deformation plot for Column 1 is shown in Figure 5(g). The hysteretic response was similar for both directions and the column showed stiffness degradation early in its loading history. The response showed no distinctive yield point. Successive load peaks increased following a non-linear trend until a maximum load of 120 kN (27 kip) and a corresponding displacement of 43 mm (1.7 in) were reached. For greater displacements the response showed increasing softening and the test was stopped when the load dropped to 70 kN (15.7 kip). Marked pinching characterized the load-deformation response from early in the loading. The cable transducers attached to the column indicated negligible rigid body translation or rotation during the test. Hence, the pinching was caused mainly by bond-slip failure. The strain gages installed on the reinforcing bars indicated that they did not reach yield, confirming bond-slip problems.

Column 1, retrofitted with a continuous jacket, also did not perform as expected, failing at a load and displacement significantly lower than those of the control column. Pinching, as in other cases, was associated with bond-slip failure at the dowel reinforcement. The lack of rigid body motions shown by this column reaffirms the bond-failure hypothesis. In contrast with the behavior shown by Columns 2 and 3, pinching in Column 1 occurred before yielding of the reinforcement, as confirmed from strain measurements during the test. Cross sectional cuts were made after failure of Columns 1 and 3 to visually inspect the concrete. Again it was observed that the concrete was very poorly consolidated around the column and dowel bars in Column 1, while the same concrete in Column 3 was sound and well compacted. The cause of premature failure of Column 1 was poor consolidation of the repair material.

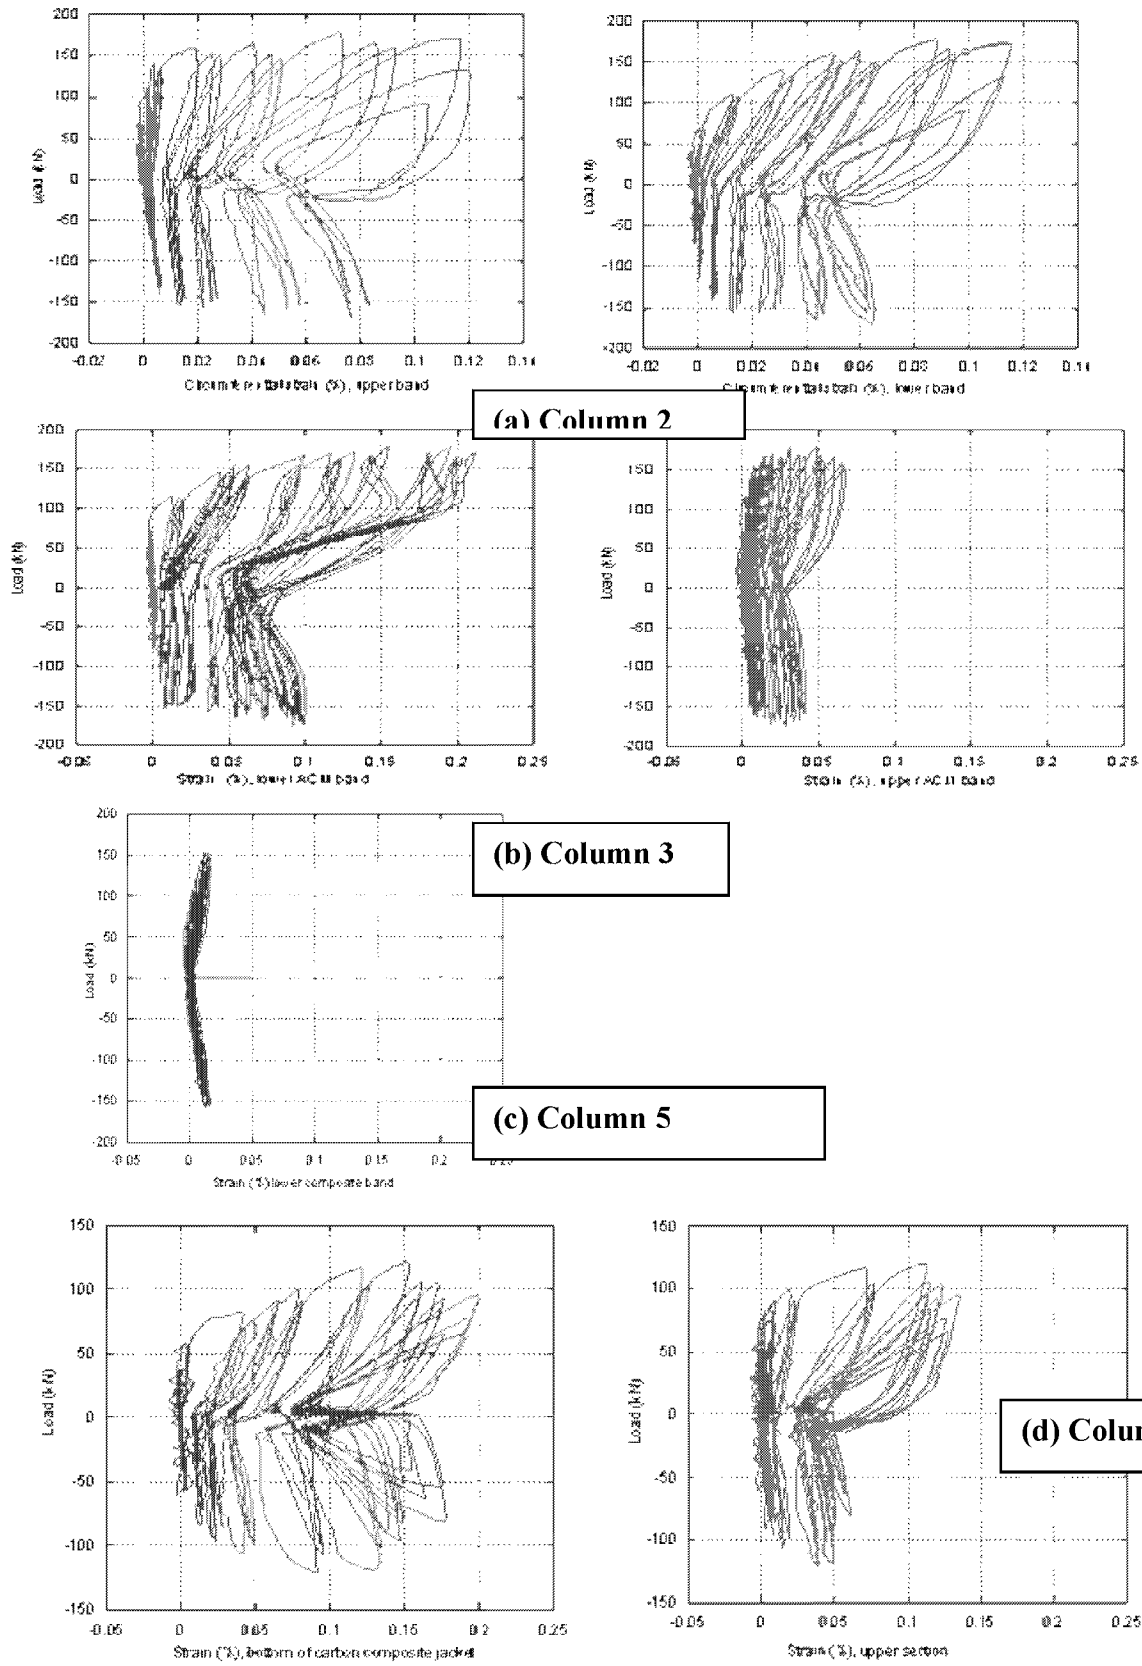
**Figure 6. Circumferential Strains in FRPC wrans**

Load-circumferential strain plots for the FRPC bands are shown on Figure 6(a). As the load increased the load-deformation cycles shift to the right, signaling damage in the concrete enclosed by the composite bands. That increase in circumferential strain was due to volumetric expansion of the concrete caused by its progressive damage. For the compression side the expansion was due to the high longitudinal compressive stresses causing marked lateral expansions, while for the tension side circumferential strains also increased due to concrete splitting caused by mechanical locking of bar lugs with surrounding concrete.

Figure 6(b) shows load-circumferential strain plots for the two lowermost FRPC bands. The strains in the lower band were significantly higher than those in the upper band. The maximum strain measured in the lower band was 0.21%, while that for the upper band was only 0.07%.

Figure 6(c) shows the load-circumferential strain plot for the lowermost FRPC band. Strains were small compared to the strains developed at maximum load for Columns 2 and 3. That low strain shows that little damage occurred in the concrete in compression and/or bond-slip before testing stopped. Clearly, the maximum load carrying capacity of this column was not reached, but probably that capacity was comparable to the capacities of Columns 2 and 3.

Load-circumferential strain plots for the FRPC jacket are shown in Figure 6(d). Strains started to increase rapidly at the relatively low load of 50 kN (11 kip). A maximum strain of 0.2% was registered by the lower gage and of 0.13% by the upper gage, despite the relatively low load capacity of the column. Again, this result supports the finding of a bond-slip type of failure.

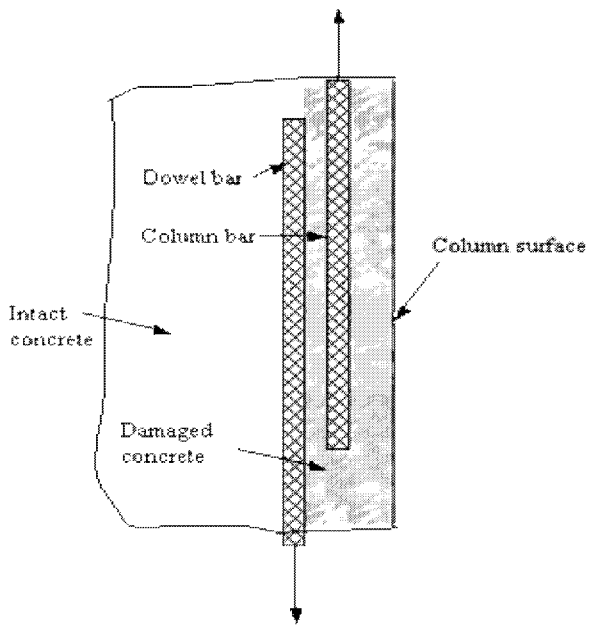
**Figure 7. Conceptual Model of Corrosion Damage**

**Importance of Repair Process.** Bond degradation dependent on the extent of corrosion was the primary factor controlling the structural response of the specimens. Figure 7 illustrates conceptually the extent of the damage in the concrete surrounding the column and dowel bars as a result of the corrosion process. Only column bars were directly connected to the external power source so that dowel bars experienced little damage from direct corrosion. However, the load capacity of Column 4 (corroded and not repaired) was 80%, and the maximum displacement was only 25%, of that of the non-corroded control column. Those facts, along with observations of the interior of the specimen after cyclic testing, document that damage in the concrete extended to the exterior surface of the dowel bars, and that therefore there was degradation of the concrete between the dowel and column bars.

The degradation of Column 4 can be explained as follows. During loading, tensile stresses are transferred from dowel bars to column bars through shear stresses in the concrete between bars. Limited capacity exists in corroded columns to carry these shear stresses because of cracking and accumulation of rust products in the concrete between dowel and column bars. Axial stresses in column and dowel bars cause radial stresses in the surrounding concrete due to the interlocking of bar lugs and concrete. Radial stresses widen the existing cracks produced by the build up of corrosion products, resulting in further loss of bond and causing loss of column flexural capacity.

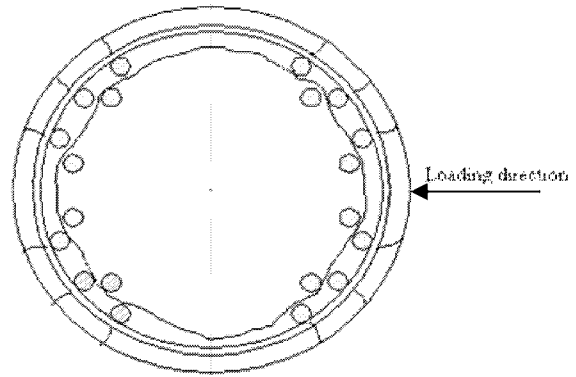
**Figure 8. Crack-Damage Pattern After Corrosion**

Figure 8 shows the crack-damage pattern for corroded specimens observed in this research. The pattern is consistent with that reported by Lee et al. (2000). Direct installation of ACM on the surface of a corroded column with the crack pattern of Fig. 8 is of little help in improving the structural behavior for lateral loading. Volumetric expansion of the concrete is required before the confinement provided by the ACM is activated, which translates into further opening of existing cracks and, hence, reduced interlock and transfer capacity across the crack surfaces. Damaged concrete must be removed and replaced before a column is wrapped with ACM.
