Recent Studies on Fatigue of Orthotropic Steel Deck at PWRI

Jun Murakoshi¹ and Noriyasu Arima²

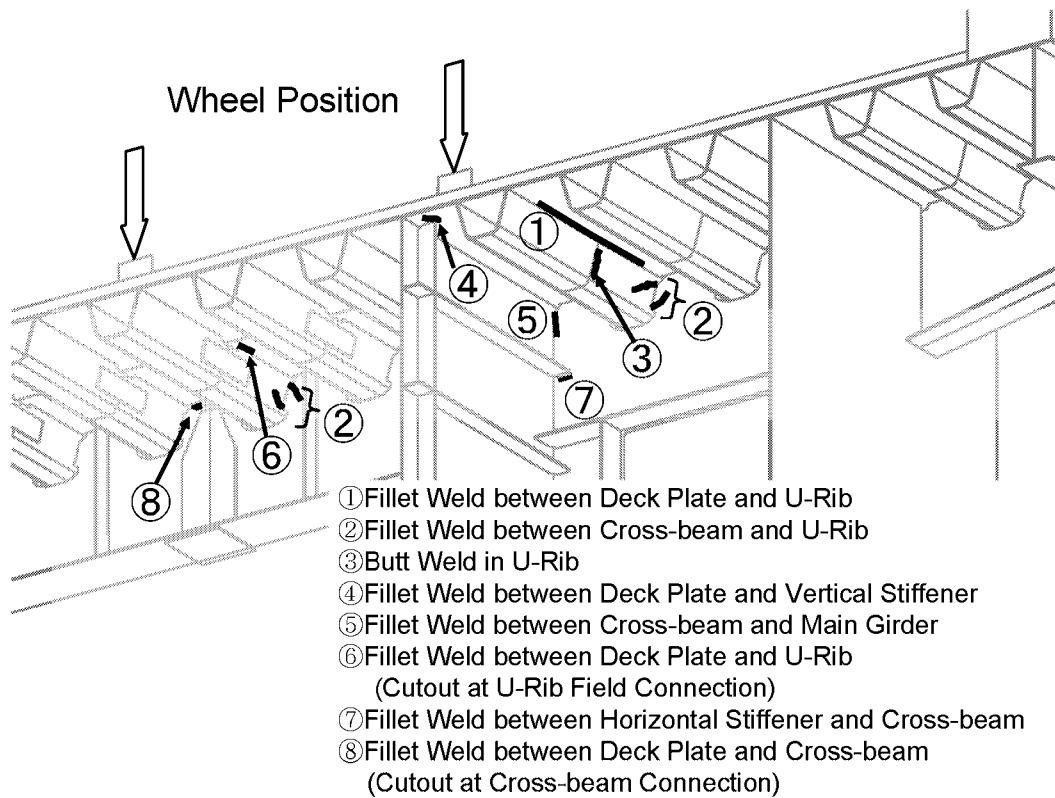
Orthotropic steel deck system is widely used in long-span bridges and urban viaduct bridges to help reduce self-weight of superstructure. Orthotropic deck is composed of thin plate members connected by welds and bolted splices, and subjected to direct wheel load of vehicles. With rapid development of large vehicle weight and traffic volume, fatigue cracks have been reported for some welded connection details, such as rib-to-deck connection, rib-to-diaphragm connection, cutout details (Figure-1) of orthotropic steel decks subjected to heavy wheel load. Recently, two severe types of fatigue crack have been reported at rib-to-deck connection. Both are root cracks which initiate at the root of the one-side fillet weld. As shown in Figure-2, one type propagates to the rib-to-deck weld bead while the other is propagated inside the deck plate.

Figure-1 Fatigue Damages of Orthotropic Deck Bridge

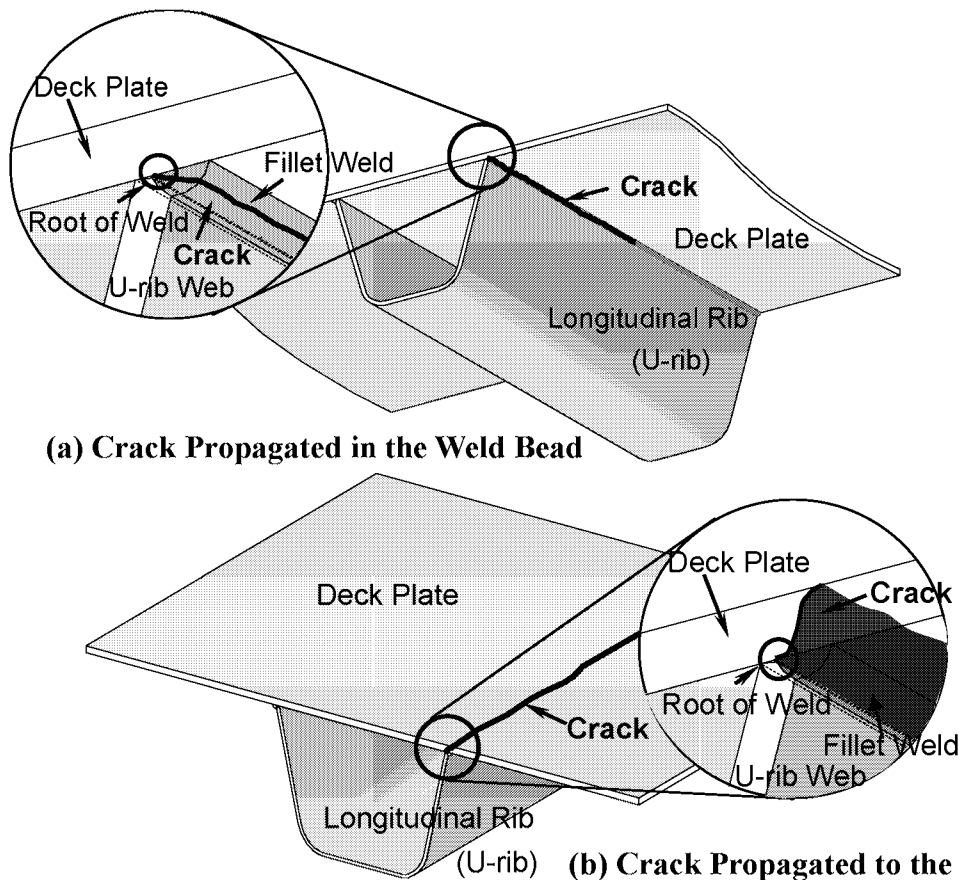
Examples of cracks that have penetrated a deck plate have been recently reported. As shown in Figure-2(b), on those spots, cracks have propagated along the weld lines, severely damaging the pavement. If those cracks propagate more, a cave-in may occur in the road surface.

Figure-2 Fatigue Crack at the Weld between U-rib and Deck Plate
