# Study on Evaluation of Deterioration of Atmospheric-Corrosion-Resistant Steel Bridges

Civil Engineering Research Institute of Hokkaido<sup>1)</sup>

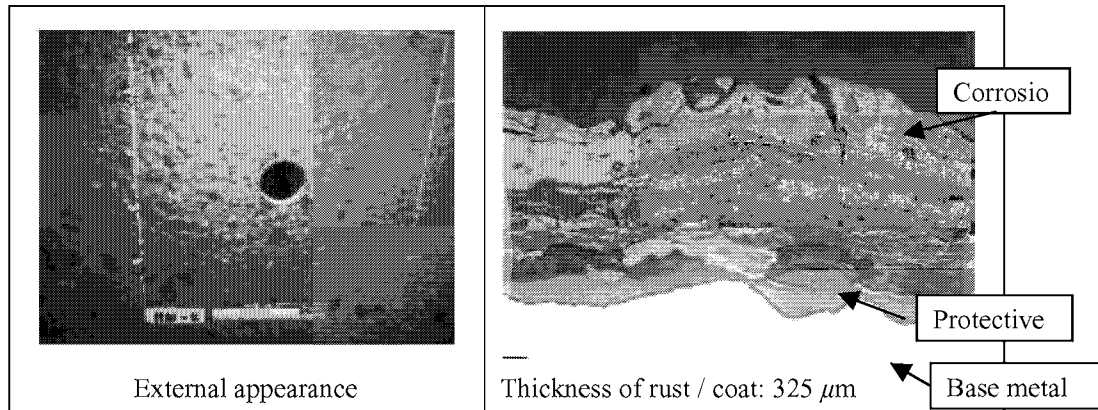
Figure 6(3). Observation results for web plate (1) of Misaki Overpass

### 3.3 Misaki Overpass (web plate No. 1)

External appearance: Rust with lamellar detachment has formed over the entire surface of the plate. For this, a rating of E3 is given.

Layer thickness: The rust layer is  $325\ \mu$  thick and is rated at 3.

Core status: A thick layer of corroded material has formed on the surface of the plate. A protective layer has formed on the surface of the base metal.

Evaluation: While a layer of rust with lamellar detachment has formed on the surface of the plate, a good protective layer has also formed. For this, a rating of C3 has been given which is in conflict with the external evaluation.
