ANALYSIS OF DAMAGE OCCURRING IN STEEL PLATE GIRDER BRIDGES ON NATIONAL ROADS IN JAPAN

Abstract

Data on damage found in steel bridges on national roads in Japan as a result of inspections over a recent approximately ten-year period were collated and analyzed. The subjects of this research were non-composite and composite steel plate girder bridges, which were selected because they are the most common types of bridges in the country. Three types of damage were studied: corrosion, cracks in steel and cracks in concrete decks. The corrosion was remarkable at the ends of girders; cracks in steel were often found at the end of stiffeners in connecting parts of main girders and cross beams, and cracks in concrete decks were most likely to have occurred at the end of main girders and at points one-fourth of the way across on spans.

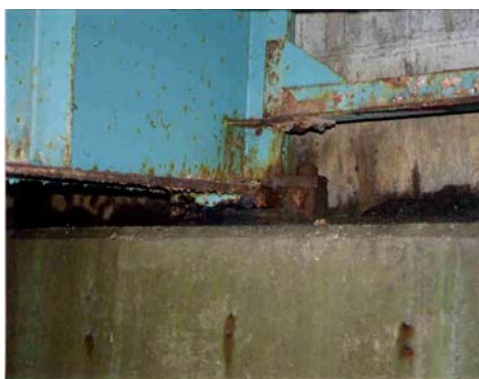
a. End of girder

Among the non-composite type, 35 bridges were corroded at the end of a girder. The rate was 92.1 % of all corroded bridges. Among the composite type, 38 bridges, 88.4 %, were the same. Corrosion cases are shown in Fig 3.5 a.

Comparatively older bridges tended to corrode as a whole on the span. Water leaks from expansion joint and drainage, besides water pool and moisture around bearings made girder ends corrode rapidly in many cases.

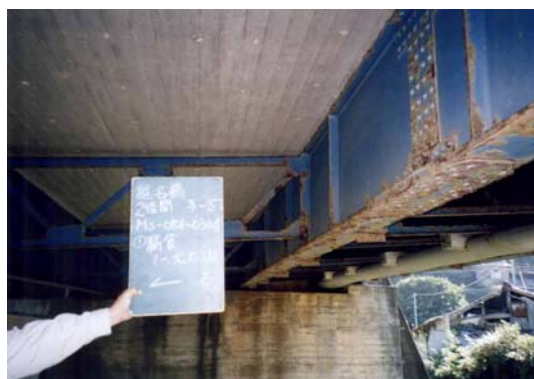
b. Splice plate

There were bridges corroded in the middle part of inner girders, the cross part of flanges on outer girders and webs, and splice plates. These were examples of corrosion other than that at the end of girders that had progressed. An example of corroded splice plates is shown in Fig. 3.5 b. There are also cross beams or stringers corroded progressively with cracks. Even among the comparatively recently built bridges, particularly those built using corrosion-resistant steel and to which freeze-resistant coatings were applied had local corrosion. Some bridges held water on its members and the corrosion progressed because of damage of drainage or irrelevant drain hole. Water had leaked through cracks in the deck, and corrosion at upper flanges in main girders was found. However, only two bridges (5.6%) were cases of corrosion being found not at the end of girders, but only at

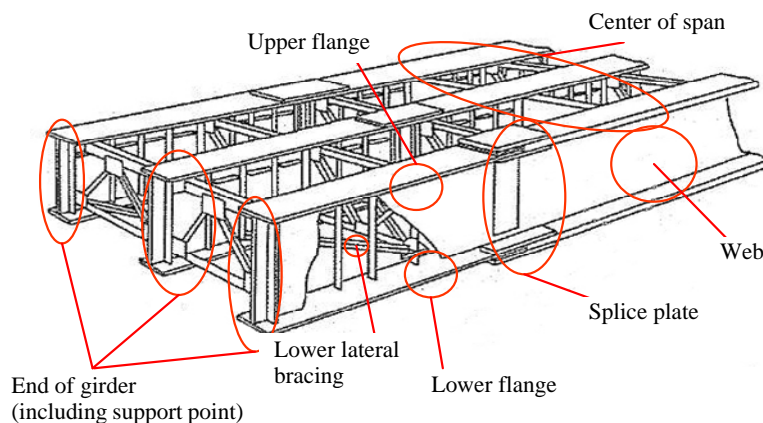
Fig. 3.6: LOCATIONS WHERE CORROSION HAD OCCURRED

Much corrosion in sections of girder in composite-type bridges appeared at lower flanges than on web or upper flanges; the rate was 65.1 % of the bridges studied.

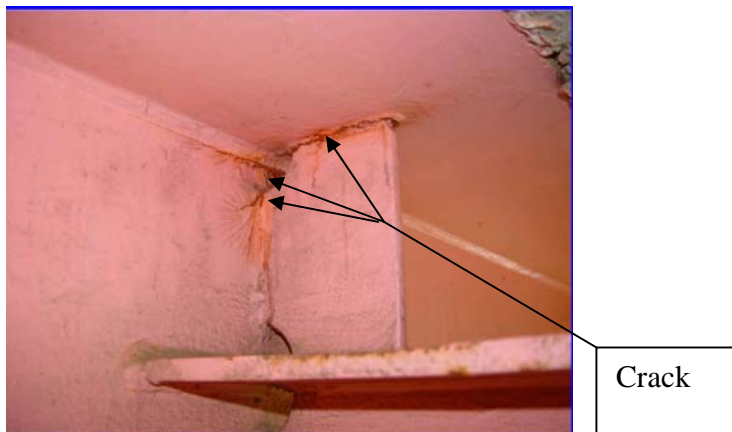
Fig. 3.9: OCCURRENCE OF A CRACK ON A COMPOSITE STEEL GIRDER BRIDGE

Among non-composite types, the number of bridges on which cracks occurred at the one-fourth point was 11 for exterior girder cracks, and 14 for interior girder cracks. These slightly exceeded those found at the end of girders. There was little difference between exterior and interior. Most of the cracks occurred in fillet welding between main girder upper flanges and stiffeners at connecting parts of main girders and cross beams, or at main girders and cross frames. Cracks occurred in 9 right bridges and 6 skewed bridges (Fig. 3.9).

Similar to the non-composite type, 4 composite-type bridges had cracks in exterior girders and 5 had cracks in interior girders. This number of the bridges was less than the number of bridges with cracks occurring at girder ends. The locations of cracks included those on the fillet welding between main girder upper flanges and stiffeners at the main girder and cross beam connections. Similar to the non-composite type, we found cracks on six skewed bridges and one right bridge.

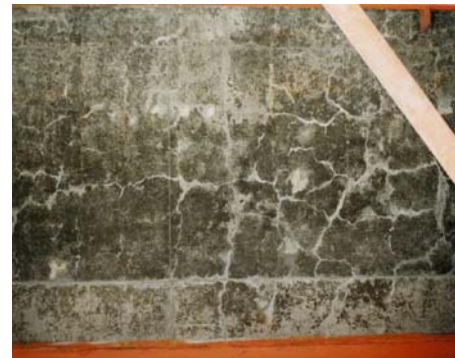
Fig. 3.12: CRACKS IN CONCRETE DECK

The bridges studied included 32 of the non-composite type. The arrangement of locations according to a numbers of crack occurrences is the one-fourth point, the ends of girders, the center of the span and the areas around the middle bearing point. Twenty-one bridges had cracks at the one-fourth point; 18 of the bridges had cracks at the ends of girders; and 14 bridges had cracks at the center of the span. There was little difference between the numbers of transverse cracks on exterior and interior girders.

Cracks at girder ends were generated on 28 bridges; 26 had cracks at the 1/4 points; and 25 had cracks in the central part of the deck span. There was no significant difference between the exterior and interior sides of the deck in the distribution of transverse cracks.
