INSPECTION AND REINFORCEMENT FOR FATIGUE DAMAGES ON ORTHOTROPIC STEEL DECK BRIDGE

Akiko Tabata¹, Yoshihiko Takada¹, Yoshihei Horie¹

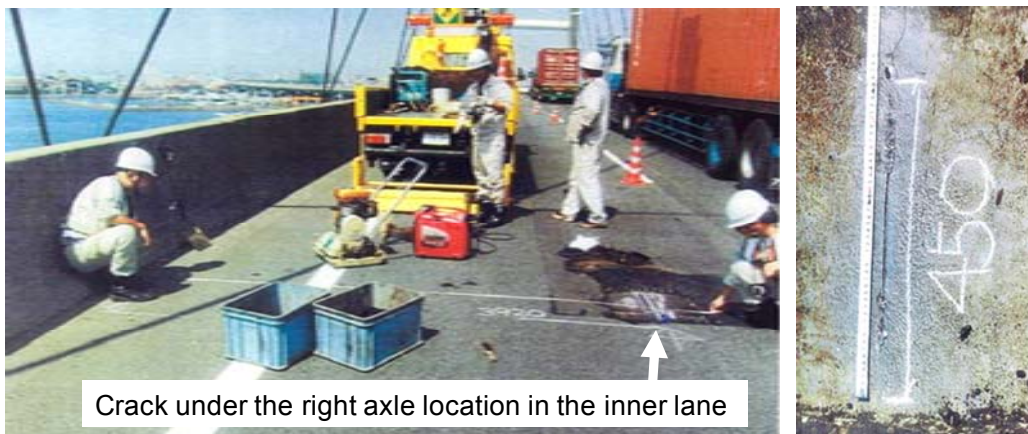
Figure 7 Crack on an orthotropic steel deck.

Penetrating crack of the deck plate in Hanshin Expressway was detected by Shinhamadera Bridge located in Wangan Route during repair work of pavement, as shown in Figure 6,7,8. This is a Nielsen-Lolse bridge with Basket-Handle type, and has a 254m center span carrying four traffic lanes. The bridge was opened in 1993. The crack occurred under the right axle location of truck wheels in the inner lane, 70.8m far from the pier. The total daily traffic in 2005 was 75,000, and 20 % were trucks. An estimated Figure 7 shows the crack on a orthotropic steel deck plate. This crack was detected by chance when asphalt paving was removed. The 6 mm thick trough were butt-welded to 12 mm thick orthotropic deck plates. The total thickness of a two-layer pavement is 65mm. Water spilled from trough rib below the fatigue crack during inspection.

(a)After removing pavement

(b)Closeup of the crack

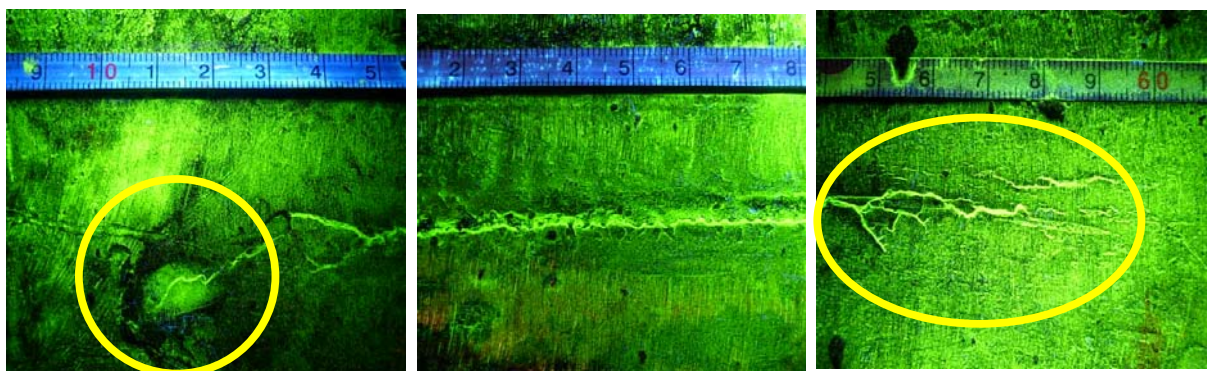
Figure 9 Magnetic Particle Testing

A detailed inspection was carried out from the deck top using MT. The length of the crack was 520 mm, which is longer than the 450 mm observed visually. The crack disappeared after grinding down 3mm in depth at a crack tip, as shown in Figure 9(a). The fracture surface showed evidence of friction of the surfaces either side of the crack in the intermediate part of the crack in Figure 9(b). Crack bifurcation (branching) was clearly observable at another crack tip in Figure 9(c). Ultrasonic Testing (UT) for inner crack detection was implemented using both angle beam and creeping wave techniques. A fatigue crack penetrating an orthotropic steel deck plate was detected as shown in Figure 10. The crack was 560mm long, 305 mm and 255 mm long on each side of the transverse beam. The undersurface crack was longer than the deck top crack. Two vertical holes were cut into the deck plate at both crack tips to restrict crack growth and to inspect. MT, applied for detection of inside defects at the drilled cores in the orthotropic deck, also indicated that the crack propagated from the interior rib-to-deck weld to the deck surface while changing direction, as shown in Figure 11. Macro-fractographic observations showed the 6mm longitudinal ribs had 2 mm penetration welds, which were about 30 percent penetration, as shown in figure 12. Investigation with an infrared camera from the ground revealed that the longitudinal rib had a lower temperature than other longitudinal ribs, as shown in Figure 13. It was also discriminated the difference of sound by hammering longitudinal ribs with and without water.

(a) Crack tip

(b) intermediate part of the crack

(c) Another crack tip

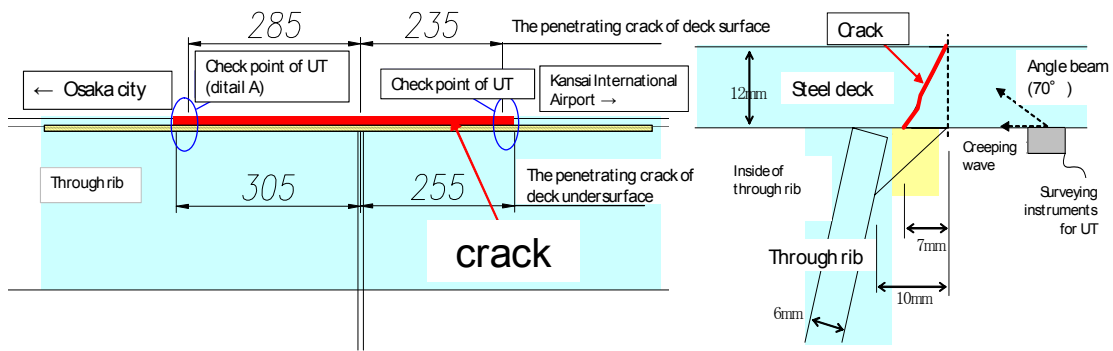
Figure 10 A fatigue crack penetrating an orthotropic steel deck plate.

- A fatigue crack penetrating an orthotropic steel deck plate was detected by UT for inner crack detection.
 - MT at the drilled cores in the orthotropic deck indicated that the crack propagated from the interior rib-to-deck weld to the deck surface while changing direction.

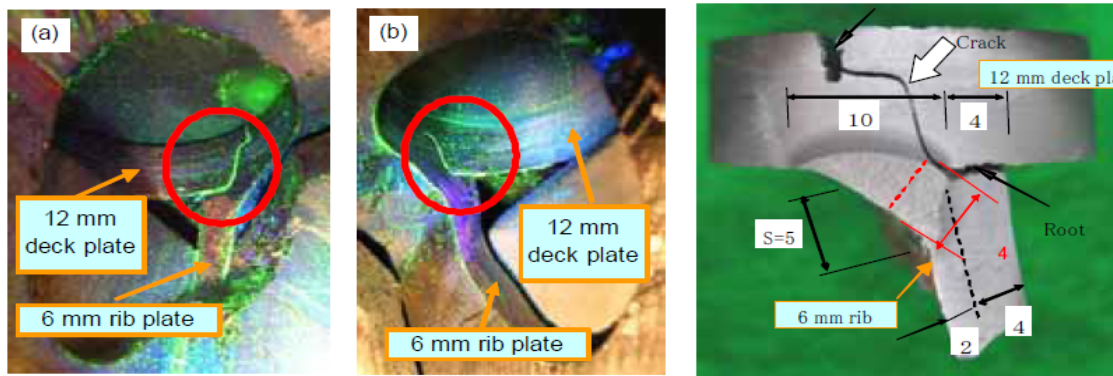
Figure 11 MT in cores

(a) at crack tip

(b) at another crack tip

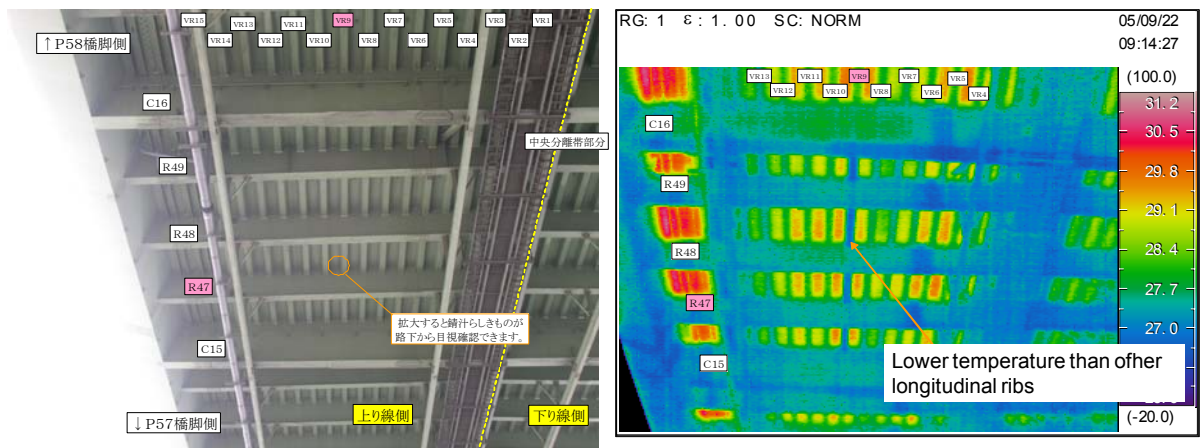
Figure 13 infrared Camera Investigation(a)Photo;(b)Infrared photo

- Stagnant water in longitudinal ribs was found by investigation with an infrared camera from an underpass.
 - Emergency repair with splice-plates and drilling holes (40mm) was carried out in order to prevent possible subsequent crack growth. The crack was spliced with bolted butt splices, located at the deck plate top surface and inside and outside of the longitudinal rib.

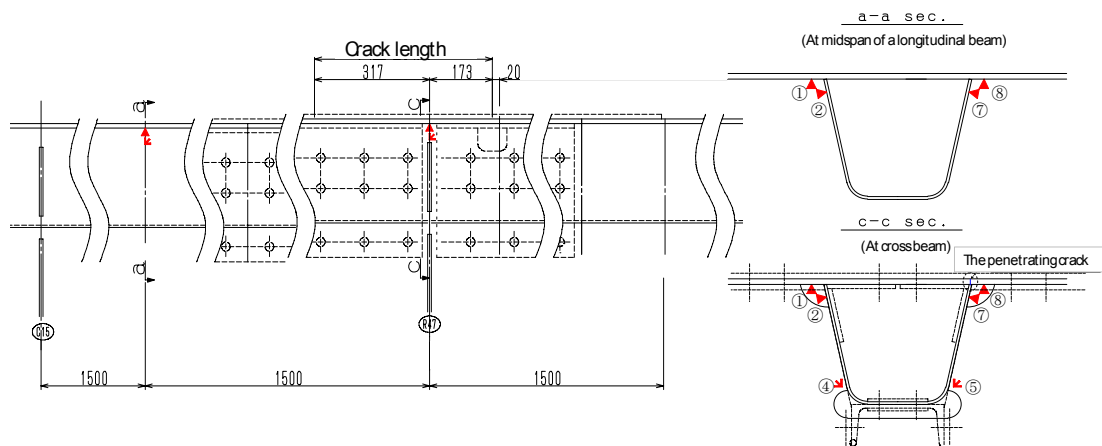
Figure 17 Resistance strain gauges placed on the longitudinal rib(VR9)

Triaxial strain gauges were placed on the longitudinal rib, at the cross beam, and at the midspan of the longitudinal rib, as shown in Figure 17. Stress measurement was carried

out for 72 hours before and after the repair work. Table 3 shows the maximum stress ranges with the rainflow cycle counting. After the emergency repair, the maximum stress range was greatly reduced from 100 MPa to 40MPa at point no.1 of the cross beam section, and from 200 MPa to 136 MPa at Point no.8 of center span of the longitudinal rib. Some amount of decrease was also observed at other points.
