INSPECTION AND REPAIR OF THE DETERIORATED RT.72 MANAHAWKIN BAY BRIDGE

Xiaohua H. Cheng¹, Gregory Renman¹ and Richard Dunne¹

The paper presents the details of the bridge structures, inspection findings, fatigue damage, cause of the damage and repair of the damage.

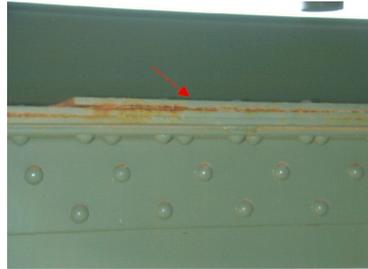
Between Girder Flange Cover Plates

Figure 2 Corrosion of Various Bridge Members

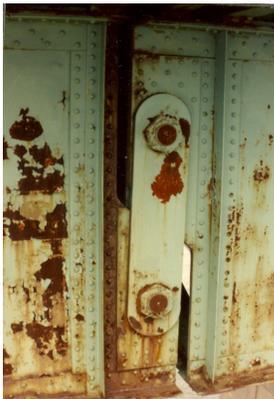
In Pin/Hanger Connection

Before the pin/hanger connections were replaced, some of the connections were corroded and frozen (**Figure 2**), which made girder not move freely at the connection. At the pier locations, the girders are continuous while the deck expansion joints were free to expand and contract with two floorbeams separate on each side of expansion joint. Since the floorbeam-to-girder bracket restrained such free movement at the top near the deck slab, the relative movement in the floorbeam web between the floorbeam top flange and top of bracket angles, that is out-of-plane bending in the floorbeam web, were significant (**Figure 6**) evidenced by the concrete spalling of deck haunch. As a result of the repeated out-of-plane bending, fatigue cracks developed at the floorbeam top flange weld toe. On the other hand, the bracket angles are connected to both the floorbeam and bracket plate with rivets, while the other side of bracket plate connected to the girder. When deck is moving, the angles are subject to repeated pry effect which caused fatigue cracks at the corner of the angles. Since the out-of-plane bending is very complex, further study on more refined analysis for the bridge global behavior and local stresses may be necessary to interpret the observations and provide guidance to avoid the poor structural design and detailing. .

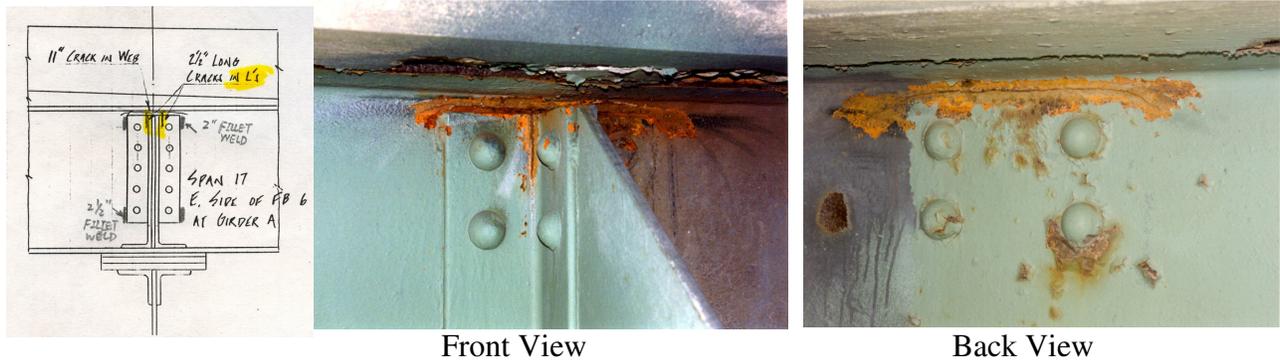
The in-depth inspection was first performed in 3-1/2 end spans (the 1st and 2nd spans at east end of the bridge and 1st and half 2nd span at west end of the bridge). 5 out of 68 floorbeam locations showed horizontal cracks in the floorbeam webs, measuring 7~11-1/2 inch (178~292mm) in length. All 5 locations also showed vertical cracks at the top in the floorbeam-to-girder bracket angles, measuring 1-1/2~6 inch (38~152mm) in length. The typical sketch and photo of the fatigue cracking are shown in **Figure 4**. In addition, concrete deck haunch cracking and spalling was displayed in all spans inspected with several areas extending as much as 6 to 10 feet (1.8 to 3.0m) in length (**Figure 4 and Figure 5**). Note that the corrosion at edge of top flange of floorbeam was due to water penetration through the deck.

In the intermediate spans, 22 of 60 floorbeam locations showed horizontal cracks in the floorbeam web and/or vertical cracks in the bracket angles at the top. Deck haunch spalling was also common throughout the spans. It was also observed that deck joint opening was measured 1~5-1/4 inch (25~133mm) when the inspection was performed in June.

It was believed that the horizontal/vertical fatigue cracks and deck haunch spalling were caused by out-of-plane bending of the floorbeam web due to the differential longitudinal movement (or relative displacement) between the deck slab and top flange of the continuous girders as live load passes across the bridge as well as the differential temperature movement.

Figure 4 Fatigue Cracks - Horizontal Crack in Floorbeam Web and Vertical Crack in Bracket Angle

At this time, the recommendation was made that the crack tips in the floorbeam webs be determined, stop holes be drilled at the crack tips and cracks be monitored for any further propagation. Cracks in the bracket angles need be monitored only. It was also recommended that expansion joints be monitored on a regular basis to determine if the bridge is expanding and contracting properly.

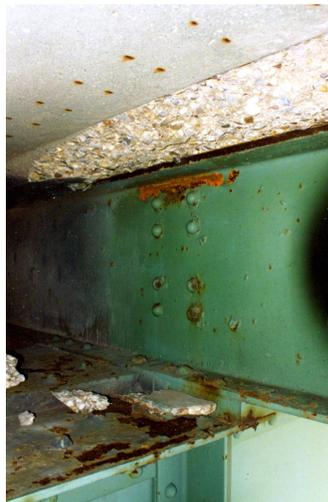
Over 75% of all haunch area were cracked, fractured and spalled in the inspection of 1997. Repair by patching was called for but no action has been taken so far. Only monitoring is made during each cycle of inspection, considering the satisfactory composite effect (shear studs) between the deck slab and floor beam top flange.

Figure 5 Concrete Deck Haunch Spalling

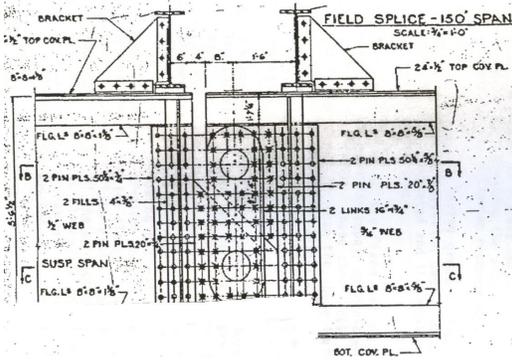
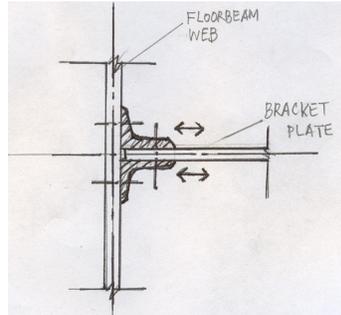
Pry Effect of Angle Causing Cracking

Figure 6 Relative Movement Between Deck and Main Girder

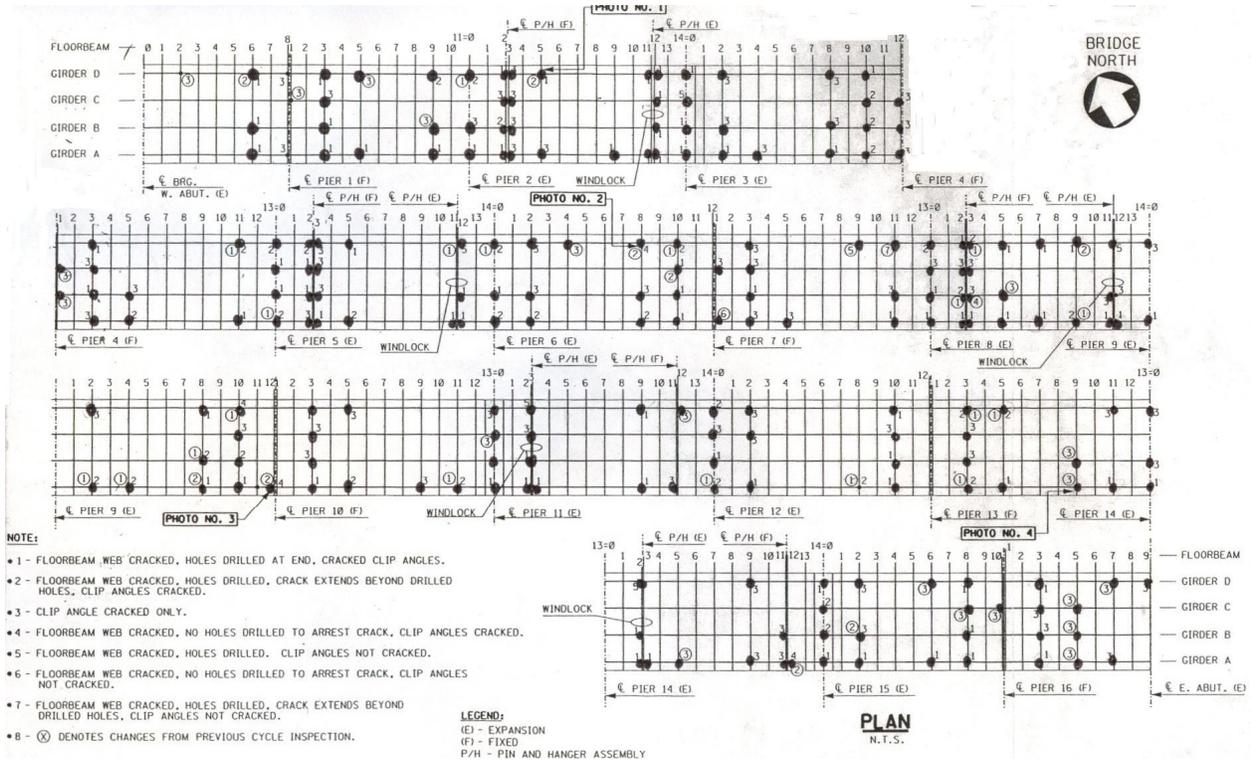
Over the years, the number of fatigue crack locations and the extent of the damage have continuously increased since fatigue damage was first reported in early 1990s. The number of cracks has grown from first 27 in 1993, to 110 in 1995, 150 in 1997, 200 in 1999, until 129 in 2005. Many cracks further propagated beyond the previously drilled holes. The new holes were drilled at new crack tips. **Figure 7** gives a sketch of fatigue crack locations in a recent inspection. It is noted that fatigue cracks have occurred in floorbeams at all four girder locations. It appears that floorbeams at fascia girder locations have more cracks than interior girder locations, and the floorbeams at/near fixed bearing locations and pin/hanger locations most likely developed fatigue cracks.

Figure 7 Fatigue Crack Locations in the Bridge

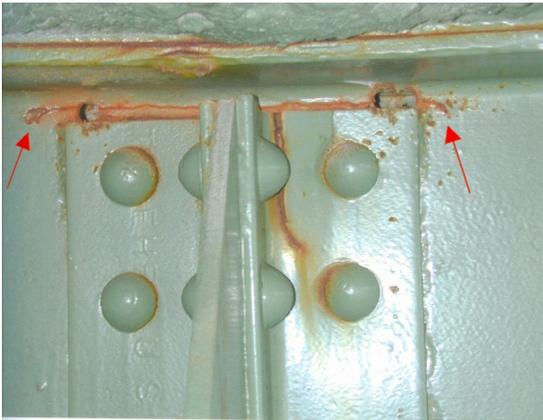
(a) First Repair

Figure 8 Hole Drilling Repair of Fatigue Cracks

Basically, all the fatigue cracks in the floorbeam webs have been repaired by drilling holes at the crack tip to stop crack propagation, as seen in **Figure 8a**. Visual monitoring of the cracks has been made during each following routine inspection. The number and extent of fatigue cracks increased over the years. For the newly developed cracks, holes were drilled in the same manner. The typical stop hole diameter was ½ inch (12.7mm). For the cracks that further propagated beyond the previously drilled hole, new holes were drilled at new crack tip. Such repair procedure may be repeated several times as shown in **Figure 8b**, leaving multiple stop holes of various diameters in a floorbeam

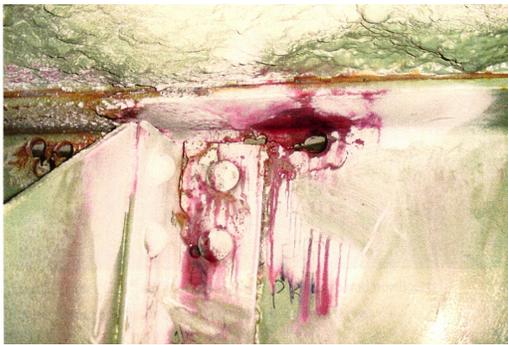
(a) Hole Drilling

Figure 9 Repair of Fatigue Cracks in Angles

For the vertical cracks in the floorbeam-to-girder bracket connection angles, they have been monitored in each following routine inspection. If the cracks propagated downwards in the angle significantly, stop hole would be drilled at the crack tip, or the angle would be replaced with new angles and high strength bolts (**Figure 9**).

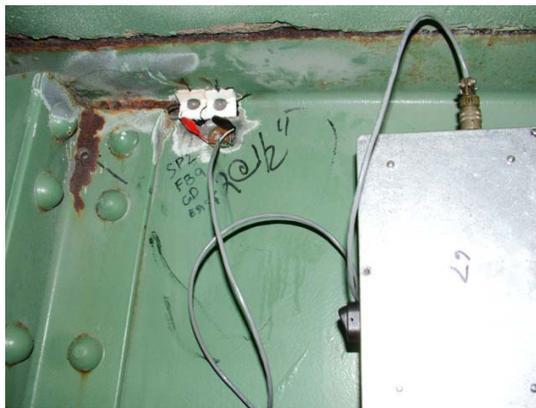
The EFS system was used on the Rt.72 Manhawk Bay bridge to help monitor fatigue crack propagation as a pilot study (MTI, 2006). The EFS system (a pair of crack measurement sensor and a reference sensor) was installed at 17 locations, that is, at visually identified cracks, areas adjacent to crack repair locations, and additional locations that exhibited similar fatigue-sensitive details as those already cracked. The EFS data analysis was used to determine whether the documented fatigue cracks were still growing under ambient traffic flow and the possible inspection of cracks that were not detected by dye penetrant and magnetic particle methods. The testing of EFS system showed that some of existing cracks were continuing to grow and others had been arrested by stop-holes and were not exhibiting active growth. The technology was confirmed by this test. **Figure 10** shows the EFS system installed at existing crack that propagated beyond a stop-hole. Further details can be obtained in the MTI report.

Figure 10 EFS System Installed At An Existing Fatigue Crack
