# **SEISMIC RETROFIT STUDY OF CABLE-STAYED BRIDGE ON TOKYO-GAIKAN EXPRESSWAY**

Yoshinori Kawahira<sup>1</sup>, Kouichirou Shitou<sup>2</sup> and Tsutomu Yoshioka<sup>3</sup>

## **Abstract**

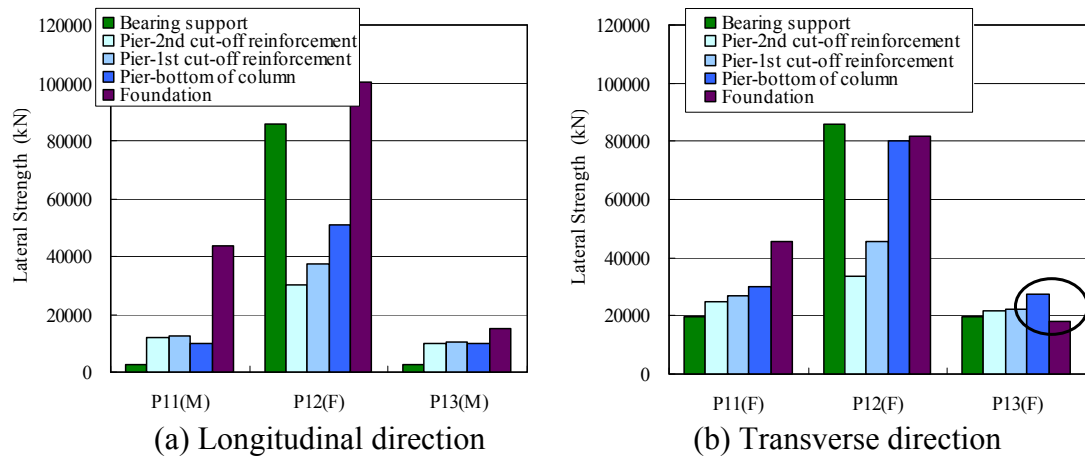
Fig.6 Comparison of lateral strength capacity of each members

Before performing a seismic response analysis, we calculated the lateral strength of the bearing support, pier and foundation, and estimated the damage sequence. As shown in Fig. 6, the lateral strength of the caisson foundation of P13 in

the transverse direction is lower than that of the pier, and the surface ground is soft. Accordingly, it is necessary to perform seismic performance verification of each part and member via seismic response analysis that takes account of the ductility of the foundation. As for the main girder made of orthotropic steel deck 1-box girder, the overhang of the deck is long, and number of ribs of the sidewalk is small. It is therefore highly probably that the main girder will buckle by an earthquake in the transverse direction, and it is advisable to use fiber elements that allow us to properly consider the nonlinearity of the material in complicated sectional form. However, the calculation load of the analysis that takes account of the plasticity of both the foundation and main girder is significant, and the calculation result is complicated. As shown in Fig. 7, we therefore decided to perform seismic response analyses on two cases; one for the case where the foundation is assumed to cause no ductility (Model A), and the other case where the ductility of the foundation is taken into consideration (Model B).

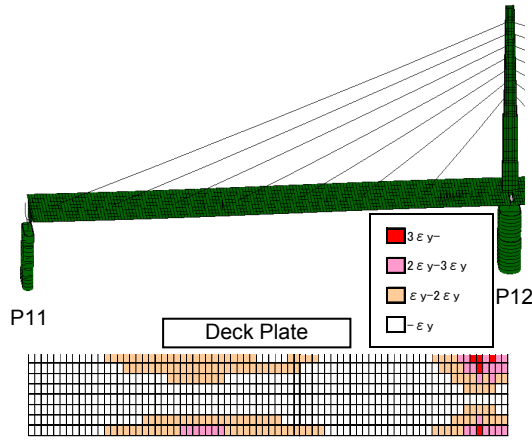
Fig.9 Strain distribution of deck plate (Dynamic analysis result by Model A)

The main girder was significantly affected by the earthquake in the transverse direction. The result of Model A that used fiber elements showed local ductility in both the sidewalk deck plate and the box girder, up to about  $4\epsilon_y$ , and  $2.5\epsilon_y$  respectively (Fig. 9). However, the nonlinear finite element analysis results suggested that the undulation

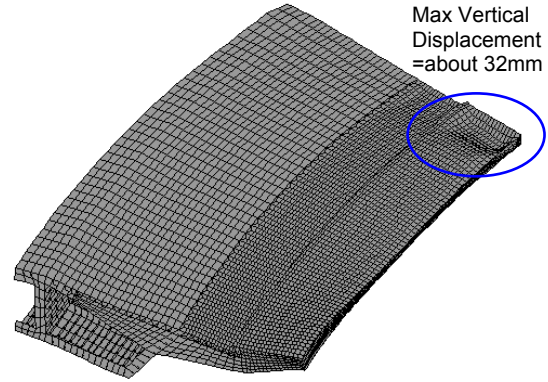
Fig.10 Deformation of deck plate (Nonlinear FEM analysis result)

of the road surface after local buckling was so small that the serviceability of the road could be ensured after earthquake (Fig. 10). Consequently, the damage level was evaluated as I, and no retrofit was deemed necessary.

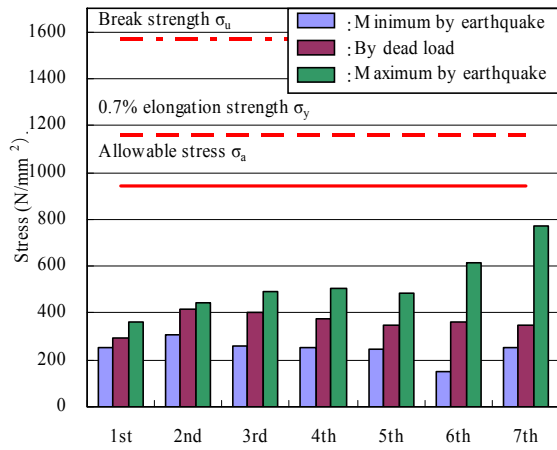
Fig.11 Performance verification result of stay cables (Longitudinal direction, Type2 earthquakes)

The cables were affected predominantly by an earthquake in the longitudinal direction, however, the maximum tensile stress caused by earthquake was  $773\text{N/mm}^2$ , namely well below the 0.7% elongation strength  $\sigma_y (=1160\text{N/mm}^2)$  (Fig. 11). The minimum tensile stress was  $151\text{N/mm}^2$ , and the cable has no tension loss. Accordingly, there is no damage.

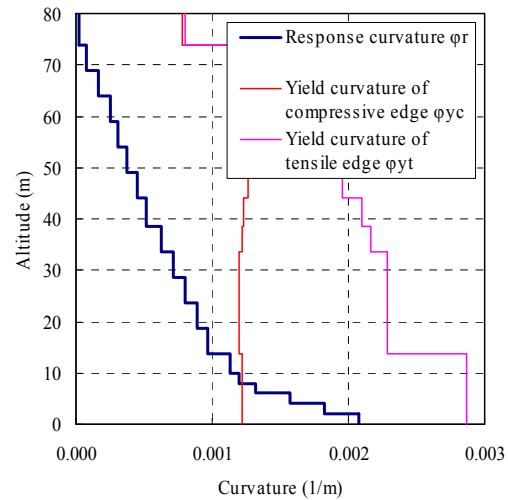
Fig.12 Curvature distribution of tower (Transverse direction, Type1 earthquakes)

The main tower was affected by a type I Earthquake in the transverse direction such that it caused local buckling in the elastic region within the range of about 26m from the foundation. For this reason, longitudinal ribs are added to control the width-thickness ratio parameter and keep it within the limiting value specified in the Design Specifications for Highway Bridges. Assuming that the parameter was

improved, the post-yielding behavior was observed, whereupon the tower was seen to show slight ductility within a range of about 8m from the foundation (response plasticity rate  $\mu_r=1.38$ ) as shown in Fig. 12. The P- $\delta$  curve of the main tower was calculated by nonlinear finite element analysis. The results showed that the tower lacked toughness of the SM570 high strength steel, and that its ductility capacity was evaluated as around 1.79 (Fig. 13). It was so close to the response value and difficult to evaluate the damage as level I, consequently, ductility enhancement measures were deemed necessary to reduce the deformation.

As for the main tower, its width-thickness ratio parameter had to be improved, and increasing flexural strength at its tower base is necessary. For these reasons, we adopted a strengthening method involving installing stiffing ribs bolted on the exterior surface and these be continuous at cross ribs and diaphragms.

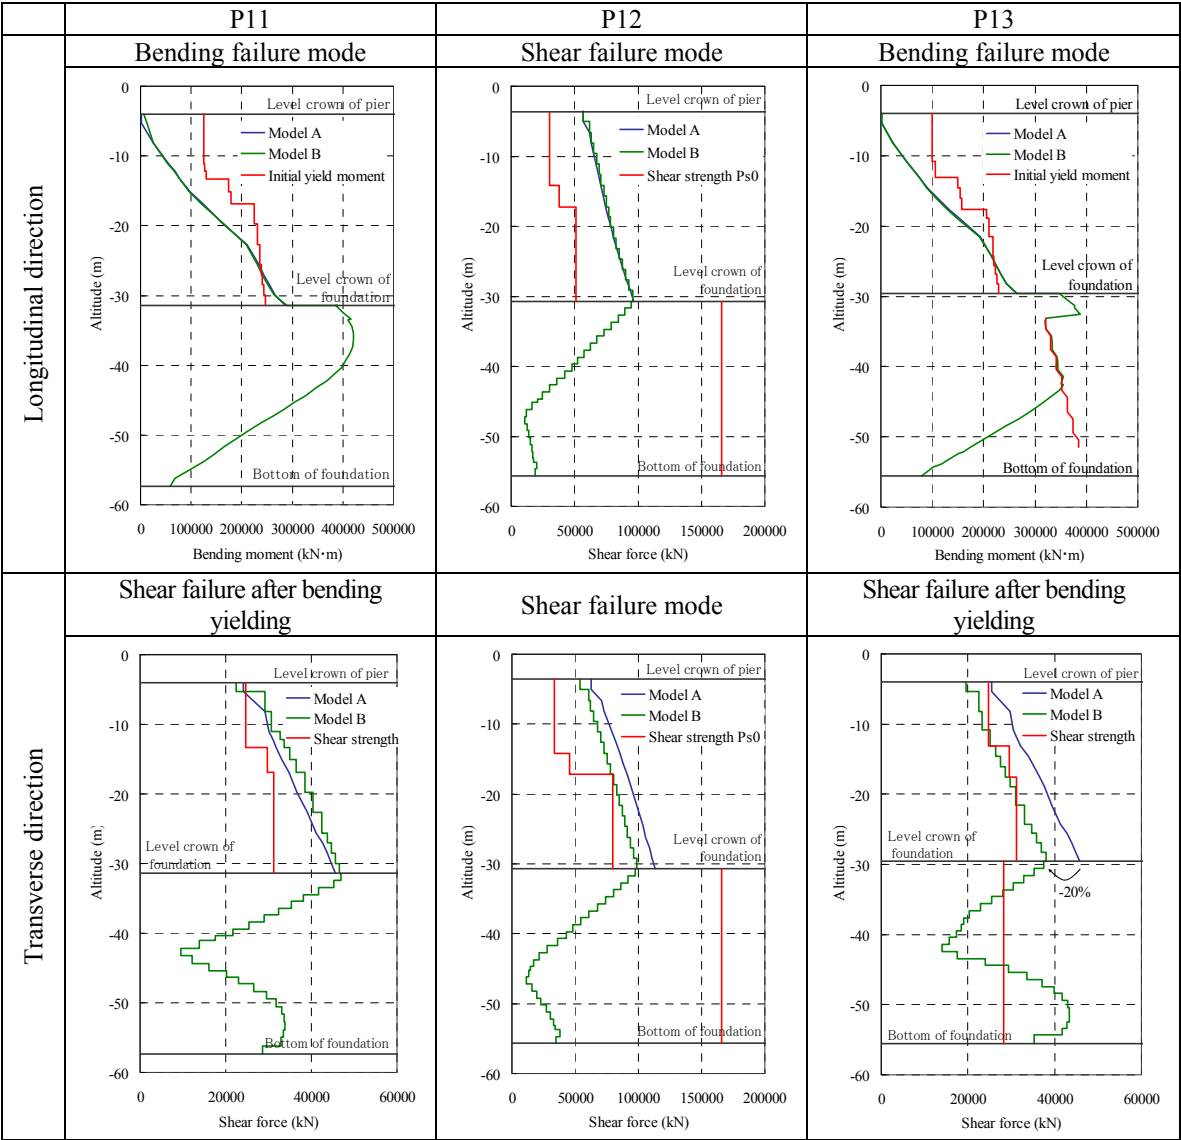
Fig.14 Maximum section force distribution of pier (Type2 earthquakes)

Figure 14 shows the maximum response force distribution of the pier that corresponds to its failure mode. This figure shows the response distribution of both Models A and B together with that of the foundation. In an earthquake in the longitudinal direction, piers P 11 and P 13 caused ductility to their bases solely by the inertia force of their own weight. In an earthquake in the transverse direction, the maximum shear force of the entire pier, including the cut-off of longitudinal reinforcement at mid-height, exceeded the shear strength, hence the high potential for the piers to succumb to shear failure. Meanwhile, P12 experienced shear failure mode in both longitudinal and transverse directions, with the shear force exceeded its

maximum shear capacity in both directions. Based on these results, all piers were evaluated as level III, and some retrofits were deemed necessary. As shown in the shear force distribution in the transverse direction of P13, the maximum horizontal force acting on the crest of the foundation diminished by around 20% in cases where the ductility of the foundation was taken into account. Consequently, such latter cases were considered to be closer to the actual behavior. It was decided to use the value of this case as the acting force to be used to verify the foundation.

Regarding the piers, P11 and P13 incurred bending damage solely due to the inertia force due to their own weight, making it difficult to adopt retrofit methods by making use of dispersion of inertia force and seismic isolation. Consequently, the RC piling method was adopted for all three piers. For its construction method, a

comparative investigation was conducted between the PC confined method that allowed underwater placement, and the method involving blocking of water by steel casings to allow work to be performed in a dry condition. The latter method was adopted because of the significant advantages in terms of both construction period and cost and low impact on water quality.

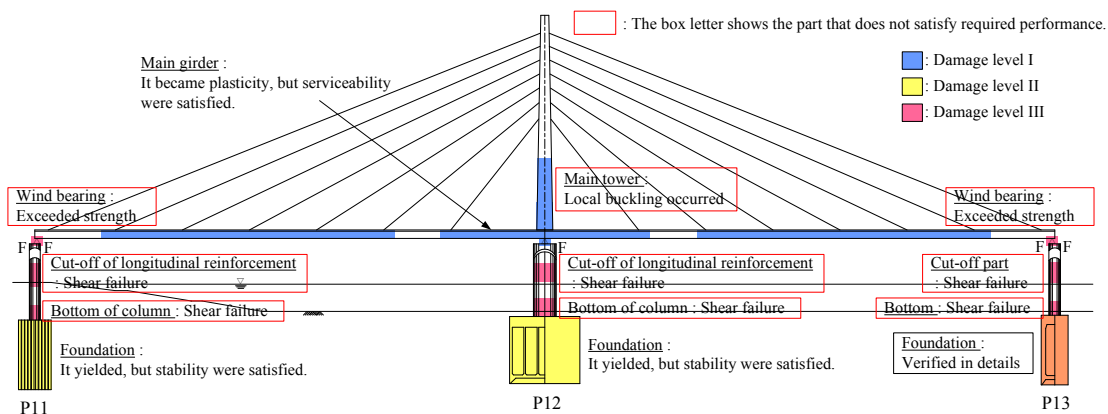
Fig.15 Summary of performance verification result (Transverse direction)

Figure 15 shows a summary of the verification results showing both the evaluation results of the damage levels of this bridge, and the locations where the required performance were not met when exposed to an earthquake in the transverse direction

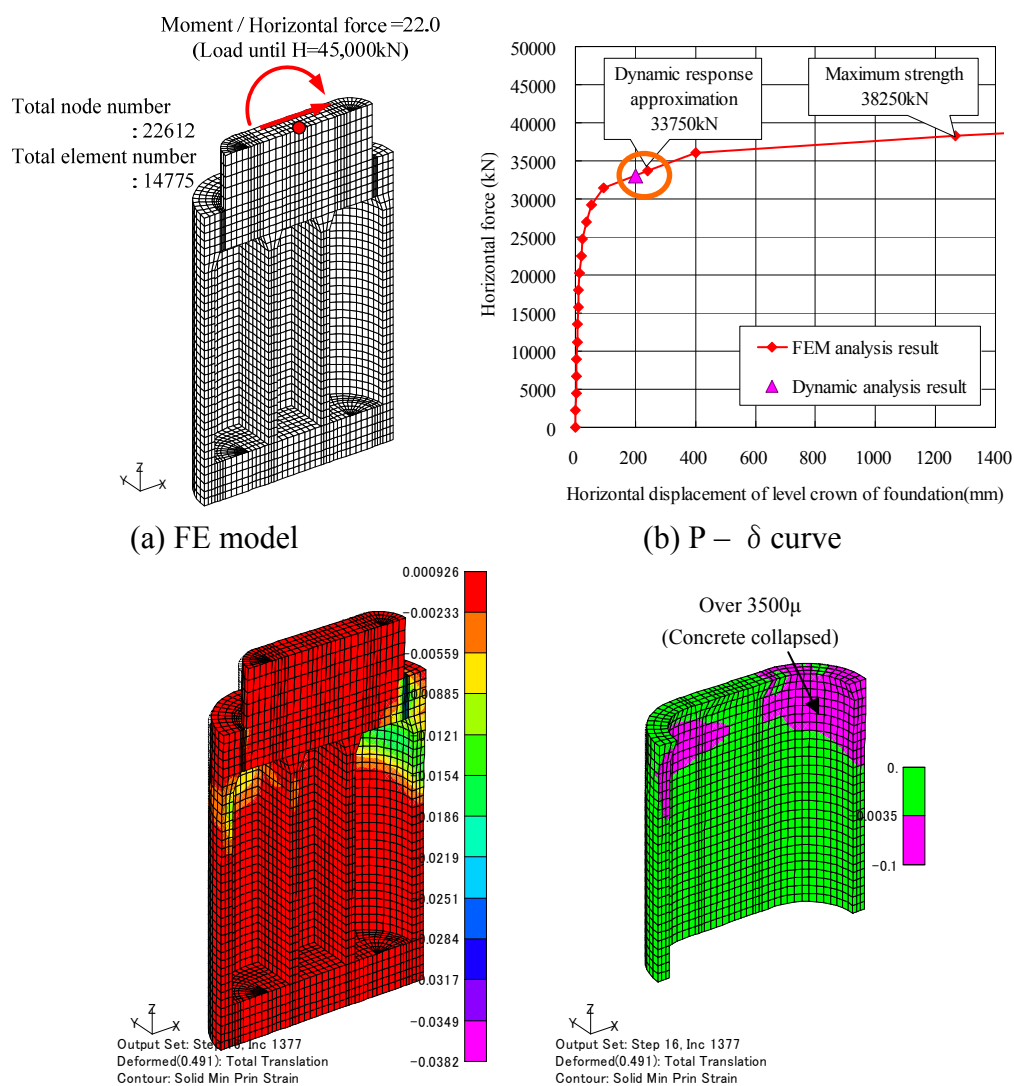
Fig.16 Nonlinear FEM analysis result of P13 caisson (Transverse direction, Type2 earthquakes)

Figure 16 (a) shows the FE model of the caisson foundation of P13 that was verified in detail using nonlinear finite element analysis. On the FE model, the caisson foundation was modeled with a solid element, and the reinforcement was modeled with a rebar element. The surrounding soil was modeled with a nonlinear spring element, which was arranged at each joint on the peripheral surface. To reduce the computation,

Figure 16 (b) shows the P- $\delta$  curve obtained from the analysis. Stability verification was performed at the loading step corresponding to the dynamic analysis response of approximately 200mm, the horizontal displacement of the foundation crest. The result showed that the ductility demand of 6.4, although slightly exceeding the ductility capacity of 5.9 that included a safety factor of 1.8, did not reach the ultimate ductility factor of 9.8. The dynamic analysis response value was on the upward gradient region, and assuming that the horizontal strength of 38,250kN were considered, there is 13% margin remained until the strength. Therefore, although the foundation caused plasticity, it was considered the safety was maintained.

The members were checked for the loading steps that corresponded to the dynamic analysis response value. As shown in Fig. 16 (c), stress concentration associated with bending in the upper corner of the sidewall occurred. The right figure shows the minimum principal strain of the concrete expressed with the contour in two colors, when the ultimate strain was 3,500 $\mu\epsilon$ . This stress concentration exceeded the ultimate strain, and there was a possibility of causing spalling of cover concrete, and buckling and expansion of reinforcement. However, the dead load analysis performed on a model with no members in the circular area of the sidewall revealed that the stresses on the linear section of the side and partition walls were approximately half the allowable stress. Based on this result, it was considered that the members were able to support the dead load caused by the level 2 earthquake motion.

As described above, the caisson foundation was reevaluated by nonlinear finite element analysis, and the result showed that it was able to satisfy the stability requirements. However, the validity of this analysis method has not yet been confirmed by experiments. PWRI is now conducting experimental research into the caisson foundation of low steel reinforcement.

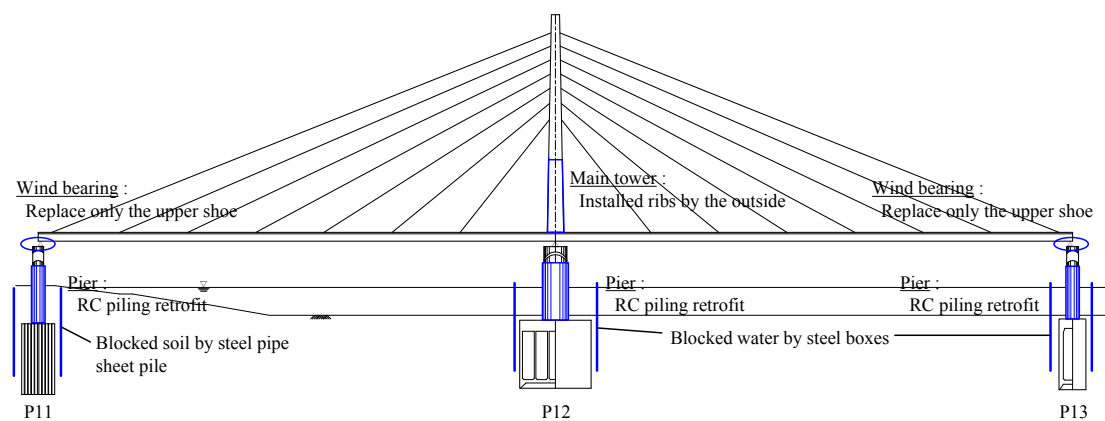
Fig.17 Seismic retrofit measures

Based on the seismic performance verification results described above, Fig. 17 shows a summary of the areas requiring retrofit and the details.

For the wind bearing, two methods were compared: 1) replacing the bearing, and 2) installing a structure limiting excessive displacement. Finally the method involving the replacement of only the upper bearing was adopted from an economic reason.
