REPAIR OF HIGH SHEAR STANDARD REINFORCED CONCRETE BRIDGE COLUMNS USING CFRP

Ashkan Vosooghi¹ and M. Saiid Saiidi²

Abstract

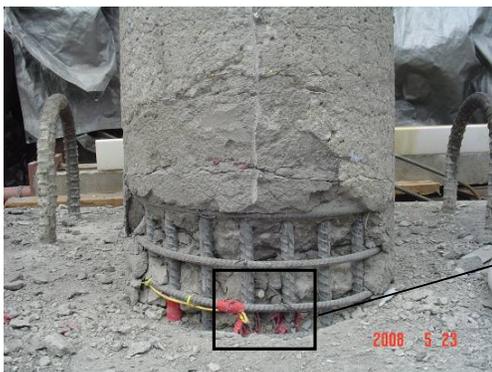
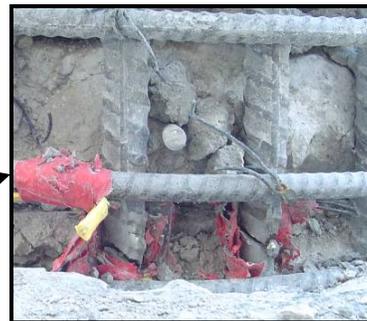
The columns were tested on one of the shake tables for University of Nevada, Reno. The failure mode for NHS1-R was fracture of two longitudinal bars at the base (**Fig. 3**). In NHS2-R failure was due to the CFRP rupture at the column base on the compression dominant side along with rupture in two longitudinal bars at the base (**Fig. 4**). In both columns, bar ruptures were noted by removing the CFRP jacket.

Fig 3. Bar ruptures in NHS1-R. (CFRP was removed after shake table tests.)

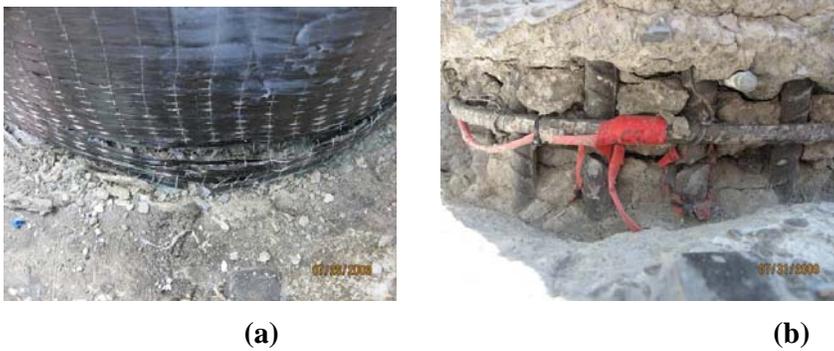
Fig 4. Failure in NHS2-R; a) CFRP rupture; b) bar rupture (CFRP was removed after shake table tests.)
