Inspection and Rating of Gusset Plates – A Response to the I-35W Bridge Collapse

Abstract

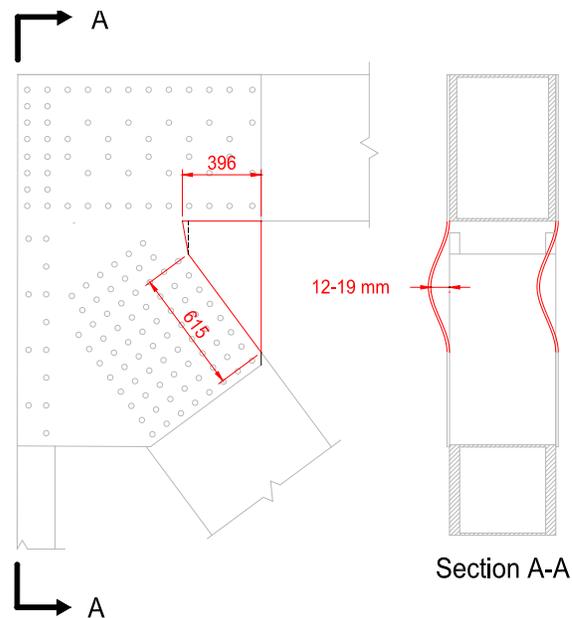
During the investigation, NTSB found photographs of the U10 connections taken in 1999 and 2003 (NTSB, November 2008). The photographs showed the vertical free edge of the gusset between the compression diagonal and the top chord was bent out-of-plane. One of these pictures is shown as Figure 2. NTSB referred to the bent shapes as “bows” and estimated the magnitude of the bows to be between 12mm and 20mm out-of-plane. For the remainder of this paper, the “bows” will be referred to as initial imperfections. The initial imperfections were integrated into the model by manually manipulating the element node locations in this region of the plate and were present from the beginning of the analysis. A cubic spline displacement field was used to represent the initial imperfection as shown in Figure 3. The cause of the initial imperfections was never identified. However, the imperfections on the four U10 gusset plates were directed to the upstream direction and to the downstream side for the complimentary U10’ connections.

Figure 2 - Picture Of U10E Connection Taken On 12 June 2003.
