FAST TRACK REPLACEMENT OF THE JEFFERSON STREET BRIDGE

Abstract

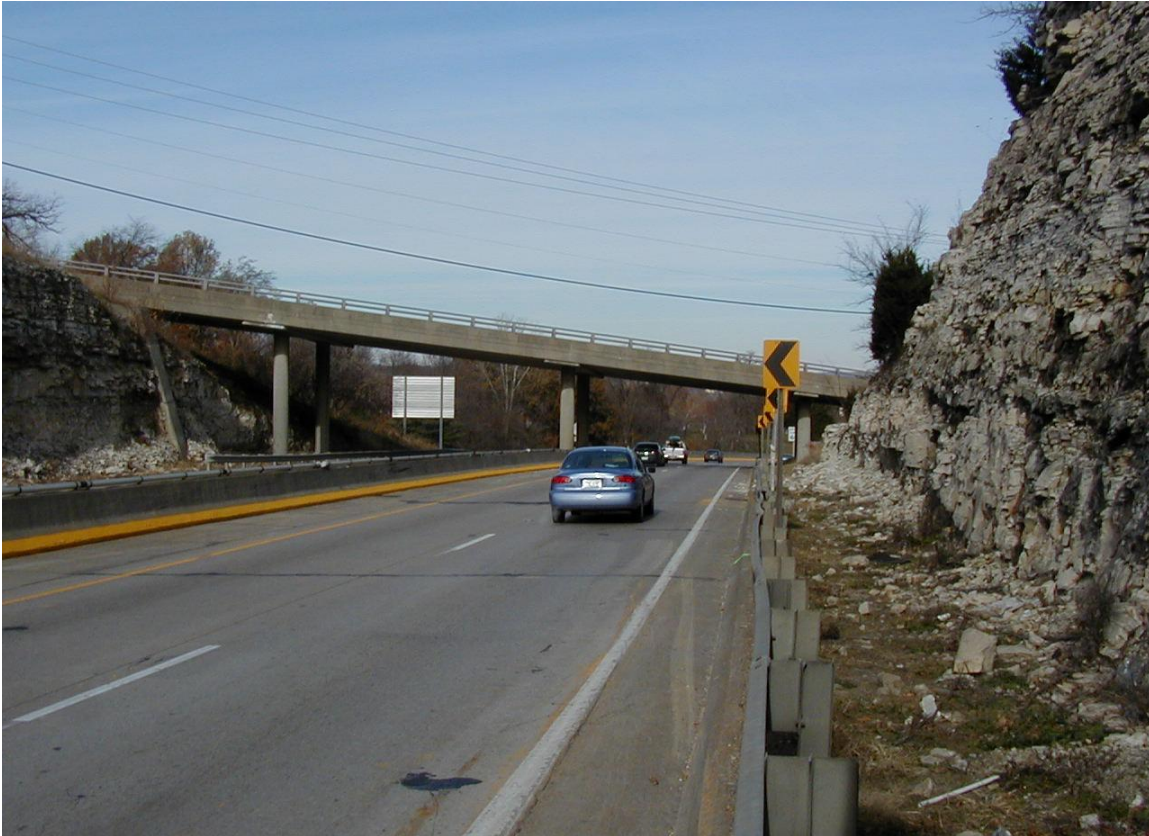
FIGURE 4

The overpass (Figure 4) was a four-span, concrete, voided-slab bridge about 184 feet (56.1 meters) in length. The span lengths were 31 feet, 54 feet, 52 feet, and 47 feet (9.4 meters, 15.5 meters, 15.8 meters and 14.3 meters). The intermediate bents consisted of a

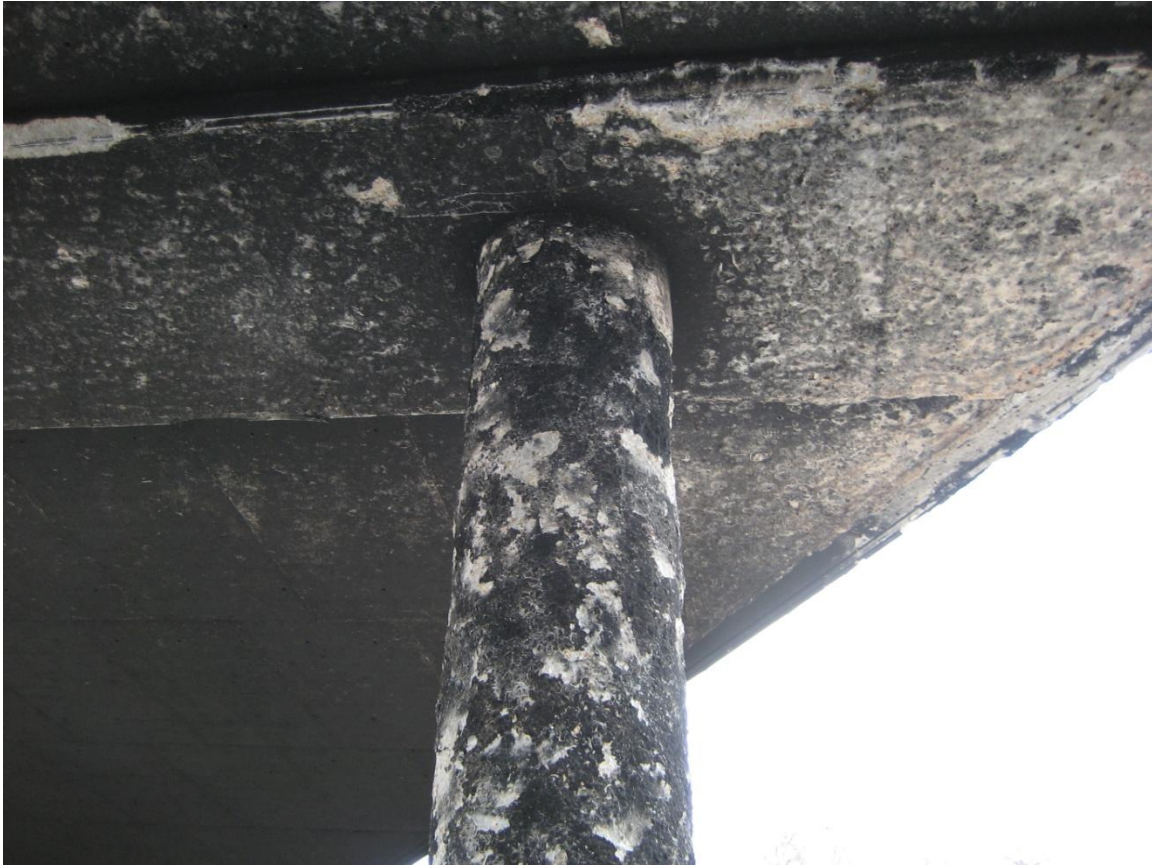
FIGURE 5

The worst findings were heavy delamination and severe spalling with resulting exposed reinforcing steel in the columns at Intermediate Bents No. 2 and No. 3 and in the under deck of the north half of span two (Figure 5). The north half of the under deck in span two also was severely scaled (Figure 6). Other damage included a handrail bent by the heat of the fire and melting of the asphalt chip seal (Figure 7). As a result the deck and superstructure were rated down from a seven to a five on a scale of nine. The substructure

was rated down from a seven to a three. Based on the inspection, the bridge was kept closed.

Next a decision had to be made whether the bridge could be repaired or should be replaced. The main arguments for repair were the shorter time and lower cost compared to replacement. The case for replacement was stronger. The extent of the damage was great and could not be easily repaired. The severity of the damage and the reliability of potential repairs were uncertainties. There were concerns that fracture planes would develop along the lower mat of reinforcing steel. Additionally, the durability of the bridge was reduced. The main consideration, as always, was safety of the travelling public. The capacity of the bridge to carry Jefferson Street traffic was uncertain. Route 54 underneath the overpass is a principal arterial with an average daily traffic of 14,000 vehicles. An urgent concern was the danger of falling debris onto the high volume of traffic passing below the damaged bridge.

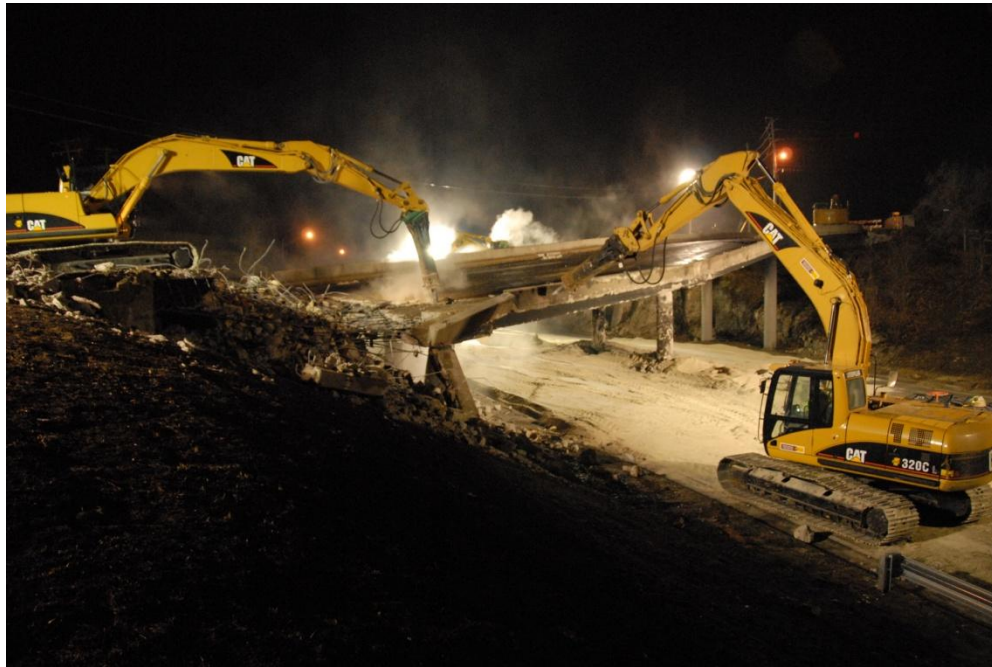
FIGURE 8

Under these conditions, demolition began on the evening of Friday, December 7. The contractor utilized the first weekend closure of Route 54. After installing a cushioning layer of sand on the roadway below, the bridge was dropped in large sections (Figure 8). Demolition was largely completed in twenty-four hours. To fully take advantage of the closure, the footings were excavated and poured that weekend (Figure 9). By the end of the first week of construction, columns had been poured at Bents 3 and 4, and the beam cap at Bent 3 was poured (Figure 10). The steel piles at Abutment 5 had also been pre-bored and

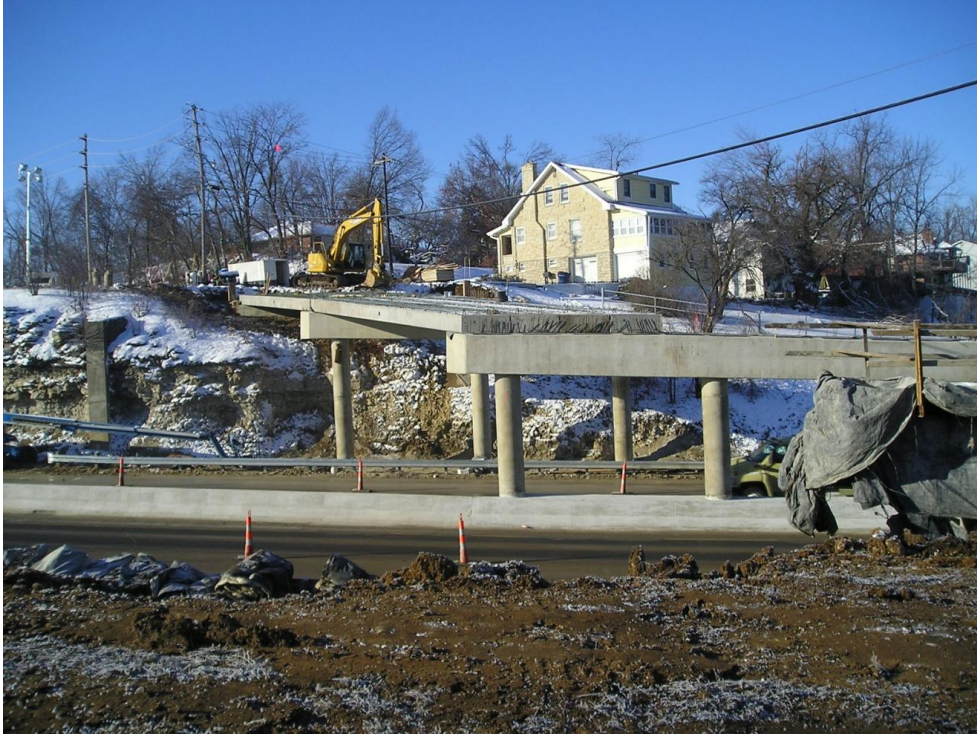
FIGURE 12

Work towards completing the superstructure continued in week three. The rest of the deck steel was placed and tied (Figure 12). The deck and integral concrete diaphragms were poured at the bents and abutments. As the deck cured, reinforcing steel for the barrier curbs was being placed. Attention also turned to the Jefferson Street approaches. Curb, gutter and sidewalk were poured. Existing pavement was removed and the pavement base was prepared to match into the new bridge ends.

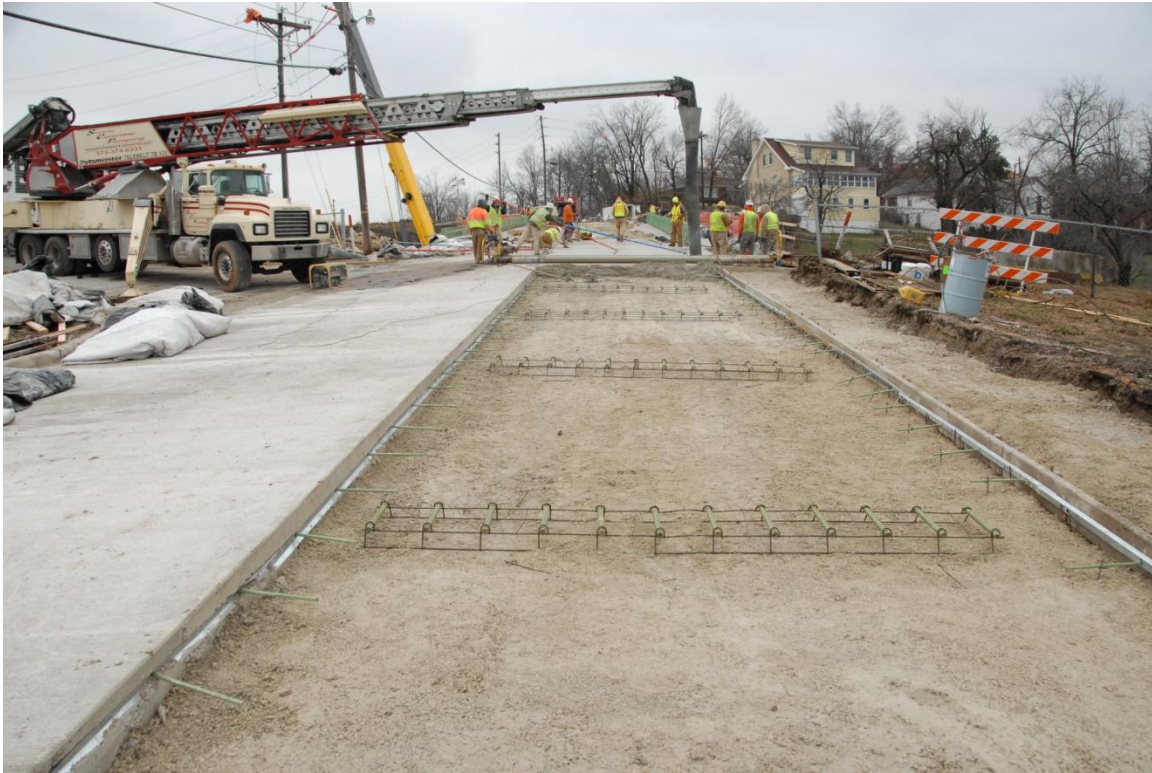
FIGURE 13

The final items were completed in the fourth week. The Jefferson Street approaches were completed, which included roadway paving and fencing (Figure 13). The barrier curbs were poured on the bridge and the bridge pedestrian fence was installed.

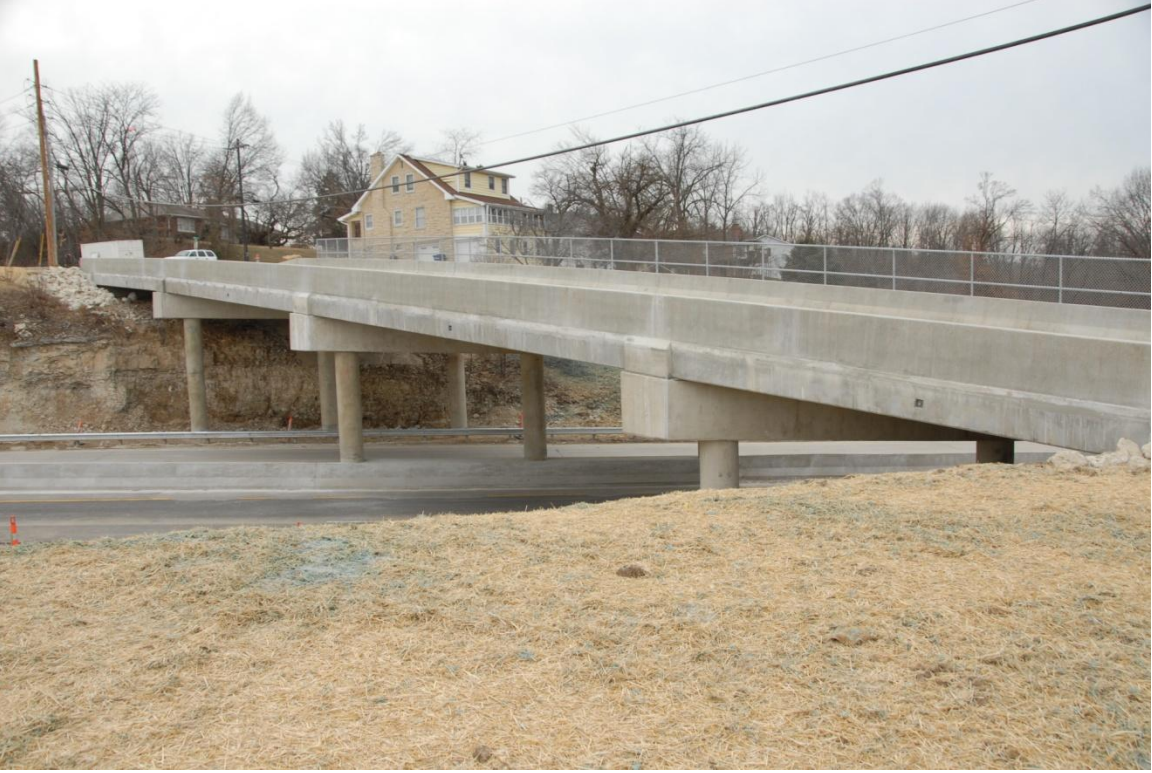
FIGURE 14

Striping was completed on both Jefferson Street and Route 54. Seeding and mulching of any disturbed areas were the final touches. At seven a. m. on January 3, the bridge was opened to traffic (Figure 14).
