2010 CHILE EARTHQUAKE IMPLICATIONS TO THE SEISMIC DESIGN OF BRIDGES

Genda Chen¹, Phillip W. Yen², Ian Buckle³, Tony Allen⁴,
Daniel Alzamora⁵, Jeffrey Ger⁶, and Juan G. Arias⁷

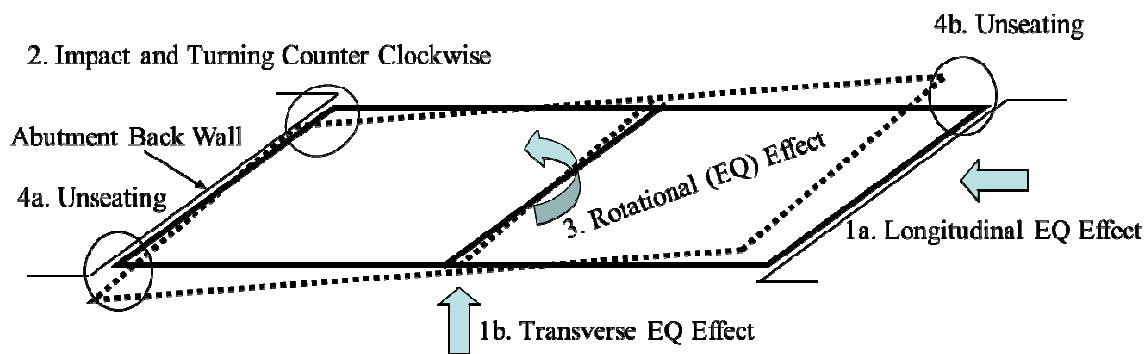
FIG. 3 DECK ROTATION OF A REPRESENTATIVE TWO-SPAN BRIDGE

Based on the observations on skewed bridges, the movement of a bridge superstructure can be illustrated in four steps as shown in Fig. 3. Under the earthquake excitations (1a, 1b, and possibly 3 in Fig. 3), the bridge superstructures first moved towards one abutment (left as shown in Fig. 3) and impacted against the abutment's back wall (2 in Fig. 3). The reaction from the back wall then turned the superstructure in a direction opposite to the skew direction (counter clockwise in Fig. 3). The rotational motion (3 in Fig. 3) was amplified due to the fact that the rotational vibration mode of the bridge superstructure is more sensitive to the ground motions as illustrated in Fig. 2, since all the concrete girder bridges listed in Table 1 have superstructures supported on neoprene pads and restrained with vertical seismic bars. The superstructures are weakly restrained in the plan with the fundamental vibration mode in translation. With continuing deck rotations, the acute corners at two ends of the bridge finally moved away from the abutments, knocking off the curtain walls and becoming unseated (4a and 4b in Fig. 3). Note that the possibility of having significant rotational ground motions at the bridge sites can further amplify the rotational motion (3 in Fig. 3).

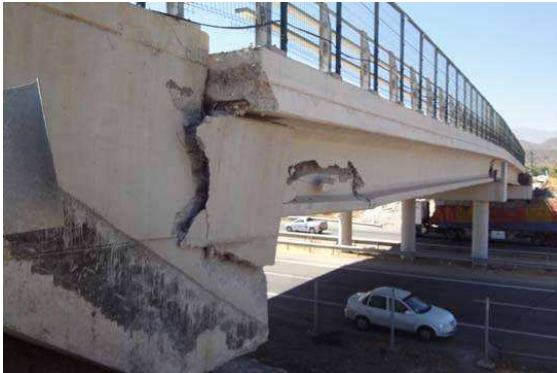
As an example, the 2-span Chada overpass as shown in Fig. 4 (a) is discussed in detail. The bridge superstructure was displaced significantly during the earthquake. The transverse offset between the deck and abutment seats ranged from 64 cm to 78 cm. The longitudinal gap between the end of girders and the abutment was up to 9 cm. The bottom flange and web of the exterior precast girder that hit the curtain walls at each abutment failed in shear as seen in Fig. 4 (a). The failure of the bottom flange is clearly seen in Fig. 4 (b). The two curtain walls at the intermediate bent were both damaged as shown in Fig. 4 (c). The bridge experienced strong shaking as indicated by the induced gap around columns, Fig. 4 (d). No structural damage was observed in the bridge columns.

(a) Curtain wall shear failure at abutment

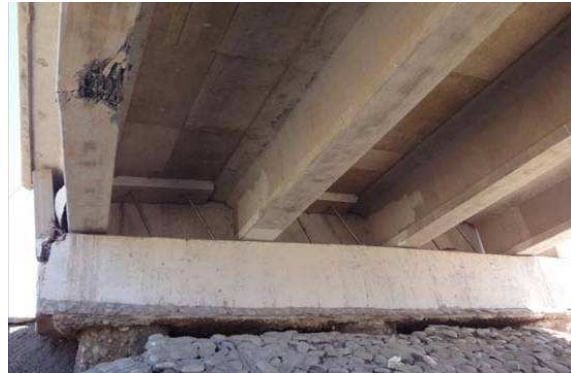
(b) Bottom flange damage

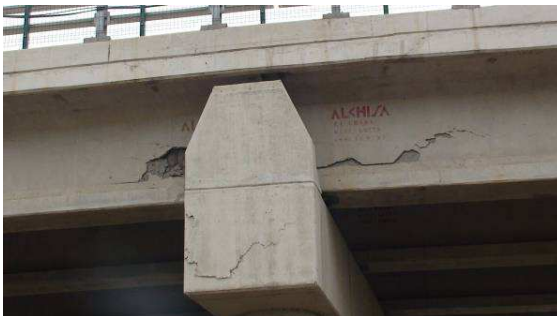
(c) Curtain wall damage at bent

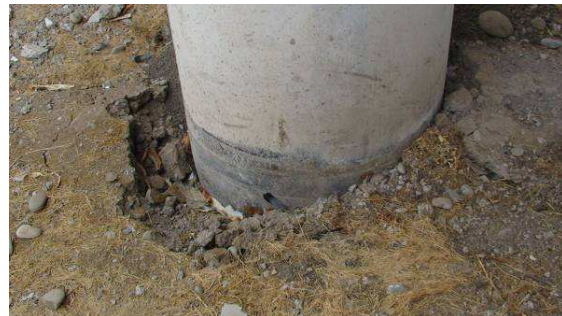
(d) Soil separation from column

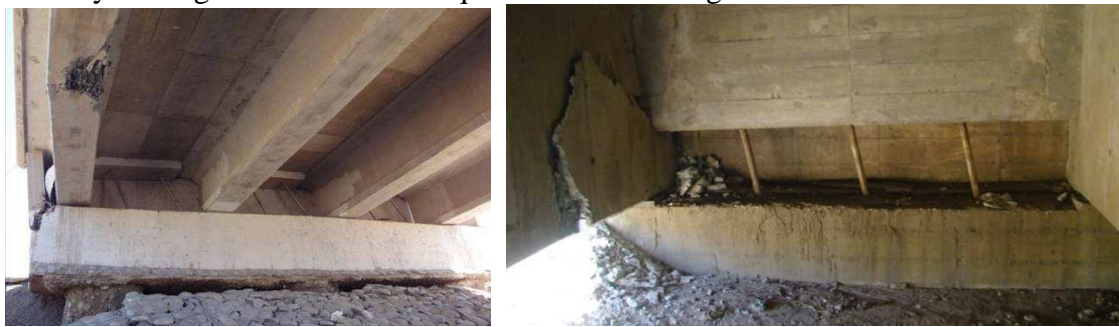
The exterior prestressed concrete (PC) girders of the Romero and Chada bridges (7 and 8 in Table 1), which were constructed without diaphragms, experienced out-of-plane block shear failures due to transverse impact loads from shear keys as illustrated in Fig. 5 (a). When partial diaphragms were used between the girders such as in the San Nicolás bridge, the bottom portion of the exterior girder still experienced significant shear cracks as shown in Fig. 5 (b). However, with the use of even partial concrete keys between girders as shown in Fig. 5 (c), both exterior and interior prestressed concrete girders of the Llacolén bridge suffered no visible damage. This was because the concrete keys provided sufficient lateral restraints on most of the girders, making them work together and share the transverse seismic force. With full diaphragms, the 260-m-long East Ramadillas bridge

(a) Chada bridge with no diaphragms (b) San Nicolás bridge with partial diaphragms

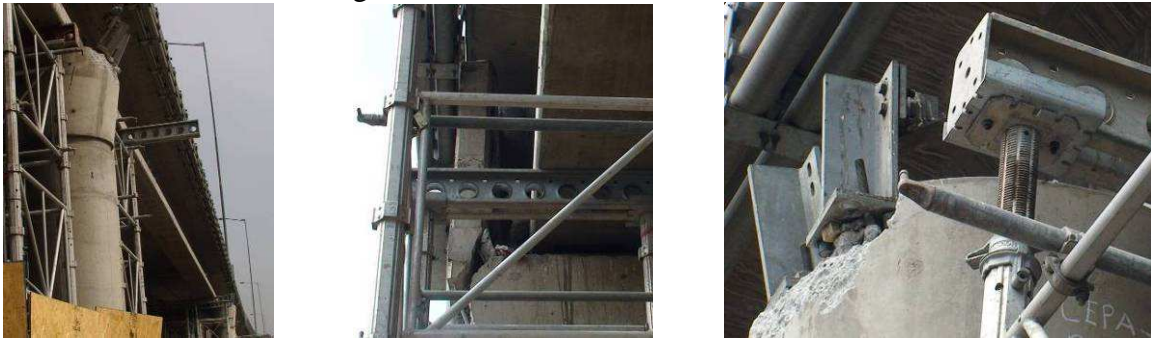
As an example to illustrate the role of diaphragms, two bridges oriented in the E-W direction at the Independencia/Américo Vespucio site were considered. Built in 2004, the bridge that carries eastbound traffic is a four-span structure with five discontinuous prestressed, precast, girders and a continuous deck. It almost collapsed during the earthquake, experiencing a lateral offset of greater than 0.5 m, as indicated by the use of temporary heavy supports in Fig. 6. The superstructure had steel stoppers but no intermediate or end diaphragms. As shown in Fig. 6 (b, c), both the curtain wall of the abutment and the steel stoppers were significantly damaged. Each stopper was anchored with two bolts that were embedded into the capbeam for a depth of 90 cm. The steel stoppers were intended to restrain both horizontal and vertical motion of girders.

(a) Overall damage (b) Curtain wall at the west abutment (c) Damage to steel stoppers
 FIG. 6 DAMAGE TO THE EASTBOUND INDEPENDENCIA BRIDGE

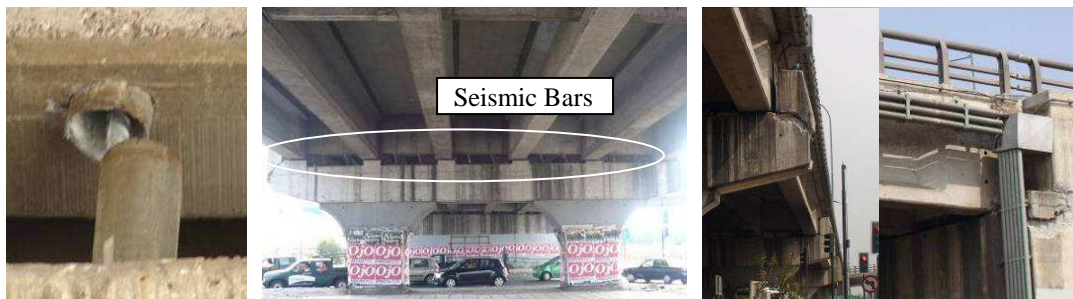
The westbound bridge is a four-span structure with six discontinuous prestressed precast girders and a continuous deck as shown in Fig. 7. Built in 1997, each bent has two flared wall piers. The bridge was designed with both intermediate and end diaphragms, and survived the earthquake with damage limited to concrete shear keys and excessive deformations in the seismic bars. In comparison to the eastbound bridge, the presence of diaphragms seemed to have helped maintain the structural integrity of the westbound bridge. More importantly, the concrete shear keys likely served their design purpose during

(a) Displaced seismic bar (b) Typical flared wall pier (c) Damage of shear keys
 FIG. 7 DAMAGE TO THE WESTBOUND INDEPENDENCIA BRIDGE

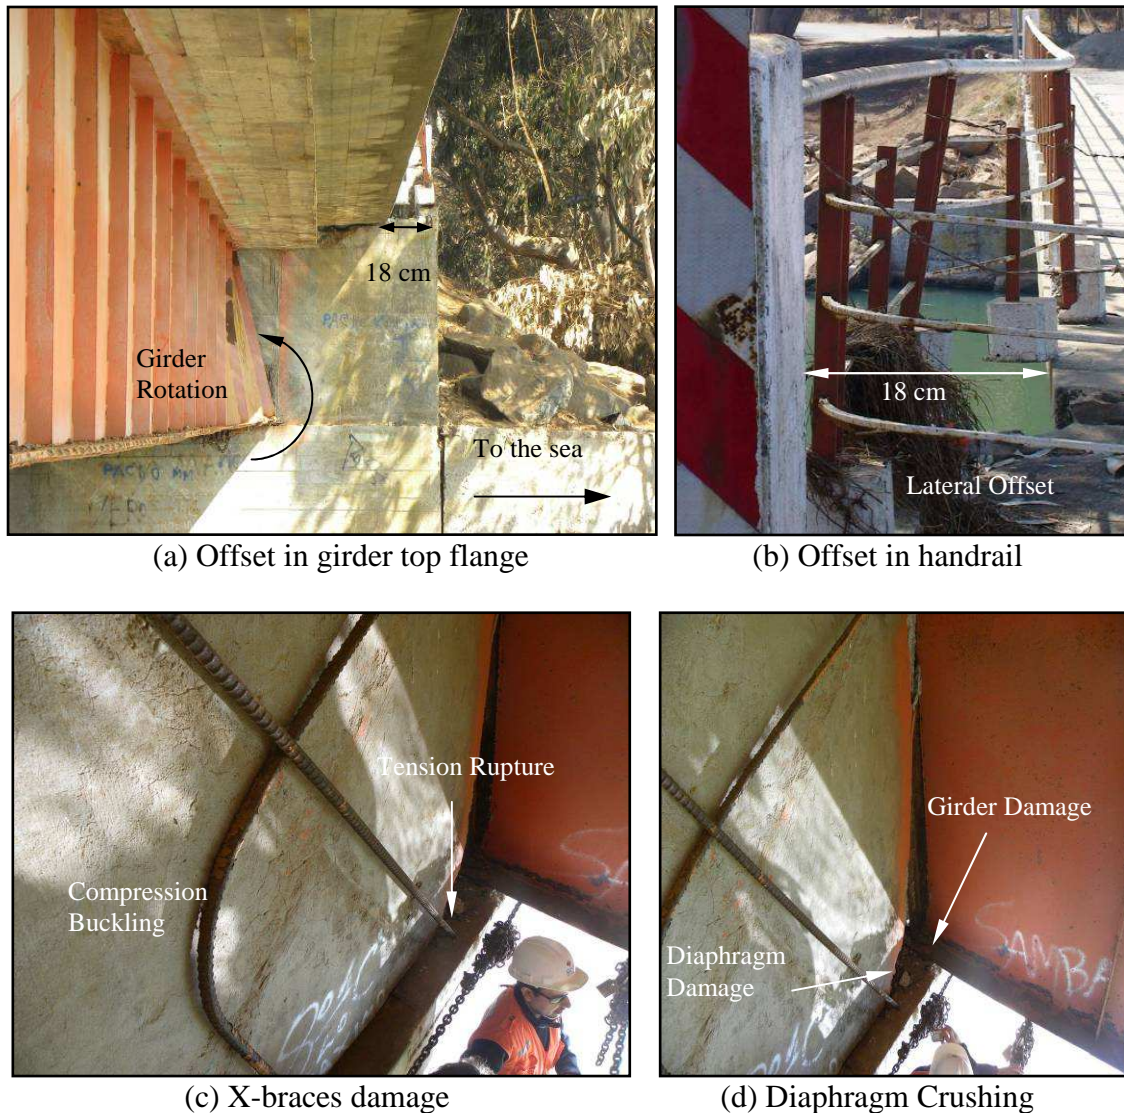
The tsunami at the City of Iloca was characterized by three sea waves that arrived every 25 minutes on the average, starting approximately 4:00 am. Since the clear height of the bridge from the water level was about 1.5 m, the tsunami waves passed over the bridge inducing large lateral forces on the girders. At the south abutment, the bridge deck experienced a permanent lateral displacement of about 18 cm, as indicated in Fig. 8 (a, b).

The seaward girder rotated about the bottom flange and suffered torsional deformation and flexural deformation about the weak axis of the section. Damage was also found in the concrete diaphragm and bracing system with tension rupturing in one bar and compression buckling in the other one as shown in Fig. 8 (c, d). The fracture failures in bracings and seismic bars as well as the compression buckling of bracings are attributed to their reduced cross section as a result of corrosion. The north abutment suffered little damage.

FIG. 8 DAMAGE AT THE SOUTH ABUTMENT OF THE PICHIBUDIS BRIDGE

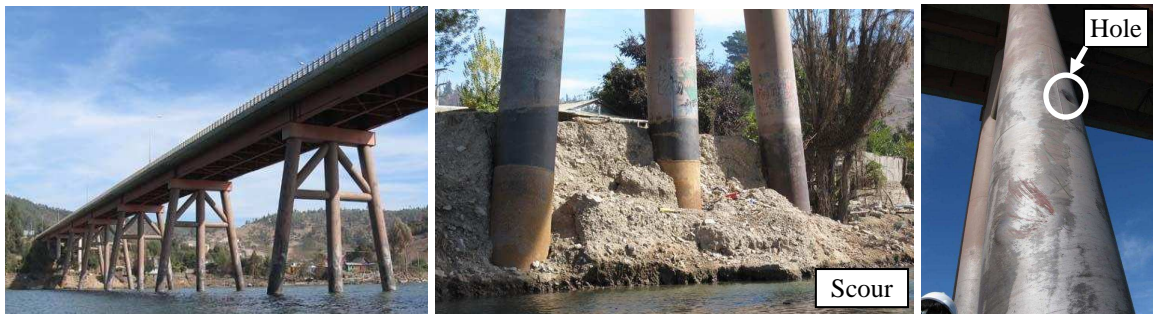
14 mm. Their overall height from pile tip to soffit ranges from 44.5 to 51.5 m. The maximum clear height above the water is about 25 m. This portion of the structure appeared to have performed relatively well during the earthquake compared to the NE portion, but suffered local damage at several locations due to tsunami effects. Four major waves were recorded near Constitución with arrival times ranging from 3:50 am to 5:20 am after the mainshock. Wave heights ranged from 6.9 to 11.2 m passing under the superstructure. Nevertheless these waves eroded river sands and gravels from around the piles, Fig. 9 (b), to a depth of about 4.5 m, and wave-borne debris punctured a hole in the wall of one of the steel legs as shown in Fig. 9 (c) (Courtesy of the Ministerio de Obras Públicas de Chile or MOP).

(a) Southern spans and pile bents (b) Erosion of alluvial materials (c) Debris-impact hole
 FIG. 9 DAMAGE TO THE CARDENAL RAÚL HENRÍQUEZ BRIDGE (MOP)

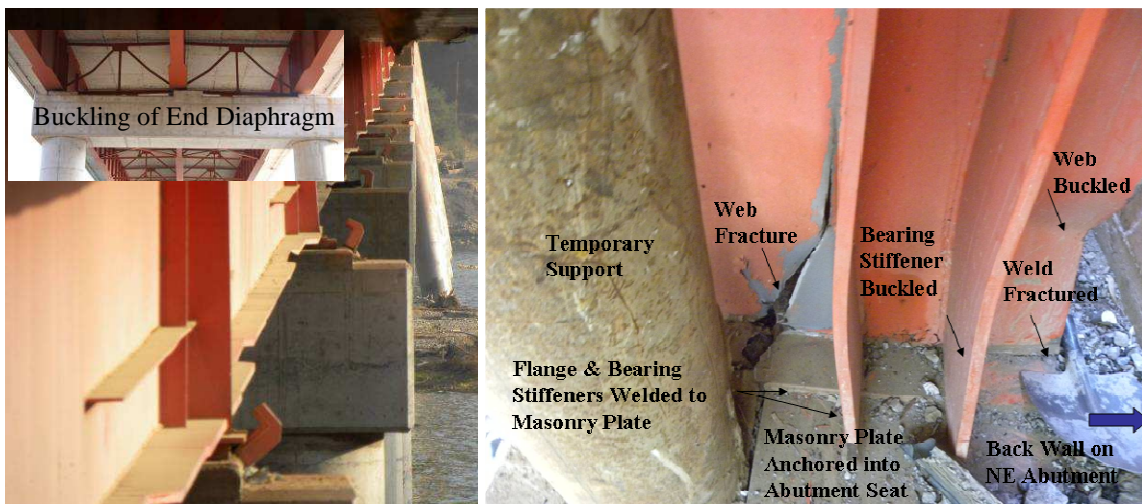
During the earthquake, the NE portion of the bridge moved transversely from west to east as shown in Fig. 10 (a). All steel stoppers were deformed and girders were displaced from their elastomeric pads, resulting in the web and flange bending of the exterior girder

about its weak axis at the NE abutment, as shown in Fig. 10 (d). The transverse diaphragms at the intermediate bents and abutments buckled as shown in Fig. 10 (a, c). At the NE abutment, the webs and bottom flanges were fractured in all three steel girders, and both bearing stiffener and web buckled as shown in Fig. 10 (b). This type of damage is indicative of large longitudinal loads in the superstructure being attracted to the fixed bearing at the abutment. The weld detail at the abutment transferred the longitudinal loads into a significant bending moment, locally causing stress concentrations in the steel girders at the end of their supporting masonry plates. Note that the weld between the girders and the masonry plate did not fail. As shown in Fig. 10 (d), due to severe damage in the web and flange of girders, a steel beam was used to temporarily transfer loads from the flange to the abutment seat bypassing the web of the girders.

(a) Girder offset and cross frame buckling (b) Girder damage at north abutment

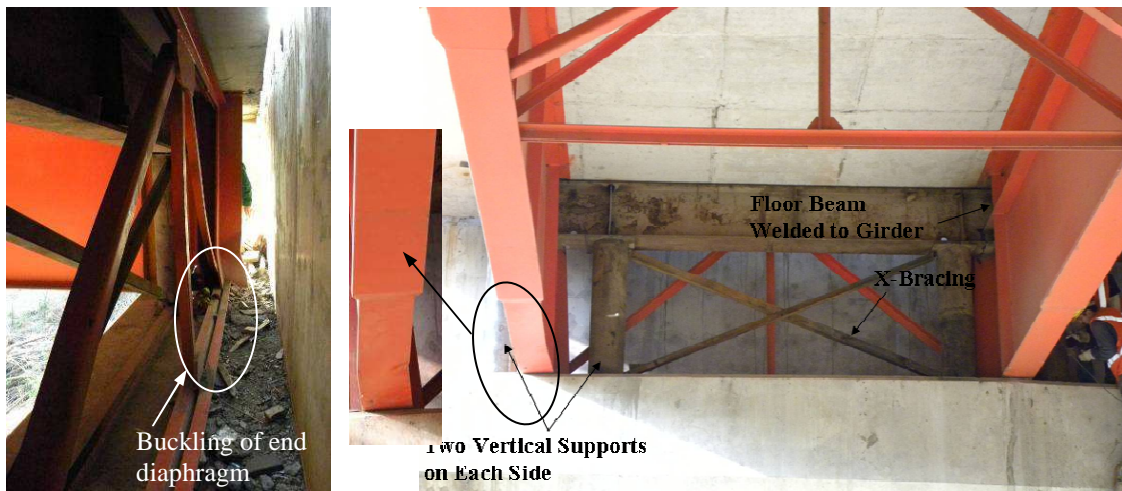
(c) Crossframe buckling (d) Temporary repair at NE abutment

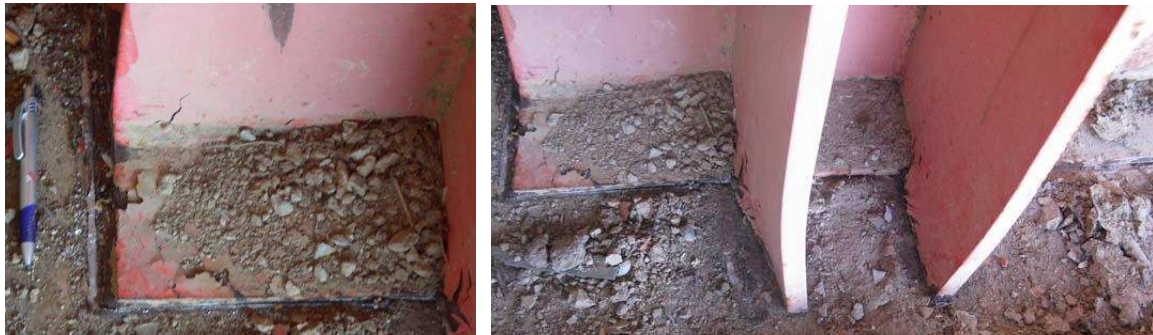
FIG. 11 DAMAGE AT THE SW ABUTMENT (MOP)

Although similar in connection details, the girders at the SW abutment were subjected to less damage than that at the NE abutment, limited to the buckling of the bearing stiffeners. The reason for this difference is probably due to the fact that the fillet welds connecting the girder flanges and bearing stiffeners to the masonry plates failed during the earthquake and large longitudinal loads were not attracted to this abutment, as shown in Fig. 11 (Courtesy of MOP).

(a) The girder end

(b) The transverse stiffeners

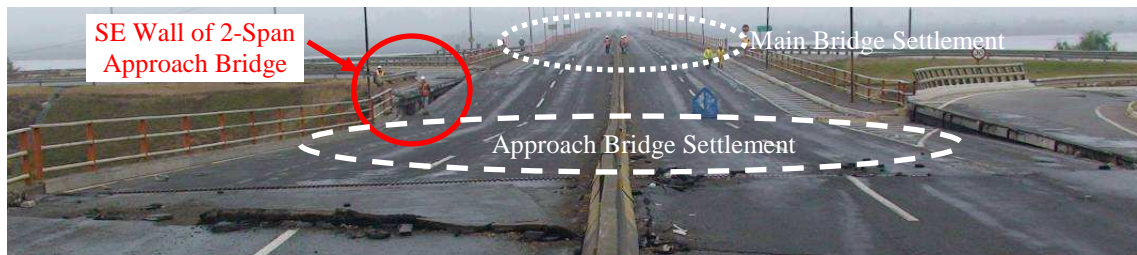
Whereas the river-front overpass was generally undamaged, the 2-span approach structure was damaged both globally and locally at the intermediate bent as shown in Fig. 13 and Fig. 14. It is clearly seen in Fig. 13 that the intermediate bent has settled for over 1 m with respect to the two end bents, leading to a substantial depression in the roadway surface. However, the wall at the SE corner of the approach structure settled little though the surrounding slope settled about 2 m. Supported on drilled shafts, the wall seemed to be newer than the approach structure, probably built with more stringent foundation design requirements together with the NE off-ramp on approach fills that suffered no damage during the earthquake. As indicated in Fig. 14 (a, b), the intermediate bent comprises two rectangular columns which most likely experienced uneven, liquefaction-induced, settlement during the earthquake. The consequential change in stiffness between the two columns shifted the longitudinal seismic force from one to the other column which then failed in shear as shown in Fig. 14 (b). The transverse reinforcement of the failed column was spaced at 46 cm. It is noted that the ground further settled against the undamaged column and the cap-beam above the undamaged column experienced cracking.

(a) Overall settlement of the Juan Pablo II Bridge (facing the Bio Bio River)

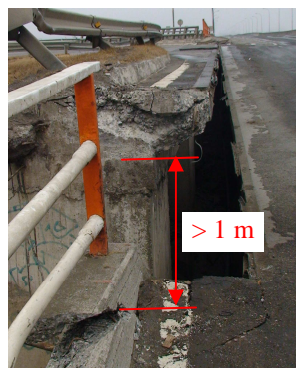
(b) SE wall of approach spans

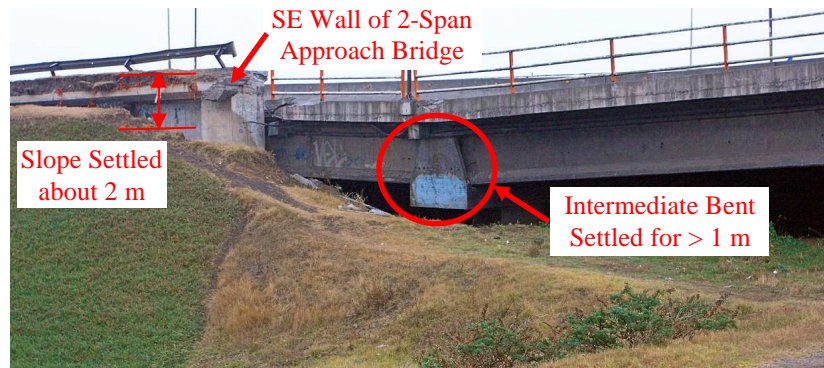
(c) Intermediate bent settlement of approach spans

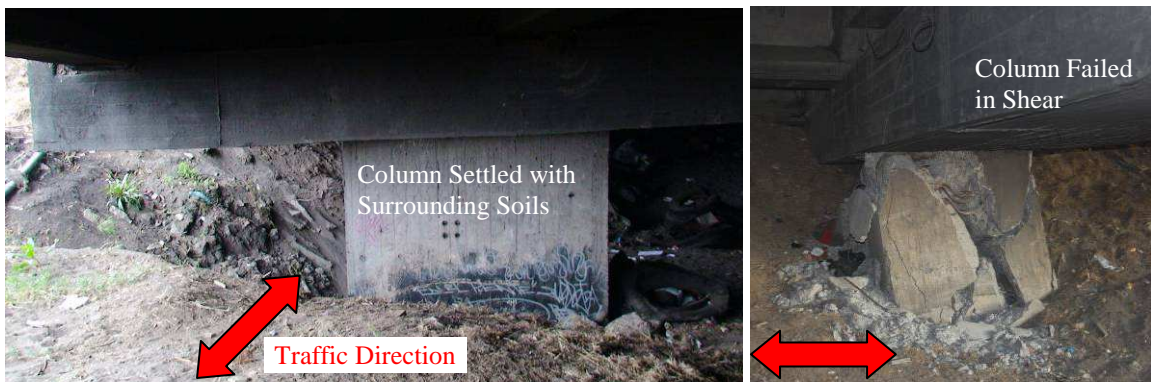
(a) Column settlement (cracks on far side) (b) Reduced column height due to shear failure
 FIG. 14 DAMAGE TO INTERMEDIATE BENT OF APPROACH SPANS

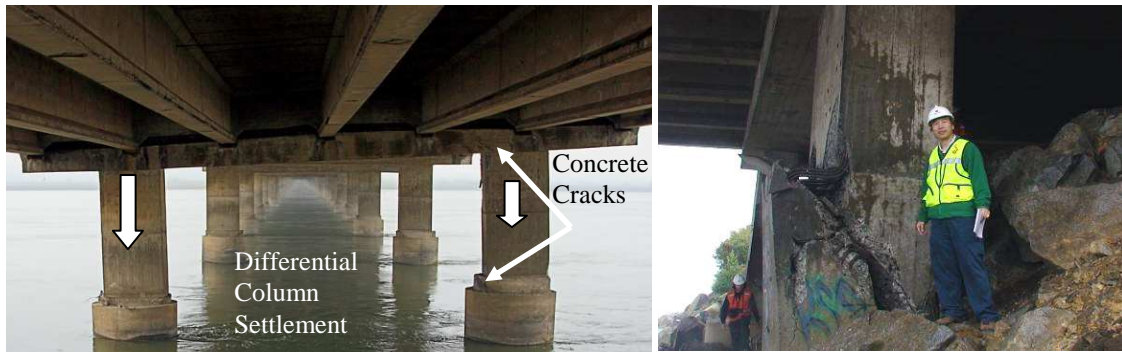
The spans of the main bridge also have experienced uneven support settlement as shown in Fig. 13(a), which then tilted the columns and rotated the bridge deck about the centerline of the bridge as seen in Fig. 15 (a). In addition, lateral spreading of the NE bank attempted to move the columns of the bent at this position towards the river. But this movement was restrained by the superstructure and the columns were consequently placed in single shear. One failed catastrophically in shear as shown in Fig. 15 (b) and the other was seriously damaged. The difference in behavior between the two columns might be due to the uneven settlement and rotation of the bridge deck. The longitudinal movement of the first column (upstream side) was approximately 56 cm at the top of the shear plane and 41 cm at the bottom. While the bridge did not collapse due to severe differential settlements and lateral slope movements, it was seriously damaged and closed to traffic.

(a) Uneven settlement and induced damage (b) Shear failure in upstream column
 FIG. 15 DAMAGE DUE TO UNEVEN SETTLEMENT AND SLOPE FAILURE
