Bridge Lessons Learned from the Chile Earthquake in 2010

W. Phillip Yen, Ian Buckle, Genda Chen, Tony Allen, Daniel Alzamora, Jeff Ger & Juan G. Arias

ABSTRACT

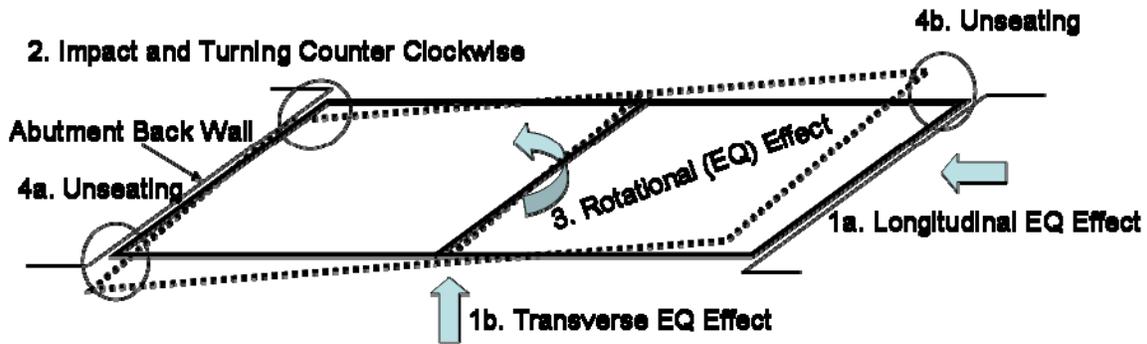
Figure 4 Deck rotation of a representative bridge (two spans shown in plan)

Based on the previous observations, the movement of a bridge superstructure can be illustrated in four steps in figure 3. Under the earthquake excitations (1a, 1b, and possibly 3 in figure 3), the bridge superstructures first moved towards one abutment (left as shown in figure 3) and impacted against the abutment back wall (2 in figure 3). The reaction from the back wall then turned the superstructure in a direction opposite to the skew direction (counter clockwise in figure 3). The rotational motion (3 in figure 3) was amplified due to the fact that the rotational vibration mode of the bridge superstructure is more sensitive to the ground motions as illustrated with the acceleration response spectra recorded at the Hospital Station in Curico, figure 4, since all the concrete girder bridges listed in Table 2 have superstructures supported on neoprene pads and restrained with vertical seismic bars. The superstructures are weakly restrained in plan with the fundamental

vibration mode in translation. With continuing deck rotations, the acute corners at two ends of the bridge finally moved away from the abutments, knocking off the curtain walls and becoming unseated (4a and 4b in figure 4). Note that the possibility of having significant rotational ground motions at the bridge sites can further amplify the rotational motion (3 in figure 4).

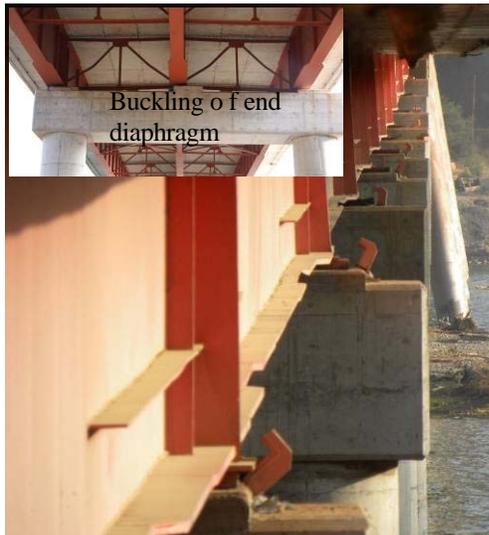
The most plausible reason for the girder damage at each abutment, is excessive longitudinal force applied on the end support. During the earthquake, the majority of the inertia force on half of the bridge superstructure was resisted by the end support at each abutment. The excessive force resulted in either fillet weld fractures at the SW abutment or steel girder fractures in web and bottom flange at the NE abutment.

(a) Girder offset and crossframe buckling

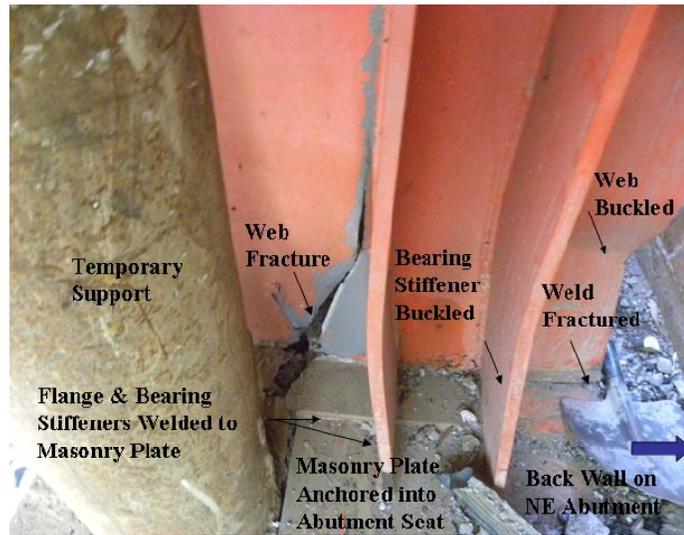
(b) Girder damage at north abutment

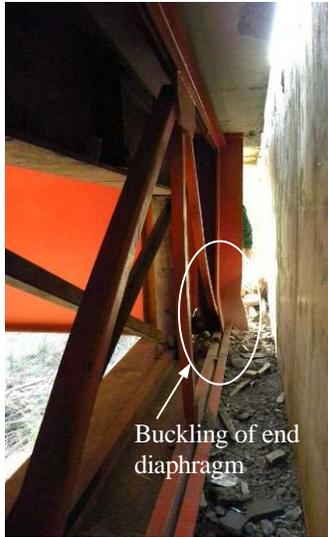
(c) Crossframe buckling

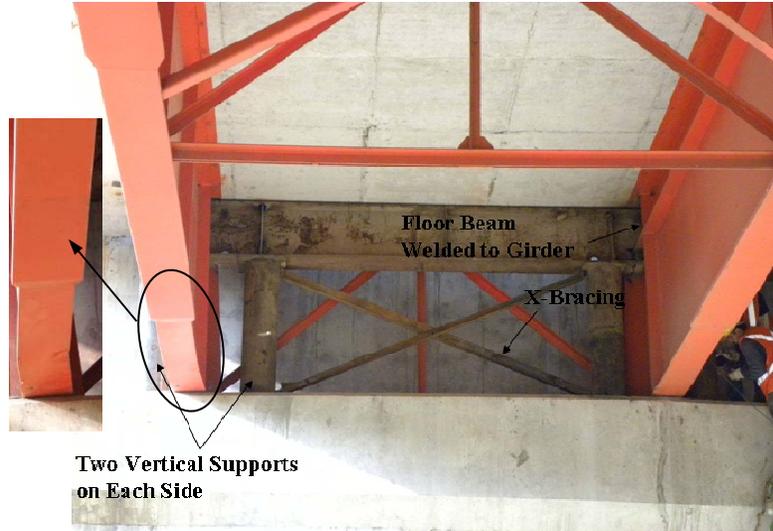
(d) Temporary repair at NE abutment

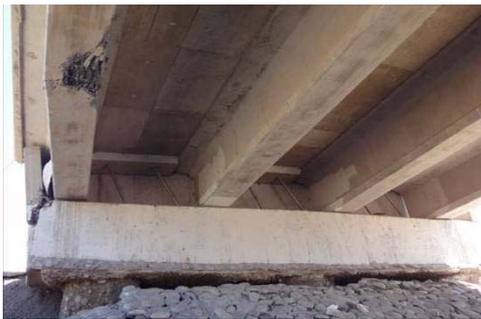
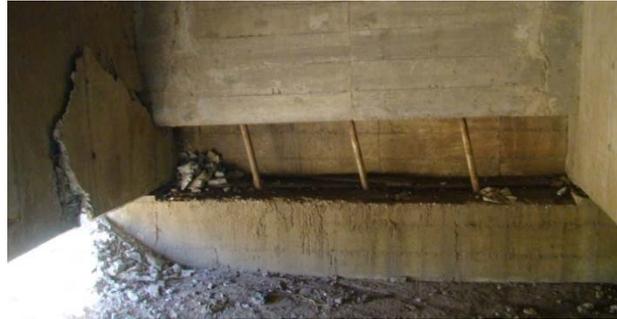
Exterior PC girders in Chada and Romero bridges without diaphragms experienced out-of-plane block shear failures due to transverse impact loads from shear keys as illustrated in figure 7(a). When partial diaphragms are used between girders in bridges such as San Nicholas bridge, the bottom portion of an exterior girder can still experience significant shear crack as shown in figure 6-3(b). With the use of even partial concrete teeth between girders as seen in figure 7(c), both exterior and interior PC girders suffered no visible damage. The most severe damage occurred in the west portion of LLacolen bridge was a shear crack on one interior girder. This is because the concrete teeth provide sufficient lateral restraints on most of the PC girders, making them work together and share the transverse seismic force.

(a) Chada bridge with no diaphragms (b) San Nicholas bridge with partial diaphragms

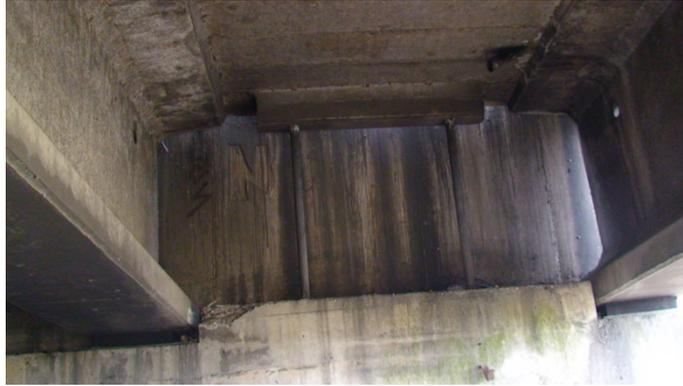
(c) West abutment of LLacolen bridge with concrete teeth

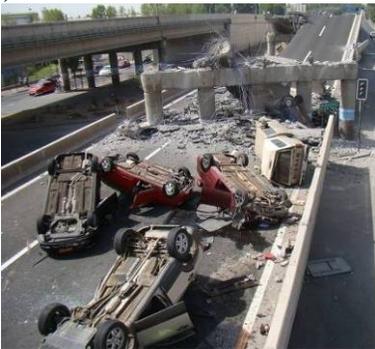
Steel stoppers used in several bridges (e.g. Independencia, Miraflores, and Lo Echevers bridges) failed prematurely. The Independencia bridge with steel stoppers was out of service while the parallel bridge with concrete shear keys and diaphragms survived the earthquake with repairable damage. The two-bolt connection from each steel stopper to capbeams is too weak to resist any significant bending moment. However, once welded to steel girders, steel stoppers appeared to function well to prevent lateral movement of girders as observed in Quilikura bridge. (See Figure 8)

(a) Collapsed bridge

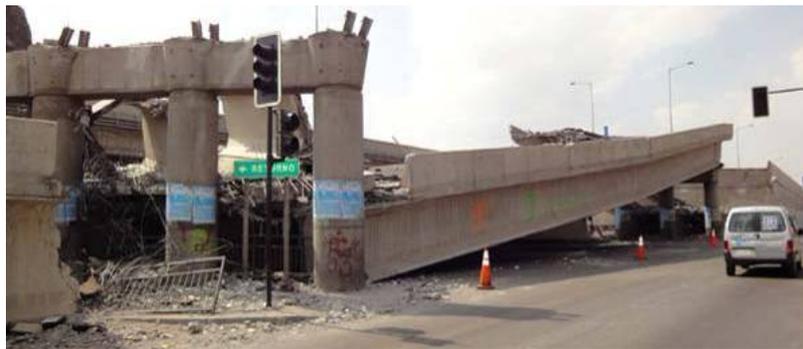
(b) Three unseated spans

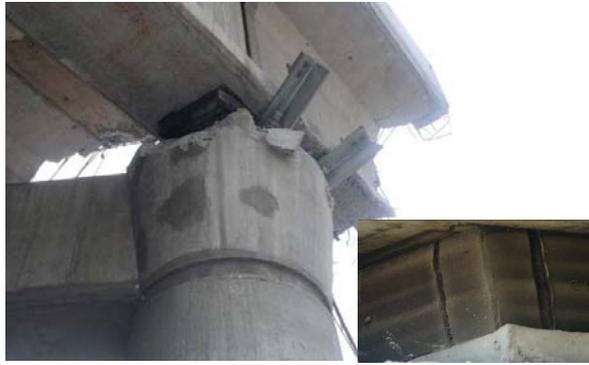
(c) Displaced elastomeric bearing

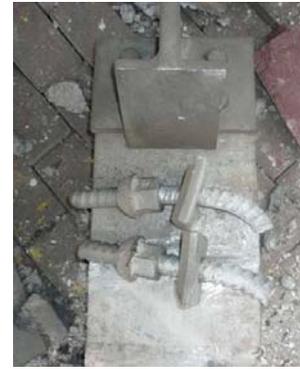
(d) Failure of a steel stopper

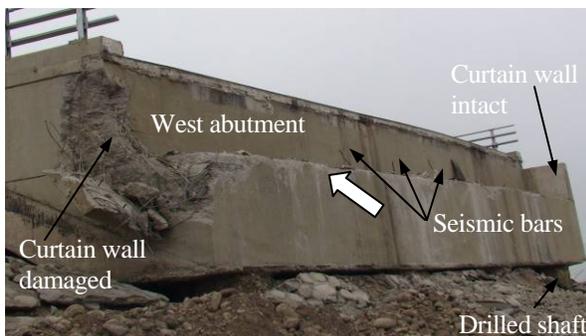
Vertical seismic bars were used in a number of bridges (e.g. Chada, Las Mercedes, LLacolen, Romero, Hospital, and Pichibudis bridges). In general, they are flexible, experiencing significant deformation during the earthquake. Almost all of them were well anchored into capbeams and decks since only those bridges with felled-off spans left signs for bar pullout. It was uncertain whether they have provided vertical restraints to bridge girders even though no sign of up-and-down jumping of girders was observed at bridge sites (see figure 9). This point can only be clarified after significant bridge analyses using recorded ground motions.

(a) Seismic bars at west abutment

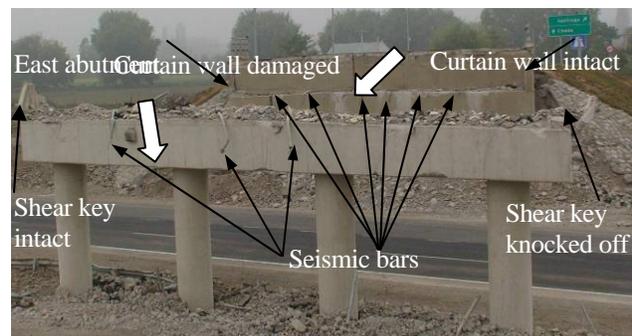
(b) Seismic bars at east abutment

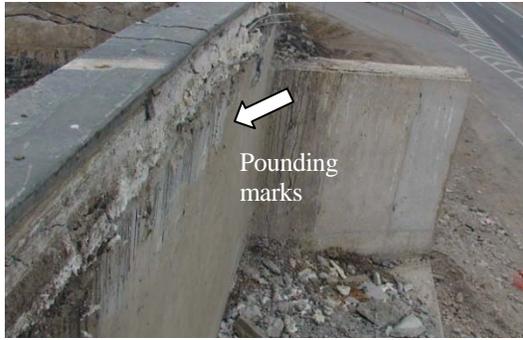
(c) Pounding at west abutment

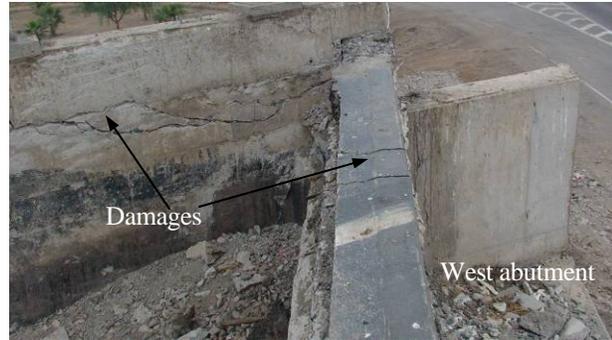
(d) Wingwall damage at west abutment

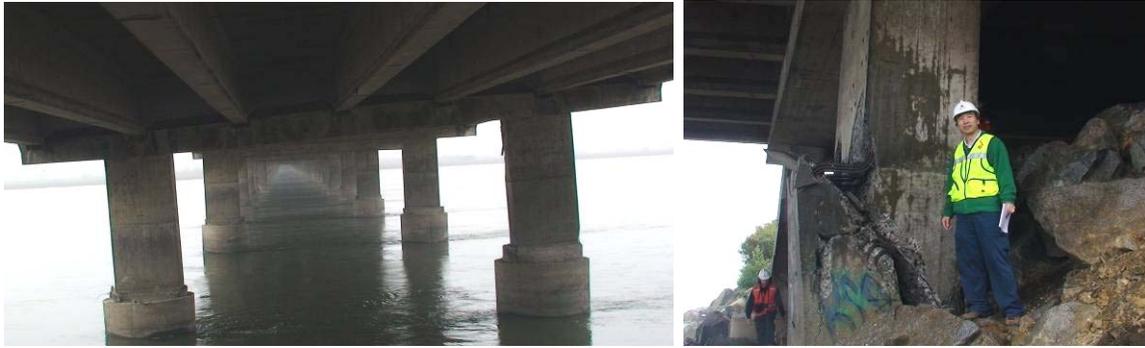
Except for the ground settlement and lateral spreading effects (e.g. LLacolen and Juan Pablo II bridges), bridge substructures (capbeams and columns) received virtually no damage during the earthquake. This represented a successful design of bridge substructure. Several columns in the LLacolen and Juan Pablo II bridges failed in shear (See figure 10).

(a) Underneath first span over water (b) Shear failure in upstream column
 Figure 10 Damage to intermediate bent under approach spans to Juan Pablo II Bridge.

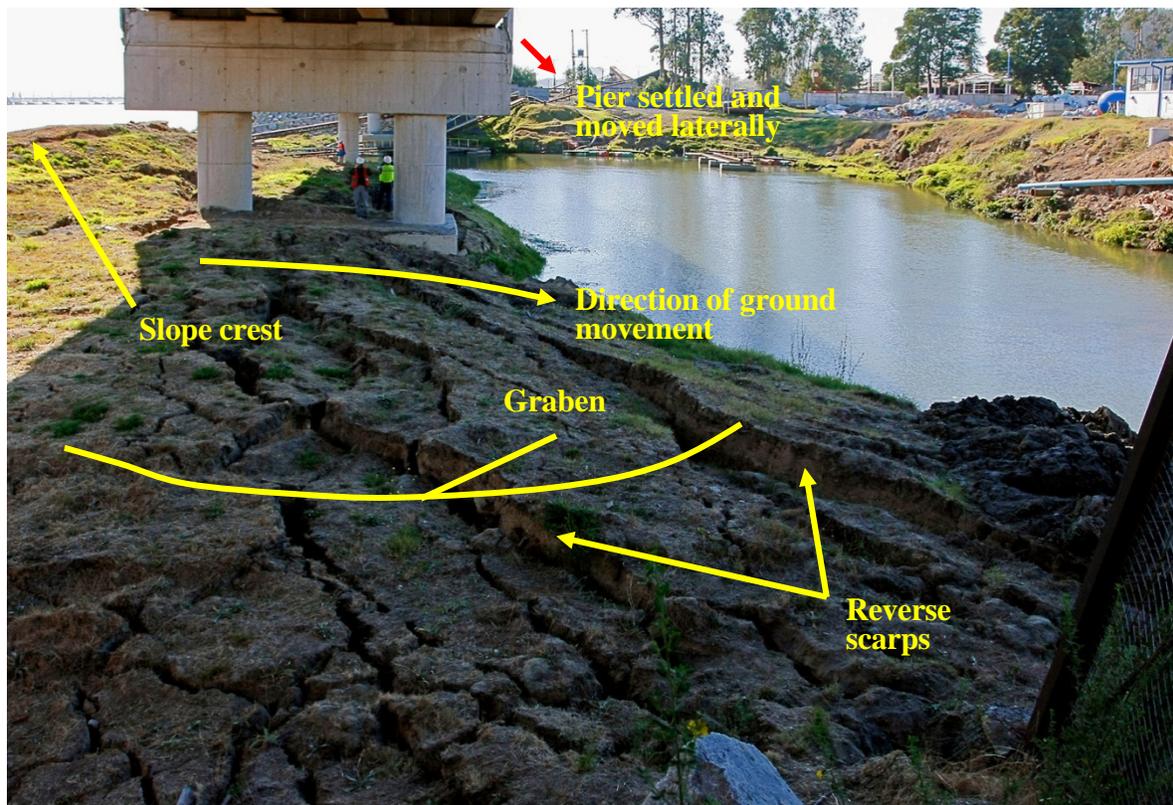
What was most surprising was the good performance of bridge abutments retaining 4 to 8 m high approach fills over gently sloping ground even when severe vertical and horizontal approach fill deformation (e.g., 0.5 to 1 m or more), likely due to liquefaction of soil below the approach fill, occurred (see figure 11). While there were a few cases where 50 to 150 mm of lateral movement of the abutment appears to have occurred, in most cases no discernable movement occurred. This may

Figure 11. Severe ground failure at La Mochita Bridge.

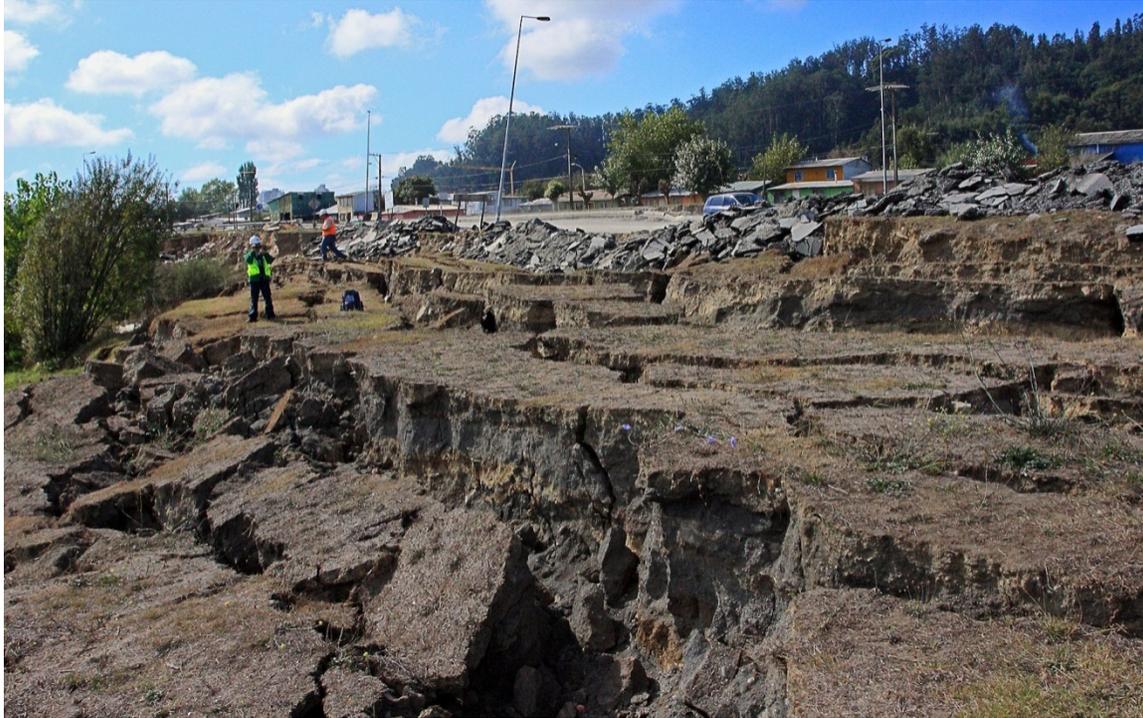
Liquefaction induced ground settlement was observed at many of the bridge sites where liquefaction occurred. However, settlement of the bridge foundations only occurred for a few of those sites (i.e., Site No's 25 – Juan Pablo II Bridge, 27 – La Mochita Bridge (see Figure 12), and 31 - San Nicolas Bridge). In general, regardless of the amount of liquefaction induced ground settlement that occurred, the foundations did not settle significantly if these were supported underneath by a reasonably good bearing layer of soil. However, if the foundation was relatively shallow and not supported by a good quality bearing layer, significant settlement of the foundation did occur.

Figure 12 Ground failure of north approach fill for the La Mochita Bridge, looking toward the north away from the bridge.
