# **SAN FRANCISCO-OAKLAND BAY BRIDGE EYE BAR FRACTURE – LESSONS LEARNED**

Barton J. Newton, PE<sup>1</sup>

## **Abstract**

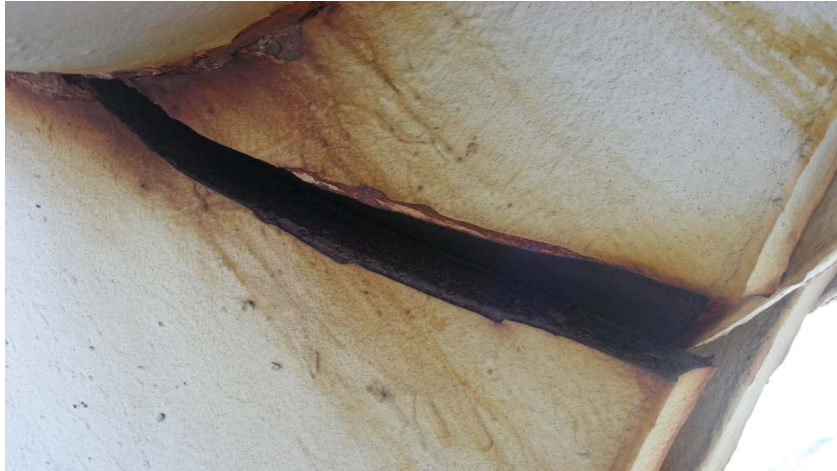
During a regularly scheduled inspection of the SFOBB, while the structure was closed over the 2009 Labor Day weekend, bridge inspectors found a fracture in one of the eye bars on the cantilever portion of the bridge that carries traffic between Yerba Buena Island and Oakland. The fractured eye bar is one of 1,680 eye bars on the eastern portion of the bridge, including 1,120 eye bars on the structure's cantilever section. Eye bars were a common construction technique used in the 1930s for truss members which are subject to only tension forces or for connecting bridge cables to their anchorages.

*FIGURE 1-THE FRACTURE PROPAGATED ACROSS THE FULL WIDTH OF ONE SIDE OF THE EYE SECTION OF THE EYE BAR.*

It was concluded that after seventy years of cyclic loading, a fatigue crack initiated at the outside edge of the eye bar and propagated gradually to the center, leading to a loss of cross section. The loss of cross section exceeded the material's ability to carry the imposed load, leading to full cross-sectional failure.

When the fracture was discovered, Caltrans engineers decided to keep the bridge closed until the capacity of the eye bar was restored. With the bridge already closed to traffic, an emergency repair was initiated. A temporary repair strategy was developed incorporating the use of high-strength steel rods as part of a saddle apparatus to bypass the cracked area of the existing eye bar. That repair was installed and the bridge reopened on the day after Labor Day.

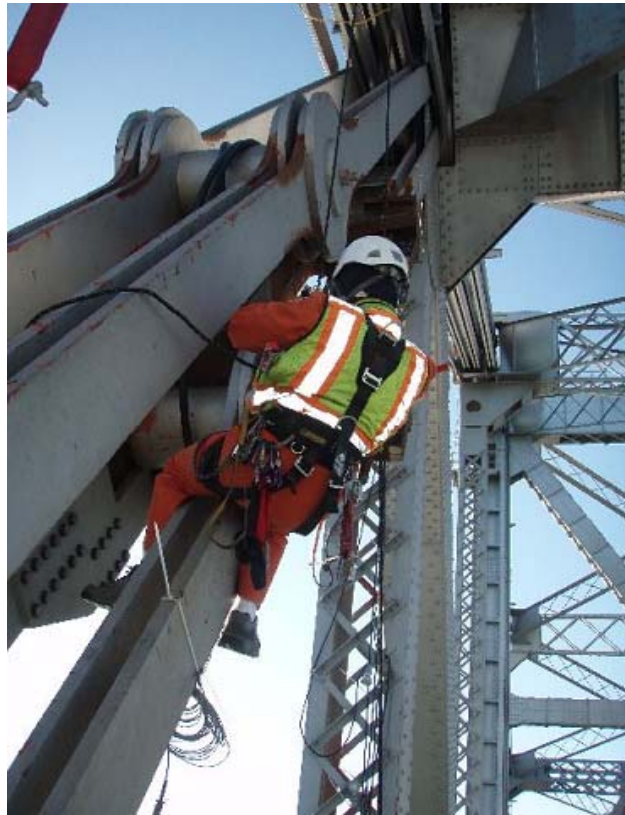
*FIGURE 2-CLOSE-UP INSPECTION OF THE DIAGONAL EYE BAR WAS CONDUCTED.*

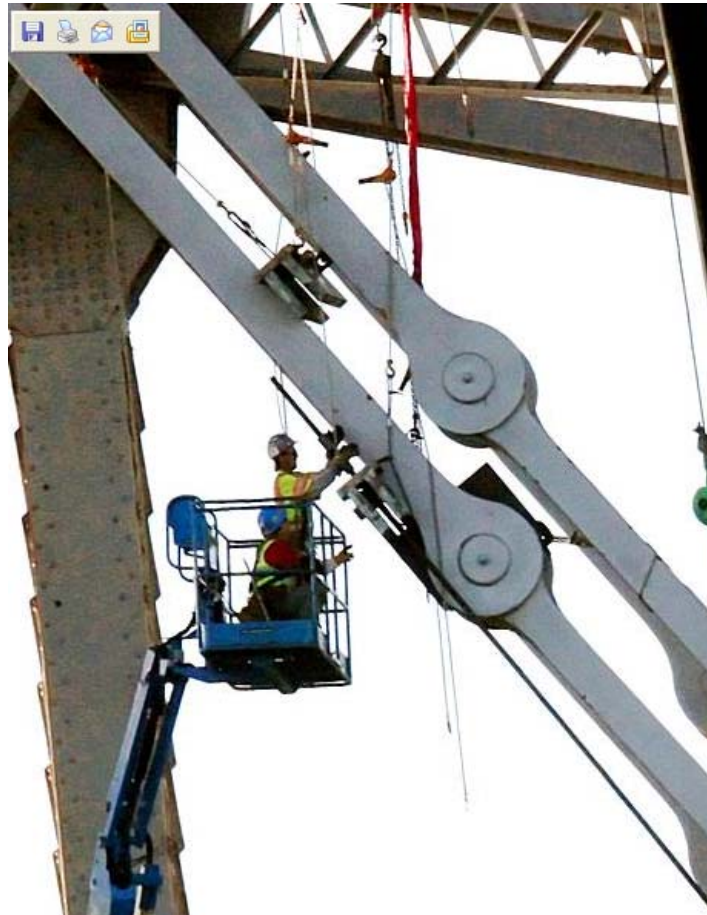
On Tuesday evening, October 27, 2009, a high-strength steel rod snapped from the steel saddle installed to repair the cracked eye bar. A portion of that assembly landed on the deck of the bridge. While there were no injuries, the bridge was immediately closed. Work began on a new repair and an investigation was launched to determine why the initial repair failed.

*FIGURE 3-THE ORIGINAL FIX INVOLVED THE USE OF HIGH-STRENGTH RODS TO BYPASS THE CRACK.*

Following the failure of the initial repair, Caltrans enlisted the assistance of outside experts to serve as a Peer Review Panel and assist in the development of a second short-term repair to allow for the reopening of the bridge: This repair included several design enhancements to the original short-term repair to ensure that the problem that occurred on the initial repair did not happen again. Tie rods were tensioned with a system that centered the rods through the holes in the saddle components to prevent metal-on-metal contact that could generate a stress concentration. The tie rods were strapped to one another and to the eye bars with a turnbuckle system to reduce vibration that could cause fatigue.

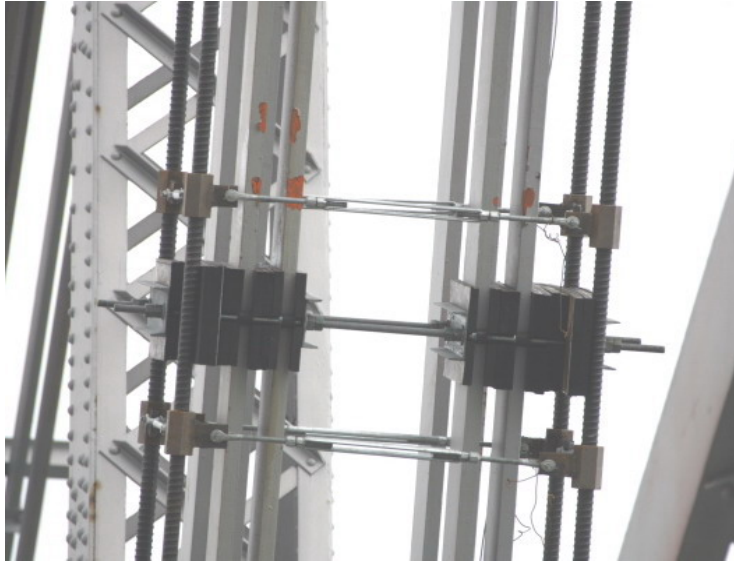
*FIGURE 4-DAMPERS ARE DESIGNED TO REDUCE VIBRATION.*

The crossbars attached to the tie rods were reinstalled to the saddles, essentially fusing them together as one piece. In the unlikely event of a tie rod failure in the future, the crossbar would remain attached to the saddle and keep the elements from falling. As a further precaution, the saddles were also chained to the pins and all repair system elements were tethered together to prevent them from falling onto the roadway.

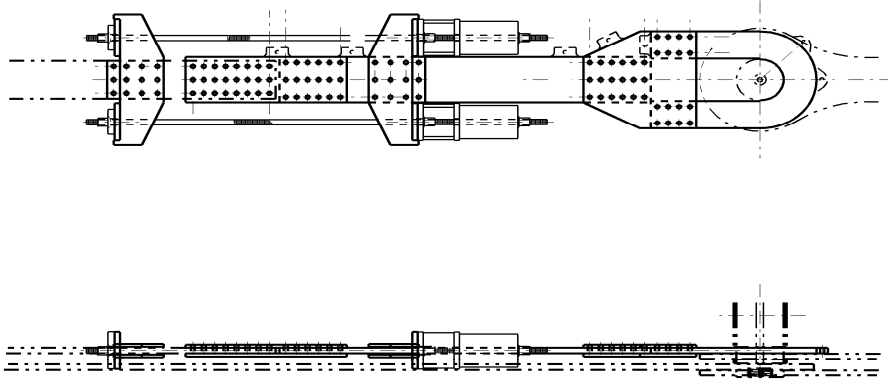
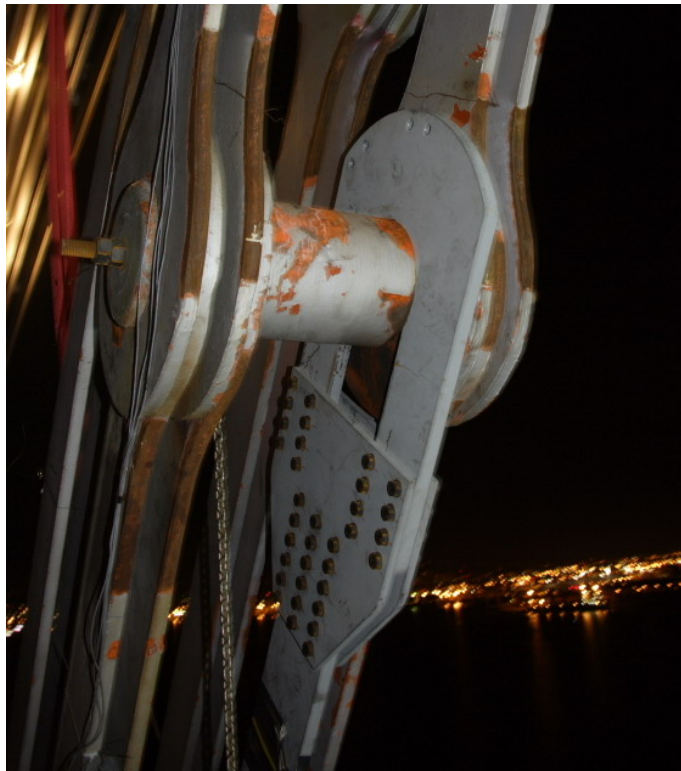
*FIGURE 5-COMPLETED REPAIR OF THE PERMANENT EYE BAR.*

The Internal repair was chosen because it best met the design objectives. A 12-foot section of the fractured eye bar was removed and replaced with new structural steel. Replacement of the eye bar head was done without the need for a full bridge closure by staff working at night with limited lane closures. The major work was completed just

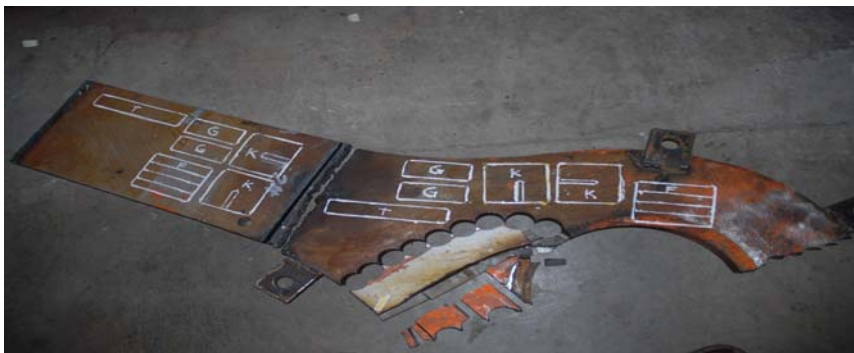
Two reports concerning the eye bar were produced. In the first report, completed November 18, 2009, analysis concluded that a crack initiated at the outer edge of the eye bar and propagated toward the center pin location. The second report, dated February 9, 2010, validated the strength and toughness in the steel from which the eye bar was forged. The eye bars were manufactured using a die-press process that resulted in the eye bar heads having a concave side with sharp edges. Stress was concentrated in the sharp edges. The fatigue crack was initiated in this area of stress concentration.

*FIGURE 6-DETAILED TESTS WERE PERFORMED ON THE STEEL FROM THE CRACKED EYE BAR.*

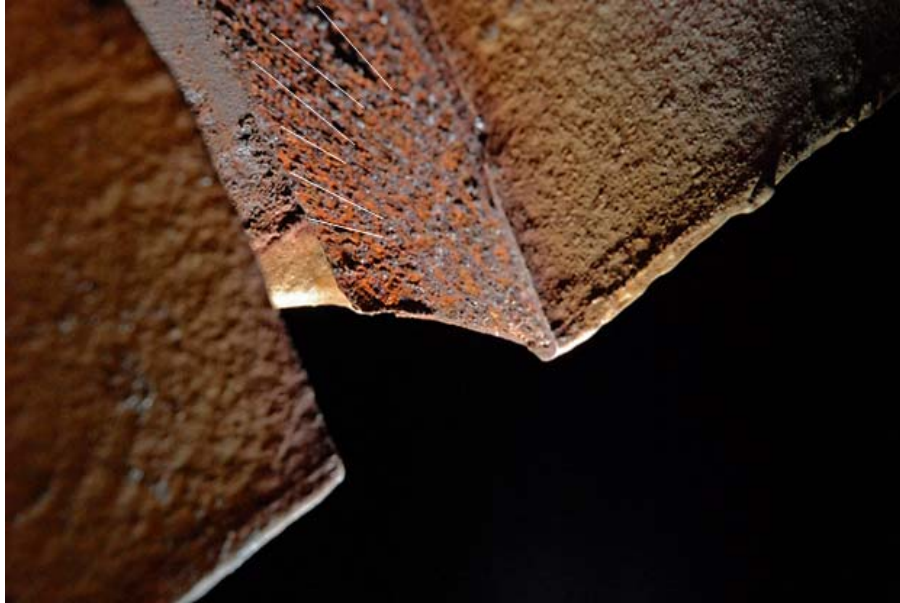
*FIGURE 7-CLOSE-UP OF FRACTURE SHOWING RADIAL RIDGES POINTING TO LOCATION OF CRACK INITIATION.*

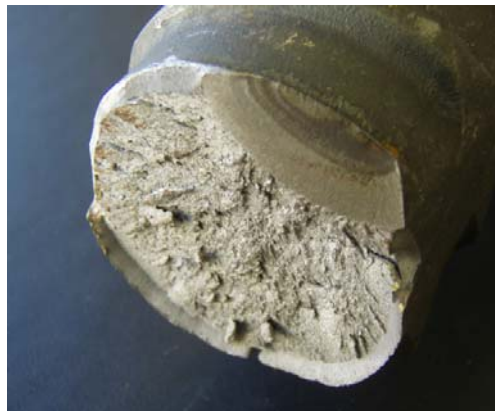
In addition, the cause of the failure of the high-strength rods used in the initial repair was investigated. The office's November 18, 2010, report concluded that the failure of the steel rod was caused by fatigue. Wind conditions on the bridge caused the rods to vibrate significantly, which was determined to be a contributing factor.

*FIGURE 8-CLOSE-UP OF FRACTURE HS ROD.*

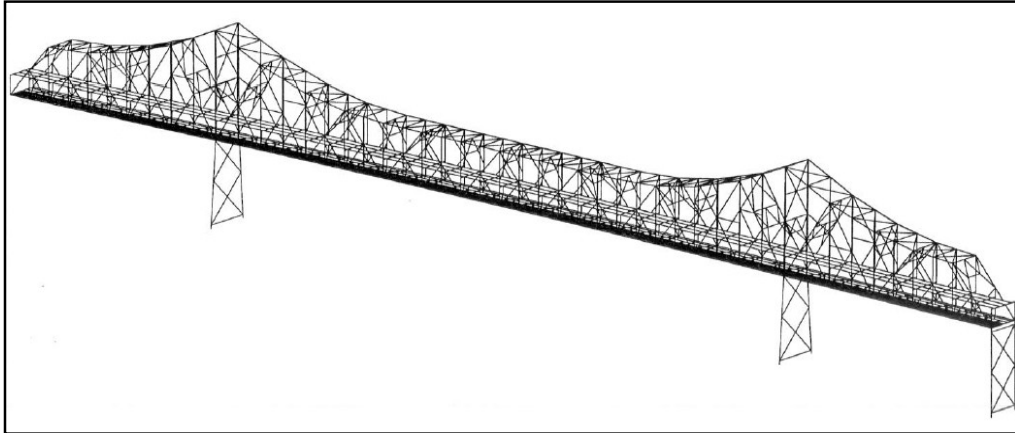
*FIGURE 9-MODELING FRAME.*

An extensive computer analysis of the cantilever portion of the bridge confirmed that the elements of the bridge, including the eye bar chains, had load-carrying redundancy providing for an enhanced factor of safety.

It was also this modeling and analysis that verified that the diagonal eyebar chains had the least amount of redundancy and ability to redistribute the load to other members if one of them failed. This is the basis of the Department focus of the inspection and monitoring on these sixteen diagonal chain locations on the bridge.

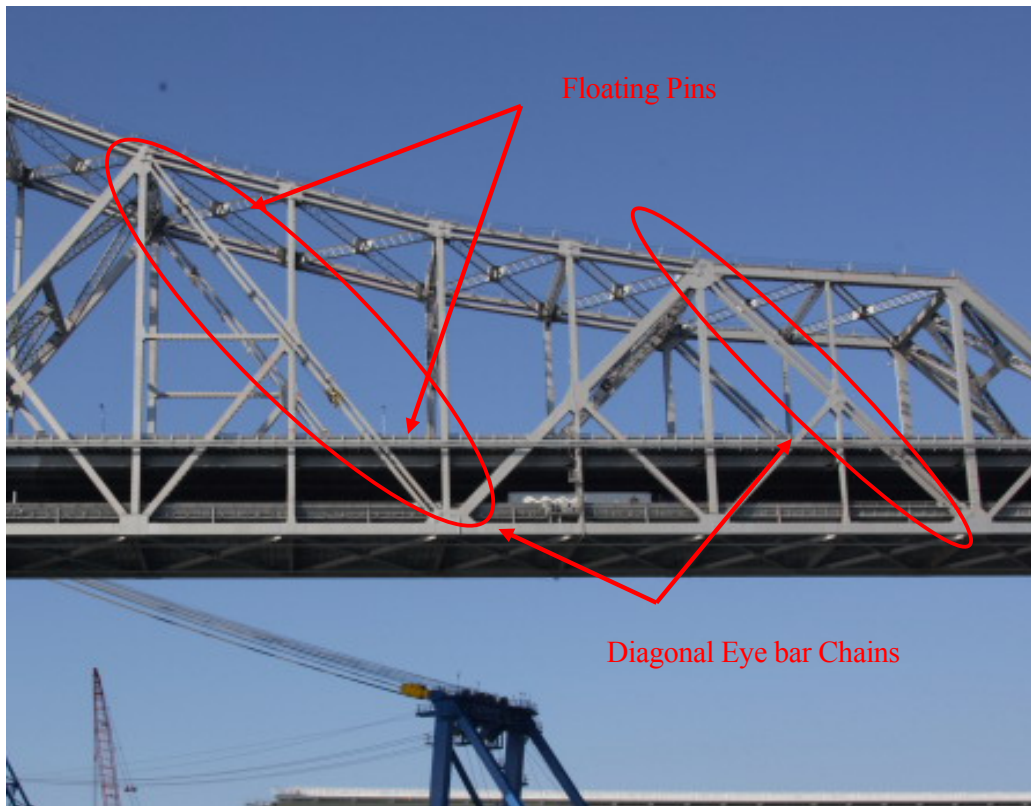
*FIGURE 10-DIAGONAL EYE BAR CHAINS ARE CIRCLED.*

Nondestructive techniques are being used at the sixteen locations where eye bar chains are located. These inspection techniques include dye penetrant and ultrasonic testing. Dye penetrant testing involves spraying dye into the steel to identify surface imperfections. Ultrasonic testing uses sound waves to identify the presence of flaws in the interior of the structural steel. Areas of potential stress concentrations on the critical locations of the diagonal eye bars, such as concave surfaces and minor surface imperfections, have been mitigated by grinding the surfaces smooth. In addition, Caltrans structural steel technicians are performing dye penetrant testing and removing any potential areas where a crack could form on the exterior of the diagonal eye bars.

Vibration dampening systems have been installed at the sixteen locations with diagonal eye bars. Inspectors have observed a noticeable reduction in vibration of eye bars.
