USING POST-TENSIONING TO MITIGATE ALKALI-SILICA REACTION DAMAGE

Barney T. Martin, Jr.¹ and Wagdy G Wassef²

Opened in 1931, the Bayonne Bridge connects the cities of Bayonne, New Jersey, and Port Richmond on Staten Island, New York. The bridge is owned by the Port Authority of New York and New Jersey (PANYNJ). The main span of the bridge, supported on massive concrete abutments founded on diabase bedrock, consists of a two-hinged parabolic steel arch 1675 ft. (510.5 m) long (see Figure 1). The New Jersey arch abutment is a concrete block, measuring approximately 133 ft. (40.5 m) x 107 ft. (32.6 m) at the base and is 40 ft. (12.2 m) high. Over the years, this abutment exhibited signs of deterioration in the form of random cracking of the exposed concrete surfaces. Attempts were made in the late 1970's and the mid 1980's to seal and repair the surfaces but were not successful in stopping further cracking.

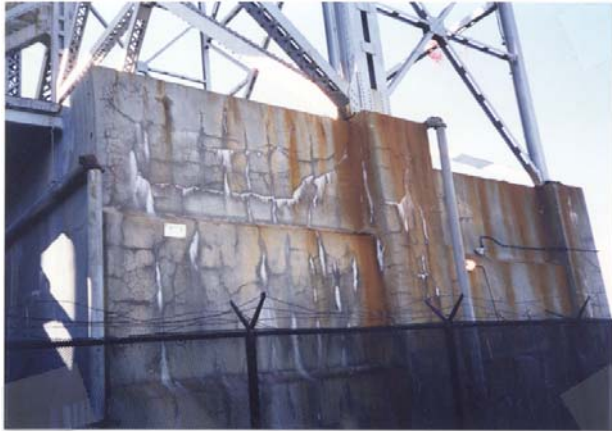
the vertical faces of the abutment with a 1 inch (25 mm) thick layer of shotcrete. In spite of these efforts the deterioration continued with widespread random cracking and staining of the shotcrete and, in some areas, separation of the shotcrete from the original concrete. Figure 3 shows the staining and random cracking of the vertical surfaces of the abutment following the application of the shotcrete.

Figure 3. A view of the north side of the abutment at the start of the project

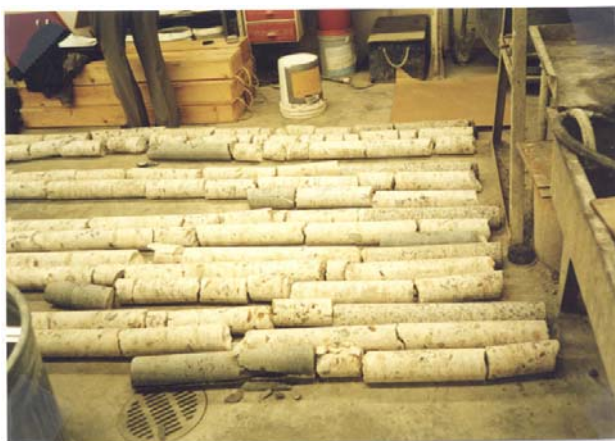
The samples from each core were arranged into a 40 ft. (\pm) (12.2 m) long concrete cylinder (see Figure 4). The cylinders were visually inspected and defects in the concrete were documented. In addition to the visual inspection, the drilling logs and the observations made during drilling were reviewed.

Figure 4. Vertical cores during inspection in the PANYNJ materials laboratory

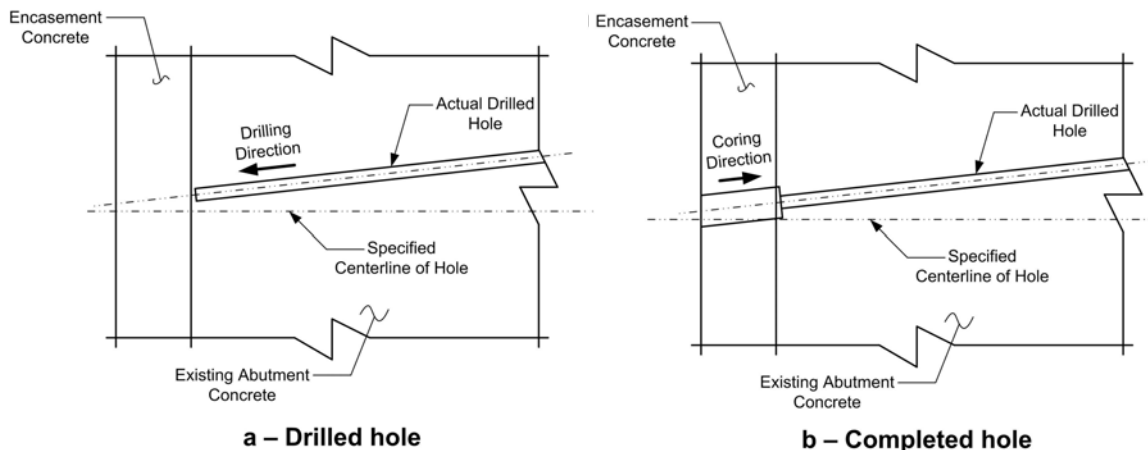
The design team was concerned about damage to the concrete as the drill bit exits the concrete at the exit end of the hole. To eliminate this damage, the drill was stopped before reaching the new concrete at the exit end. Knowing the location of the hole inside the concrete, a core drill was placed at the far end and was used to back-core toward the drilled hole. The location of the center of the cored hole at the surface of the encasement concrete was determined based on the location of the end of the drilled hole and the direction of the drilled holes. This allowed the drilled and cored hole to meet smoothly without having a “kink” in the hole. Figure 7 illustrates the drilling procedure at the exit end of the horizontal holes.

Figure 7. Drilling procedure for horizontal holes

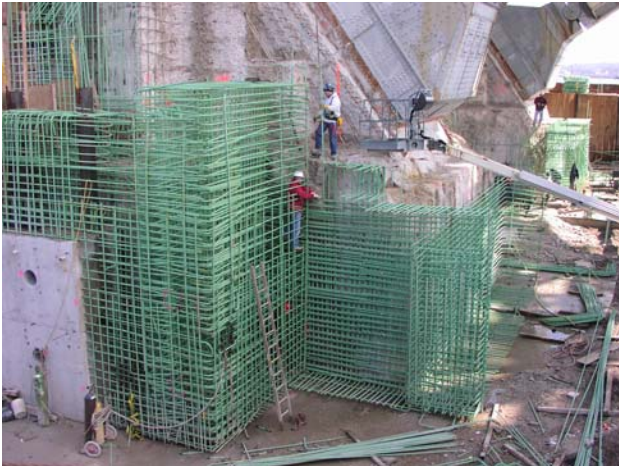
Figure 9. Construction of the encasement

- Construct the concrete encasement around the abutment. Figure 9 shows the abutment during construction of the encasement.
- Drill 29 vertical holes, 4 inches (102 mm) in diameter, to reach bedrock. Grout the holes using low-alkali grout under 150 to 200 psi (1.0 to 1.4 MPa) grout pressure. This initial grouting process was meant to fill many of the existing cracks and voids in and under the original abutment.

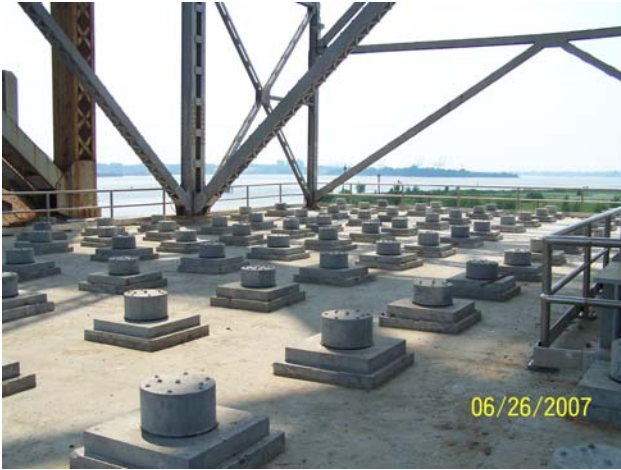
Figure 10. Photo of the top of the abutment after completion of work

- After completing the installation of the horizontal tendons and reviewing the drilling records to ensure that the horizontal holes are within the specified tolerances, drill the vertical rock anchor holes and install the anchors. No more than 20 open holes were allowed at any time and no open holes were allowed within 11 ft. (3.3 m) from each other. Figure 10 shows the top of the abutment after completion of the rock anchors.
