## Study on Rating the Deterioration of Weathering Steel Bridges

Toshikazu Sawamatsu<sup>1</sup>, Takashi Sato<sup>2</sup>, Mitamura Hiroshi<sup>3</sup> and Hiroaki Nishi<sup>4</sup>

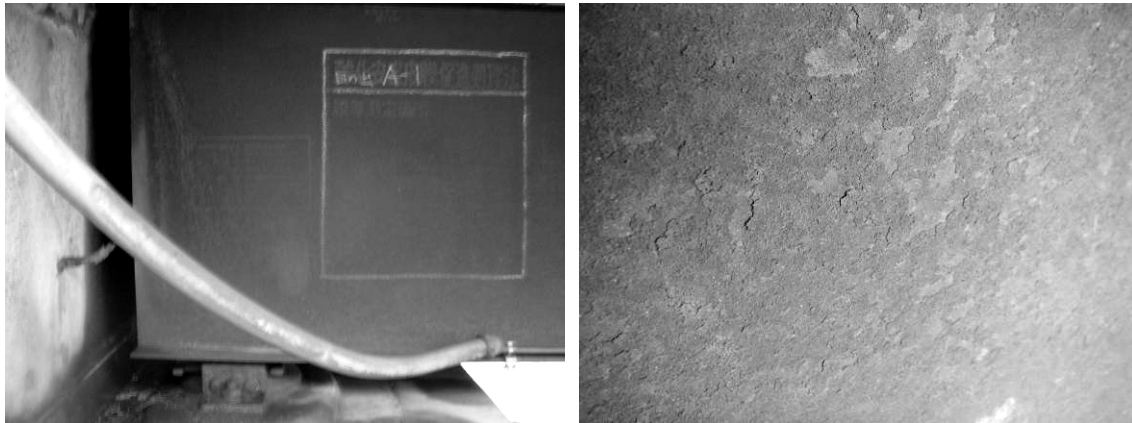
Fig- 5 The surface condition of Hinode Overbridge

Hinode Overbridge is a two-span continuous, double-box-girder bridge whose span lengths are 22.4 m and 31.2 m. When the bridge was completed, survey points were established on the web plates of the main girders of the abutments, shown as A1 and A2 respectively in figures 4 and 5. Their external appearance was rated C in 2010 and 2003. Film thickness over time for the Hinode Overbridge is shown in Figure 4. At both A1 and A2, the film increased in thickness with time. It increased to 234  $\mu\text{m}$  from 158  $\mu\text{m}$  at A1 and to 301  $\mu\text{m}$  from 268  $\mu\text{m}$  at A2 between 2003 and 2010. It is presumed that because the bridge is close to a frontage road and there is little clearance under the girder, various substances containing anti-freezing agents, which hinder the formation of stable rust, have been splashed up by travelling vehicles and have adhered to the bridge. The volume of chemicals applied to prevent ice formation on the road surface has been increasing since the 1980s. The ratings by external appearance of C in 2003 and 2010 are appropriate because no residual protective film was observed (Figure 5) and the films were 300  $\mu\text{m}$  thick. Considering that the film thicknesses increased and are expected to keep increasing as long as the bridge continues to be exposed to the various substances that hinder the formation of stable rust, it is necessary to monitor the bridge over time.

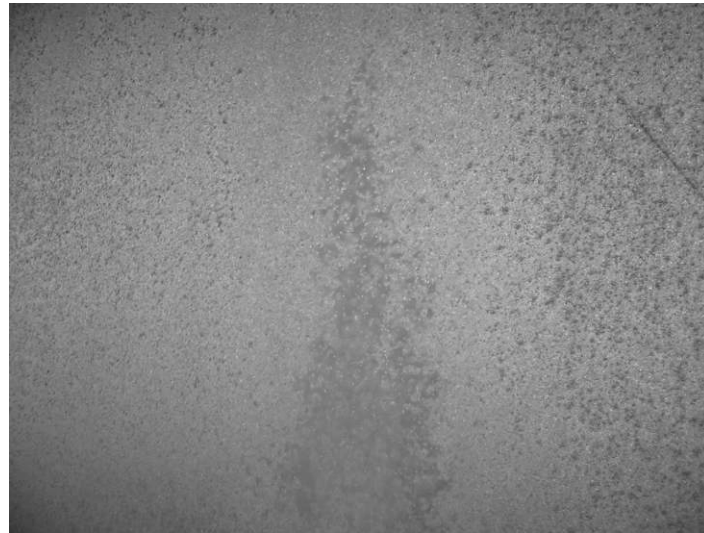
(a) Wanishi 2003

Figure 6 shows the changes in the film thickness over time for Wanishi Overbridge. Since 1978, the film has become thicker only gradually. As compared to the 136  $\mu\text{m}$  measured in 2003, the film thickness surveyed in 2010 evidenced a slight increase to 164  $\mu\text{m}$ . As shown in Figure 7, the external appearance did not change greatly in the same period. Residual protective film was observed and a stable iron oxide film is unlikely to have formed. The external appearance was rated B. Judging from the external appearance and the film thickness at present, the bridge remains at B. The rating of the bridge is likely to shift to C as a stable iron oxide protective film gradually forms. However, because the protective film is not thick enough, it is also possible that the bridge will be down-rated to D or E in the future, due to the effects of snow-melting agents.

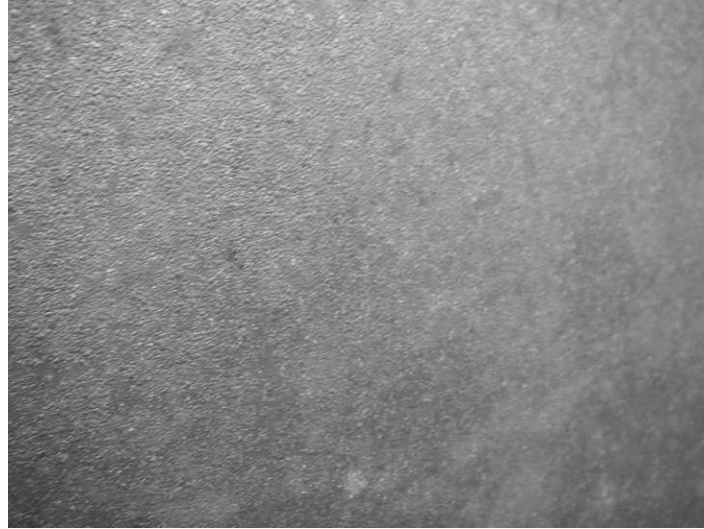
Fig-8 Surface condition at Misaki viaduct

In the 2003 survey, Misaki Overbridge was rated B and its film thickness was 95  $\mu\text{m}$ . In the 2010 survey, it was found that the bridge had undergone little change in external appearance and that the film thickness had increased to 115  $\mu\text{m}$ . Because the film has not formed to a sufficient thickness, the bridge is not in a stable condition and needs to be monitored. As with Wanishi Overbridge, this bridge seems to be in the process of a gradual shift to C ( Figure 8 ) .

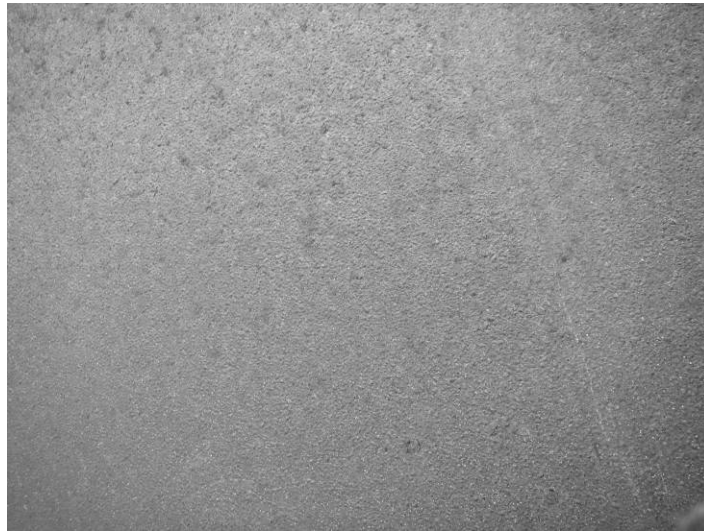
Fig-9 Surface condition at Bokoi viaduct

The observation point of Bokoi Overbridges has changed because of partial corrosion of the girder end where the observation point was set. The speciation of that part has changed from weathering steel to painting. Although this makes difficult to apply the

same rating criteria as were applied to the above-mentioned overbridges, this bridge was rated C (stable) in the 2003 survey, and the condition of the bridge around its observation point was also rated C in the 2010 survey ( Figure 9) .

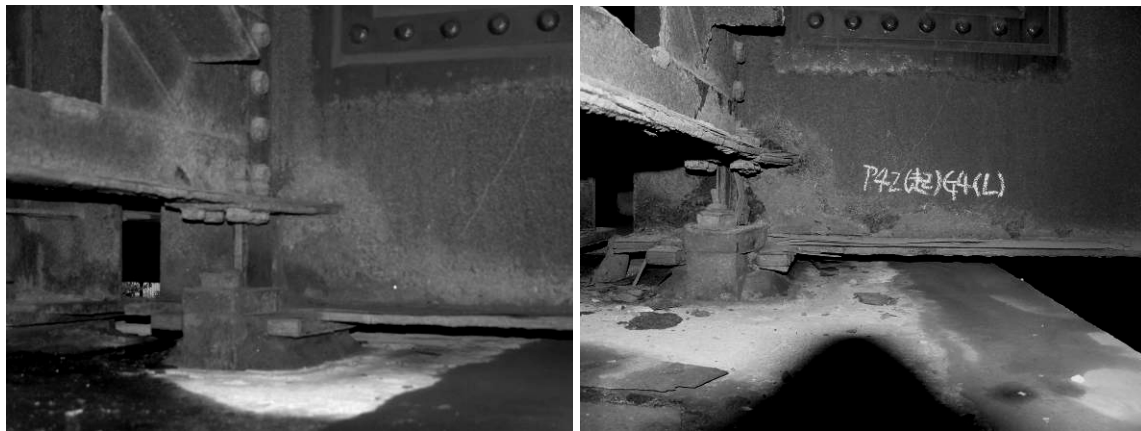
Fig-10 Corrosion due to water leakage at girder ends (Wanishi Overbridge)

(3) At some points on the bridges, partial corrosion has been expanding due to water leakage from expansion joints or water seepage from floor slabs. Figure 10 shows affected girder ends observed in the 2004 and 2009 inspections at Wanishi Overbridge. The damage was minor in 2004, but partial sectional loss and layer-by-layer rust exfoliation were observed in 2009. The damage has worsened to the point of requiring remedial measures. To ensure the safety of weathering steel bridges, it is critical to precisely understand the changes in the surface conditions at the observation points that are chosen to determine the general condition of each bridge. Monitoring and maintenance toward eliminating the causes of corrosion are particularly important at girder ends that are vulnerable to corrosion.
