Static Ice and Observed Damage to the Lake Champlain Bridge

Theodore Zoli, PE¹

On December 28th, 2009, the Lake Champlain Bridge between New York and Vermont was explosively demolished given extensive pier damage and the potential for catastrophic failure. Visible pier damage was consistent with ice abrasion and freeze thaw damage at the waterline. Diving inspections indicated large cracks around the entire perimeter of these large unreinforced substructures, even for expansion piers, which suggest that static forces associated with lake ice contributed significantly to observed damage. Lake ice is often considered benign and does not warrant consideration in pier design. Thermal movements of a large intact ice sheet induce sizeable forces on pier elements and contributed strongly to the observed damage. This paper explores design issues associated with static ice for bridges that traverse lakes in cold regions.

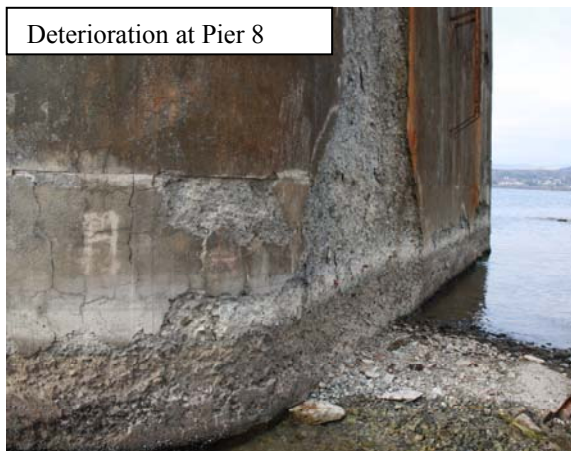
As had been highlighted in previous inspection reports, piers 5, 6, 7, and 8 exhibited severe deterioration of the existing concrete at the water level. A drop in the water level in mid September of 2009 exposed surface deterioration that was much worse than had been previously noted. Upon further investigation, together with concrete coring in this region, the water piers exhibited approximately 30% section loss (a depth of nearly 460mm, as compared to 10mm noted in previous

inspections). Cores taken at the waterline also indicated the presence of horizontal and vertical cracks deep into the piers (between 750mm to 900mm from the face of concrete). This degree of deterioration, together with an evaluation of the safety of the piers under live load and temperature/wind loads described in more detail below, the bridge was closed to traffic on October 16th, 2009, and the design of emergency repairs begun. In concert with this design effort, a dive inspection and pier monitoring were implemented to further assess the degree of damage to identify the extent and degree of proposed repairs.

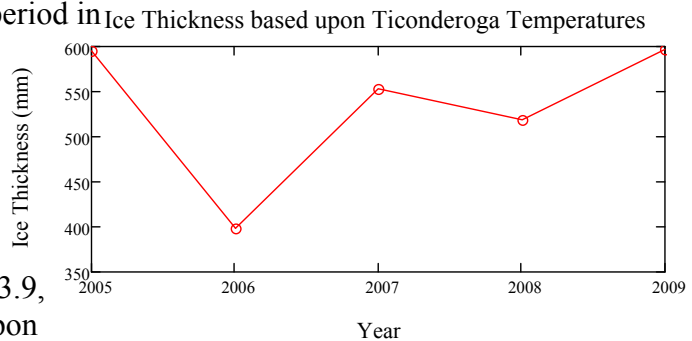
The graph depicts temperatures

for winter months in 2006-2007. The high variability illustrates conditions conducive for ice formation followed by a rapid thaw period in which ice can break apart and ice floes form. For the static ice condition, the formation of a large thick ice sheet between the shore and piers represents the most severe case.

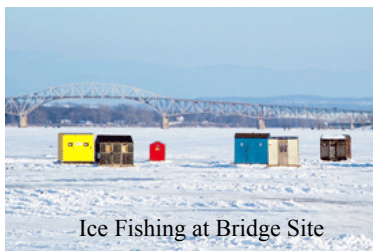
Ice Fishing at Bridge Site

Average ice thicknesses calculated per AASHTO LRFD Section 3.9, are depicted in the figure below based upon temperatures in Ticonderoga for the last four (4) years. Ice thicknesses computed in this manner are approximate; it is preferable to use local measurements where available. Given that this portion of Lake Champlain is a popular ice fishing location, we are fortunate to have independent measurements of ice thickness. Local accounts observe maximum ice thicknesses on the order of 600mm to 750mm of ice encountered each year during peak fishing season.

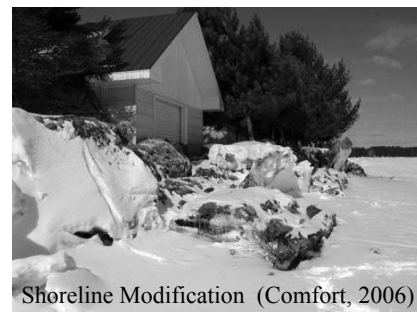
Shoreline Modification (Comfort, 2006)

Another key consideration is the shoreline configuration and the presence of approximately 100 ft of mud flats along both the Vermont and New York shorelines. In many cases, static ice pressures are limited by localized failure of the ice at the shoreline, particularly where the banks slope gradually upward, with resulting shoreline modification. In the case of mudflats, it is highly likely that the ice sheet and shoreline bond remains intact, and the ice sheet is thereby able to impart significant forces to the piers under thermal expansion. There are no indications

of shoreline modification, consistent with an effective ice-sheet shoreline bond. This is consistent with the observations for Lake Champlain shoreline modifications associated with thermal ice expansion (Wagner, 1970).

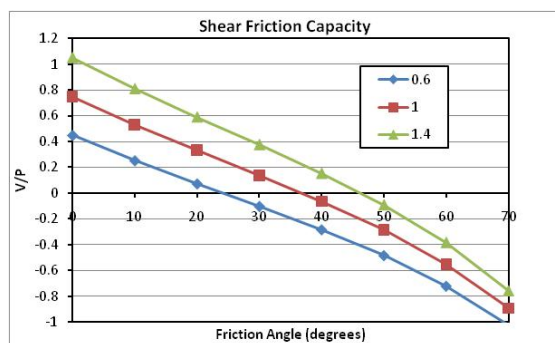
A graph of V/P for varying crack angles and friction coefficients is shown below (only values up to 70 degrees shown):

The influence of both the friction coefficient and the crack angle is clear. Notice that if the crack angle is great enough, V/P becomes negative, which means the pier no longer has adequate capacity under dead load alone and collapse is imminent, noting that this assessment applies only to cracks extending through the pier cross section. The cracks that are vertical or near vertical in the transverse direction are not directly at issue.

From the underwater inspections, horizontal cracks were found along both faces of all piers. From the locations of the cracks, it can be implied (though not definitively) that any through-thickness cracks are relatively flat. However, pier 7 in particular shows a number of horizontal cracks at varying elevations, making it difficult to predict at what angle a through thickness crack may develop. Another uncertainty is the friction

coefficient, though a lower bound of 0.6 is recommended given the size, distribution, and severity of the cracking together with the marine environment. From the above graph, it is clear that for cracks that exceed an angle of 20 degrees, failure can be anticipated for nominal lateral loads. Given that applied shears under static icing events approach 20% of the pier dead load ($V/P=0.2$) this is particularly concerning, as the through cracks at an angle as shallow as 10 degrees is at the strength limit.

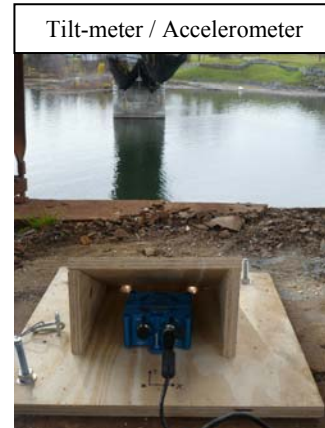
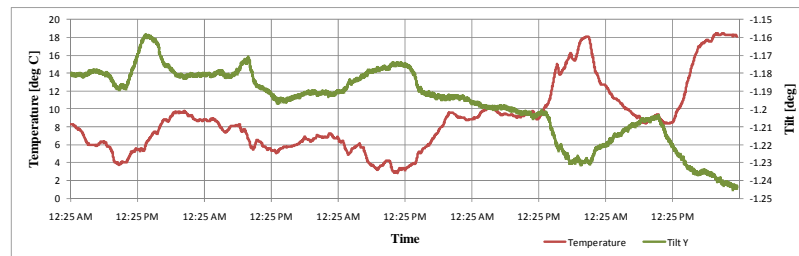
To assess the degree to which frozen bearings were influencing pier behavior, a triaxial accelerometer / bi-directional tilt meter was installed at pier 5. Installation of

this remote sensor system was completed on November 4th, 2009. The monitoring system confirmed the top of pier 5 translates approximately 30mm for every 30°C of temperature change, and tracks . This behavior is strongly indicative of poor performance of the expansion bearings intended to isolate the piers from the thermal behavior of the superstructure.
