# BRIDGE PERFORMANCE DURING THE GREAT EAST JAPAN EARTHQUAKE OF MARCH 11, 2011

M. Lee Marsh, Ian G. Buckle, W. Phillip Yen, Shideh Dasti, David Frost, Eric Monzon (See Acknowledgements for author affiliations)

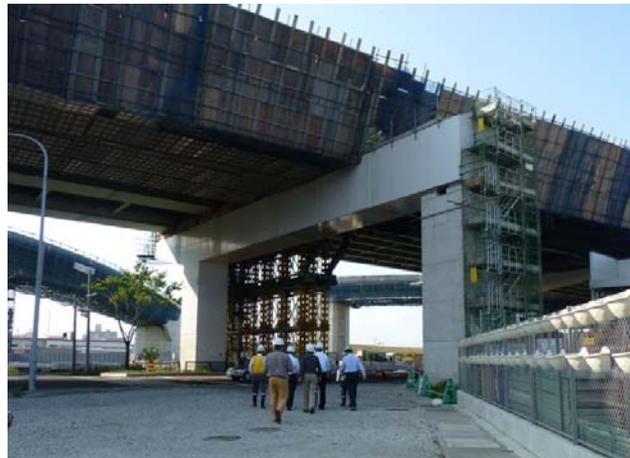
FIGURE 2 – TWO-COLUMN FRAME, PIER 56 SENDAI-TOBU VIADUCT (Photo: E. Monzon)

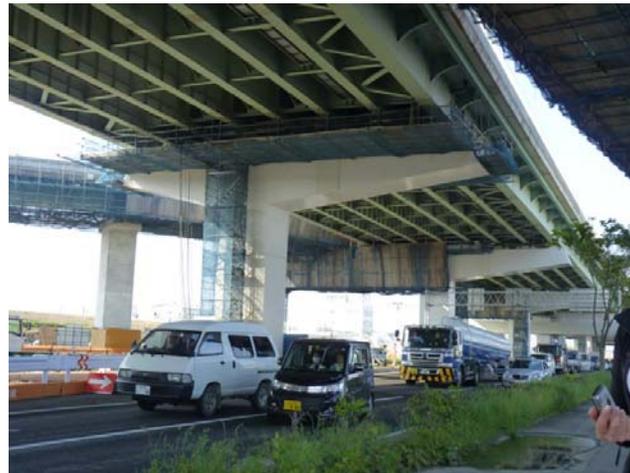
FIGURE 3 – SINGLE COLUMN, PIER 57 SENDAI-TOBU VIADUCT (Photo: E. Monzon)

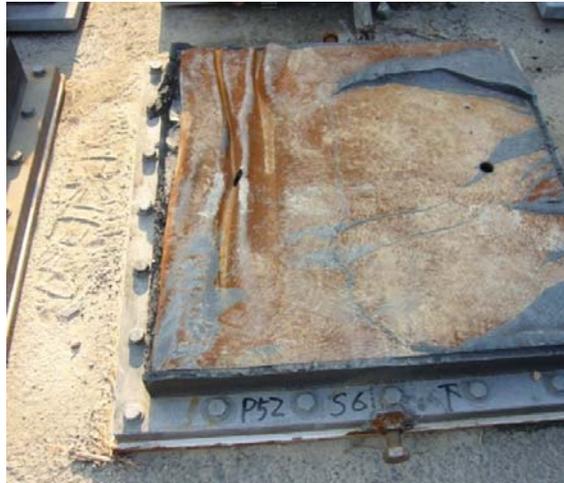
Inspection of the damage to the bearings showed that many had ruptured completely through the elastomer, as if in direct tension. Others showed damage to the internal shims which had been severely distorted (Figure 4). Typical dimensions of the bearings at Pier 56

The shim damage seen in Figure 4 most likely occurred when a ruptured bearing impacted a toppled stopper puncturing the cover rubber layers and distorting the edge of the shim plate. On the other hand, the expected failure mode of an elastomeric bearing is rupture within a rubber layer and not delamination at the shim plate. The clean surface of this plate in Figure 4 implies inadequate bond between the elastomer and shim during manufacture thus reducing the bearing's capacity for combined tension and shear.

FIGURE 4 – DAMAGED ELASTOMERIC BEARING FROM PIER 52, SENDAI-TOBU VIADUCT (Photo: E. Monzon)

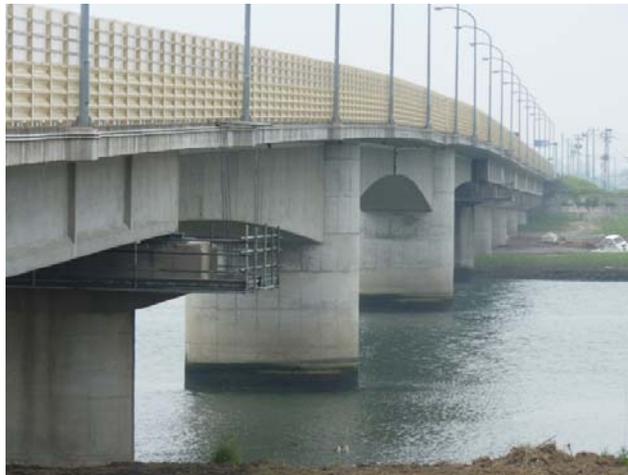
FIGURE 5 – MAIN SPANS OF THE YURIAGE BRIDGE (Photo: E. Monzon)

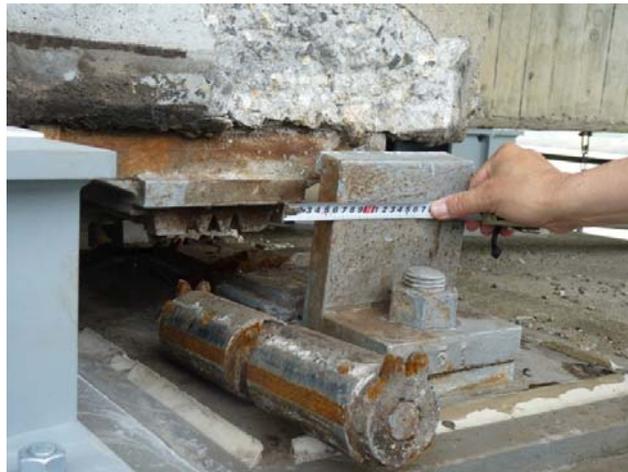
Complete bearing failures occurred at Piers 2 and 5, at the transition between the approach spans and main spans. These failures are attributed to permanent pier movement possibly caused by liquefaction. Evidence of extensive liquefaction was found under the approach spans and in some cases 30 cm of ground settlement was observed adjacent to one of the piers under the south approach. Since Piers 2 and 5 are close to the river, lateral spreading may have caused these piers to move towards the center of the river channel. Figure 6 shows this movement for Pier 2 to be of the order of 6 cm, which clearly exceeded the capacity of the roller bearing at this location. In addition damage to the transverse stopper is evident, indicating the simultaneous occurrence of significant shaking transverse to the bridge.

FIGURE 6 - EJECTED ROLLER BEARING AND PERMANENT LONGITUDINAL MOVEMENT AT PIER 2, YURIAGE BRIDGE (Photo: E. Monzon)

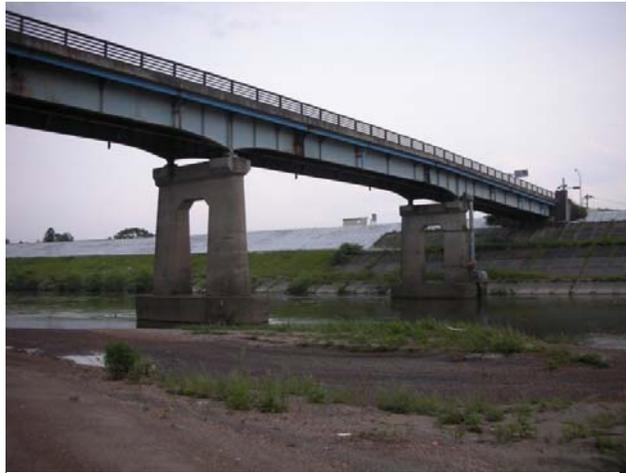
The Shida Bridge is a nine-span steel plate-girder bridge carrying Route 32 over the Naruse River east of Osaki. The bridge was built in 1957 and is comprised of a two-girder steel superstructure supported on concrete two-column piers. The foundation type is unknown. The bridge is straight, has no skew and only a slight vertical curvature. Typical piers are shown in Figure 7. The superstructure is articulated in every other span with drop-in spans, whose in-span seats form inflection points rendering the structure determinate (Figure 8). Such a drop-in span is visible in the center span of Figure 7 where rust stains from the

deck joint have discolored the two in-span hinge areas. Also visible are seat extensions installed on the piers throughout the bridge. No other seismic retrofitting was seen.

FIGURE 7 – PIERS 7 AND 8 OF PLATE-GIRDER SHIDA BRIDGE (Photo: L. Marsh)

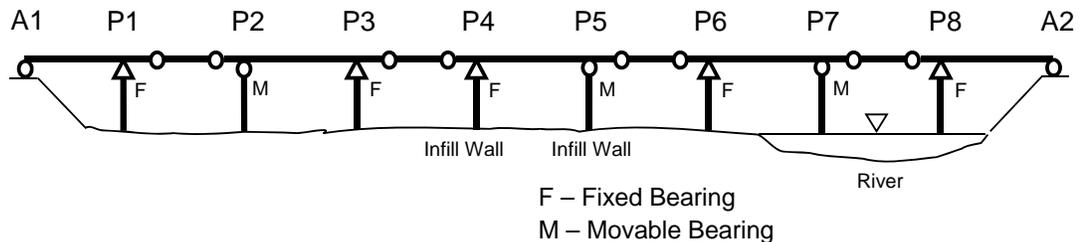
The superstructure rests on steel bearings at each pier and each continuous span (i.e. alternate spans to the drop-in spans) has one fixed and one movable (sliding) bearing in the longitudinal direction arranged as shown in Figure 8.

FIGURE 8 – LOCATIONS OF IN-SPAN HINGES AND F-M BEARINGS IN THE SHIDA BRIDGE (Graphic: L. Marsh)

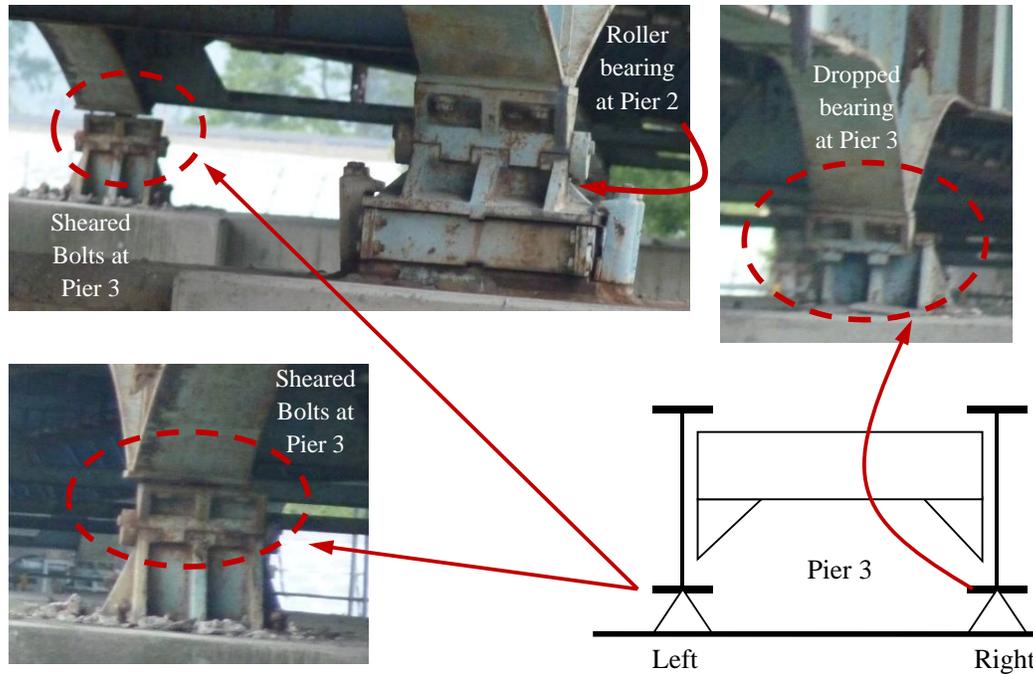
One of the fixed bearings at Pier 3 failed by dropping off its lower seat as seen in Figure 9. Also seen in this figure is a gap between the top of the bearing and the bottom of the girder. This indicates that the bolts of the other fixed bearing at Pier 3 have been sheared off and the girder at this location has lifted clear of the bearing. This means that the bearing that dropped on the other end of the pier must be supporting the gravity load at the pier, because no redundant load path exists. The bearing and girder have dropped far enough that the upper bearing has become wedged against the lower portion of the bearing, thus providing

vertical support. It is likely that the upper bolts of the left-hand bearing sheared before the right-hand bearing dropped from its pedestal. There is no vertical load path through the bearing pin to sustain tensile forces on the bolts and thus shear is the probable mode of failure. Following loss of shear capacity on the left side, all shear for this frame would have to be resisted by the right-hand bearing. This increase in shear demand likely caused the right-hand bearing to unseat. Failure of this bearing is probably the reason for the noticeable dip in the elevation of the bridge roadway and handrail (estimated at 10 cm) seen in Figure 10. It also possible that some of this deformation is due to foundation settlement due to widespread liquefaction in the area.

FIGURE 9 – UNSEATING AND FAILURE OF BEARINGS AT PIER 3, SHIDA BRIDGE  
(Photos and Graphic: E. Monzon)

Pier 3 is one of the infill-wall piers. The infill probably increased the stiffness at Pier 3 in the longitudinal direction which the forces in the fixed bearing resulting in this dropped bearing. Close inspection of the anchor bolts at the top of the left side of Pier 3 indicates that those bolts were elongated or hammered outward more than any of the bolts on the other fixed piers of the bridge. This leads to the conclusion that the forces were higher at Pier 3 due to the infill wall.

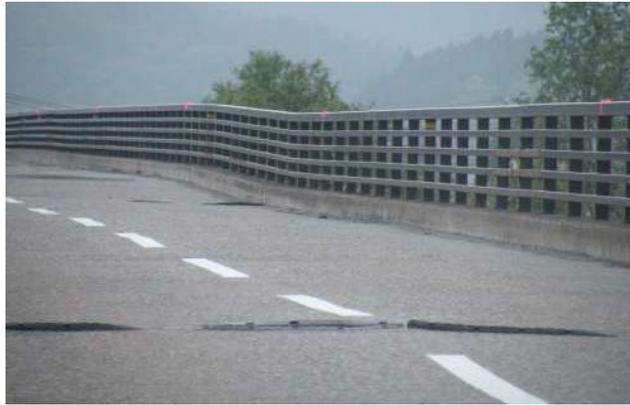
FIGURE 10 – SETTLEMENT IN BARRIER AND DECK AT PIER 3, SHIDA BRIDGE (Photo: D. Frost)

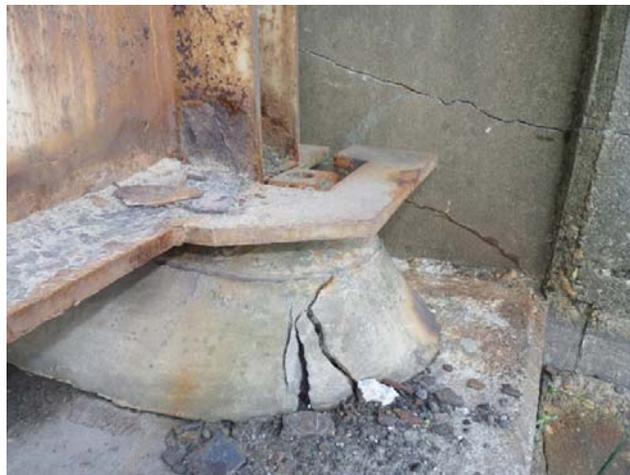
Approximately 15 cm of settlement occurred in the backfill behind the abutment and pressure behind the abutment backwall was sufficiently large to crack and yield this wall. This likely occurred as the abutment fill settled and moved towards the river channel during the earthquake. The abutment is founded on a levee that parallels the river channel and movements in this levee, just upstream from the bridge, are described later in this section.

FIGURE 11 – DAMAGE TO PEDESTAL AND ABUTMENT BACKWALL, SHIDA BRIDGE (Photo: E. Monzon)

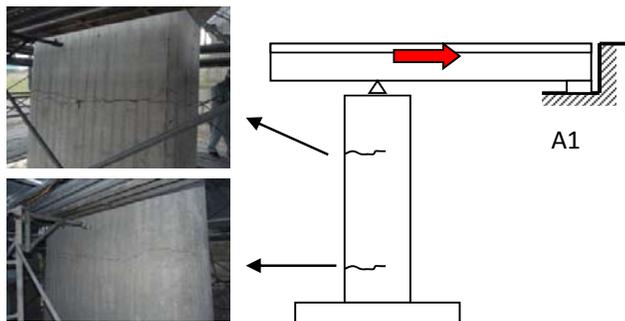
At two other fixed piers, Pier 1 and Pier 6, the anchor bolts between the bearing and the top of the pier were either elongated or pulled out of their embedment by the longitudinal inertial action of the superstructure. The longitudinal response of the bridge was probably limited by the yielding or slippage of these bolts, and this action provided partial force limitation. However, it was not enough to prevent damage to the piers below the bearings. At both Piers 1 and 6, moderate cracking and potential yielding occurred. Figure 12 shows examples of such damage, and in fact both piers were undergoing repair at the time of the reconnaissance visit. This is evident by the scaffolding and enclosures present at these piers.

FIGURE 12 – FLEXURAL DAMAGE IN PIER 1 DUE TO LONGITUDINAL MOVEMENT, SHIDA BRIDGE (Photos and Graphic: E. Monzon)

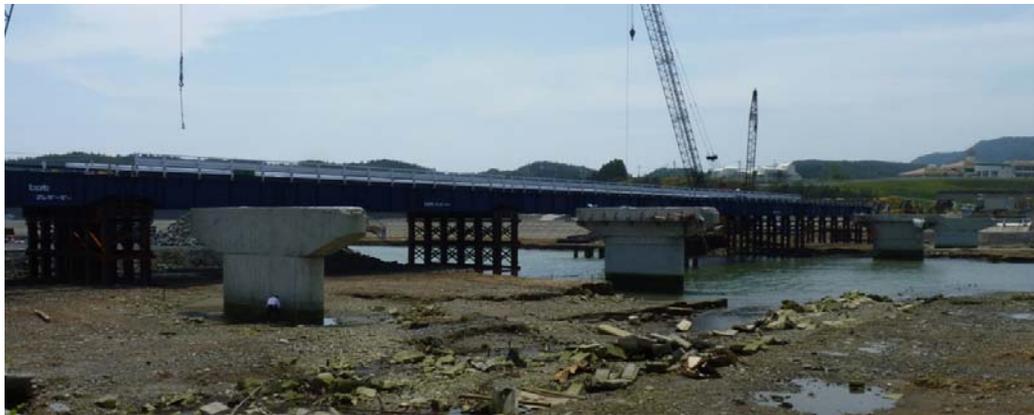
All six spans were swept away during the tsunami (Figure 13). Wave heights of the order of 11.8 m were registered at Ofunato City just north of this site and the tsunami clearly overtopped this bridge taking all six spans upstream. Based on damage to the levee on the north bank of the river, some of these spans were lifted off their piers and swept along the top of the levee on the north bank, then over the levee altogether on the north side, and later back over the levee into the main channel where they came to rest about 400 m upstream from the bridge (Figure 14). Other spans took a different path and came to rest about 300 m upstream but on the south side of the levee on the south bank of the river. Four of the five piers are still standing, but the center pier (Pier 3) was overturned and believed to be under water in the river channel just upstream of the bridge (Figure 13).

FIGURE 13 – REMAINING PIERS OF KOIZUMI BRIDGE. TEMPORARY BRIDGE IS UNDER CONSTRUCTION ON SEAWARD-SIDE OF ORIGINAL BRIDGE (Photo: E. Monzon)

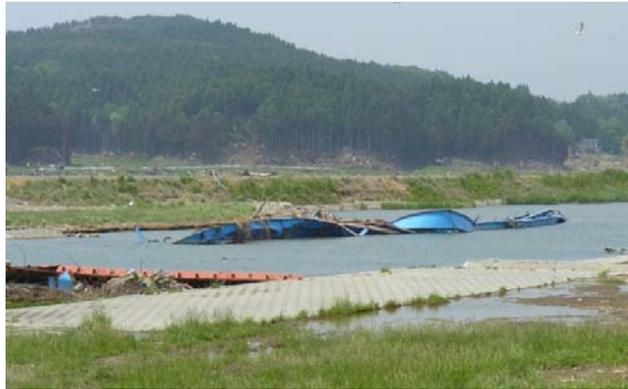
It is clear that the longitudinal dampers installed at the abutments and the transverse keys (stoppers) over the piers, offered little restraint to the lateral loads imposed by tsunami. Once these devices failed, the relatively light weight of the steel I-girders, together with the buoyancy effects of air trapped between the girders, enabled the superstructure to be easily lifted and carried significant distances upstream. The loss of Pier 3 was probably due to scour but this could not be confirmed. Despite the low tide at the time of the visit, the foundation was still underwater.

FIGURE 14 – GIRDERS FROM KOIZUMI BRIDGE 400m UPSTREAM IN TSUYA RIVER CHANNEL (Photo: E. Monzon)

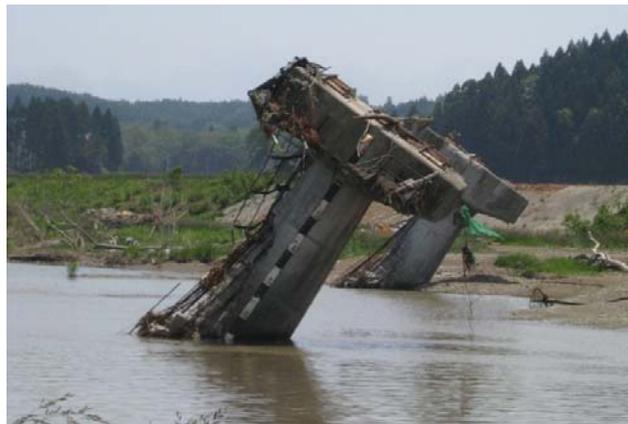
FIGURE 15 – DAMAGED PIERS OF THE JR RAIL VIADUCT AT THE TSUYA RIVER (Photo: S. Dashti)

Of interest is the damage to the lower portions of the piers. The exposed reinforcement seen on the left side of the each pier appears to have been pulled outward from the center of the column and rupturing the relatively light transverse steel. This type of behavior is seen in the failure of beams that are unreinforced for shear, where a shear crack precipitates failure and tearing of the tensile reinforcement from the beam. In the case of the JR East piers, potential buoyancy of the superstructure due to trapped air and the hydrodynamic forces produced lateral loads on the piers along with eccentric vertical loading. The piers may have failed in shear above the foundation after plastically deforming under the combined lateral and vertical effects. Following the loss of shear capacity at the base, the tension reinforcement was torn from the piers.

In this postulated mode of failure the tilting of the pier is due to structural failure and not to scour and subsequent rotation of the foundation. Inspection of the columns and footings below the water line is required to confirm this behavior.

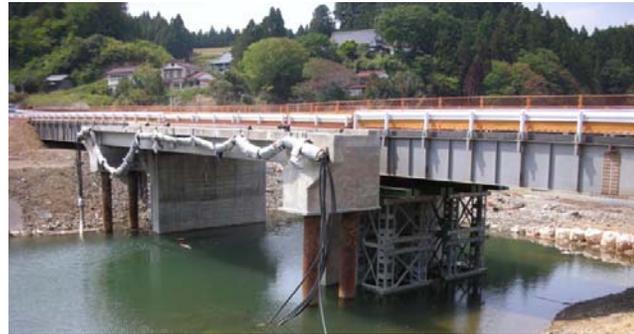
FIGURE 16 – LOSS OF BACKFILL ON BOTH APPROACHES TO SINGLE-SPAN NIJYU-ICHIHAMA BRIDGE (Photo: L. Marsh)

Apart from the loss of the seaward extension, this bridge has performed remarkably well from a structural point of view. It is essentially intact and the principal reason for closure was the loss of back fill due to erosion. Despite the buoyancy of trapped air, the superstructure was well anchored both vertically and laterally to the abutment seats and was not dislodged by the tsunami despite being overtopped. It is of course possible that the erosion of the abutment backfills and the opening up of two alternative hydraulic channels took load off the bridge, but nevertheless the performance of this bridge under these circumstances is noteworthy.

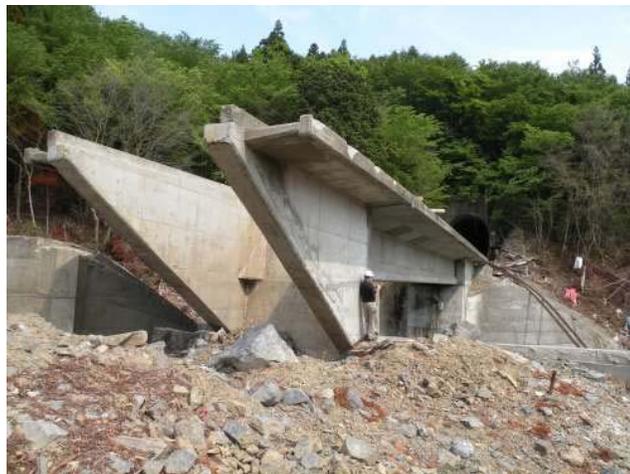
FIGURE 17 – EXPOSED WINGWALLS OF JR RAIL BRIDGE 100m UPSTREAM OF NIJYU-ICHIHAMA BRIDGE DUE TO LOSS OF APPROACH EMBANKMENT (Photo: D. Frost)

bridge over the river (Figure 17). The unprotected embankment fill appeared to be a granular material. As the wave overtopped the embankment, it displaced the tracks and significantly scoured and removed the upper 4 to 5 m of the fill. Apart from the loss of the approach fills, all the bridges in the valley appeared to be intact.
