INVESTIGATION AND COUNTERMEASURES FOR FATIGUE CRACKS THAT EMERGED ON THE FINGER JOINT OF THE CABLE-STAYED BRIDGE "TSURUMI-TSUBASA BRIDGE"

Abstract

As a result of a follow-up investigation for fatigue crack damages of the finger joint of the Tsurumi-tsubasa Bridge in 2012, where emergency repair had been carried out from 2008 to 2010, 140 cracks were found along the root of the welded part of the face-plates. Due to analysis of tendency for crack causing, it was confirmed that weld detail at the time of fabrication was one of the factors for crack causing.

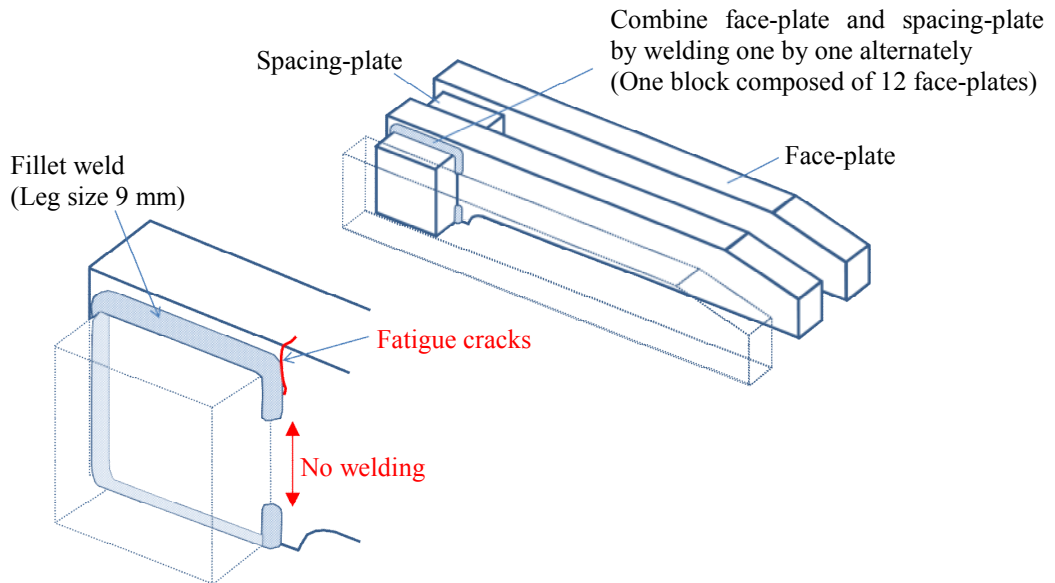
Fig.4 Weld structure of the face-plate block

from thick steel plates and spacing-plates that are welded mutually. Weld structure of the face-plate block is shown in Fig.4. As for the blocks of the face-plate, welding is done around the spacing-plate by fillet weld with the leg size of 9mm, but welding was not fully done in narrow spaces sandwiched between the face-plates, because it was physically difficult to weld in narrow spaces at the time of fabrication. Crack damage found during this investigation all generated from such parts.

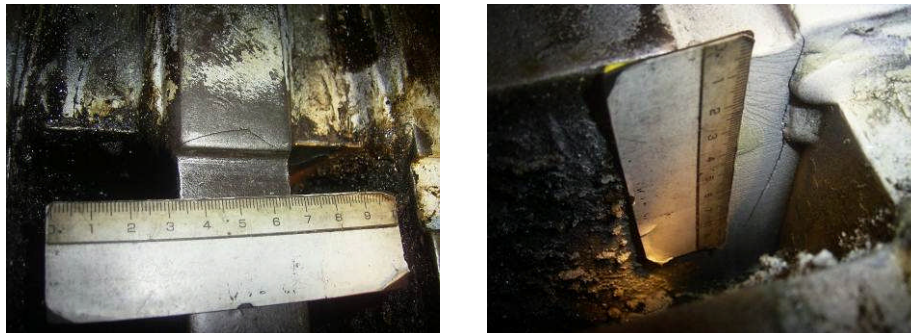
Fatigue cracks were found on the finger joint of Tsurumi-tsubasa Bridge for the first time during the inspection in 2004 (Fig.5). The cracks which could be observed visually generated from the parts welded to the root of the top surface of the face-plate. Subsequently, an emergency inspection was carried out for these parts, and approx. 80 cracks were found. As a countermeasure, removal of the cracks by machining and replacement of the face-plate blocks were implemented.

Fig.5 Cracks from the root of the welded part of the face-plate found in 2004

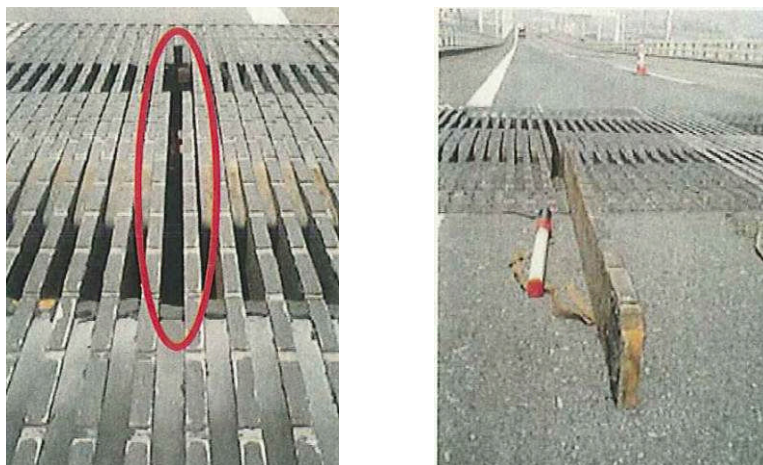
Since then, follow-up investigations and support for damages were carried out repeatedly, but a fracture of the face-plate occurred in 2010 (Fig.6). Fortunately, it did not affect traffic, because it was only one face-plate that fractured. The cause of this fracture was a new type of crack that generated from the corrosion part of the bottom surface of the face-plate (Fig.7). At that point, an emergency inspection was carried out against the corrosion part of the bottom surface of the face-plate and the same type of cracks generated from the corrosion part were found at approx. 10 points besides the fractured face-plate. This time as well, replacement of the face-plate blocks was carried out as a countermeasure.

Fig.6 Fracture of the face-plate that occurred in 2010

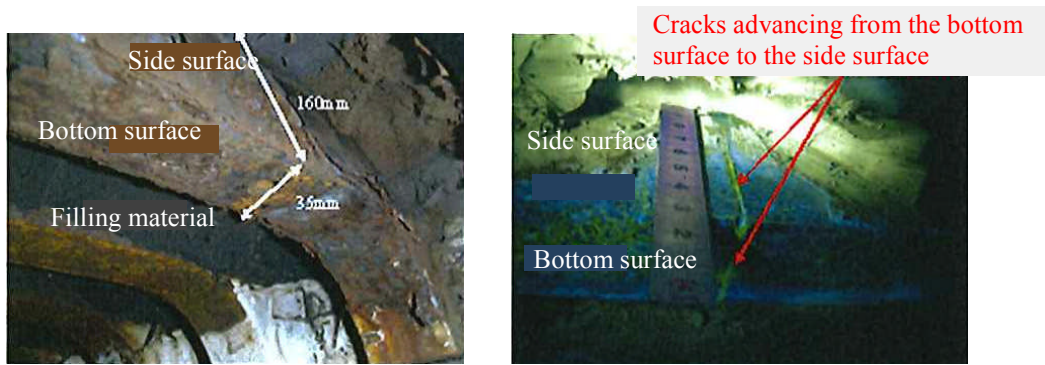
Fig.7 Cracks generated from the corrosion part of the bottom surface of the face-plate

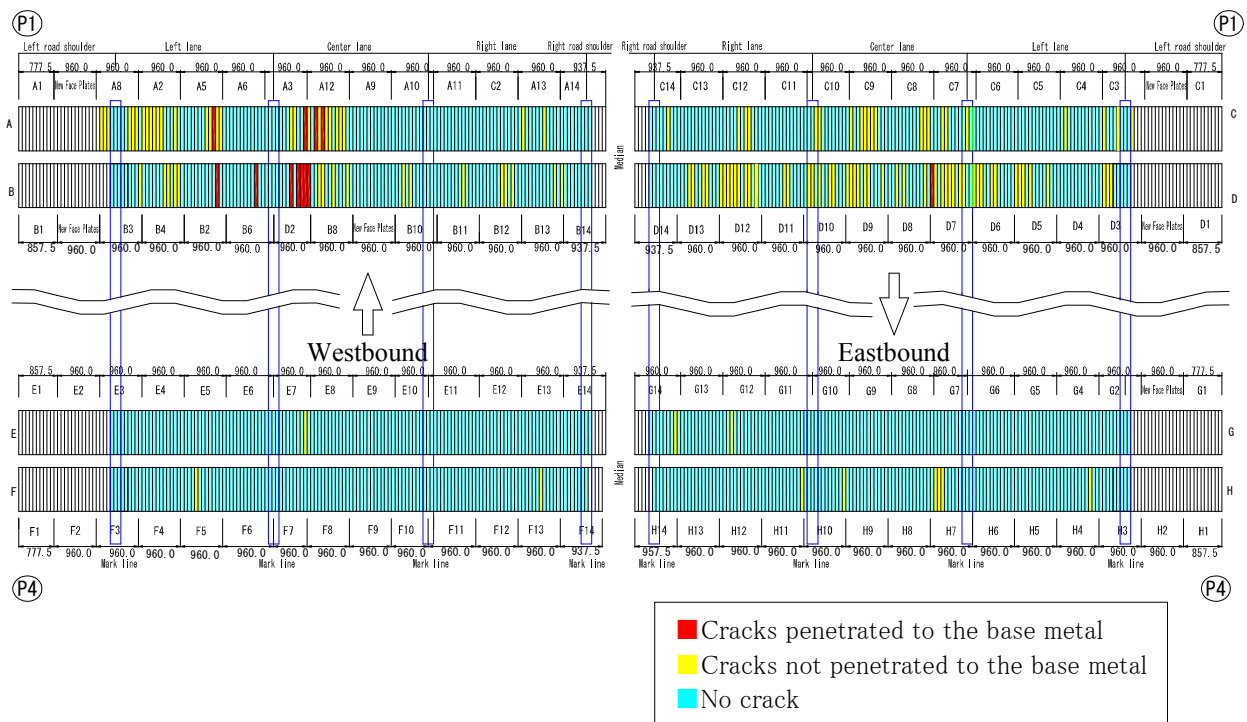
Fig.10 Genesis location of cracks

As a result of a magnetic particle examination conducted at 1500 points on the top and bottom surface of the face-plates, 140 cracks were found at the root of the welded part of the top surface. Genesis location of the cracks is shown in Fig.10 and the breakdown of the number of cracks is shown in Table.1. During this investigation, a flaw indicating pattern was not found on the bottom surface of the face-plates.

Most cracks which were found during this investigation generated at the finger joint on P1 pier. Of all 140 points, cracks penetrated to the base metal were found at 12 points, and cracks penetrated from the welded part of both sides of the face-plate to the base metal were found at 4 points, which could lead to fracture. The most severe damage is shown in Fig.11. As for the blocks of the face-plate with remarkably serious damages, they were replaced as an emergency measure by robust ones which had been installed under the road shoulders, and thereafter were replaced by newly fabricated blocks as a permanent measure.

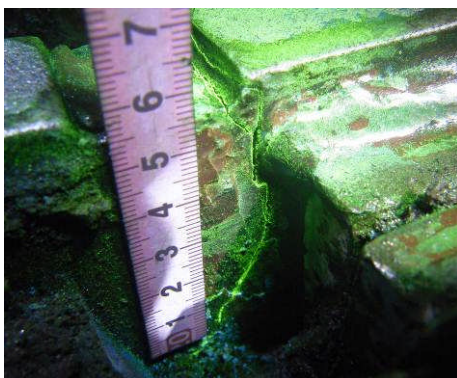
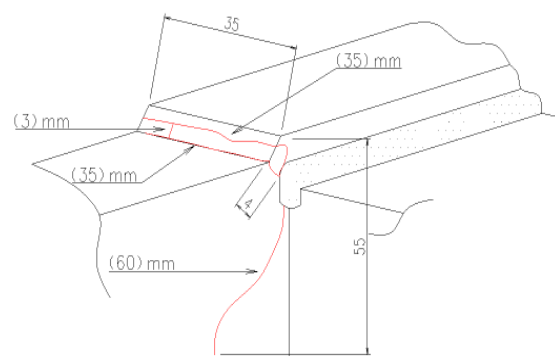
Fig.11 Cracks penetrated to base metal

Of the 140 crack damages found during this investigation, as for the 12 damages which penetrated to the base metal of the face-plate, an emergency measure by replacing the blocks by robust ones that are installed under the road shoulders, was rapidly carried out from the aspect of ensuring safety for vehicles, then a permanent measure of replacing them by newly fabricated ones was applied.

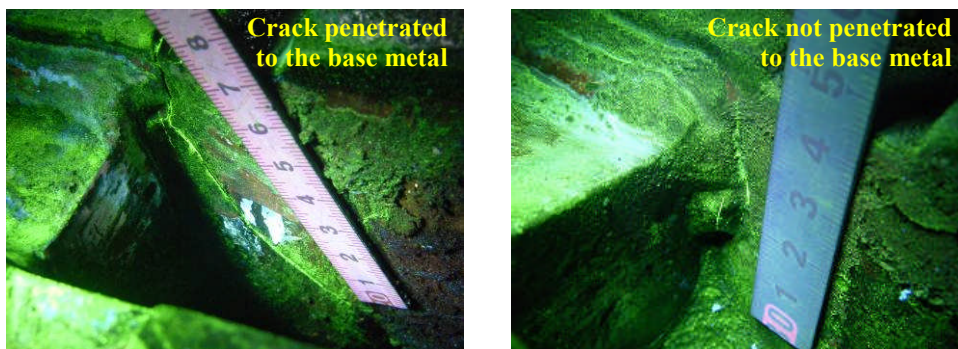
All cracks generated from the root of the welded part of the face-plate, and most of them generated from the weld toe. This type of crack tends to penetrate to the base metal if they remain untouched (Fig.12).

Fig.12 Cracks with (left) and without (right) penetration to base metal

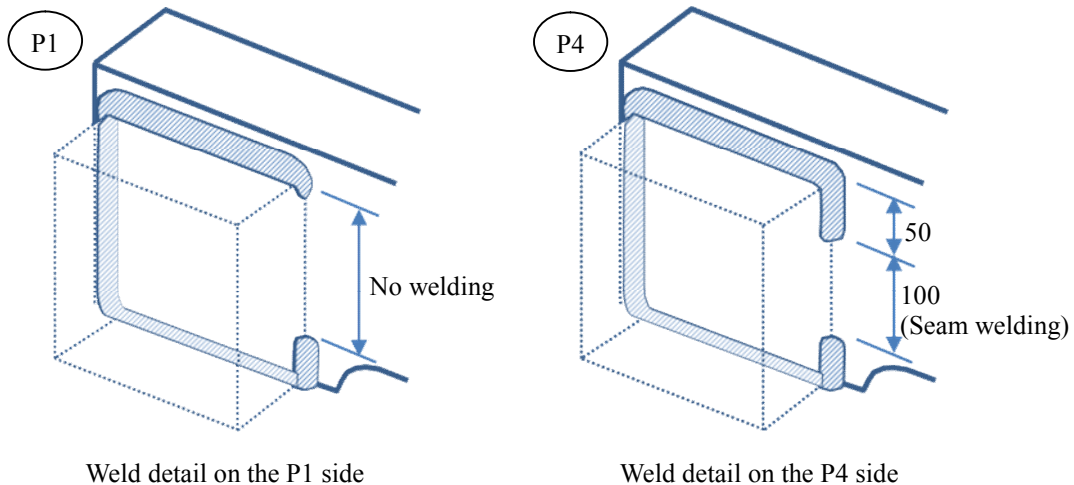
Of all the 140 damages found during this investigation, 129 damages were found at the finger joint on P1 pier. By confirming detailed fabricating structure, difference of welding status of the finger joint on the two piers was identified, as shown in Fig.13, and an un-welded spot was left between face-plates on both piers. At the finger joint on P4 pier where there were few cracks, welding was done vertically within approx. 50mm from the corner of the spacing-plate. However, at the finger joint on the P1 pier where there were many cracks, welding was done only at the corner of the spacing-plate. Furthermore, finishing process or the weld toe on both piers was not conducted sufficiently. So, causing factors for the crack damages are considered as the following;

- A breakpoint was installed in the weld structure with an overlapping joint, and of

low fatigue durability.

- A start/end position of welding subject to damage was installed at the corner of the spacing-plate, a point of stress concentration where stiffness changes.
- Finishing process was not sufficiently provided at the weld toe.

Fig.13 Weld detail of the root of the face-plate

- Remove all crack damages by machining, and restoring by fillet weld ensuring enough length of bead.
- Leaving no insufficient welded places, not-welded and/or seam-welded
- Not to leave the start/end position of welding.
- Conduct finishing process for the welded toe.

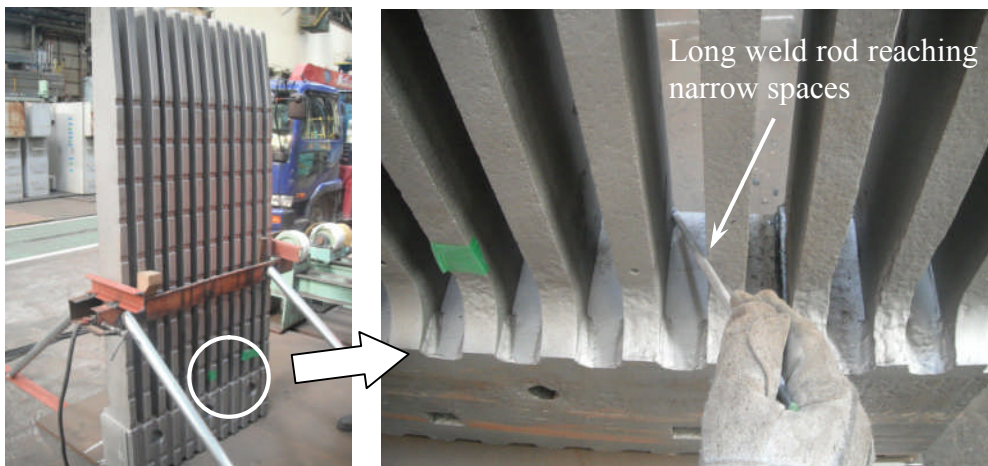
Fig.14 Working conditions and weld rod used for this work

Welding repair for crack damages was restored by re-weld, after weld bead of the cracks were completely removed by machining, and at the same time, insufficient welded places were restored by welding ensuring enough leg length of the bead. As for the welding work, the finger joint was fixed upright and a downward stance of welding which causes less flaw was adopted. Also, coated arc welding was implemented for narrow spaces using a longer weld rod than usual. The welding status restored by this process is shown in Fig.14, and the restored weld bead is shown in Fig.15. As for start/end position of the restored weld bead, a new bead was welded onto the existing one and then was removed by a grinder.

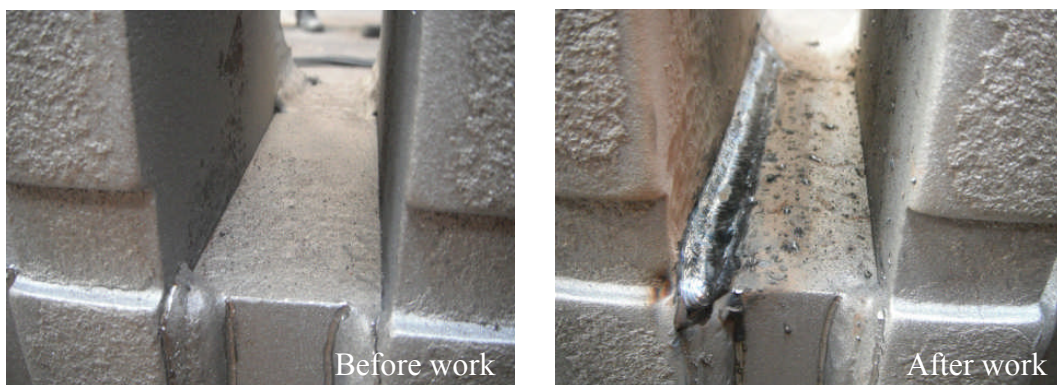
Fig.15 Restored status of welding for narrow spaces (before work, after work)

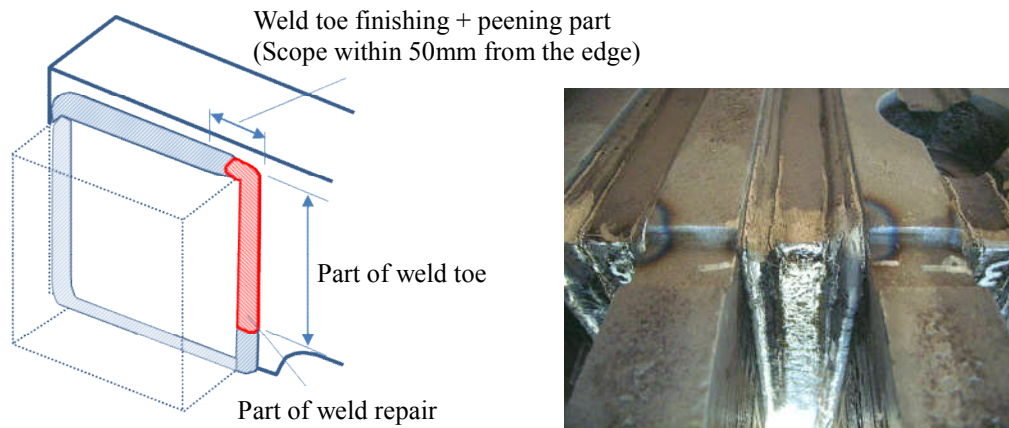
Fig.16 Status of processing the weld toe (final status)

As for the processing the of the weld toe, welding start/end position in narrow spaces between the face-plates were finished by a grinder, and the scope within 50mm from the edge of the top surface of the spacing-plate was processed furthermore by peening. The status of processing the weld toe is shown in Fig.16.
