PRELIMINARY SEISMIC CONSIDERATIONS FOR PULASKI SKYWAY REHABILITATION PROJECT

Xiaohua H. Cheng¹

Abstract

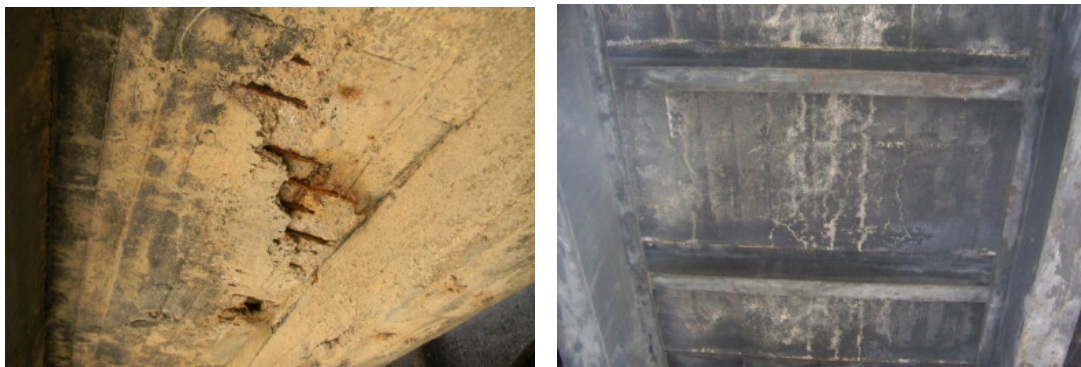
Deck and Joints The deck is in overall “poor” condition due to continued extensive deterioration of the underdeck (spalling and cracking with efflorescence), and continued spalling of the top of the deck (**Fig.3**). The loose concrete on the underside of deck has become a safety issue for roadway below. The slide plate and steel finger

(a) Concrete Deck Spalling (underdeck): Left – Rebar exposure; Right – Cracking with efflorescence (chloride contamination)

- Deck replacement:
 - Using precast panels with stainless steel reinforcement, and using partially lightweight concrete;
 - Structural response to be monitored by sensors during different construction stages

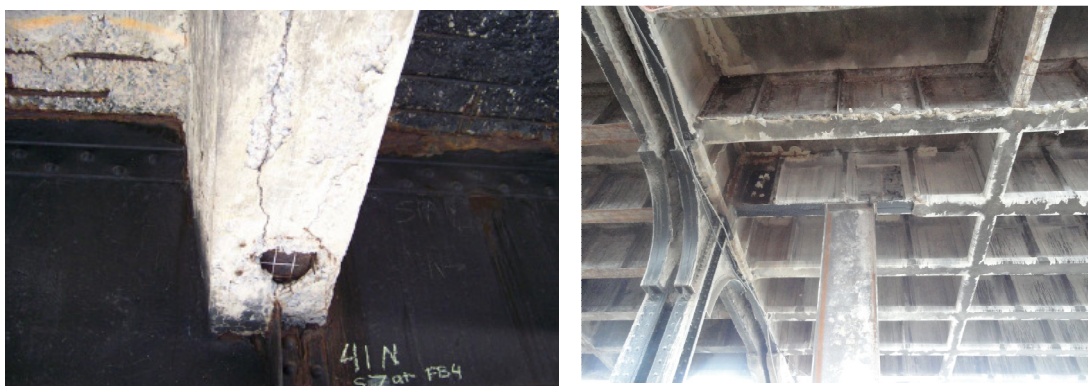
Concrete encasement for the stringers and girders typically exhibits minor to moderate deterioration. The on-going maintenance has performed to remove most of the existing encasement from the steel girders and expansion pier bents, both to prevent falling concrete onto roadways and ensure that hidden section losses at the joint areas can be discovered and repaired (**Fig.3**).

(a) Encasement Loss in Stringer/Floorbeam and Steel Girder Encasement Removal

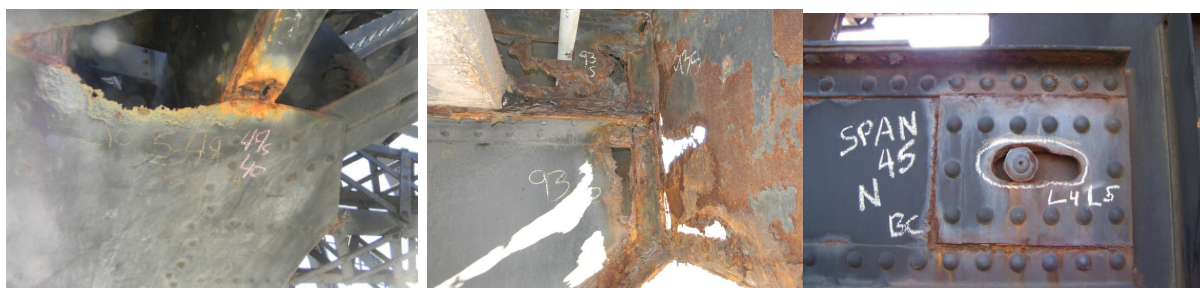
Superstructure The structure steel exhibits areas of moderate to severe rust throughout, with substantial pack rust and local areas of heavy section losses; Severe rusting occurs primarily at the truss lower chords and joints, and in all steel components below the open deck joints and floorbeam cantilever ends. The paint system has generally failed throughout the structure.

Typical deterioration of truss members in through trusses and deck trusses are shown in **Figure 3**. The rate and amount of localized deterioration represents a progressive structural distress that has continued since last biennial inspection.

The truss pin assemblies of upper and lower chords typically exhibit localized material loss due to wear around the exposed surface of the pin between the truss connection plates, or rust. UT testing of primary truss pins and accessible truss pins of other spans was performed. The observation indicated the presence of 3 small localized discontinuities which are acceptable due to corrosion pitting, etc.

(b) Severe Rust and Section Loss of Truss Chord, Stringer and Floorbeam; Wear Pin Connection Hole and Pack Rust

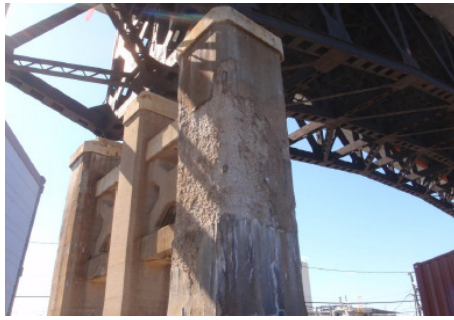
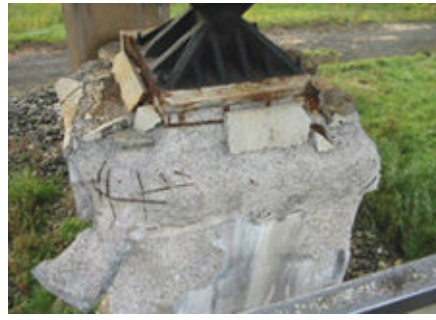
The substructure is in “fair” condition. Most deterioration is concrete cracks with heavy efflorescence, spalling, delaminated concrete areas. Many of these defects have previously been repaired with concrete patches and epoxy crack sealant, which is deteriorated/cracked again. The previously added post tension rods and beam collars appear to be limiting crack propagation (typically for Piers 65 to 67 Main Truss over Hackensack River) (**Fig.4**).

(a) Severe Concrete Scaling with Efflorescence in Pier Column, and Chipped Concrete and Expose Rebar at Bearing Seat

- Repair of concrete columns/piers, bent caps/strut beams, pedestals and abutments
 - Retrofit of foundations/footings (dependent on seismic retrofit analysis)

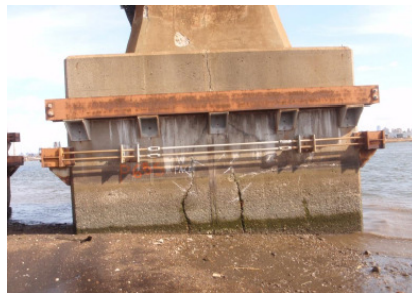
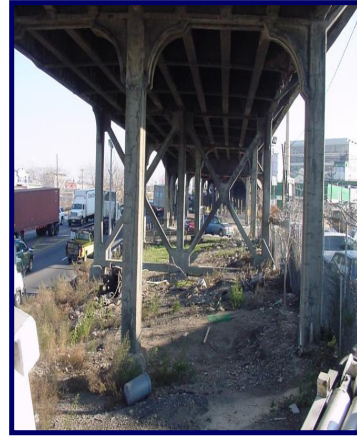
(b) Wide Concrete Cracks and Efflorescence in Column Pedestal and Previously Added Post Tension Rods and Beam Collars; Concrete Encasement Cracking

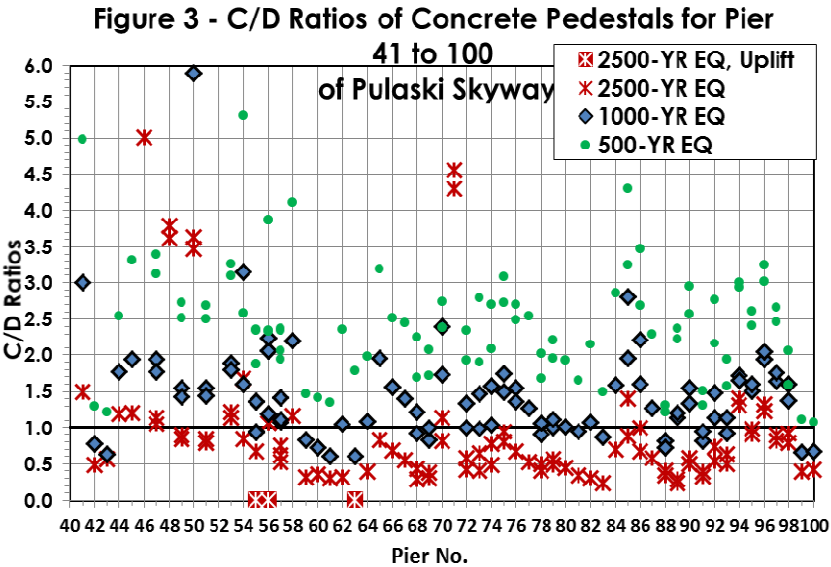
Figure 9 Seismic Capacity to Demand Ratio (C/D) Evaluation for Concrete Pedestals

The results for Piers 41 to 100 are plotted in **Figure 9**, presenting elastic moment C/D ratio for concrete pier pedestals (column bases). Pier column results are skipped herein. Most of the concrete piers were found to be deficient for the 2,500-year event, i.e. C/D is less than 1.0. The computed C/D ratio is as low as 0.16 for column (not shown herein) and 0.23 for pier pedestal (column base). According to available drawings, some original pier columns and pedestals appear to be unreinforced. In addition, some piers were subject to net uplift under 2,500 year event without capacity. It is clear that seismic retrofit required for 2,500 year event would be very extensive.

For the 1,000 year event, the computed C/D ratios are significantly higher than 2,500 year event, and most columns and pedestals are adequate (i.e. C/D is equal or greater than 1.0). The lowest C/D is 1.5 for pier column and 0.61 for pedestal, and none of them would be subject to net uplift for the 1,000 year event. Comparing to 2,500 year event, the seismic demand is greatly reduced and hence seismic retrofit required would be less extensive. It is noted that although seismic demand may be lower, due to existing pier condition and soil site condition, the vulnerability to seismic damage does exist. For 500 year event, computed C/D ratios for pier columns and pedestal are greater than 1.0 for all piers from 41 to 100.
