SOUNDNESS EVALUATION OF PRESTRESSED CONCRETE STRUCTURES BY VIBRATION MEASUREMENT

Hidetaka Homma¹, Yoshitomi Kimura¹, Akiko Hiroe¹

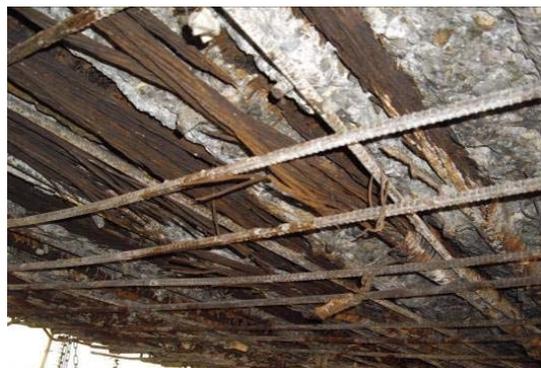
Figure1. Corroded and Broken Cables in Precast Segment Box Girder Bridge

Since prestressed concrete (PC) structure can control cracking by the use of prestressing, it is advantageous in respect of durability. However, even these PC structures deteriorate throughout in-service years. As shown in Figure 1, deterioration has been seen in some PC bridges at stages earlier than their service life due to defective grout filling or other reasons. Therefore, effective estimation of remaining strength of a deteriorated PC structures would be the challenge in the maintenance of PC bridges.

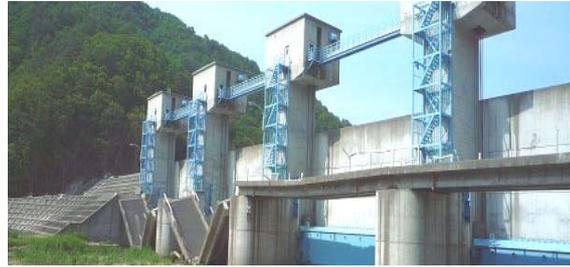
Figure 2. Fudai floodgate maintenance bridge (after Tsunami)

Fudai floodgate maintenance bridge suffered severe damage due to the attack of gigantic tsunamis generated by the 2011 Great East Japan Earthquake.

As shown in Figure 2, two spans of the bridge collapsed totally due to failure at their mid span and another two spans survived with large vertical residual deflections. Especially in the 3rd. span, maximum deflection of 300mm and bending cracks with the maximum width of 5mm were observed. Therefore, it was considered that the span might collapse anytime. On the other hand, in the 4th. span, the maximum deflection was 80mm.

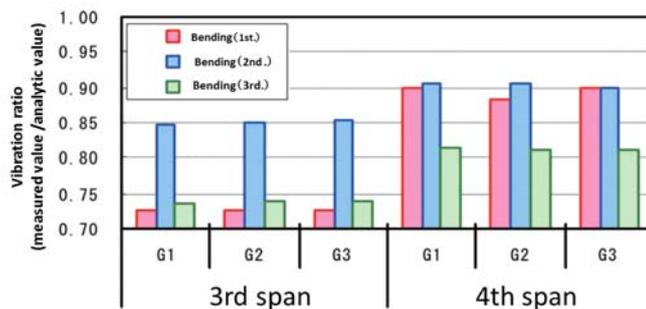
Figure 4. Vibration frequency ratio for the analytic value

Figure 4 shows the result of measurement. A slight difference was observed in each of the main girder vibration frequency. Compared with the analysis result of intact model, frequencies of 3rd. span are 20 to 30 percent lower and those of 4th. span are 10 to 20 percent lower than that of intact state. Tendency of

reduction of vibration frequencies was consistent with extent of damage. It was confirmed that it is possible to detect the load-bearing performance degradation by measuring the vibration of the member, if the PC member is subjected to large

mechanical damage. Reduction rate of the second bending mode in the 3rd. span was small compared to the first bending mode and the third bending mode. The reason of this difference is that the portion of the maximum amplitude of the 1st and 3rd modes coincides with the severely damaged portion of the girders as shown in figure 5. Moreover, in the 4th. span, reduction of vibration frequency of higher mode was remarkable.

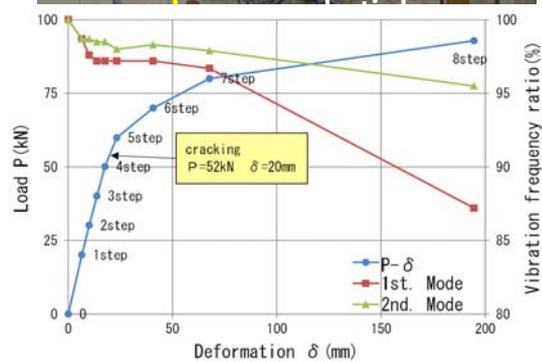
Figure 7. Transition of vibration frequency(pre-tensioned girder)

The result of vibration measurement of the pre-tensioned girder is shown in Figure 7. The decreasing ratio of the frequencies of the first and second modes are plotted in the figure. The deformation was measured at the maximum deflection point, not at the measurement points of vibration. Before the bending cracks appeared (loading step 4), decrease of frequencies was observed for the first and second modes. But they did not change very much after the appearance of the bending cracks. And finally at step 8 at which applied load was higher than the design bending strength of 80kN and the girder considerably deformed, decrease of the

frequencies reached approximately 13% and 5% for the first and second modes respectively.

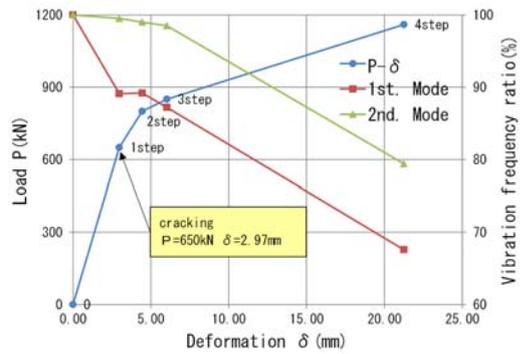
Figure 8. Transition of vibration frequency(post-tensioned girder)

The result of vibration measurement of the post-tensioned girder is shown in Figure 8. The steps at which the girder was unloaded and the vibration measurement was conducted were set after the appearance of the bending cracks. From the figure, it was found that the frequencies did not decrease much between the appearance of cracks and the yield of steel members, although that of the first mode decreased significantly between the beginning of the loading and the appearance of the cracks.

On the other hand, the decrease of the frequency was approximately 30 % at the primary bending mode and approximately 20 % at the secondary bending mode in Step 4 which is the final point of the member after reaching the maximum load.

It can be considered that one reason of the decreasing of the frequency in the early loading stage is that the supports were not stable enough at the beginning of the loading. From the above, it was verified on both pre-tensioned and post-tensioned girder that the frequency decrease significantly when the member is close to the ultimate state, while the frequency did not change remarkably around the load level of the appearance of the flexural cracks or that of the yield of members. This reason can be conceived that on PC members, the cracks closed by the restoring force after unloading and the stiffness of member was recuperated.

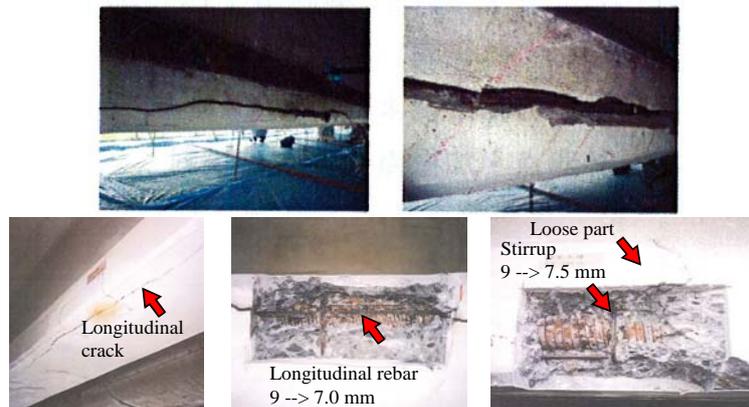
Figure 10. Deterioration of PC bridge

The PC bridge at which the vibration measurement was performed is shown in Figure 9. The structural type is a five-span simple PC T-section girder bridge. It was constructed in 1967 and served more than 40 years. Since the bridge was constructed on the coast of Japan Sea and therefore severely damaged by chloride attack, repairs had been performed more than once as damages of concrete or corrosion of steel were identified. However, because of confirmation of re-deterioration due to corrosion and breakage of PC wires as shown in Figure 10, rebuilding of the bridge was planned, and its service was terminated in September, 2010. Before its demolition, the vibration test was performed by vehicle falling method, weight falling method, and ambient vibration method as shown in Table 2. Excitations were applied at 1/2 and 1/4 points of the span on the G3 girder, and measurements were performed at points that divide the G1 and G5 girders equally into 8 segments.

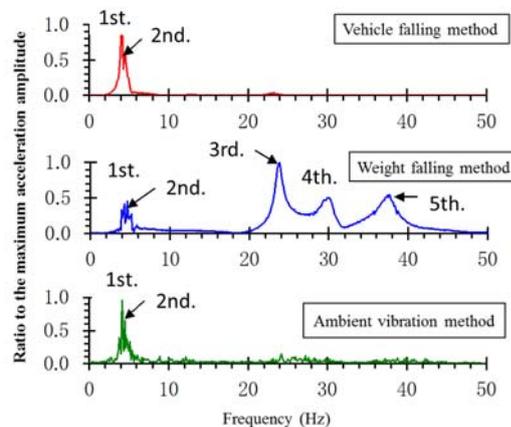
Figure 13. Measured spectra

The Figure shows results obtained in the 1st. span with excitation point located at 1/4 point of the span and measurement at 1/2 point of the G3 girder span. Dominant frequencies have been concentrated near 4Hz in the all method. Additionally, dominant frequencies in the range of 20 Hz ~ 40 Hz were found in the weight falling method. Also, for the weight falling method in which the third through fifth dominant frequencies (20 Hz ~ 40 Hz) were

found, dominant frequencies of the 1st. span, where damage was severe, and the 2nd. span, where damage was minor, were shown in Table 3. According to the inspection data of the past, section loss of concrete and breakage of PC cable by chloride attack has been found in the 1st. span. Deterioration of the 1st. span was severe while that of the 2nd. span was comparatively minor. For higher modes, frequencies of the 1st. span were much smaller than those of the 2nd. span. As mentioned in the shear loading test, it may be possible to grasp the deterioration by measuring the high-order vibration modes.
