Application of NDT method for the concrete girder damaged by chloride

Applicability of NDT on decommissioned PC girder

This is a pedestrian bridge in Ishikawa, Japan (Photo 1). It was a 2-spaned simple post-tensioned PC T -girder bridge placed 90m from sea. The details of this bridge and standard section were shown on Table 1 and Figure 1. In past 2 times detailed inspection, flaking of concrete was found on girders and it was revealed in chipping inspection that two of the eight prestressing tendons were broken. Therefore, this bridge was judged that

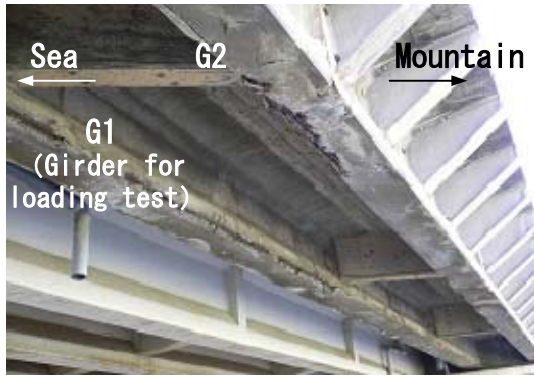
Photo 1 before replacement

the replacement was superior than repair from the view point of Life cycle cost. It was replaced after 38 years use.

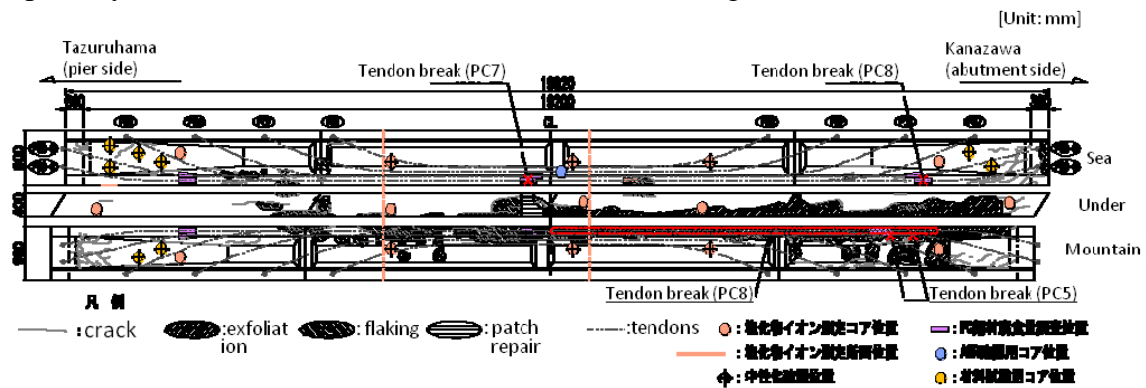
Figure 2 damage condition before loading test

Figure 2 indicates the damage condition of the girder before the loading test. The break of prestressing tendons are found on the south side (the right side of the Figure 2) of the girder. More cracks and flaking can be found on the south side than the center, and especially on the mountain side and the underside of the girder.

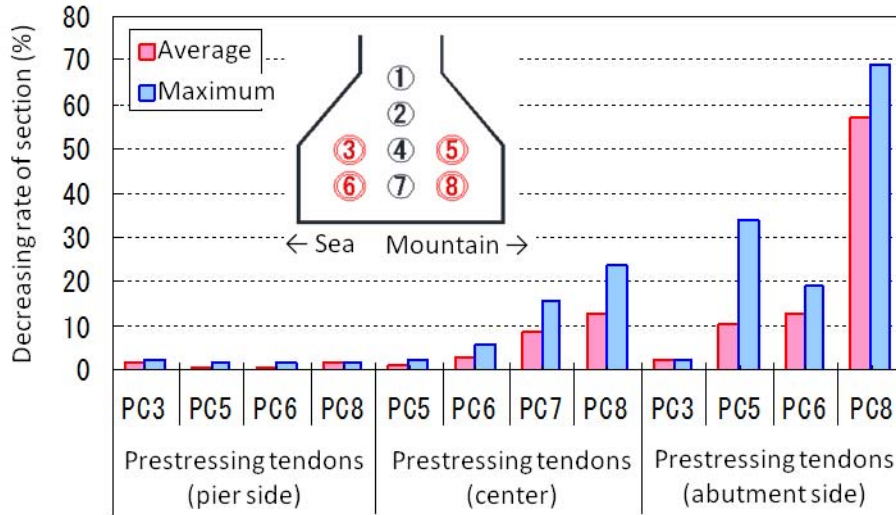
Figure 3 decreasing rate of prestressing tendons section

Figure 3 represents the decreasing rate of prestressing tendons section at girder ends and center of a span. The rate in the figure shows the average of the cross section of 12 tendons in each sheathes. The significant corrosion was found on the girder end near the abutment, and PC8, lowest sheath on the mountain side, lost itself.

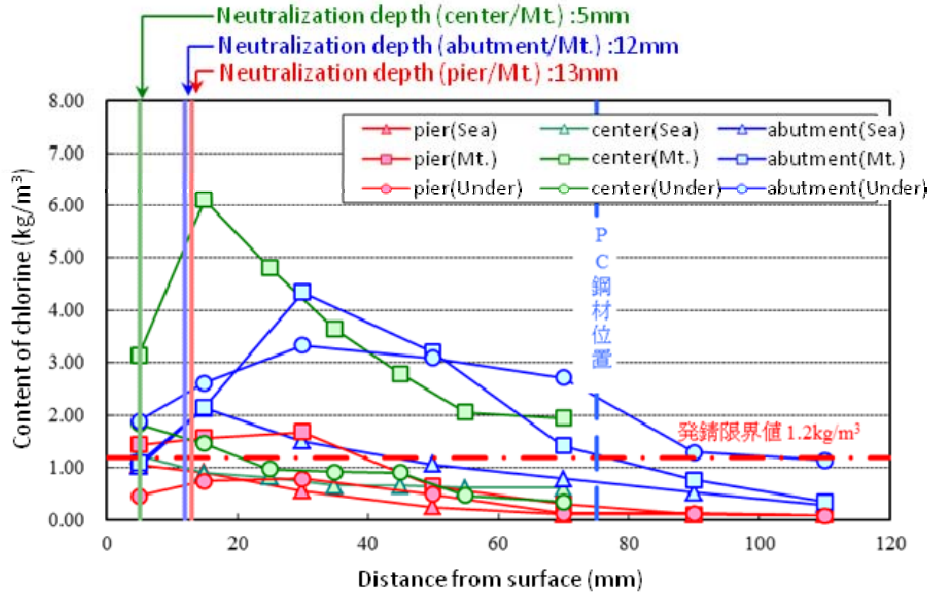
Figure 4 distribution of chlorine content by potentiometric titration

Chlorine content was tested by the core taken from the girder. The chlorine content distribution was drawn in Figure 4. Chlorine content was low on the mountain and the sea side in the pier side which was less damaged. On the other hands, on the mountain side in the center part, the mountain side and the underside in the abutment side, which were significantly damaged, contained a lot of chloride ions. The chlorine content was more than 1.2 kg/m³ at the prestressing tendons in those portions. The chlorine content near surface is low in the same portion. The neutralization depth on each mountain side, the maximum value of point equally dividing the circumference of each core into 8 parts, was

shown in Figure 4 and it could be found the relation between the neutralization depth and the chlorine content near surface. It is considered that this phenomenon occurred because of the concentration of chloride ions by neutralization.

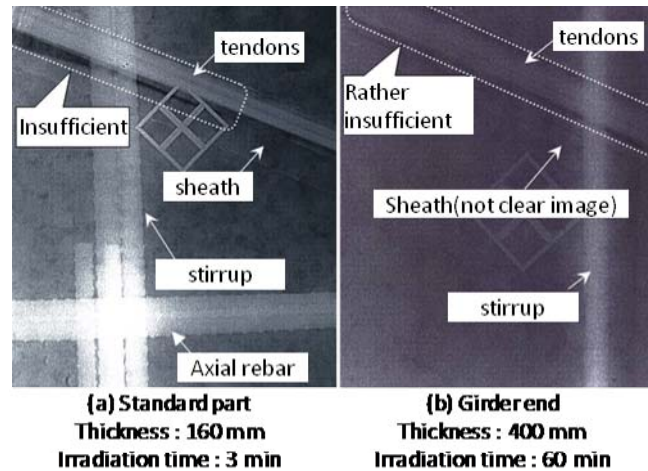
Figure 7 the condition of grout filmed using X-ray

The results of the grout sufficiency check are shown in Figure 7.

Insufficiency of grout because of a flow a head phenomenon or bleeding was found in some place but the condition of grout was relatively good. The required time to get a clear image is approximately 3 minutes when the thickness of the specimen is around 160mm. But when the thickness is 400mm at the girder end, a clear image could not be taken by even 1 hour irradiation. The trial of X-ray transmission method was done at the point where the breaks or corrosion of steel was found but a significant results were not obtained. In the anatomical study, the sufficiency of grout was investigated from the sheaths, taken out from the girder and cut into round slices (Figure 8). The results were same as NDT.

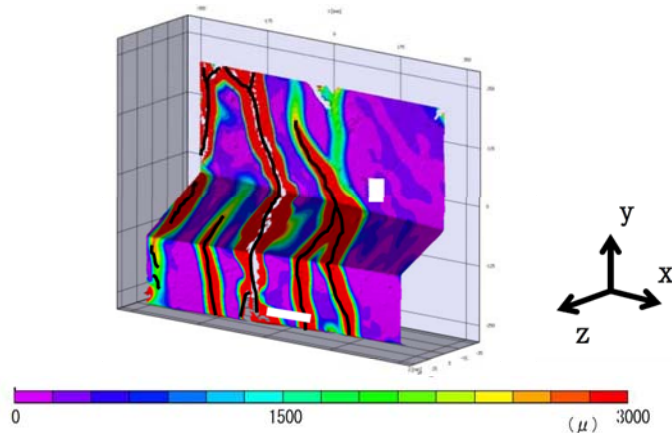
Figure 10 distribution of strain (load: 520kN)

The results of the comparison among DICM, contact-type displacement gauge and strain gauge is shown in Figure 9. In Figure 10, the distribution of strain from the full-field optical measurement is drawn and the crack found by visible check is also in the figure with a black line. The full-field optical measurement captured displacement and strain generally. Strain gauge is only able to measure a point but the full-field optical measurement is able to capture strain planarly. Development of this method is expected.

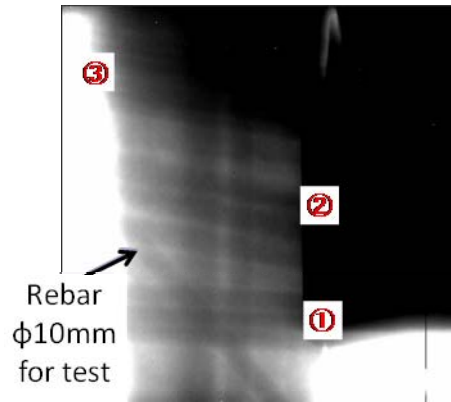
Photo9 X - ray image (expose time: 1 sec)

This part is 40 cm thick. It takes approximately 1 hour to x-ray by former X-ray devices but Photo 9 could get an image with only several seconds. This girder adopted a post-tension system and 12 prestressing tendons which are 7mm in diameter are settled in each sheath. In each sheath, only 3 prestressing tendons is able to recognize from Photo 9 because this image is taken from one direction. However this X-ray device can take plural images with different angles in short time. Therefore, CT technology is developed in parallel with the development of device itself for improvement of accuracy.
