# The Fujita Tornado Intensity Scale: A Reassessment from Structural Engineering Perspective

## ABSTRACT

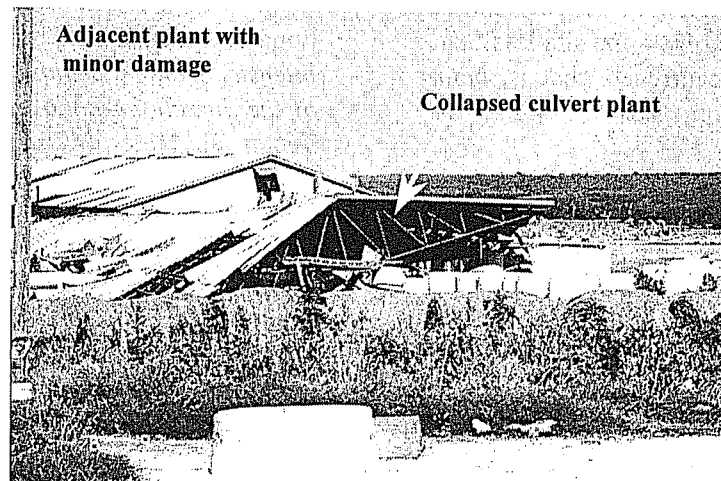
The first structural damage in Jarrell occurred at the corner of County Road 305 and County Road 307, where a culvert plant collapsed in place (Figure 1). The plant was a light steel frame construction with non-reinforced masonry and steel tube columns supporting steel pipe, gable roof trusses. The steel tube columns were cast into a concrete mat foundation on grade. The roofing, supported by wood purlins, consisted of corrugated sheet metal. An identical plant located approximately 15 m away from the collapsed culvert plant, and a mobile home located about 150 m north-northwest of the plant sustained only very minor damage. As the tornado continued its track south-southwestward, a barn located just southwest of the culvert plant and just north of the Double Creek Estates subdivision in Jarrell was destroyed. The tornado then moved through the Double Creek Estates subdivision and the surrounding areas, where the destructive path widened to its maximum of 1.2 km and the tornado became most deadly.

Figure 1. Ground view of collapsed culvert plant.

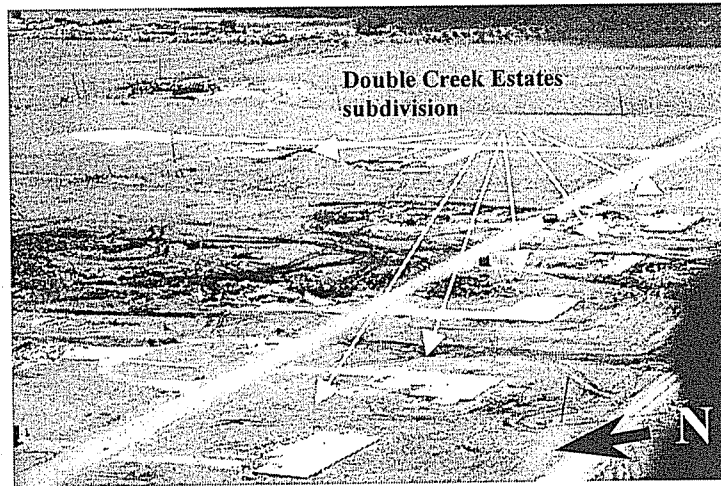
Figure 2 shows a portion of what remained of Double Creek Estates subdivision after the tornado passage. The structures in the subdivision consisted mainly of single family residences built over the last 15 years or so, of the typical slab-on-grade construction type. Owing to the presence of a limestone bedrock most houses had no basements or underground shelters. The houses, which consisted mainly of wood frame construction, were completely swept off the concrete foundations. Inspections of the concrete

Figure 2. Aerial view of portion of the Double Creek Estates subdivision after tornado passage

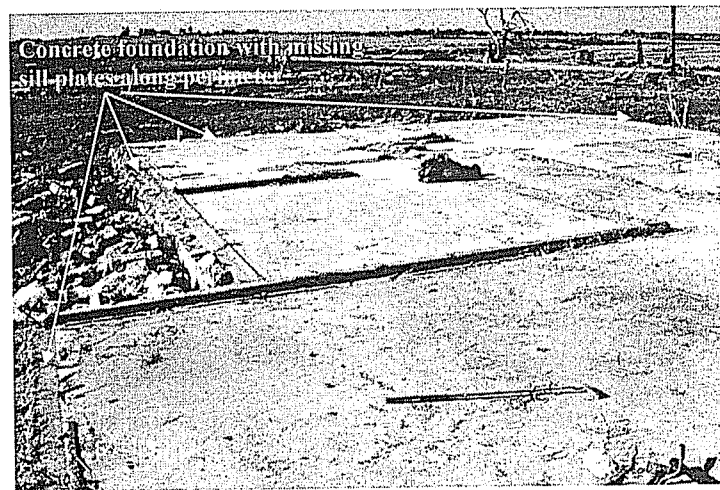
slab-on-grade foundations performed during the ground surveys revealed that, in many cases, even the sill plates that connect the wood frames to the concrete slab-on-grade foundations were blown away (see Figure 3). There was evidence that the sill plates had been connected to the foundations by explosive-driven nails. Figure 4 shows a nail that remained in the foundation but pulled through the sill plate. Figure 5 shows nails, spaced 0.9 m apart, that pulled out of the foundation. The Council of American Building Officials (CABO): One and Two Family Dwelling Code and other nationally recognized model codes require that sill plates of exterior walls for wood-frame construction be anchored to the foundation by anchor bolts not more than 1.83 m apart, but no evidence of anchor bolts was found by the team. It should be noted that Williamson County *has not adopted a building code*, even though Jarrell was also hit by a tornado on May 17, 1989.

Figure 3. Close-up view of a typical slab-on-grade foundation of houses in Jarrell. Only one sill plate remains connected to the concrete foundation.

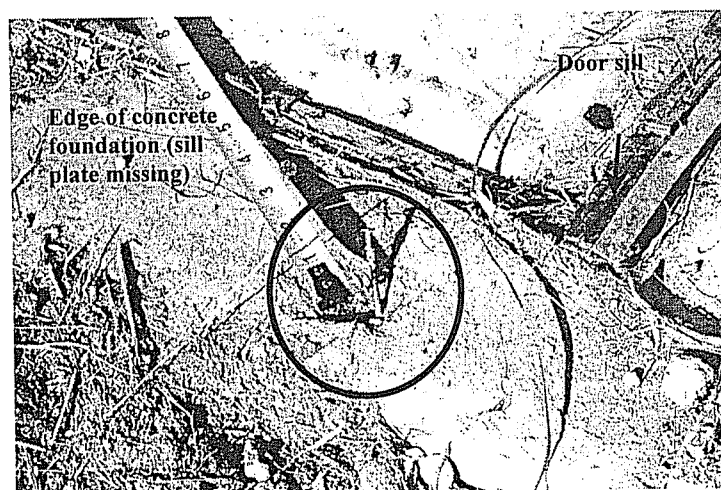
Figure 4. Evidence of nail that was used for connecting sill plate to concrete foundation.

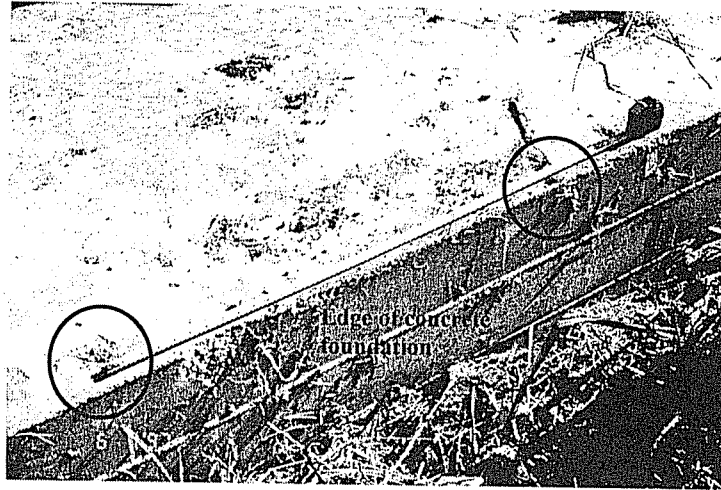
Figure 5. Evidence of pullout of nails used to fasten sill plates to concrete foundation.

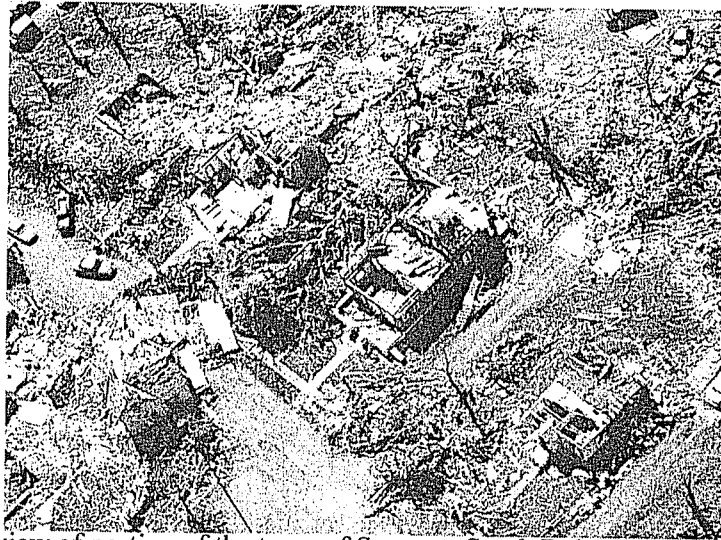
Figure 6 shows an overview of the town of Spencer after the tornado passage. Within the town of Spencer, the observed damage ranged from total disintegration of structures in the direct path of the tornado, to light damage to envelopes of structures in the outlying areas. The structures affected varied in age and structural systems. Completely destroyed structures included one and two-story wood-frame, heavy timber, and engineered metal frame constructions. Among these were wood-frame constructions that were either poorly connected or totally unconnected (i.e., relying on gravity alone) to the concrete or brick foundations. However, structures that were totally destroyed also included some (post office, fire department, gas station, antique and other stores) that were properly anchored to the concrete slab-on-grade foundations by 12.7 mm (½-in) anchor bolts with proper spacing as required by CABO (1995) and other nationally recognized model codes (see Figures 7 (a) and (b)). Many heavy trucks, some reportedly fully loaded, used in transporting grains to and from the town's grain processing and storage warehouses, were lifted and carried more than 30 m away by the wind. Trucks and houses exhibited widespread evidence of missile impacts from broken wooden power poles, tree branches, and other debris.

Figure 6. Aerial view of portion of the town of Spencer, South Dakota, after tornado passage.

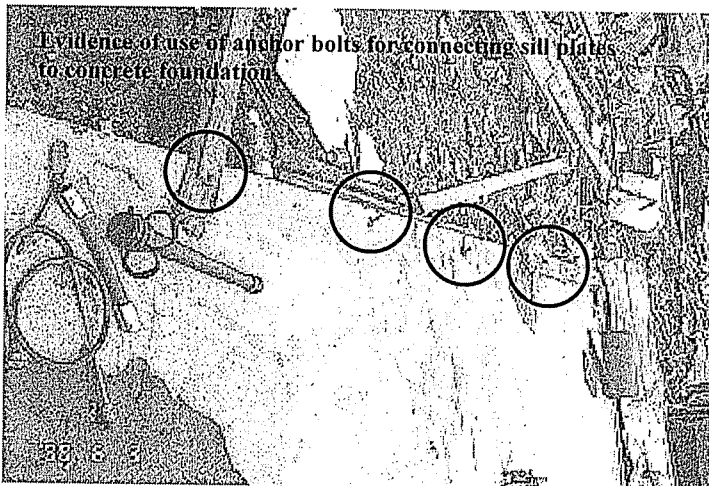
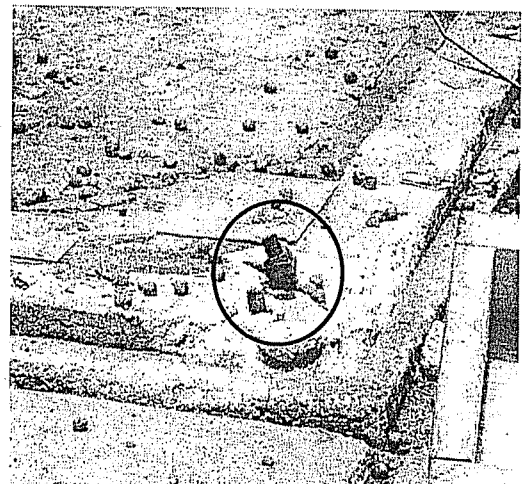
Figures 7 (a) and (b). Evidence of anchor bolts used to connect upper structure to concrete slab-on-grade foundation in Spencer, South Dakota.
