# Report on the Western Tottori Prefecture earthquake of October 6, 2000

MATSUO Osamu<sup>1)</sup>

## ABSTRACT

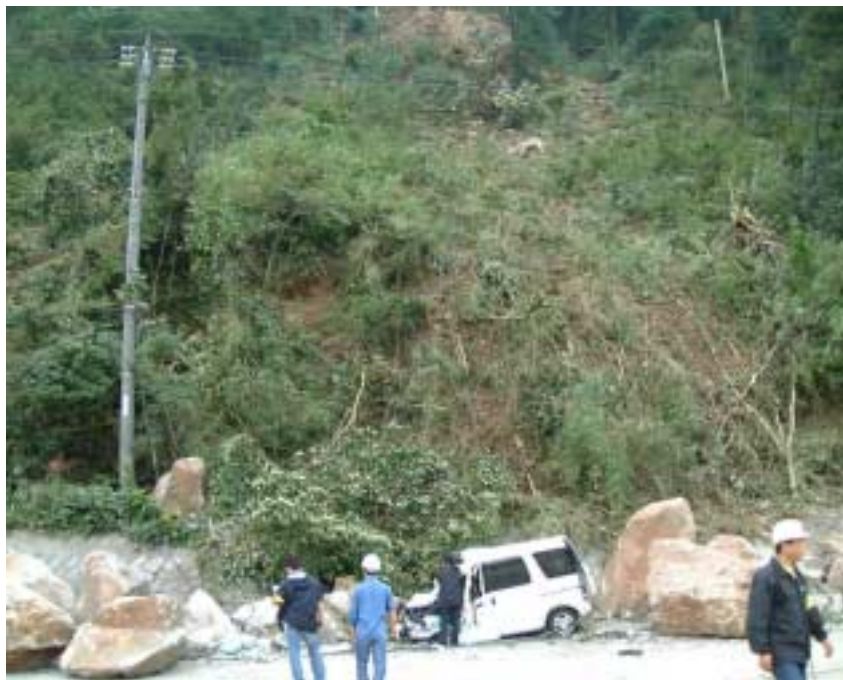
Rockfalls also took place at many sites. At several locations, falling rocks hit the roads. As an example, **Figure 9** and **Photo 1** show a rockfall damage that occurred at the Hino-Mizoguchi Line (regional road), Mizoguchi town. A total of about 30 rocks with diameters of approximately one to 3 meters fell down the neighbouring steep slope from a scarp of about 70 meters high. The rocks rolled down the hillslope, crushing down trees. Many of them stopped at the slope toe but some crossed a paved road. Unfortunately, one of the rocks hit a car that parked at the parkway locating at the slope side. The front side of the car was flattened by the large rock, resulting two aged passengers injured but very fortunately survived.

**Photo 1** Rockfalls at Mizoguchi town

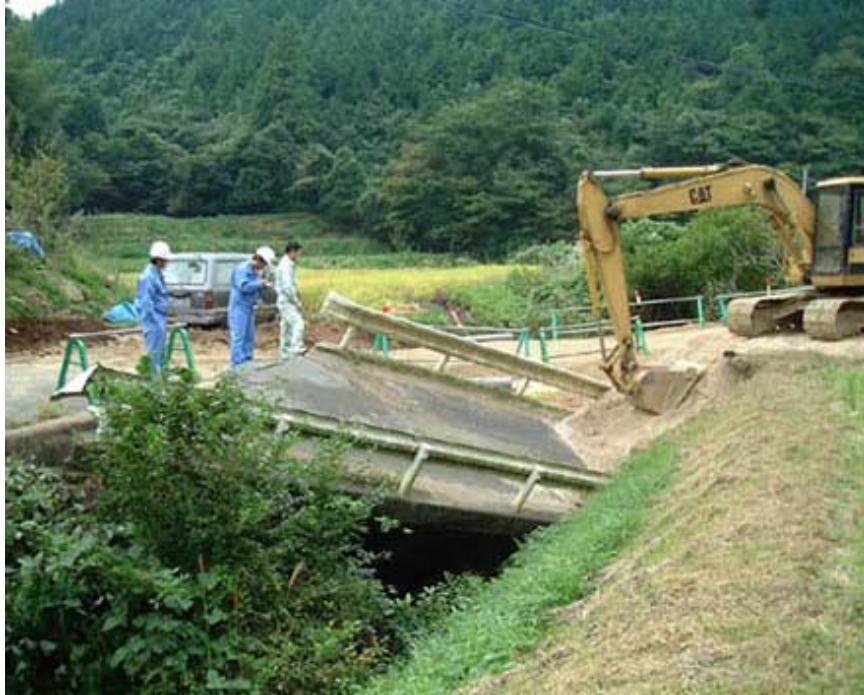
Damage to bridge structures occurred at bearing shoes, abutments, and hair cracking to piers, all of which were minor. One exception was a collapse of single-span bridge. The Harada bridge that is located in Seihaku town and is about 20 km away from the epicenter, is a single-span bridge with a length of 7 meters and a skewness of 40 degrees. The girder fell down as shown in **Photo 2**. One side of the girder was supported directly by a masonry retaining wall, which broke down due to seismic earth pressure, eventually leading to collapse of the girder. The masonry was made from natural boulder, presumably constructed as a revetment to protect the slope surface of the small river.

**Photo 2 Collapse of girder, Harada bridge, Akantani municipal road of Seihaku town**

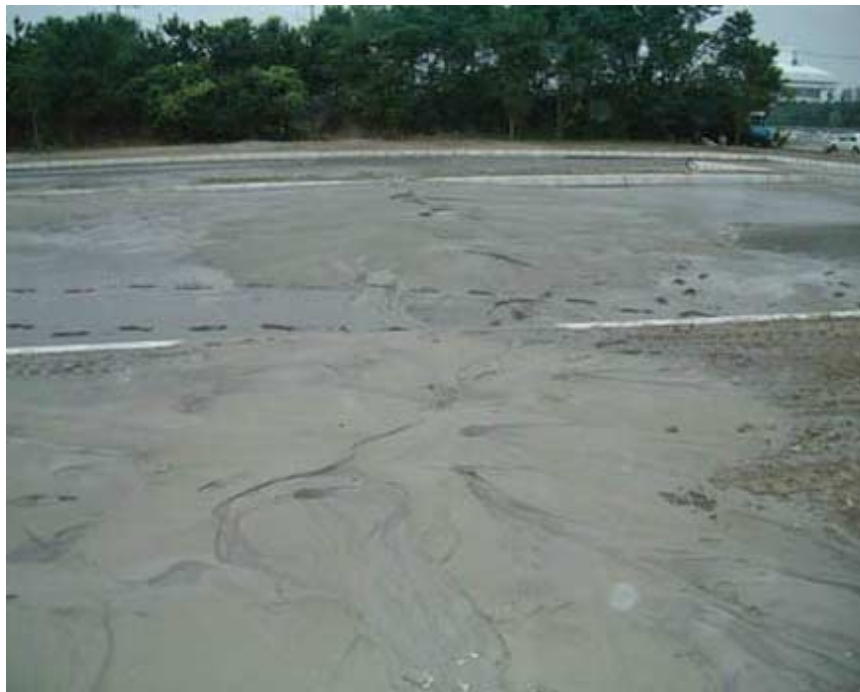
Another example is interesting to note from the geotechnical point of view. Yumeminato bridge connects the Takenouchi Industry Complex (a reclaimed fill) and Yumigahama peninsula crossing over a channel called Takamatsu-gawa. During the earthquake, extensive sand boiling were observed at both sides of the bridge (see **Photo 3**). The land-side ground spreaded out laterally due to subsoil liquefaction, causing the outward displacement of the revetment as large as 2 meters. As illustrated in **Photo 4**, road shoulder concrete blocks of the approaching road in the land side was pushed up due to the ground displacement. The ground displacement also caused the abutment of the Yumeminato bridge to push the girder and tilt back (see **Photo 5**). As can be seen in **Figure 10**, the land-side abutment (A1) was supported by steel pipe piles with a diameter of 500 millimeters and a length of 27 meters. The abutment collided with the girder. But as the girder propped the abutment head to move outward like a strut member, only the abutment bottom was allowed to move outward, thus resulting the abutment to tilt back with an inclination of 3 degrees. From the evidence of the ground lateral spreading and the distortion mode of the abutment, it

**Photo 3-1 Extensive liquefaction near the Yumeminato bridge**

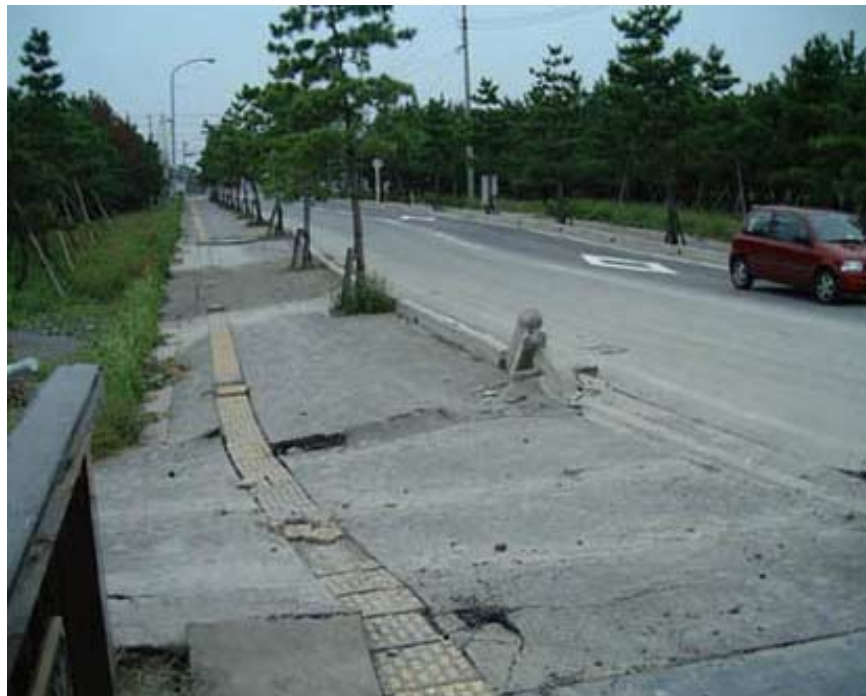
**Photo 4 Distortion of road shoulder concrete blocks due to ground displacement, near the Yumeminato bridge**

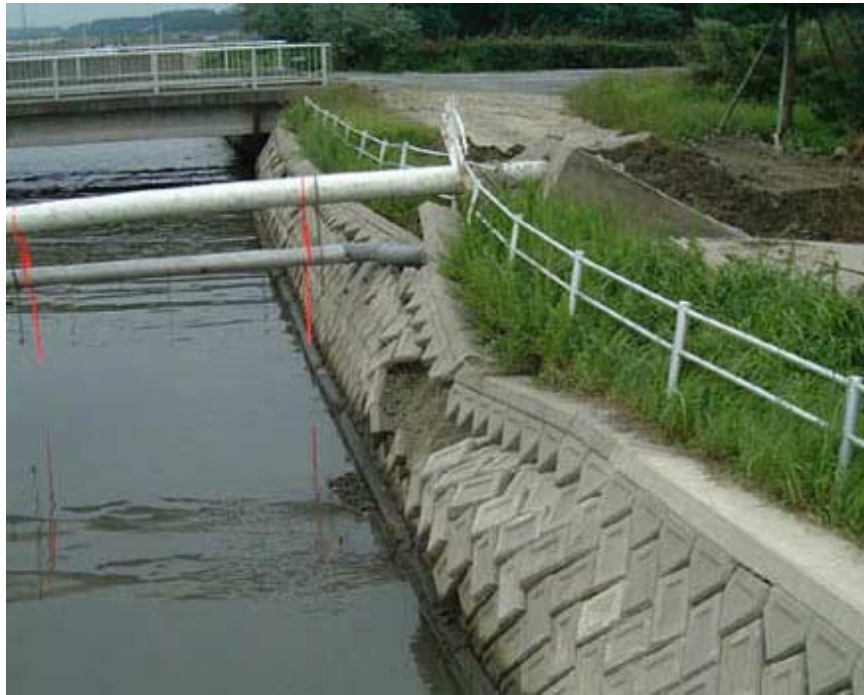
is readily understood that the abutment and the pile foundation was pushed by the soil.

**Photo 5 Distorted revetment and Yumeminato bridge**

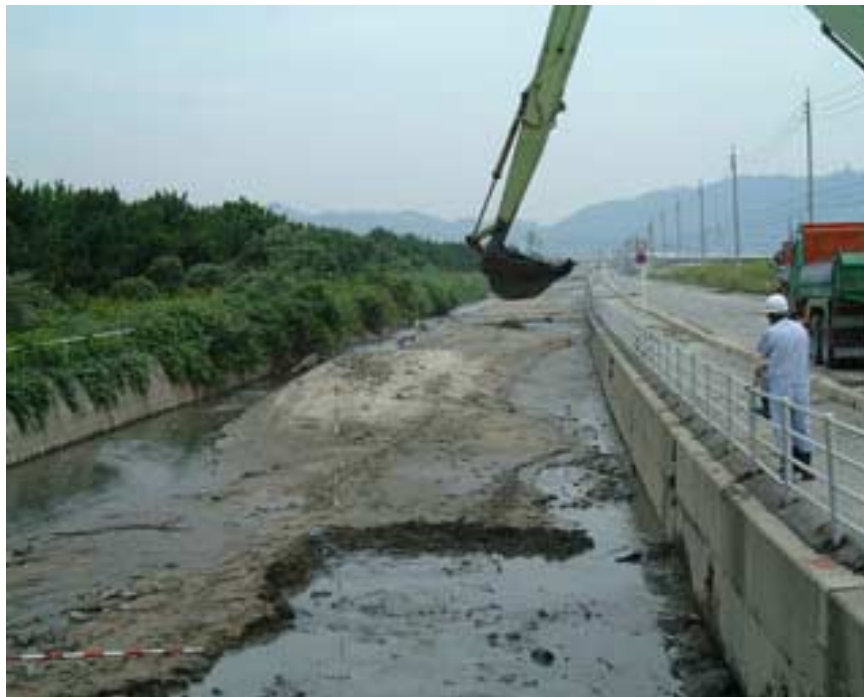
**Photo 5-2 Extensive amount of sand boiling at Takematsu-gawa (Looking from Yumeminato bridge)**

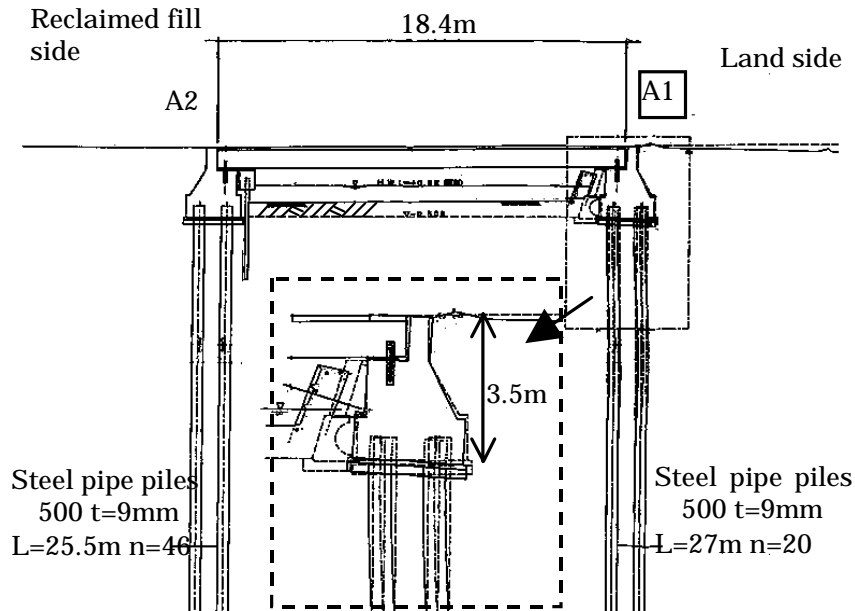
Figure 10 Cross section of Yumeminato bridge and distortion of the A1 abutment (inset)

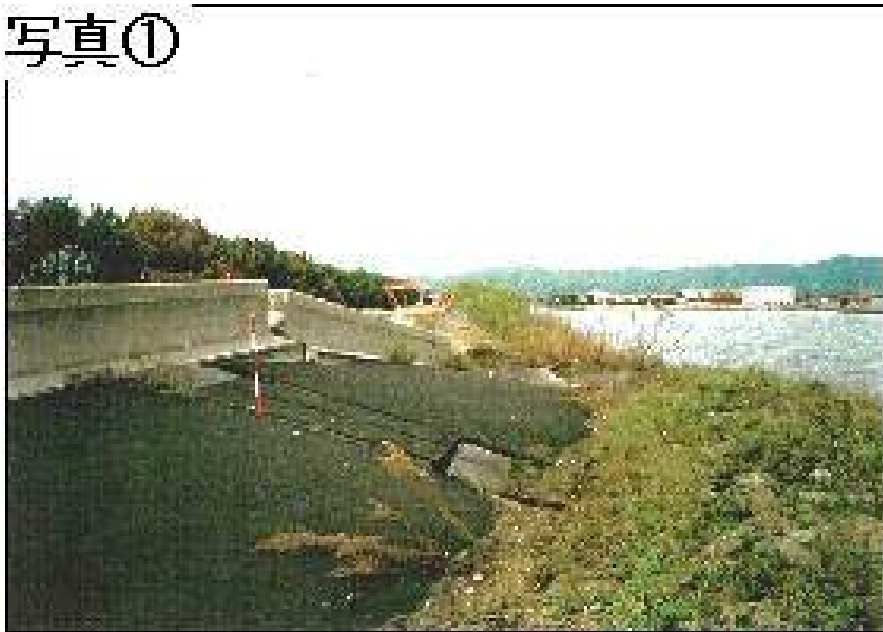
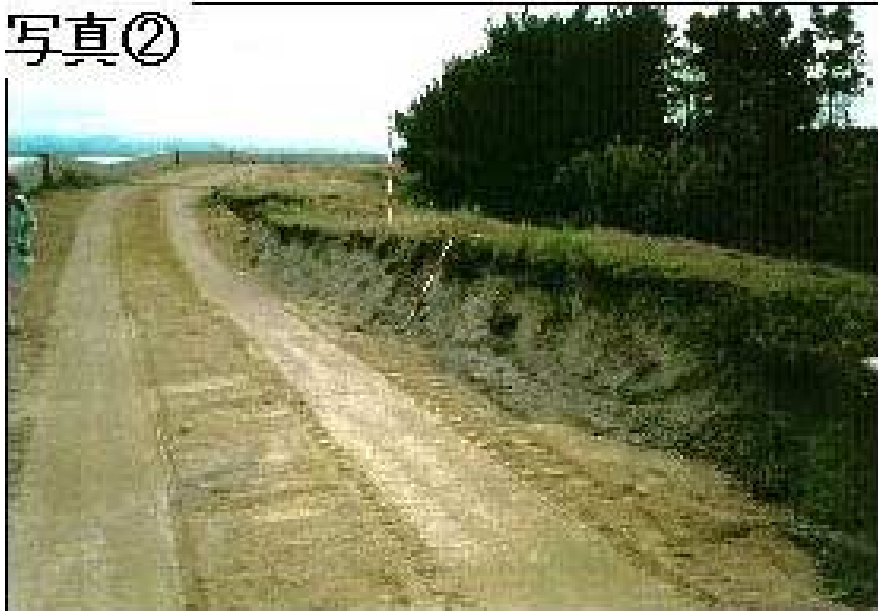
Embankments surrounding the reclamation lands located in Nakaumi Inland Sea slumped and cracked. Most seriously damaged were the embankments surrounding the Yumigahama and the Hikona reclamation lands. These lands were constructed in 1970's to 1980's by filling the dredged waterbed soils in Nakaumi. In Yumigahama, the embankment had a height of 2.0 to 2.5 m from the normal water level, a crest width of 5.5 m, and slope inclination of 1:2.0-3.0. In most part of the length, the embankments were protected with berms from being washed out by wave action. The most seriously damaged was the embankment locating at the south-east corner of the land. As illustrated in **Figure 11** and **Photo 6**, the front side slope spreaded out laterally (the lateral movement of the parapet wall was 2.5 meters) and the crest settled 1.2 m. Sand boiling was observed widely in the area. From the boring data given in Figure 10 and the evidence of sand boiling, it is no doubt that the embankment distortion was induced by the subsoil liquefaction.

Photo 6 Damage to the embankment at Yumigahama Reclaimed Land

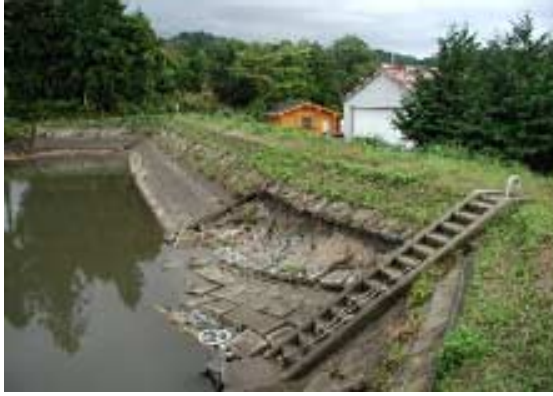
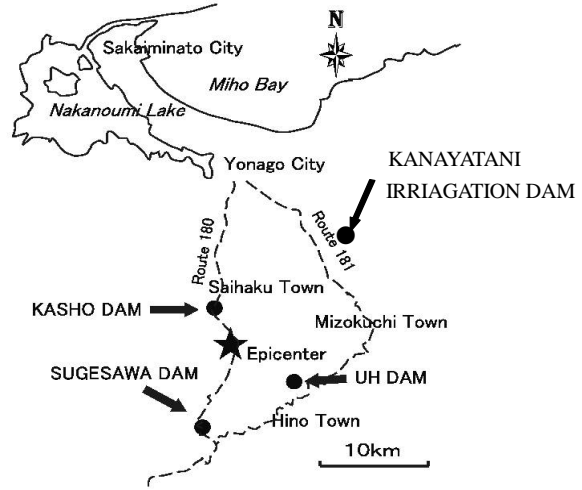
Among irrigation dams in Tottori Prefecture constructed out of the legislative rivers, all of which were generally small-sized earth dams, damage to 40 dams were reported. Most of the damaged dams were located in the epicentral region. Damage included cracking to auxiliary structures, longitudinal cracking at the crest, and displacement of the concrete block revetment on the upstream slope, however, no functional damage took place. **Figure 13** shows sliding failure of the upstream slope at Kanayatani Irrigation dam made from weathered granite soil (called "masado" in Japanese) with a height of 4.5 m. The upstream slope spreaded out through the entire length, while the sliding occurred over seven meters length.

**Figure 13 Sliding of upstream slope at Kanayatani Irrigation Dam**

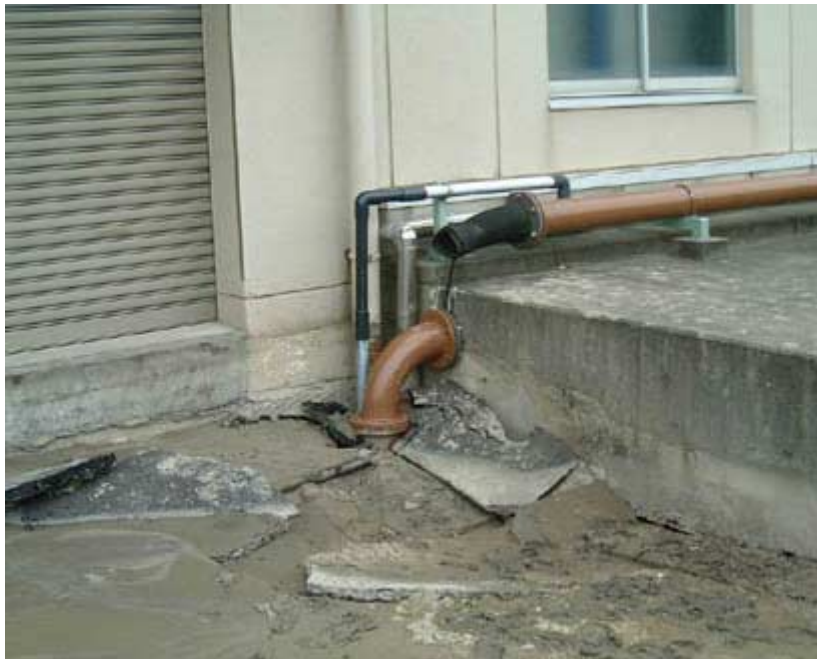
Sewage treatment facilities and pipelines sustained damage. The damage was concentrated in the Yumigahama peninsula and its coastal area. Structural damage were reported at four sewage treatment plants, all of which were located in the Yumigahama Peninsula. The damage included ground settlement at perimeters of buildings and the associated breaking of pipes and underground corridors (see **Photo 7**). The buildings were supported by pile foundations. Soil liquefaction and associated ground settlements were observed only in the region within a few meters away from the structures. This proved that the soils refilled during construction of the buildings liquefied, whereas natural deposits did not liquefy. Compaction of refilled soil may not have been adequate.

**Photo 7 Settlement of the ground and associated breakage of pipes, Sakai-minato Sewage Treatment Center**

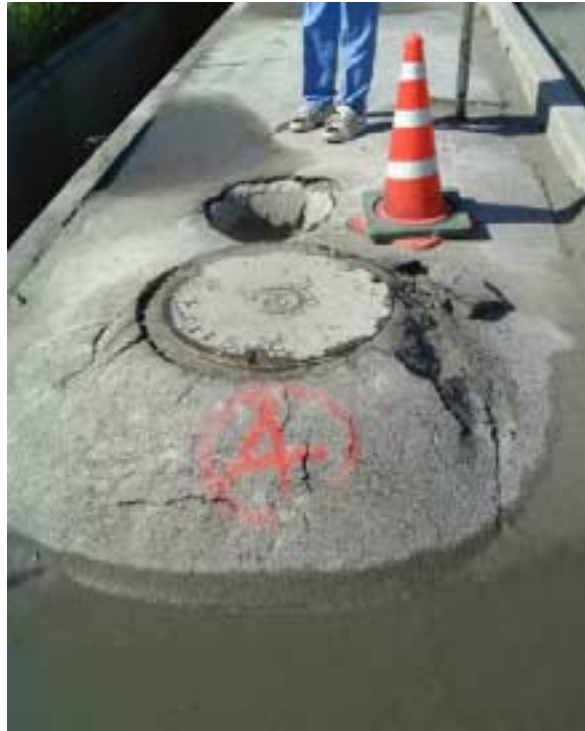
Industry Complex yard, a lot of manholes were projected with respect to the ground surface, as shown in **Photo 8**. This projection was deemed to have been caused by the settlement of the ground and the uplift of the manholes due to buoyant force of the liquefied soils. In conclusion, most of the damage to sewage treatment facilities were caused by soil liquefaction.

**Photo 8** Projection of a sewage treatment manhole, Takenouchi Industry Complex
