Bolu Viaduct: Damage Assessment and Retrofit Strategy

Hamid Ghasemi, Ph.D.

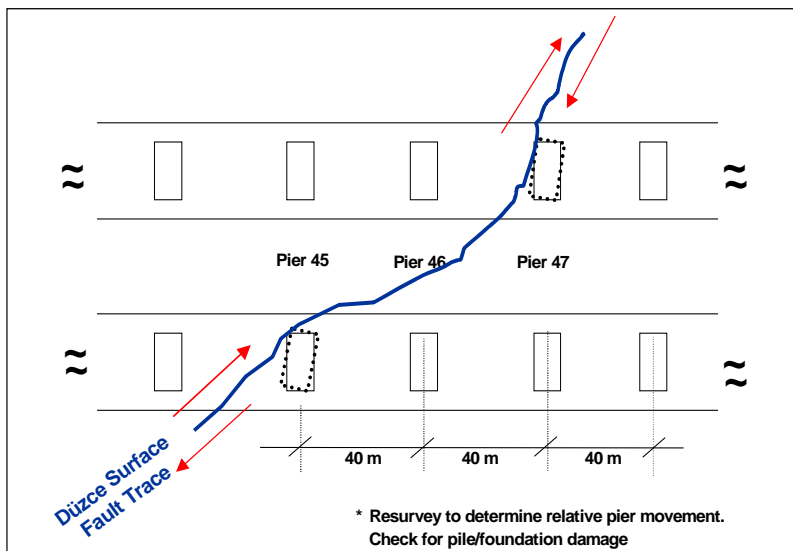
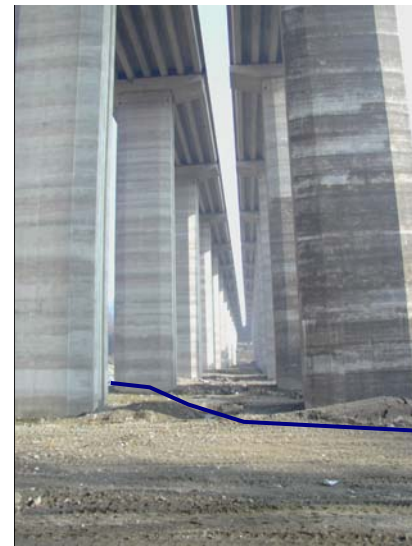
The Bolu Viaduct was subjected to extensive damage and narrowly escaped collapse during the Duzce earthquake. A surface fault rupture crossed a segment of the Viaduct between piers 45 and 47 (*Figure 5*). Evidence of high velocity impulses was observed from the earthquake records and from on-site inspections.

Figure 5- Fault trace between piers 45 and 47

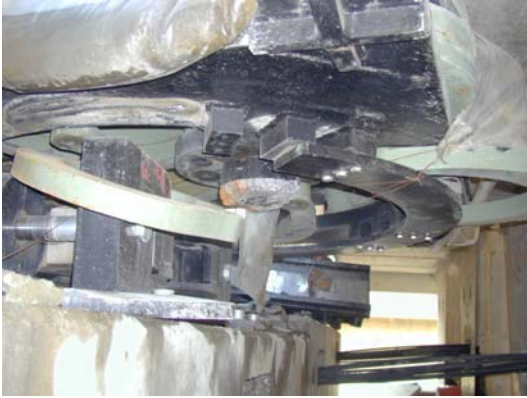
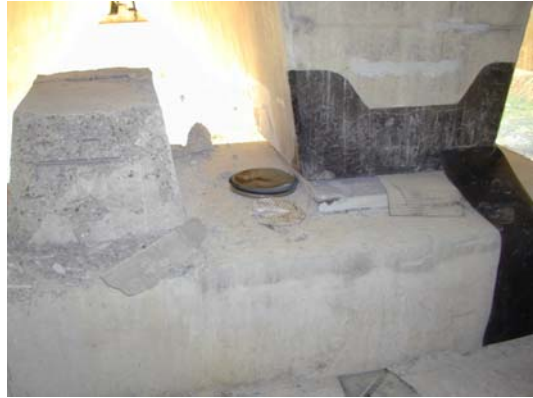
Significant damage did occur to all the EDUs and bearings of Bolu Viaduct, from surface rupture displacements and ground shaking (*Figure 6*). These caused the girders to translate on top of the piers about 1100 mm longitudinally and 500 mm transversely. Observation of the scratch signs on the surface of the stainless steel plates indicates that the bearings slid off their pedestals probably in a very early stage before any significant cyclic movement.

Impact between the ends of the central beam and the concrete pedestal supporting the EDUs occurred at most spans, destroying many of the support pedestals and damaging many of the beam-ends. Impact between the transverse shear keys and the sides of the girders caused extensive damage to the shear keys, and some damage to the girders. The hollow reinforced concrete pier stems were largely undamaged, though a number of piers have small but significant tilting and rotation. At the location of the fault rupture crossing, piers rotated about their vertical axis by 3.6 degrees. Also, limited damage to the foundation system was observed at vicinity of fault crossing where plastic hinging at top of the piles and significant pile-cap cracks were noted.

Figure 6- Damage to an EDU, shear key and a pot bearing

As part of the retrofit it was necessary to replace both the damaged sliding pot-bearings and the damaged EDUs. Seismic isolation of the superstructure from the piers was identified early on as essential for the repair/retrofit of the elevated highway. Also, the use of seismic isolation technology assured that the piers of the Bolu Viaduct will remain elastic for future major earthquakes. As part of the retrofit design program, the original (1992) probabilistic seismic hazard studies for ground shaking and fault rupture were updated to include more recent data, particularly the two 1999 earthquakes. The Italian consultants (G.M. Calvi and Nigel Priestley) carried out the design of the repair and retrofit of the damaged elevated highway.

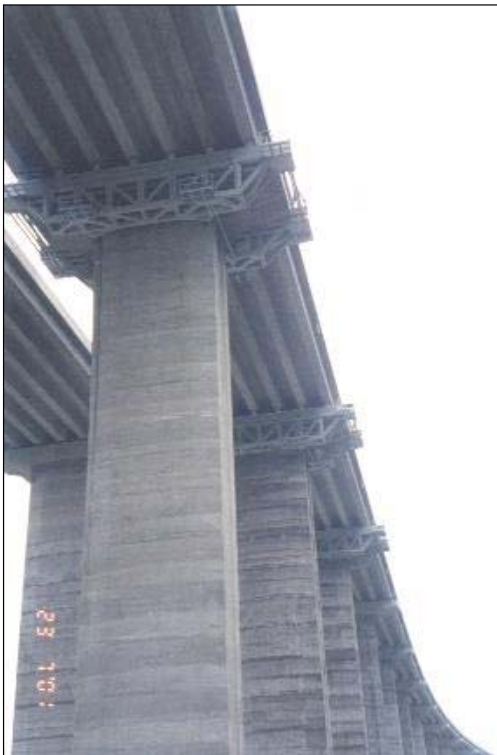
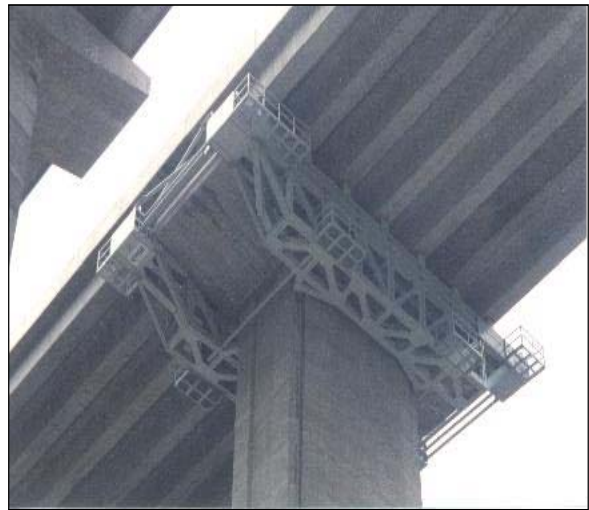
Figure 7- Temporary truss supports

Soon after the Duzce earthquake, temporary steel trusses on both sides of the pier cap were added to three piers to support the unseated span ends and to prevent collapse in the event of moderate aftershocks (*Figure 7*). The 130 ton steel trusses were raised into position using deck-mounted lifting and clamped to the pier caps by prestressing tendons. In addition, cable restrainers were installed at the abutments to prevent excessive movement of the end spans.

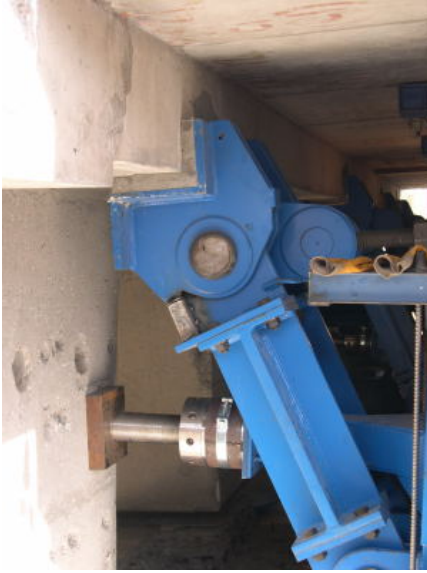
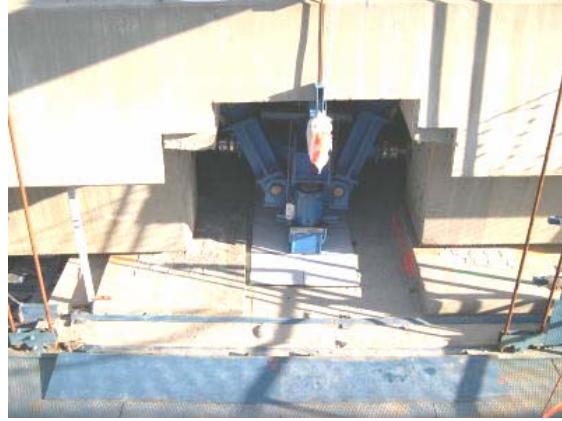
Figure 8- The jacking system

The repositioning of the viaduct will be undertaken for an entire 10-span segment at a time. But first the EDU support blocks, transverse shear restraint blocks and broken EDUs will need to be removed before repositioning occurs. Next, the displaced span ends are to be lifted and placed on temporary supports and low-friction sliders (3 to 5 percent). Then, the longitudinal repositioning will take place by using two hydraulic jacks positioned at each of three piers of the 10-span segment, using the piers as reaction points. It is important to note that exact repositioning is not possible because of small permanent deformations at pier caps relative to the ground. Once the longitudinal repositioning is placed, a similar procedure is used to move the 10-span segment to its final position transversely. Figure 8 shows the jacking system used for viaduct repositioning.

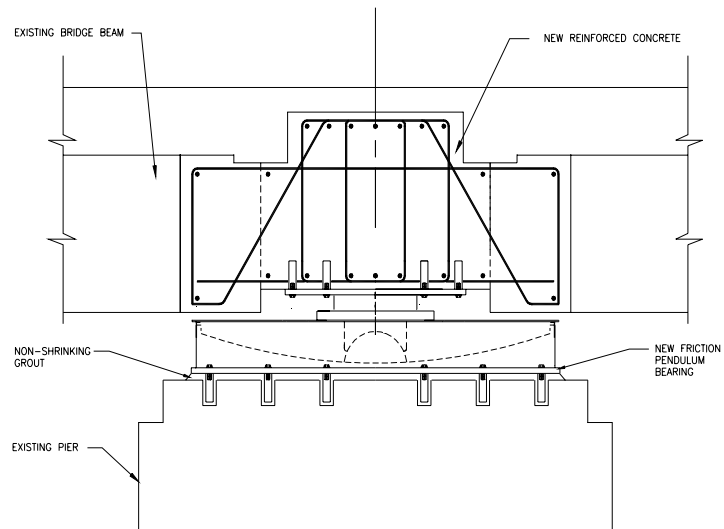
Figure 9- Retrofit scheme at typical interior pier

A decision was made to make the 10-span segments fully continuous for live load and differential thermal movements. This will involve casting a new full-depth transverse prestressed concrete diaphragm at each internal support by closing the ends of the beams and by confining the end 600mm of the girders of the two adjacent spans (*Figure 9*). This approach will avoid the unseating of the beams during major earthquakes. At the expansion joints, two separate prestressed diaphragms will be cast at each end span. Two isolation bearings would be utilized at the internal support between the diaphragm and the pier cap and four isolation bearings at the expansion joints.

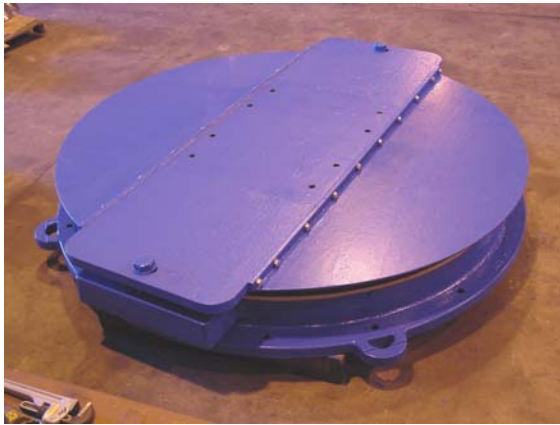
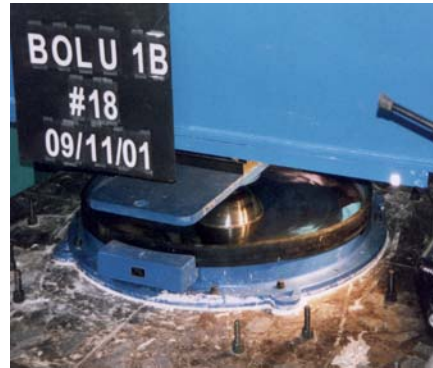
Figure 10- Friction Pendulum Isolation bearing

The client commissioned a study by High-Point Rendel of London, to undertake an industry survey of seismic isolation systems to identify the isolation system most suitable for the demanding environmental and high seismic performance requirements of the project. The high performance requirements included reliable dissipation of the large amounts of energy caused by the near field effects, and accommodation of a large permanent fault rupture offset without damaging the isolation unit and the viaduct. On the basis of this study, Friction Pendulum bearings were selected for the retrofit of the Bolu Viaduct (*Figure 10*).

In the final design approach, two isolation bearings will be utilized at the internal support between the diaphragm and the pier cap and four isolation bearings at the expansion joints. In order to optimize the design and to consider the variation in the height of the piers and the crossing of the fault rupture at a specific location, three different Friction Pendulum isolation bearings are to be used. These are;

- Displacement capacity +/- 700mm, large radius (smaller height piers and abutments)
- Displacement capacity +/- 700mm, small radius (tall piers)
- Displacement capacity +/- 900mm, large radius (piers P40 to P50, where the fault rupture crossed during Duzce earthquake)
