# Building Damage in May 26, 2003 Miyagi-Offshore Earthquake

## ABSTRACT

This paper reports the damage survey on building structures at the Miyagi-Offshore Earthquake occurred on May 26, 2003. The maximum ground acceleration recorded at the K-net strong motion observation stations was large and its response spectrum in the shorter period exceeds the requirement of the Seismic Building Standard, but the structural damage to buildings was observed not so severe. The reason of the phenomena was discussed.

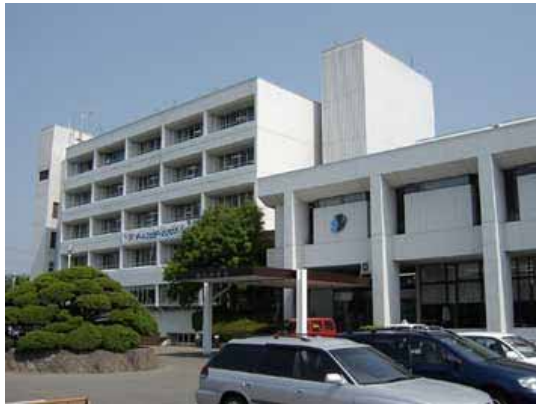
The Kitakami City Hall was built in December 1972. It is a reinforced concrete structure with two stories in the low-rise section and six stories in the high-rise section (Photo 1). No particular structural damage was observed. Diagonal cracking was observed in the glass facing the entrance in the low-rise section (Photo 2).

Photo 1 Kitakami City Hall

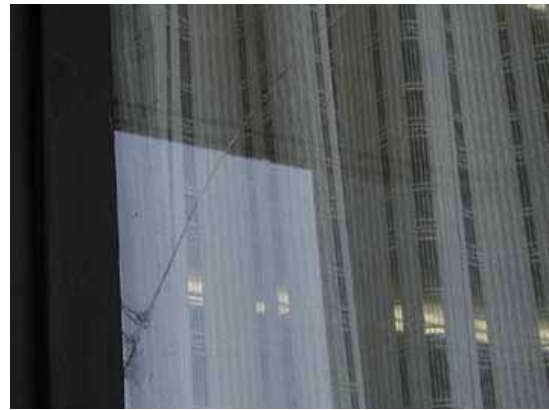
Photo 2 Glass cracking

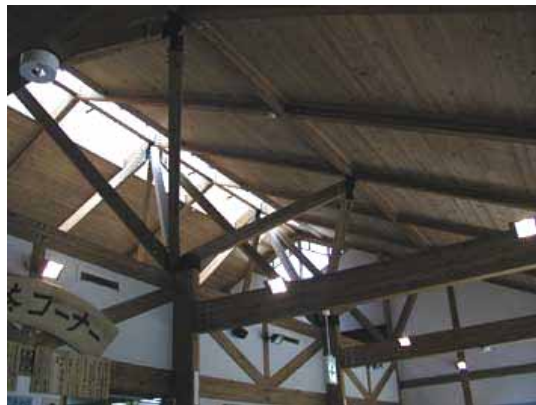
On the grounds of the Tono Kaze-no-Oka "Michi no Eki" (roadside rest station) located on National Route 283 is a structure that uses large size timber members. The structure uses a large section size member truss configuration with a three dimensional truss without vertical members (Photo 3). There was some structural damage, but the building manager reported that the earthquake caused an extremely large number of roof tiles to move. At the time the survey was conducted, repair of the roof tiles had already begun (Photo 4). The structure is located at the foot of a cliff, and there was a gap of around 5 cm between the ground and the building. In addition, near the cliff, there was cracking in the surface of the ground parallel to the ridgeline of the cliff. The reason for the damage to the roof tiles was thought to be that the axial force of the large section member of the truss configuration acted on the roof, causing the roof surface to experience short period vibrations.

Photo 3 Truss construction using large section members

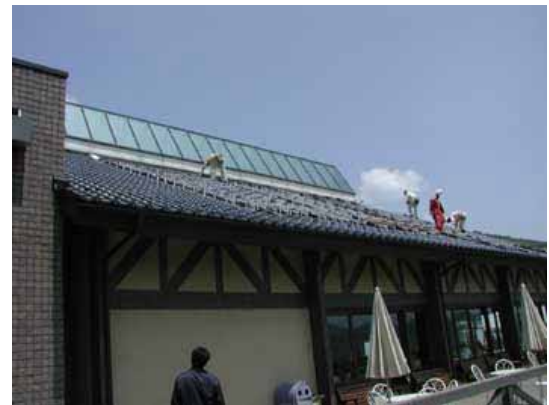
Photo 4 Repair work for roof tiles

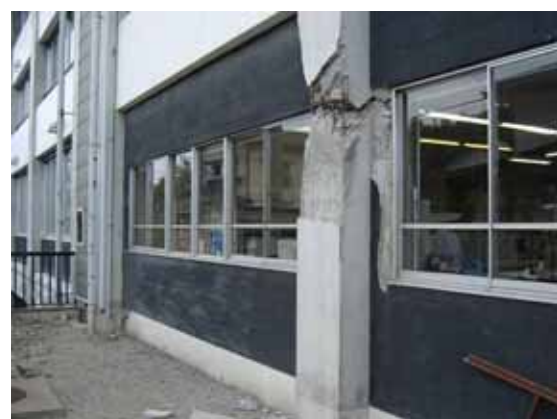
In the main building (3-story reinforced concrete building built in 1964) of the Tono City Office, shear failure was observed in two short columns (moderate damage to one column and minor damage to the other - see Photo 5) and damage to one column with a concrete rock pocket. (Photo 6), as well as cracking in the earthquake-resisting walls and beams inside. In the Tono City Office annex (two-story reinforced concrete building built in 1957 as well, cracking was observed on the walls inside, but the damage was light compared to that in the main building.

Photo 5 Shear cracking on the columns beside the entrance

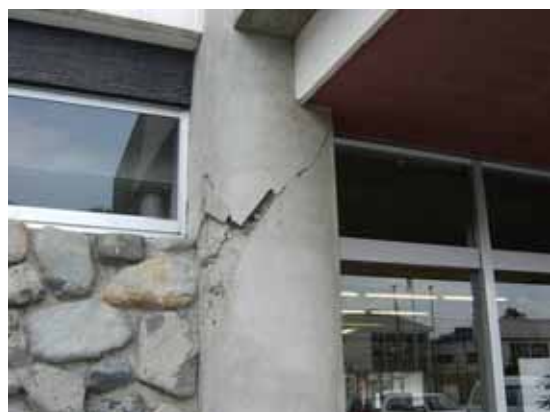
Photo 6 Damage to the columns at the rear of the main building

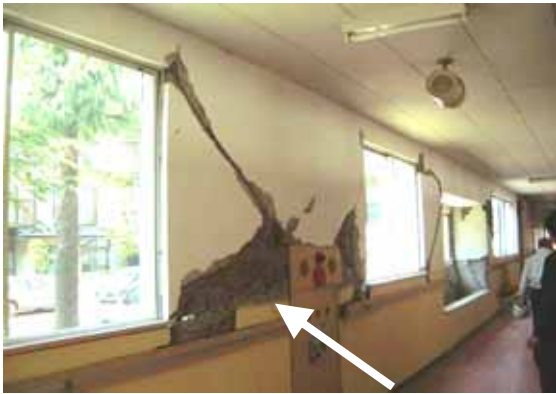
At the older Osano Municipal Elementary School building (three-story reinforced concrete building, constructed in 1973) in Kamaishi City, shear failure over a wide area was observed on the north side outer walls and walls between openings in the ridge direction (Photo 7). Almost no damage was discovered on the columns and the shear walls in the span direction. In addition, there were fallen ceiling panels at the entrance (Photo 8) and the ceiling panels in the hall of the new building (built in 1987) were damaged. No damage to the structural frames of the new building was observed.

Photo 7 Damage to the wall between openings in the first floor corridor of the old building

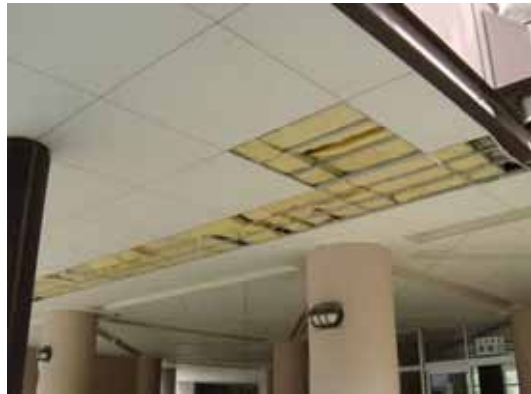
Photo 8 Fallen ceiling panels at front entrance

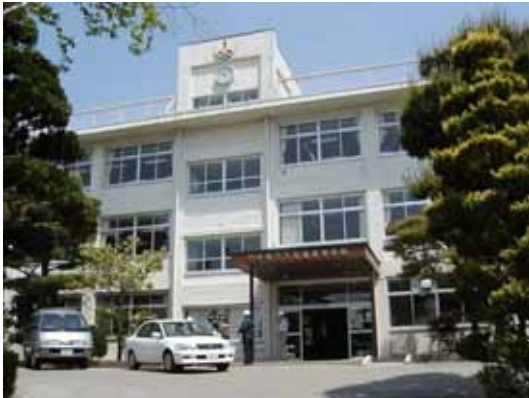
At the building of the Ofunato High School (three-story reinforced concrete building constructed in 1963 - Photo 9), the exterior column on the north side of the second floor had sustained shear failure (Photo 10), and shear cracking was also observed on the exterior column on the north side of the third floor. Damage was also noted in the expansion joints. On the first floor, there are other small rooms in addition to the classrooms, and there are more walls on this floor than on the second and third floors, and for this reason the damage is thought to have occurred on the second floor and above.

Photo 9 Ofunato High School

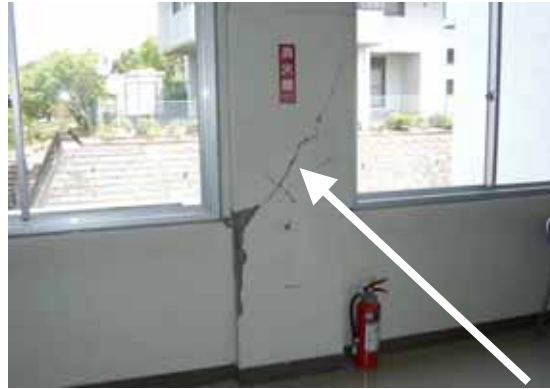
Photo 10 Shear cracking to the Second floor columns of the old building

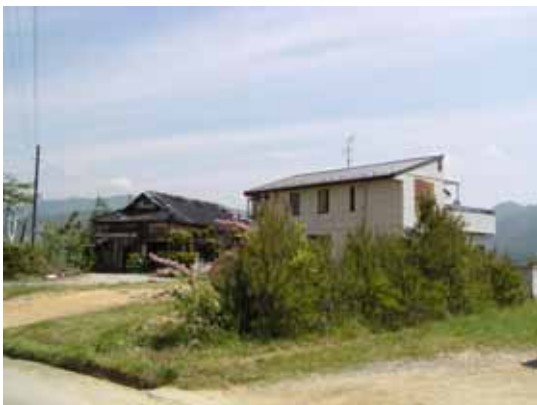
have sustained the most damage in this earthquake. According to a survey by Ofunato City, two residences suffered "severe damage" and six suffered "partial collapse." The two severely damaged residences were on land developed for housing lots located on a hill with a good view facing Ofunato Harbor (Photo 11). As far as could be determined, residences in the surrounding area suffered fallen roof tiles, blocks in block fences toppled and cracking of the retaining walls.

(2) Only two private residences in Ofunato City, Iwate Prefecture were classified as having suffered "severe damage" and it is thought that amplification of the earthquake motion due to the effect of the topography (meaning the location at the edge of a hill) led to the total collapse.

Photo 11 Two "severe-damage" residences

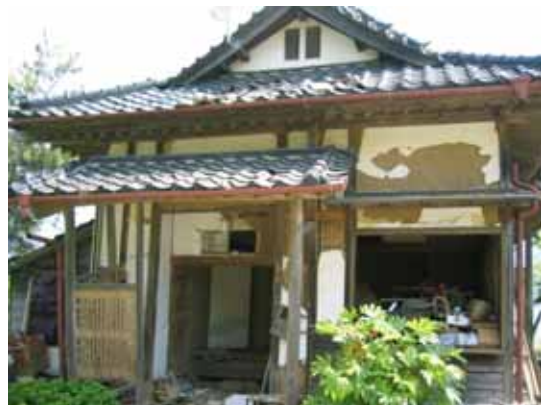
The severe-damage structures were a traditional one-story wood frame residence and a two-story lightweight steel frame prefabricated residence built 12 years ago. The one-story wooden residence had some residual story drift, but the mud-plastered wall had toppled, exposing the bamboo lath (Photo 12 / Photo 13). In addition, the toppling of the mud-plastered wall made it possible to confirm that steel reinforcing braces were used in places. Some damage was sustained to the sash due to the fallen roof tiles and the tilting of the building. The concrete was broken in places on the north side of the retaining wall.

Photo 12 Damage to outer wall of one-story wooden residence

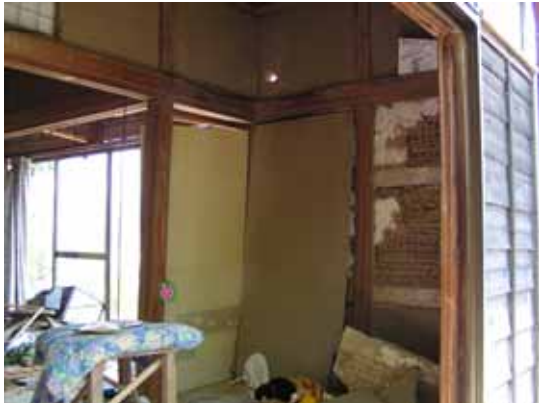
Photo 13 Damage to inner wall of one-story wooden residence

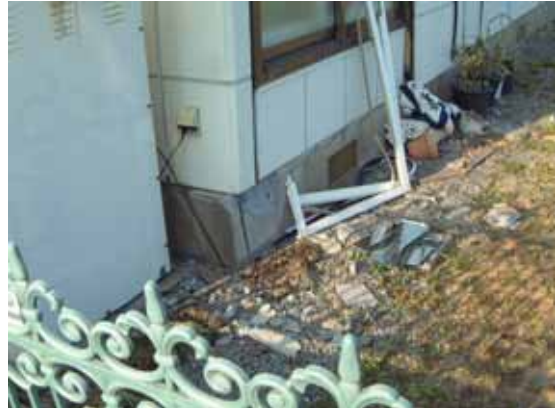
The lightweight steel frame prefabricated residence located beside the wooden residence likewise had some residual story drift and, although it appeared to have not suffered major damage, it had suffered severe interior damage. Externally, there were cracks in the ground near the foundation facing the retaining wall and the concrete of the foundation was broken near anchor bolts (Photo 14). In addition, the exterior siding had come loose and the sash was damaged. Inside the structure, the built-in storage facilities in the kitchen and the entrance had toppled or fallen (Photo 15). Joint-failures were observed on almost all of the interior walls, and some of the gypsum boards on the interior had fallen, indicating the severe shaking of the structure. It is difficult to believe that an earthquake with a measured intensity of approximately 0.3 - 0.4 m/sec could have caused this level of damage to a prefabricated house that should have had comparatively high quality maintenance in design and construction. Although it is not clear whether the fact that the

vibration of the structure was amplified due to the local geographical features (on a slope), or whether damage to the retaining wall caused the vibrations of the structure to be amplified, it is thought that earthquake motion at this location was different from that on level ground. This topic should be pursued in a follow-up study.

Photo 14 Damage to lightweight steel frame prefabricated residence

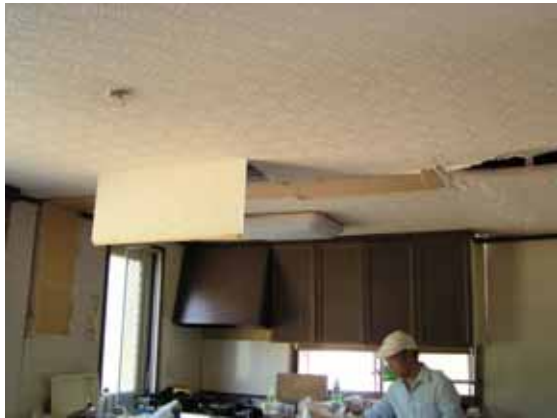
Photo 15 Fallen storage facilities in kitchen

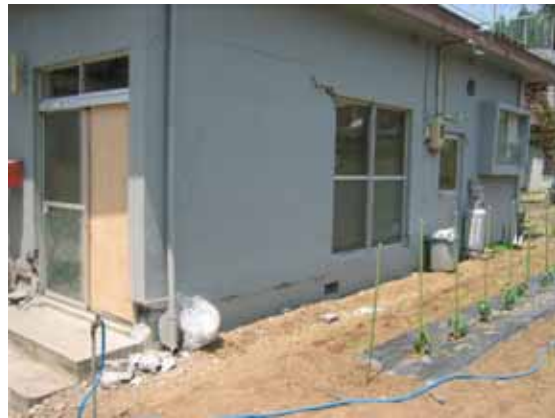
In other locations, wooden residences sustained fallen roof tiles, distortion of sash frames due to tilting, cracked and fallen mortar on the exterior walls, and foundation cracking. A concrete-block-masonry residence in Akazaki-cho, built 33 years ago, was judged as having suffered partial-collapse because of breakage of the blocks and their joints (Photo 16).

Photo 16 Damage to concrete-block masonry structure

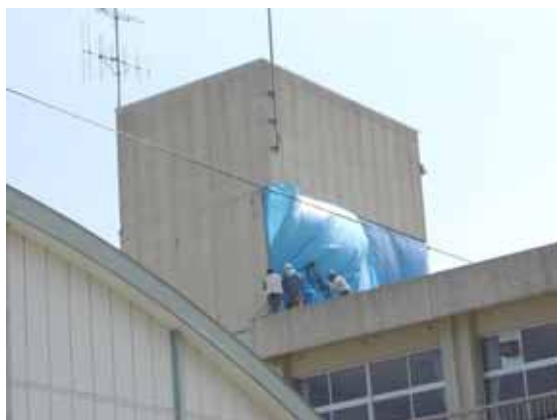
At the Hashigami Elementary School (three-story steel reinforced concrete building constructed in 1985), the foundation anchor bolts had been ruptured or pulled out (Photo 18) at the steel frame tower on the roof (two-story - Photo 17). There was also minor cracking on the walls and columns inside the school building, and broken window glass and deflection of braces were observed at the steel frame gymnasium.

Photo 17 Damage to steel frame tower on roof

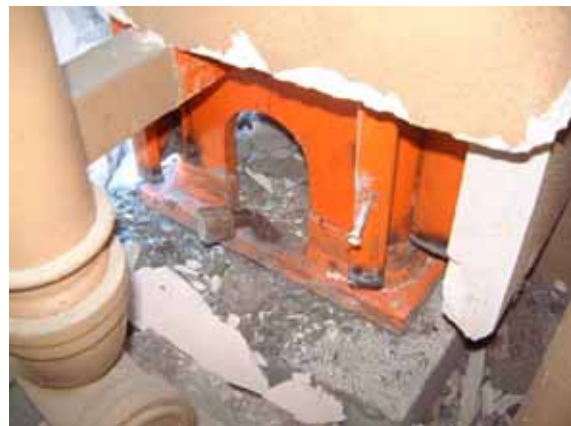
Photo 18 Rupture of foundation anchors on tower
