High Wind Damage in Japan from Typhoon Maemi and Choi-wan on September 2003

Hitomitsu Kikitsu¹, Yasuo Okuda² and Hisashi Okada³

This paper presents outline of field investigations of high wind damage by two typhoons occurred in September 2003. Typhoon Maemi attacked Miyako Island and typhoon Choi-wan did Hachijo Island, respectively. Not only low-rise buildings but also wind turbine generator systems in Miyako island experienced collapses or severe damage, and traditional timber houses in Hachijo island had damage on roofing materials and so on.

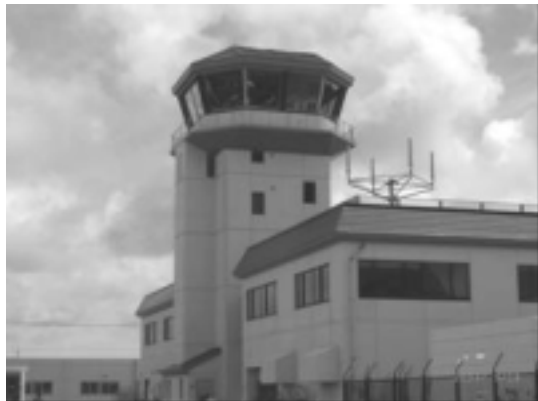
In Miyako Island, lots of public facilities such as an airport control tower, public halls and gymnasiums were severely damaged. Observed damage was on the roofing materials and cladding elements such as external wall finishing, windows and so on. The causes of damage in roofing materials can be considered to be the effects of external local suction and sudden increase of internal pressures. Most of the damage of external wall finishing and windows were caused by flying debris, but it is possible that the windows on airport control tower shown in Photo.1 was damaged by not flying debris, but external gust pressure.

Photo.1 Damaged Windows on Airport Control Tower (Miyako Island)

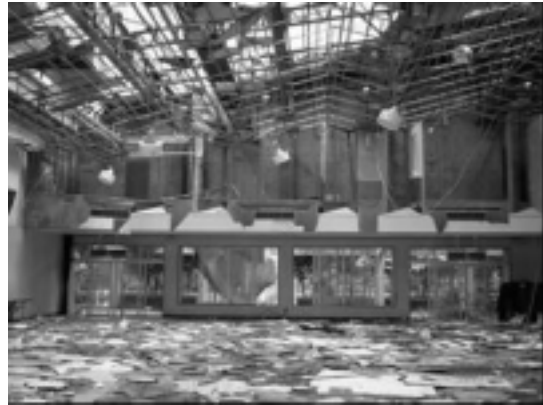
Photo.2 Damaged Roofing Materials of Public Hall (Miyako Island)

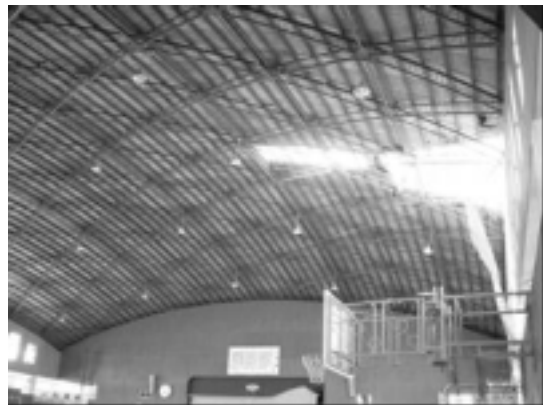
Photo.3 Separation of Roofing Materials of Gymnasium (Miyako Island)

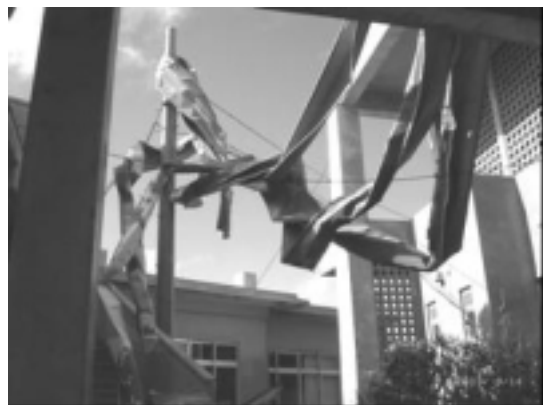
Photo.4 Exfoliation of Roofing Materials of Gymnasium (Miyako Island)

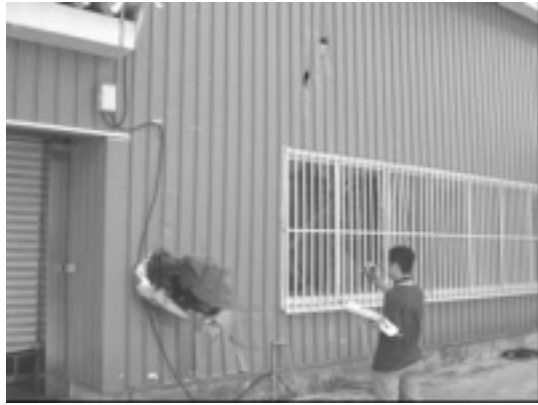
Photo.5 Damaged Wall by Flying Debris (Miyako Island)

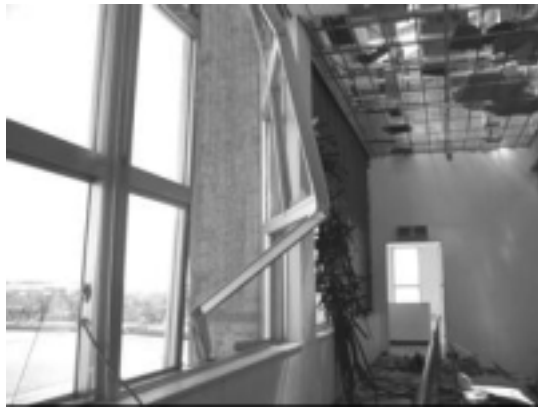
Photo.6 Broken Metal-framed Window and Ceiling Finish Materials of Gymnasium (Miyako Island)

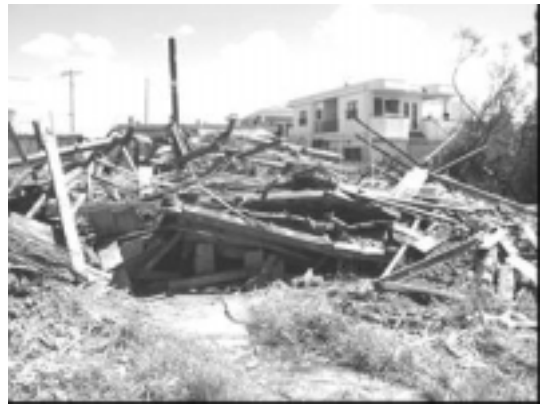
As briefly described above, since houses in Miyako Island are usually constructed by reinforced concrete, there were not so many collapsed or damaged houses except old timber houses as shown in Photo.7. Just next to the collapsed one, there were non-damaged timber house shown in Photo.8, in which useful measures are taken for avoiding high wind damage with windows covered by lattices and with crevices of each traditional roof tiles covered up with plaster.

Photo.7 Collapsed Old Timber House (Miyako Island)

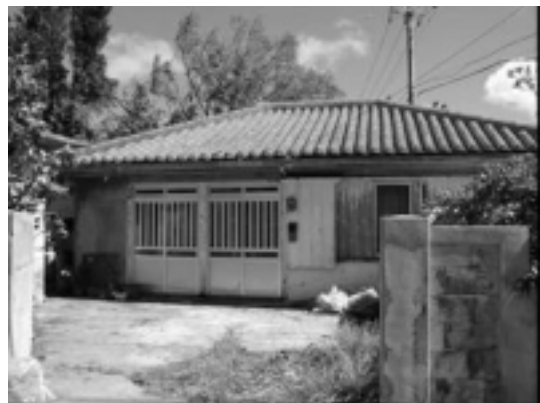
Photo.8 Non-damaged Timber House next to Collapsed One Shown in Photo.7 (Miyako Island)

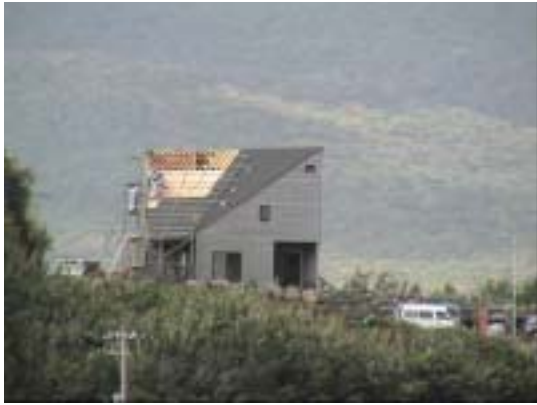
or kind of windbreaks, which exposed the house in circumstance subjected to high wind damage. In Hachijo Island, some high wind damage which was considered to be occurred due to topographic effects was observed as well. The damaged house shown in Photo.9 is constructed at the location between a hill and a mountain and the collapsed trailer house in Photo.12 stands just near the cliff of seashore, respectively. Since kind of mountain valley and cliff are considered to generate amplification of wind speed, these houses are supposed to have experienced relatively higher wind effects.

Photo.9 Exfoliation of Roofing Materials on Timber House (Hachijo Island)

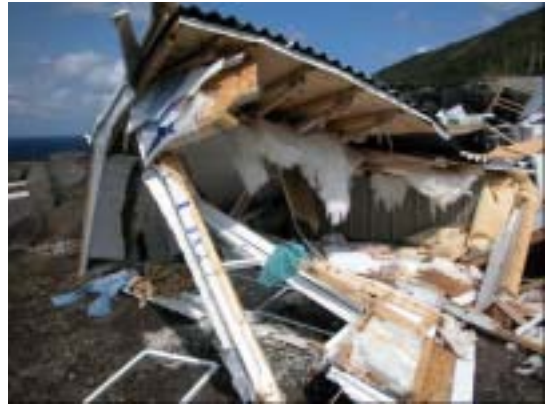
Photo.12 Collapsed Trailer House Standing near Cliff of Seashore (Hachijo Island)

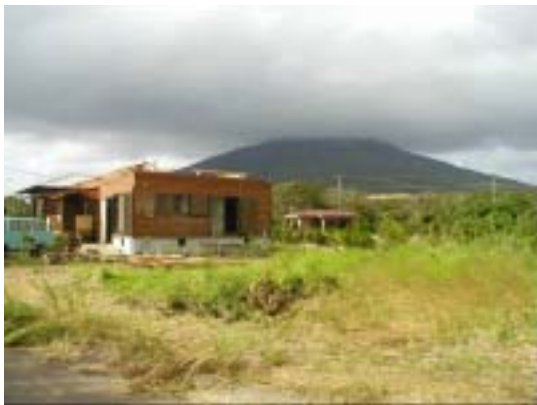
Timber houses damaged by high wind in Hachijo Island experienced not only damage on roofing materials and cladding elements, but also structural damage on roof frames. As shown in Photo.10, around the damaged house with collapsed roof frames, there are few trees

Photo.10 Collapsed Roof Frame of Timber House (Hachijo Island)

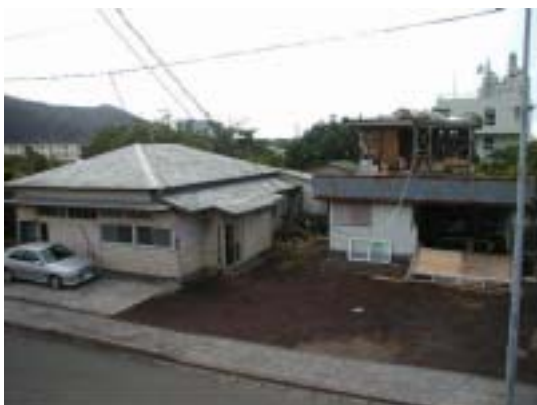
Photo.11 Marked Contrast between Damaged and Non-damaged Houses (Hachijo Island)

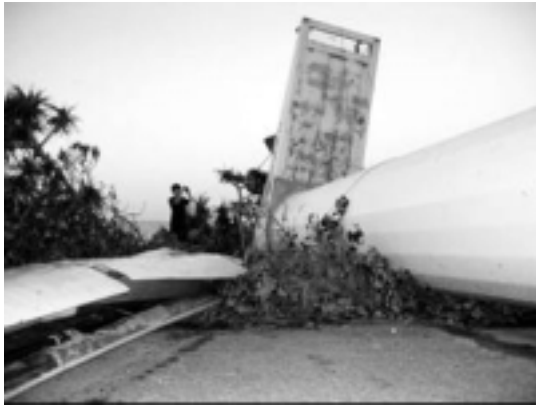
Photo.13 Broken Blades and Nasal of Wind Turbine Generator System (Miyako Island)

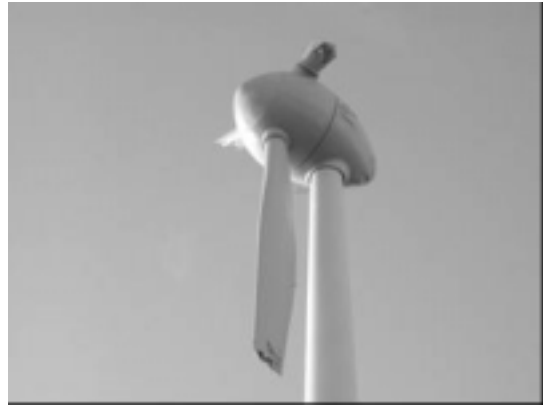
Photo.16 Damaged Blades of Wind Turbine Generator System (Miyako Island)

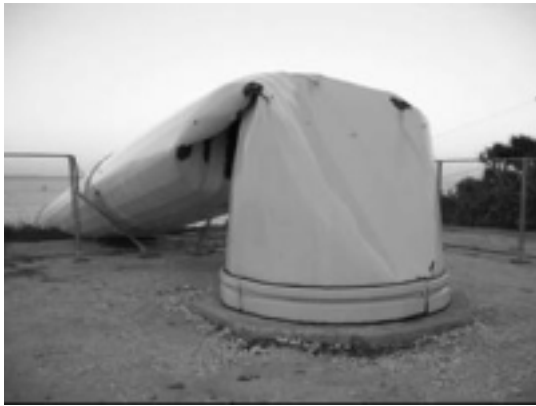
Photo.14 Broken Tower of Wind Turbine Generator System (Miyako Island)

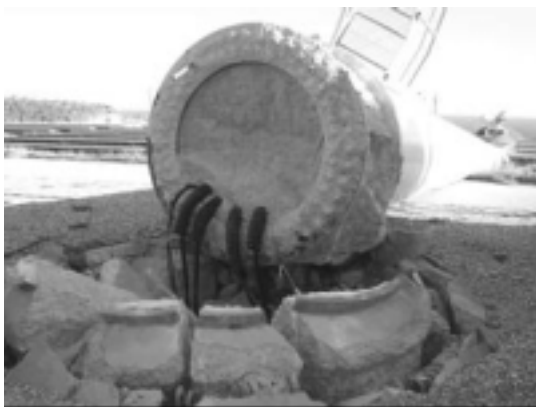
Photo.15 Collapsed Wind Turbine Generator System with Its Footing Pulled Out (Miyako Island)

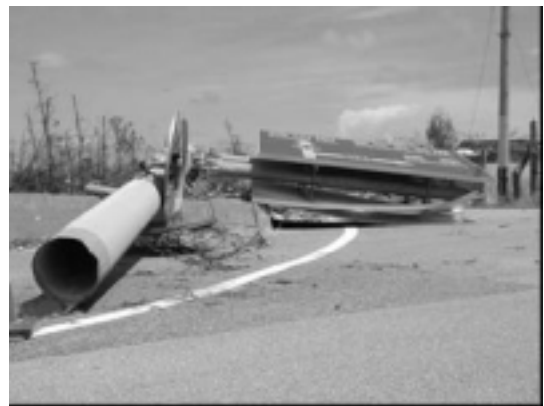
Photo.17 Collapsed Traffic Sign (Miyako Island)

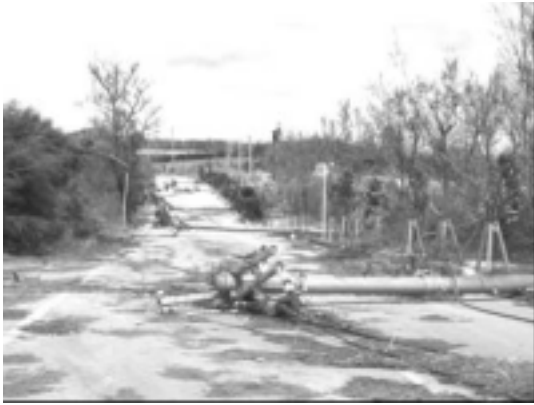
Not only buildings and power systems, but also traffic signs and so on experienced high wind damage by the typhoons as shown in Photos.17 to 21. Many rows of collapsed electric poles were seen and reported in Miyako Island, and which led to difficulties of traffics and breaks in the power supply.

Photo.18 Row of Collapsed Telegraph Poles (Miyako Island)

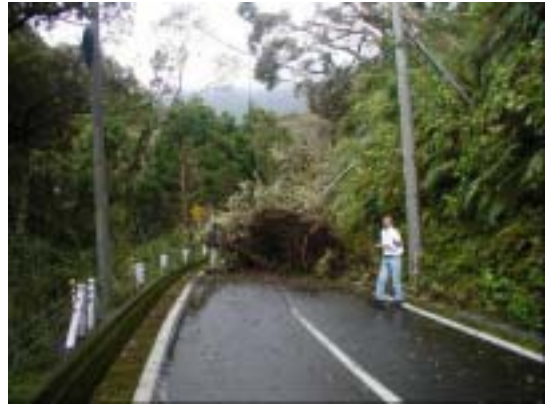
Photo.21 Fallen Trees (Hachijo Island)

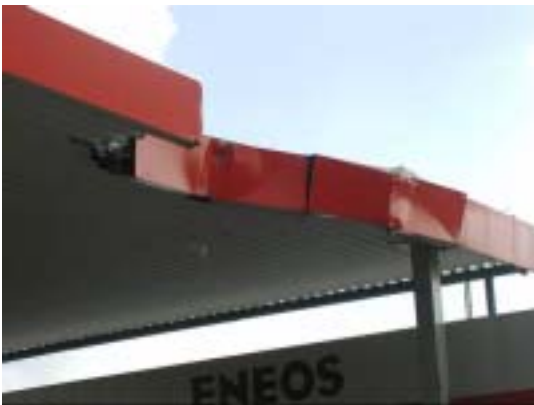
Photo.19 Damaged Roof of Gas Station by Flying Debris (Hachijo Island)

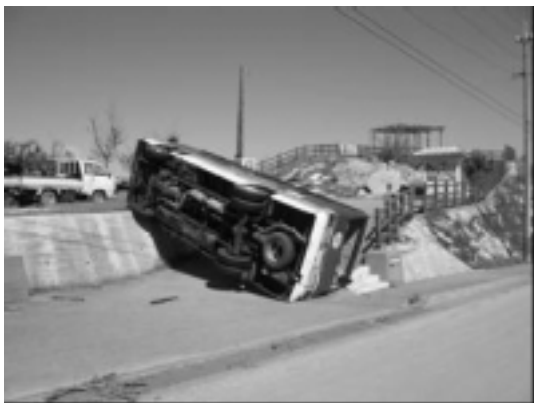
Photo.20 Fallen Bus (Miyako Island)
