Damage to Dams due to Three Large Earthquakes Occurred in 2003, in Japan

ABSTRACT

In 2003, three comparatively large earthquakes occurred in Japan. They were Miyagi-oki earthquake of Japan Meteorological Agency magnitude (Mj) 7.1 on May 26, 2003, Miyagi-hokubu earthquake of Mj 6.4 on July 26, 2003 and Tokachi-oki earthquake of Mj 8.0 on September 26, 2003. The National Institute for Land and Infrastructure Management (NILIM) and the Public Works Research Institute (PWRI) dispatched joint teams to conduct field surveys of the dams. This paper reports the outlines of the damages to the dams due to the earthquakes and the acceleration data observed at dam sites.

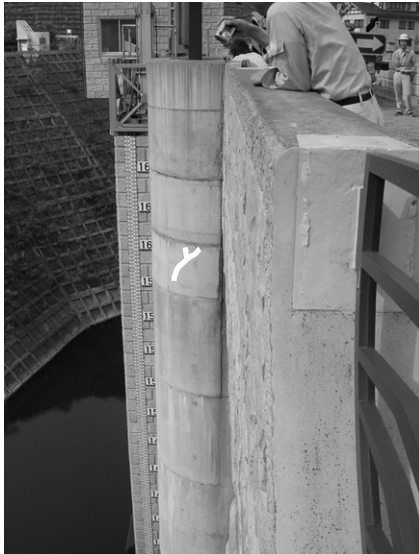
There were fine cracks in five of seven overhangs on the upstream side of the piers of the crest bridge as shown in Photograph 1. And the joints on the crest balustrade and the overhanging part at the same location were opened between 1.0 and 2.5cm as shown in Photograph 2. But these damages did not extend to the dam body section and did not reduce safety.

Photograph 1 Crack on Crest Bridge Pier (Hinata Dam; White line touched up shows location of crack.)

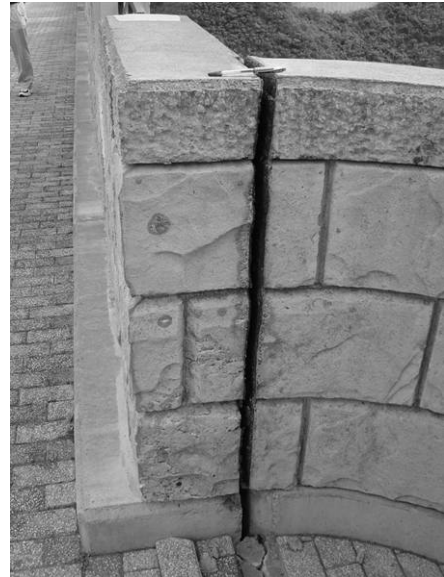
Photograph 2 Opening of Joints on Balustrade (Hinata Dam)

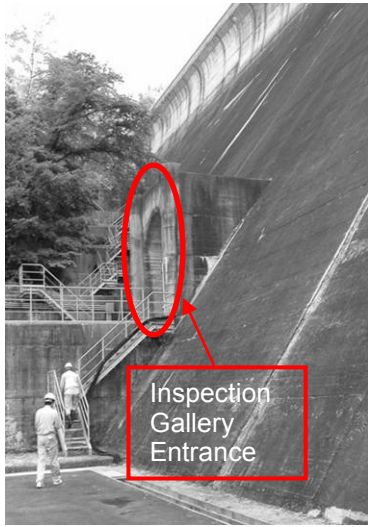
The earthquake damaged crest lighting fixtures and formed fine cracks from the downstream side of the dam body at the entrance to the inspection gallery (Photographs 3 and 4), but these did not reach the dam body section, and so they did not affect the safety of the dam body. Water leaked from displaced packing of an air bleed valve that is a low capacity valve newly installed as part of a facility improvement project that started in 1994 and was completed in 1998, but it had already been repaired by the time the survey team arrived.

Photograph 3 Inspection Gallery Entrance on Right Bank Abutment (Tase Dam)

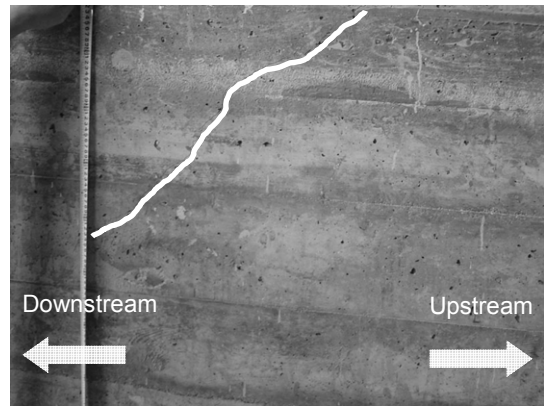
Photograph 4 Cracking at Entrance to Inspection Gallery on Downstream Side (Tase Dam; White line touched up shows location of crack.)

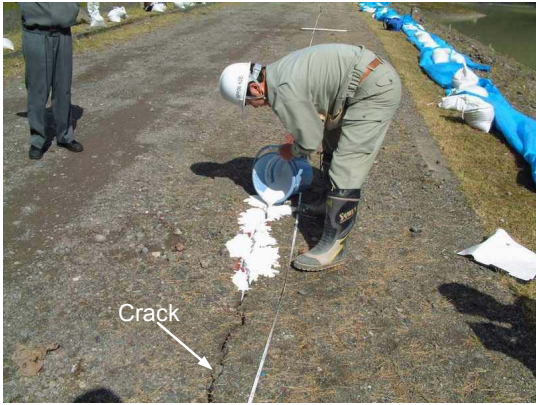
The special inspection after the earthquake found longitudinal cracks parallel to the dam axis at the crest of the dam (Photograph 5). The cracks were up to 160m long in the dam axis direction. The maximum width of the cracks at the surface was 50mm. Accordingly, on the same day, Hokkaido Prefecture that is the dam manager excavated an exploratory pit at the locations of the widest crack to measure the depth of the crack (Photograph 6 and Figure 12). The results confirmed that the cracks remained within the crest protective layer with a thickness of about 90cm without reaching the core zone. The excavated pit was filled in immediately after the survey, and to prevent seepage by rainfall from expanding the cracks to the core, the entire cracked area was covered with impervious sheets (Photograph 7).

Photograph 5 Crack at Crest of Dam (Takami Dam)

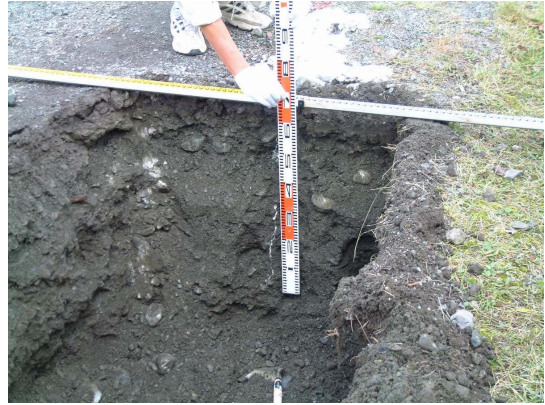
On October 20, a follow-up survey of the crack depth at the crest of the Takami Dam was carried out. The results confirmed that as in the case of the previous survey, none of the cracks extended beyond the protective layer. Accordingly, after October 21, the locations of the cracks inside the protective layer were repaired by backfilling them with identical material (Photograph 8). During the backfilling, density measurements inside the protective layer were done to control compaction so that the density would be the same as that before

Photograph 6 Survey of Crack Depth by Exploratory Pit (Takami Dam)

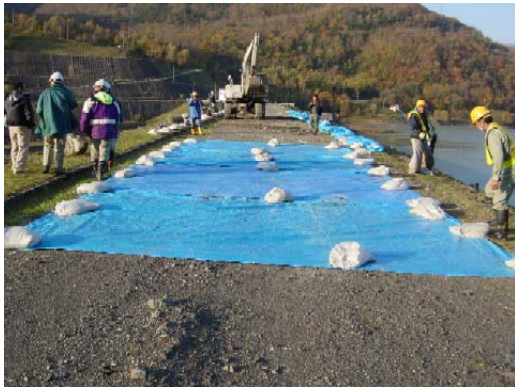
Photograph 7 Protection of Cracks at Crest (Takami Dam)

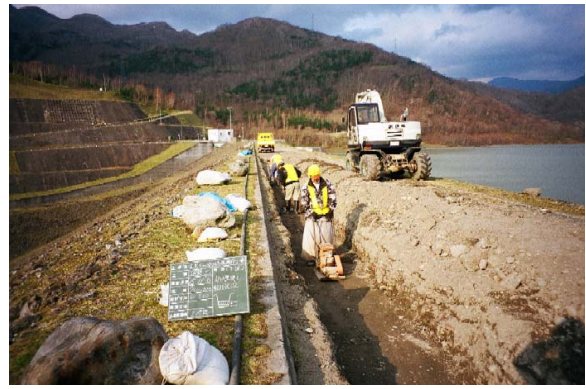
Photograph 8 Repair Work of Crack Locations (View of Excavation) (Takami Dam)

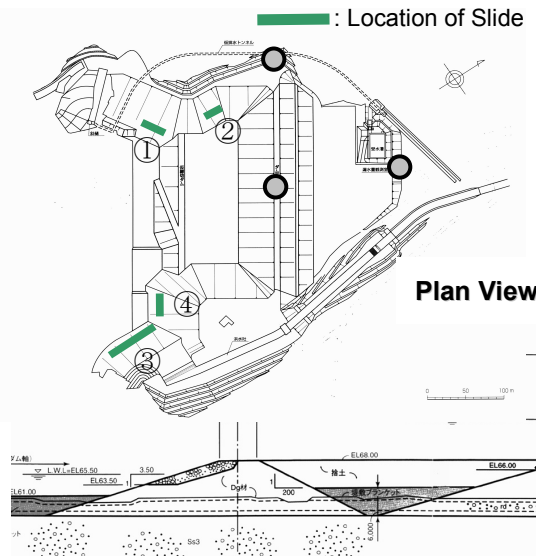
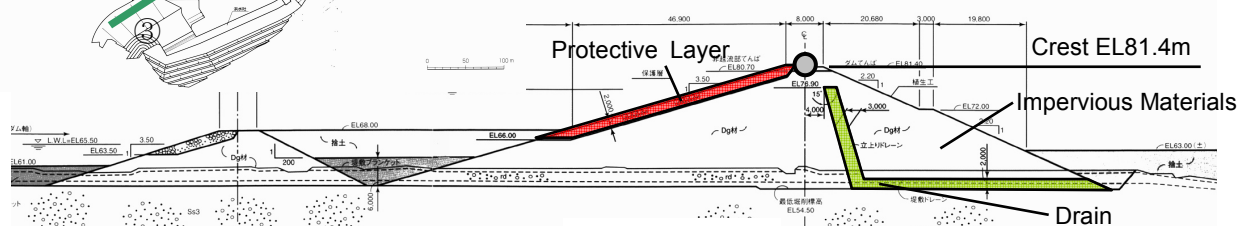
Figure 13 Makubetsu Dam

The sliding of the protective rock layer on the earth blanket placed on the left and right bank slopes of just upstream of the dam body occurred at two locations on the left bank (length (1) 20m, (2) 23m in Figure 13) and two locations on the right bank (length (3) 80m, (4) 30m in Figure 13). The topmost end of the sliding was directly above the water level during the earthquake. The location of the maximum sliding is near the spillway on the right bank side, and the maximum settlement of approximately 90cm was confirmed by the shape of the slope, and a level difference of about 40cm was formed at the top edge of the deformation (Photographs 9 and 10).

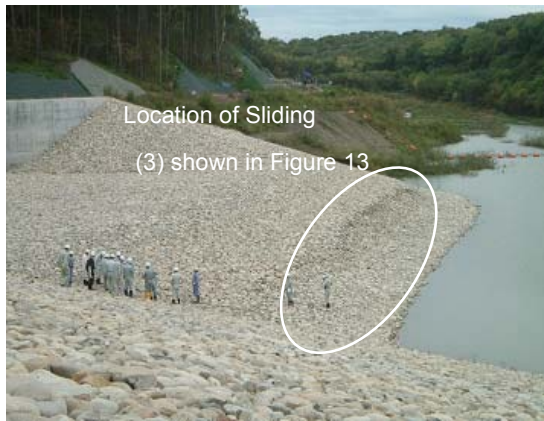
Photograph 9 Sliding of Protective Rock Layer of Makubetsu Dam

After the earthquake, the dam manager performed an excavation survey, confirming that the sliding was limited to the protective rock layer (approximately 2m) and did not extend to the interior of the earth blanket. And the part of the protective rock layer, that became thinner because of the sliding, was thickened by placing more rock materials to temporarily repair the sliding.

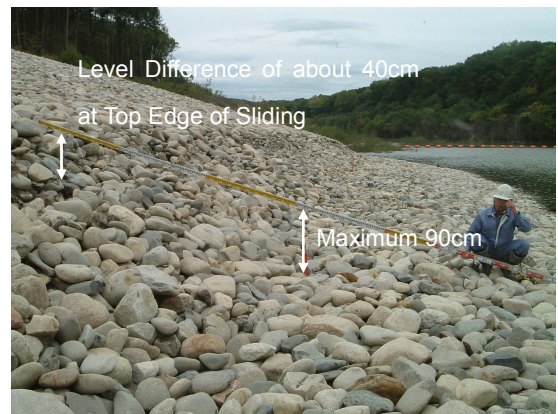
Photograph 10 Sliding of Protective Rock Layer of Makubetsu Dam (Enlargement)
