Report on Damage to Infrastructures by the Mid Niigata Prefecture Earthquake in 2004

NILIM-PWRI Joint Reconnaissance Team for the Mid Niigata Prefecture Earthquake in 2004

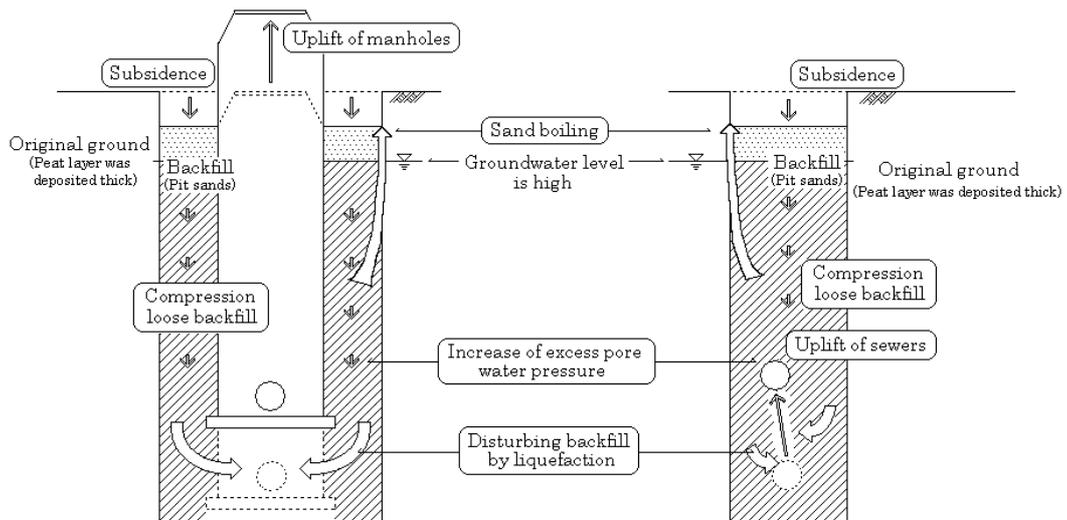
Fig. 14: Mechanisms of typical damage due to liquefaction [6]

Two typical damage types were showed in Photo 3 and Photo 4. The damage of road pavements along backfills of sewers and manholes was found at about 6000 sites. The uplift of manholes was observed at about 1500 sites. The maximum uplift displacement was more than 1m. Similar damage was observed in the 2003 Tohachi-oki Earthquake and the 1993 Kushiro-oki Earthquake, the 1993 Hokkaido Nansei-oki Earthquake. These damaged sites were chiefly distributed in the area where soft clay or peat layer exists. Recent research results indicate that backfill at the damaged sites was liquefied due to the following factors:

Identified mechanisms of typical damage due to liquefaction are illustrated in Fig. 14.

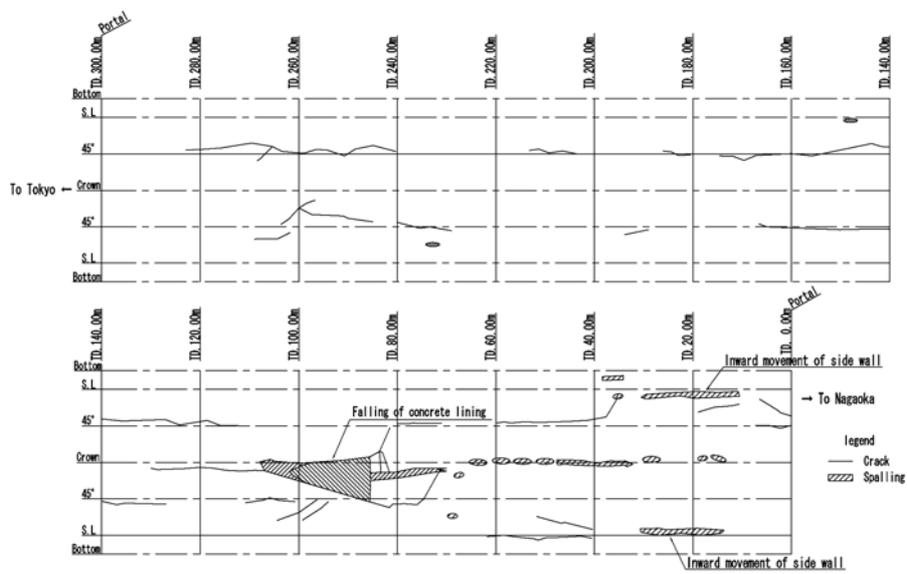
Fig. 19: Locations of crack in tunnel lining on tunnel expansion plan

Locations of crack in the tunnel lining are indicated by gray areas in the tunnel expansion plan (Fig. 19). Spalling of concrete lining from the tunnel crown was observed throughout the length of 100m from the Nagaoka-side portal and large mass of lining (2m wide and 20m long) fell off from the crown at a distance of 100m from the Nagaoka-side portal as shown in Photo 14. Inward movement of side walls, compression failure of the concrete lin-

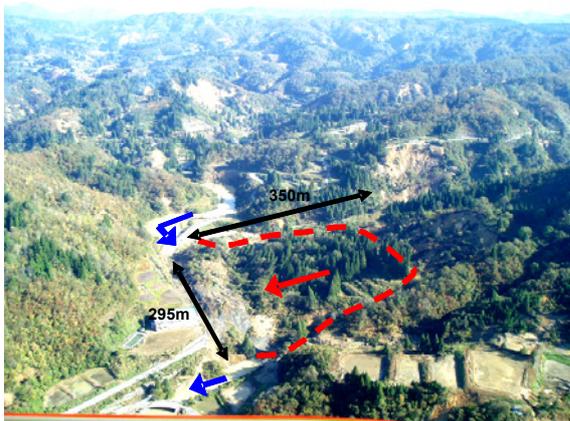
Photo 1 shows the landslide at Higashi-Takezawa. Dimensions of the sliding block were 295 m wide and 350 m long in slope direction. The sliding distance was about 100 m, and the soil mass collided the opposite slope. No sliding occurred at the opposite slope.

It is observed in the topographic map before the earthquake (Fig. 10, together with plan view of the landslide) that the slope inclination of the landslide is mild less than 20 degrees while that of the opposite slope is much steeper. This contrast is associated with the fact that the landslide slope was a dip slope and the opposite slope was a reverse dip.

Slope inclination of outcropped sliding surface was about 20 degrees. Also, the upside slope that was stable during the earthquake had the almost same inclination. In addition, it was observed in the topographic map before the earthquake that there existed slight dips along the perimeter of the sliding mass. These evidences suggest that the landslide was the secondary landslide.

Photo 1: Landslide at Higashi-Takezawa

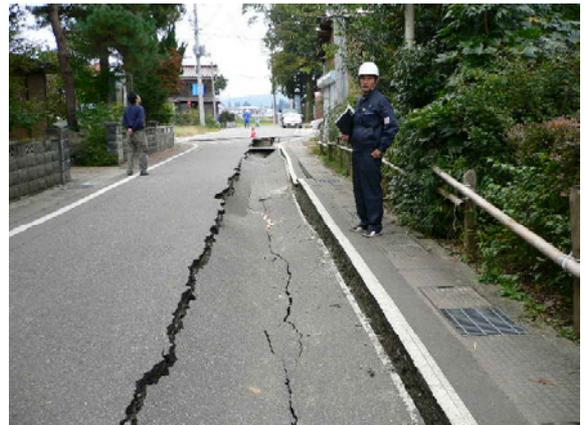
- Groundwater level was high, and backfill was widely saturated.
- Backfill was loosened when earth retaining sheet piles used for excavation were removed

- Backfill was subjected to cyclic shearing during earthquake under almost undrained condition, since excess pore water pressure built by cyclic shearing in the backfill could not dissipate to the surrounding low permeability original ground.

Photo 3: Settlement of road pavement

The Technical Committee for the Restoration of Earthquake Damage to the Sewerage Systems consisting of academic experts was established after the earthquake. The committee proposed three backfilling methods tabulated in Table 3 for the full restoration. Improvements of the backfill are the most effective measures, because most of the damage is caused by the backfill liquefaction. Compaction of the backfill increases liquefaction resistance and decrease uplift displacement of sewer and manhole. Backfill with crushed stone has high water permeability and resists liquefaction. Backfill consisting of cement mixed sand also resists liquefaction strongly.

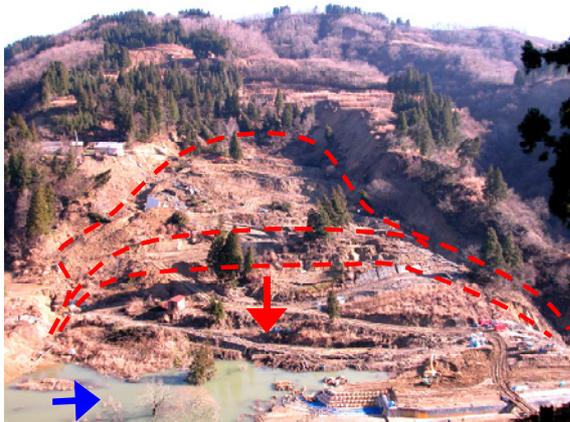
Photo 2, Fig. 12 and Fig. 13 show the landslide at Terano District. Dimensions of the sliding mass were 230 m wide and 360 m long in slope direction. The sliding mass formed a landslide dam and clogged the river flow. Similar to the case at Higashi-Takezawa, the landslide slope was a dip

The sliding mass consisted mainly of brown-coloured sandy soil, and the bedrock was mudstone. A soil sample taken from the sliding mass had a sand content of 90 % (see Fig. 11). The sliding mass consisted of three sub-blocks as indicated in Fig. 12 and Fig. 13. By comparing with the topographic map drawn before the earthquake, this slide was presumed to be the secondary landslide. Many cracks and gaps were formed on the surface of sliding masses. Infiltration of rain and snow melting water from these cracks and gaps might cause further movement of the sliding masses. Therefore, an emergency response was required to prevent the secondary disaster due to the movement.

Photo 2: Landslide at Terano

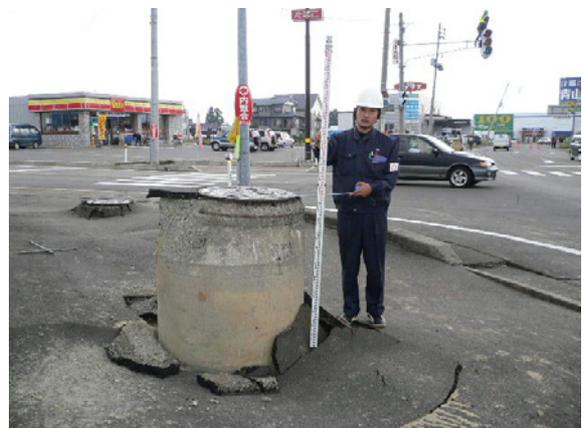
Photo 4: Uplifted manhole

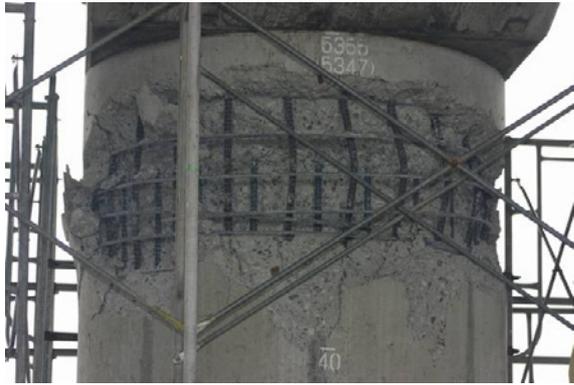
In pier No.5, (1) covering concrete falling off, (2) buckling of main reinforcements, and (3) breakage of main reinforcement lap joints were observed at the point where area of main reinforcement was changed (Photo 5). In pier No.6, diagonal shear cracks and gapping between the covering and reinforcement were found. In the other piers, diagonal and horizontal shear cracks were observed at the top of concrete column. Five upper parts of the shoes on abutment No.2 on down line showed damage in devices that limit excessive displacement. The most severe damage in the shoes was found in those supporting outermost girders.

Photo 5: Damaged RC pier in Shinkumi overpass

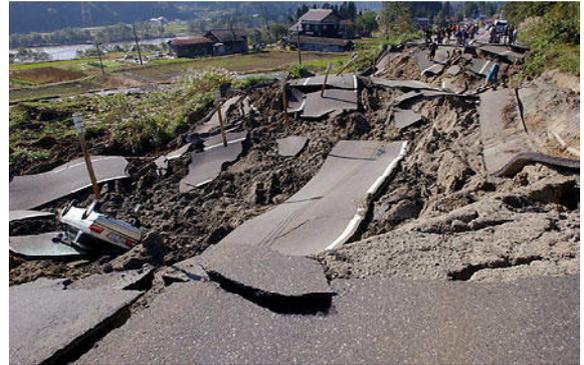
Photo 8 shows sliding failure of the embankment slope at Hosojima of Route No.117. The site conditions and the type of failure are very much similar to the above-mentioned case. Photo 6.3 also shows that the failed soil travelled far away from the embankment toe to the paddy field. The soil was also highly saturated. These evidences indicate that the failure was the flow slide that was induced by liquefaction of fill soils.

Photo 8: Sliding failure of embankment slope at Hosojima in National Road No.117

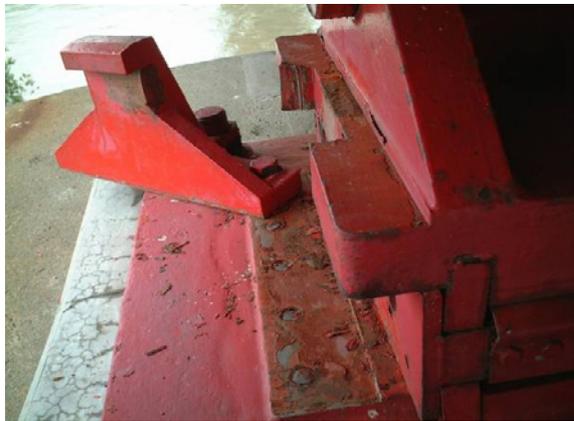
Ojiya Bridge in Route No. 17 crosses over Shinano River. Construction of the bridge was completed in 1982. The superstructure consists of a four-span continuous box girder bridge and a three-span continuous box girder bridge. These are supported by cylindrical reinforced concrete piers on pile foundations through hinged and roller bearings. In the pier supporting the four-span bridge through the hinged bearings, (1) covering concrete falling off, (2) buckling of main reinforcements, (3) breakage of main reinforcement lap joints, and (4) diagonal shear cracks were observed at the top of RC column. Three piers supporting the bridge through the roller bearings showed diagonal and horizontal shear cracks on the upstream side. The other damage found were; (1) breakage of devices limiting excessive displacement for the upper part of the shoe, (2) breakage of side blocks for the lower parts of the shoe (Photo 6), (3) deformation of a bottom flange of the three-span continuous box girder bridge around the hinged bearing, and (4) local buckling and cracks in a stiffener on the shoe.

Photo 6: Failure of side block for shoe in Ojiya Bridge

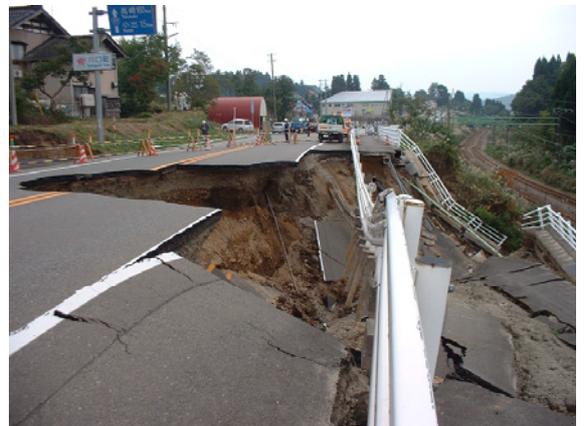
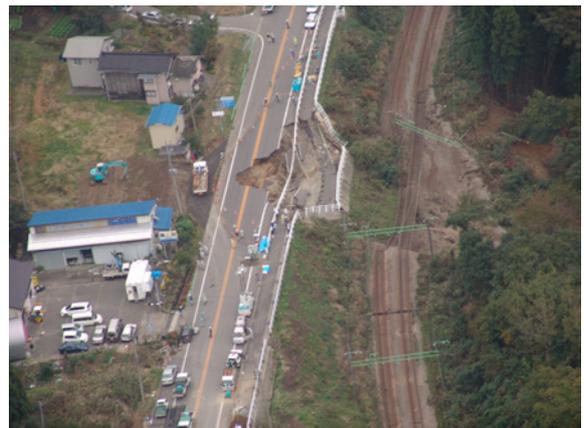
Photo 9 shows the sliding failure at Ten-noh, Route No. 17. An aerial picture of the same site is also shown in Photo 10. The road and railway run along the edge of river terrace of Shinano River. The river runs in the right-hand side of Photo 9 and Photo 10, and the height of the terrace relative to the riverbed is about 40 meters. The average inclination of the terrace slope is about 25 degrees. As can be seen in Photo 6.3, road fill slope and the neighbouring railway fill slope are sliding down as a soil mass. The width of the failure was 56 meters measured at the road shoulder. The base of the sliding was alternation of tertiary sandstone and mudstone overlain by terrace sand gravel. Observation of the scarp immediately after the earthquake showed that the road fill soil composed of gravel and sand was rather dry. However, the bottom layer of the railway fill was wet. Original topography of the damaged site corresponded to a valley, which suggests that underground seepage water tend to accumulate. The mechanism of the failure has not been made clear, but the possible reasons are (1) inertial force acting on the fill on the steep slope caused loss of stability, or (2) the bottom saturated soil of the railway fill liquefied due to the earthquake, triggering slope failure associating with the upside road fill.

Photo 9: Sliding failure at Ten-noh in National Road No.17

Photo 10: Aerial picture of sliding failure at Ten-noh in National Road No.17

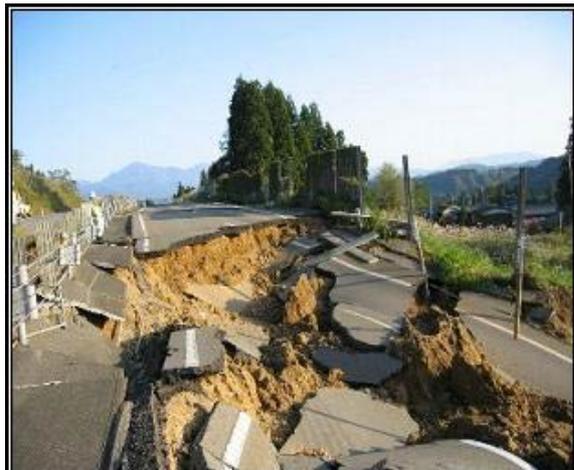
Photo 7 shows sliding failure of the embankment slope at kilopost 215.1 of Kan-etsu Expressway. The road segment was cut-and-bank (a cut slope on the left-hand side of the photo, and embankment slope on the right-hand side). The failed soil block corresponds to the fill material. It was observed that the soil at the bottom of the failed soil was very

wet and almost saturated. Therefore, it is presumed that the bottom part of the fill was saturated with seepage water at the time of earthquake, and the soil was liquefied to have induced sliding failure.

Photo 7: Sliding failure of embankment slope at 215.1kp in Kan-etsu Expressway

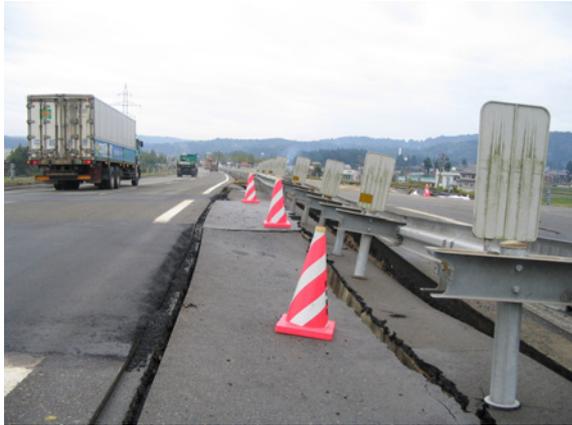
alluvium. The foundation soil in the area is generally soft clay with relatively thin sand layer. There are many box culverts underpassing the embankment to connect rural roads. The embankment slumped about 20 to 50 cm, and level difference was formed on the pavement at many locations where the culverts exist, as shown in Photo 11. The settlement of the embankment associated with the lateral spread, i.e., the embankment moved outward. The culverts displaced outward probably with drag force from the embankment, and consequently the joints between segments of culverts opened. The opening amounted to 30 cm and the surrounding embankment soil spilled down into the culverts (see Photo 12). However, no crack was observed in the culverts.

Photo 11: Differential settlement due to underpassing box culvert in Kan-etsu Expressway (near Ojiya IC)

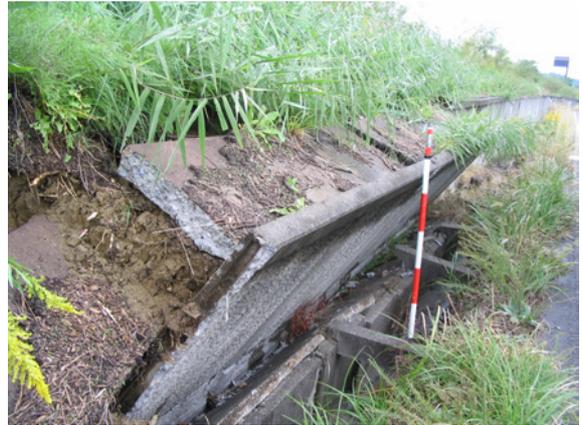
Retaining walls were also damaged. Photo 13 shows damaged L-shaped concrete retaining walls that support toe of road embankment of Kan-etsu expressway. The retaining walls with a height of 1.2 meters rotated forward with about 30 degrees. Some retaining walls collapsed at the bottom of the vertical wall. The retaining walls were pre-cast and no seismic design was considered. It would be interesting to investigate a wide variety of damage ranging from small distortion to collapse of vertical wall that took place in close vicinity.

Photo 13: Damaged L-shaped concrete retaining walls supporting toe of road embankment of Kan-etsu expressway

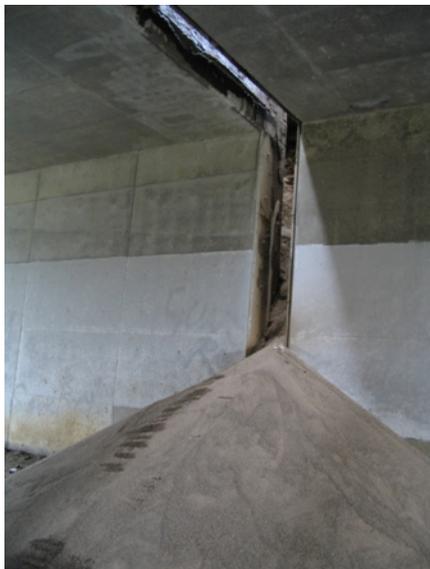
Photo 12: Opening of box culvert (near Ojiya IC)

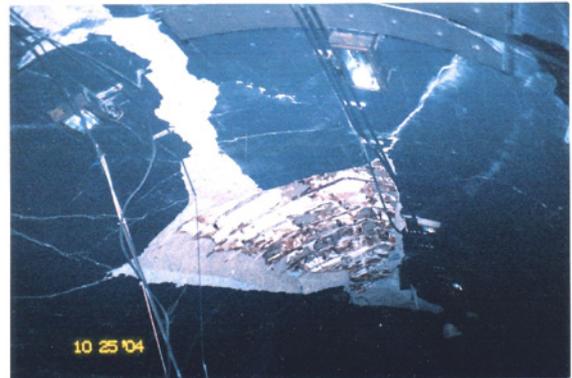
Photo 14: Large mass of concrete lining fell off from the tunnel crown

For temporary repair, (1) voids were filled with concrete, and (2) placement of steel supports and shotcrete was made. For permanent repair, the concrete lining was placed inside the temporal tunnel supports.

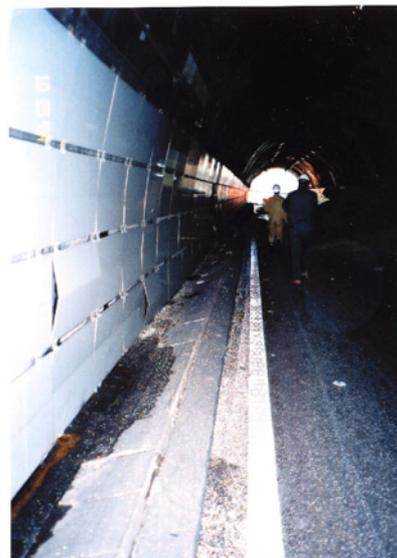
ing at springline, and deformation of a lateral groove (Photo 15) were also observed. Outside the tunnel, slope deformation and overturning of a retaining wall were found just above the Nagaoka-side portal.

Photo 15: Deformation of lateral groove
