# Outline of Reconnaissance Report of Damage of Building During the Mid Niigata Prefecture Earthquake in 2004

NILIM-BRI Joint Reconnaissance Team of Damage of Buildings\*

## ABSTRACT

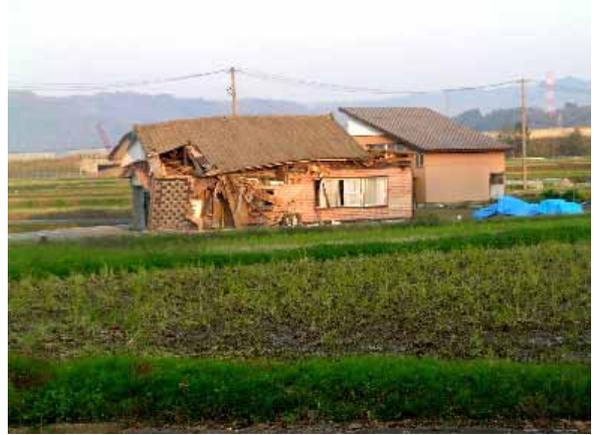
It seemed that the collapse often occurred for the slight buildings such as the barn and the workshop in which the consideration of seismic performance is scarce (Photo 1), or the buildings which were built in traditional construction method. On the other hand, the 2nd story collapse, which is so far supposed to be little in the earthquake damage of wooden houses, was observed at Wanazu in Kawaguchi-machi and Higashi-yoshitani in Odiya-shi (Photo 2).

Photo 2 Collapse of 2nd Story in House

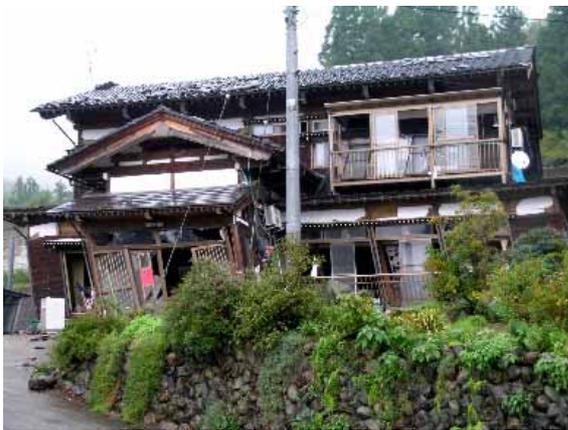
Photo 3 Damage of Traditional House

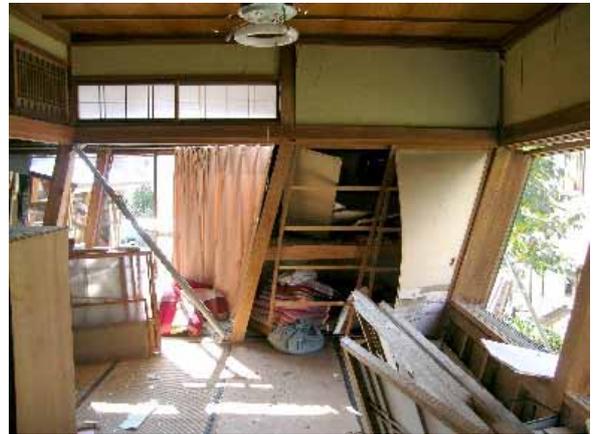
For the houses of the traditional construction method, the main seismic resisting elements are considered to be shear resistance of clay walls and bending resistance of posts with suspended wall. However, much damage of the bending rupture of posts was observed in the houses of traditional construction during the earthquake (Photos 3 and 4). The thickness of the post was usually about 120 mm and it seems insufficient as a bending element.

Photo 4 Bending Rapture of Posts

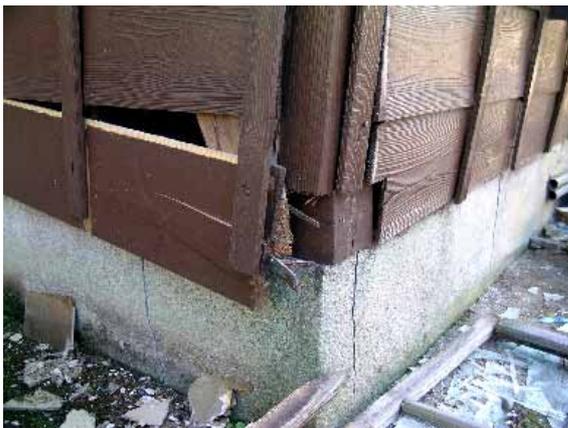
Photo 5 Joint Failure at Brace End

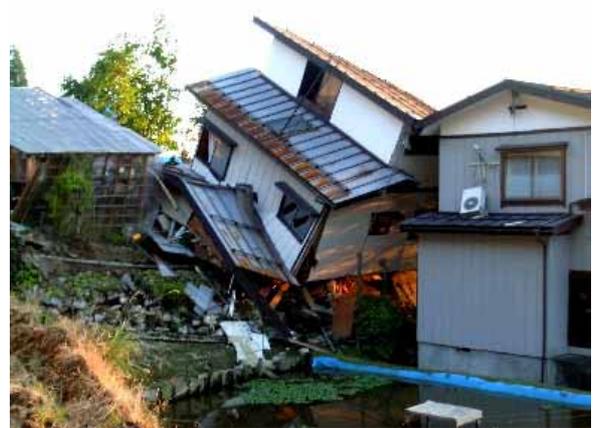
Damage of houses with recent construction method is rather slight. But, in case when damages of ground occurred, the damages of the foundation and sometimes damages of the frame structures occurred. In the mountainous areas, the houses were suffered from damage of prepared housing sites such as the landslide (Photo 6).

Photo 6 Collapse due to Landslide

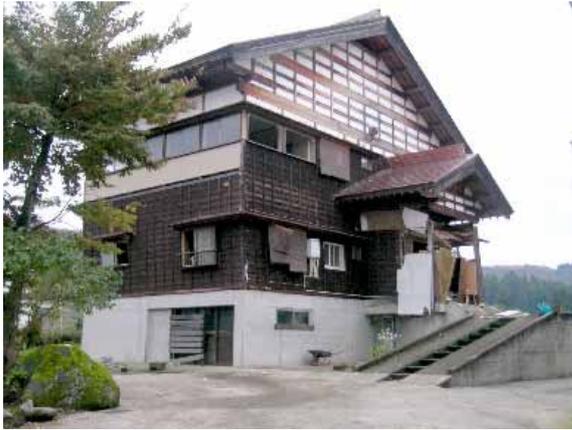
As the damaged area is a heavy snowfall area, wooden houses often have a foundation with large height (high foundation) for the convenience in snow season. As a whole, the damage of the wooden houses with RC high foundation is slight. It is reasonable to think it is because most of them were rather recently constructed and they have sufficient shear walls in the upper wooden story. When the seismic element is not sufficient in the wooden story, such houses with high foundation also were damaged heavily (Photo 7).

Photo 7 Damage of House with RC High Foundation

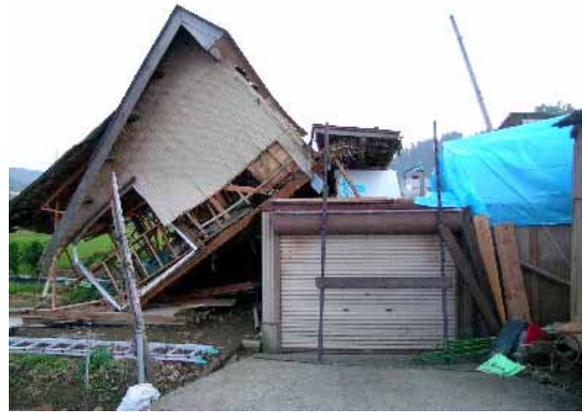
One example in Higashi-yoshitani was observed that upper wooden story on the RC high foundation completely collapsed, but the structural details are obscure (Photo 8). On the other hand, there are some cases that the RC high foundation was damaged due to site ground failure (Photo 9).

Photo 8 Collapse of House with RC High Foundation

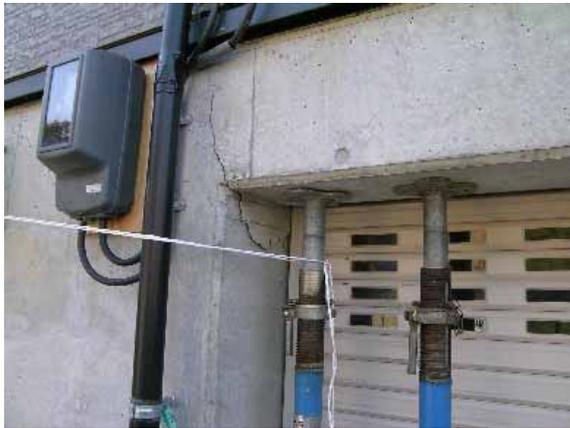
Photo 9 Damage of RC High Foundation due to Damage of ground Site

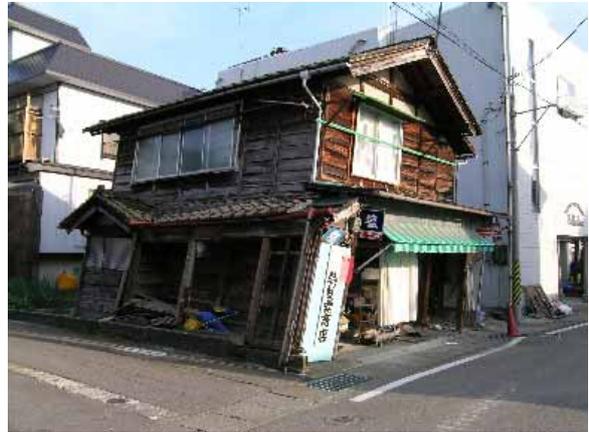
There are many damaged buildings for dwellings with shop. They usually have a large opening facing to the road, and it tends to cause insufficient amount of shear walls and eccentricity, regardless of whether construction method is traditional or recent (Photo 10).

Photo 10 Damage of Dwelling with Shop

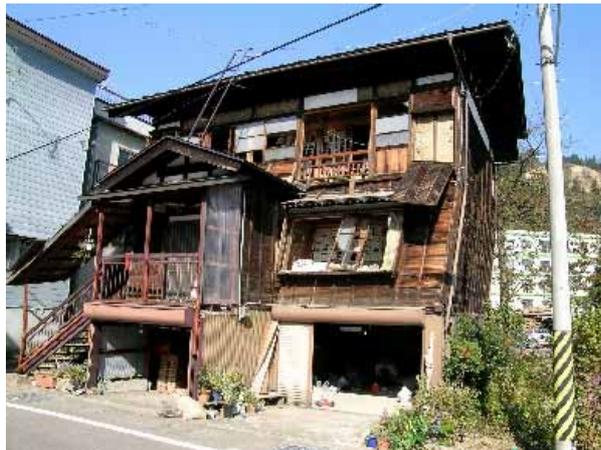
The second story in a three-storied house with the 1st story of steel structure was heavily damaged (Photo 11). This house was originally two-storied wooden house and later jacked up on the new first story of steel structure. The upper part is made by traditional construction method with less seismic resisting elements.

Photo 11 Damage of Three-storied House with 1st Story of Steel Structure

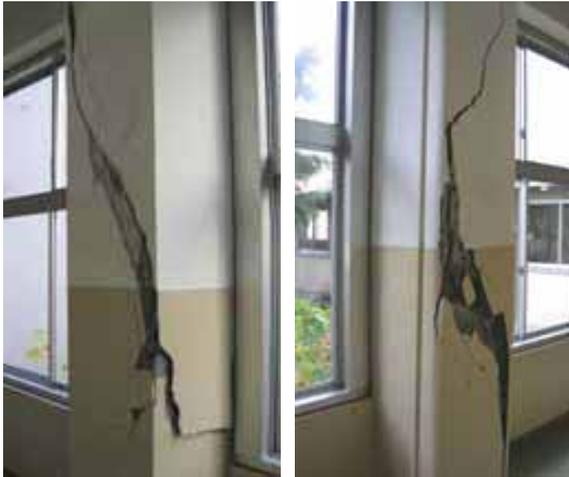
The shear failure of short columns with hanging and standing walls (Photo 12) and shear cracks were observed. On the first floor of the building for special classrooms, the shear failure was observed in not only short columns but columns

Photo 12 Shear failure of short columns (Inside)

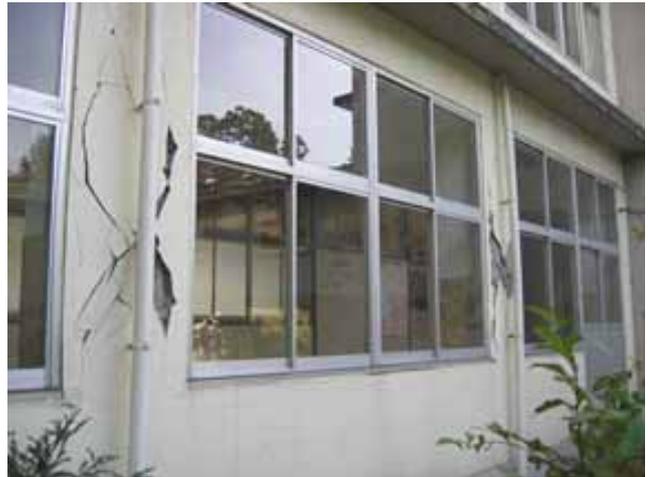
Photo 13 Shear failure of short columns (outside)

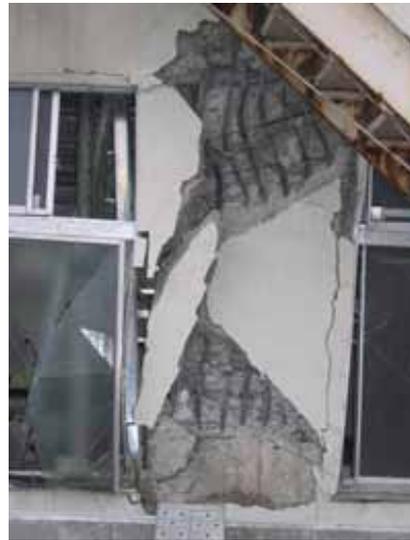
Photo 15 Shear Failure of Short Column

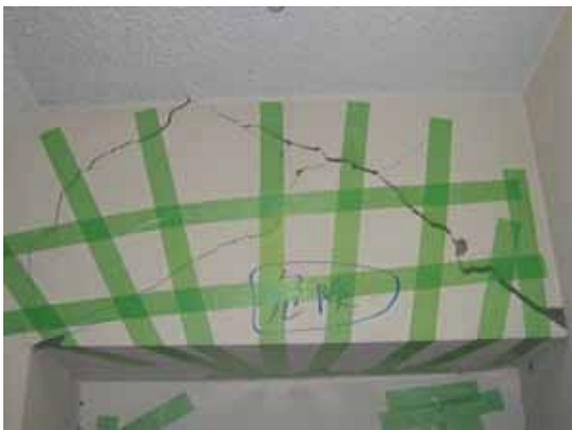
Photo 16 Shear Failure of Short Span Beam

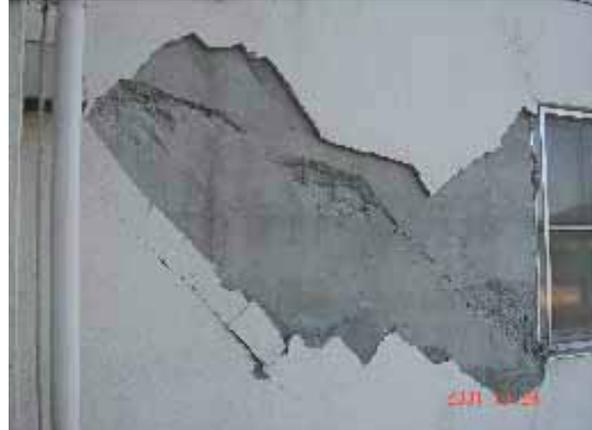
Photo 17 Damage of Nonstructural Wall

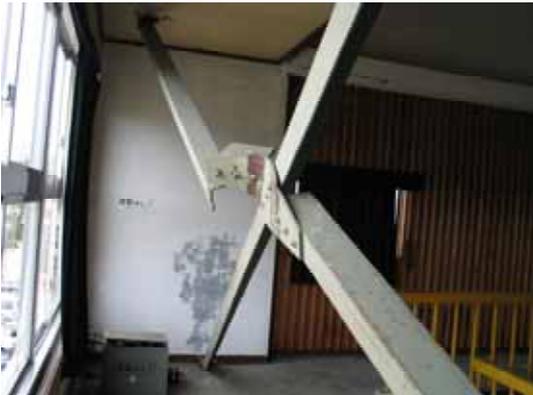
as shown in Photos 18 and 19 were observed. Fractures of bolts and welding parts at the brace connection as shown in Photos 20 and 21 were also observed. As the other structural damages, fracture and buckling of roof horizontal brace, fracture of bolts at column base (Photo 22), fracture of stud base (Photo 23) and floor settlement were observed.

Photo 18 Fracture of Brace at Bolt Connection

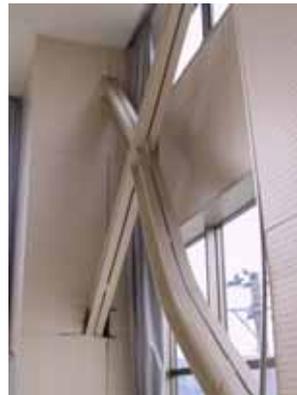
Photo 19 Buckling of Brace

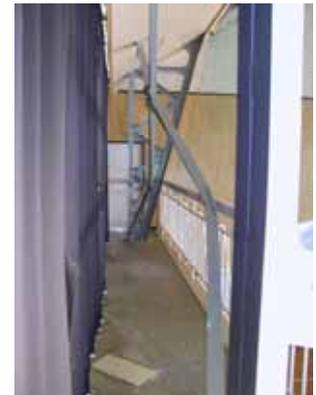
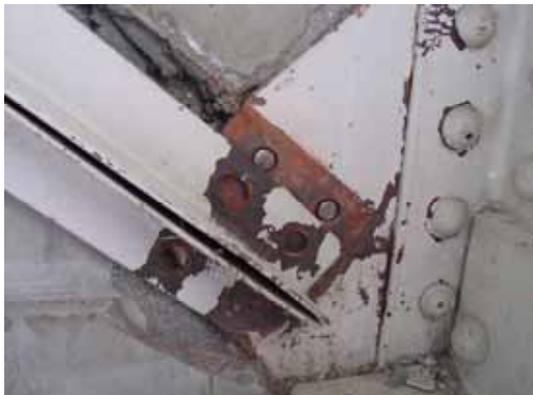
Photo 20 Fracture of Bolts at Brace Connection

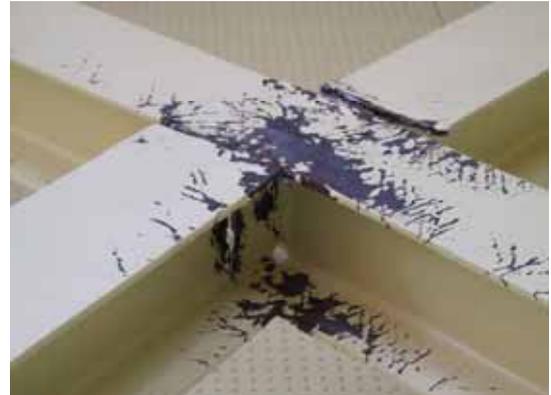
Photo 21 Fracture of Welding Connection

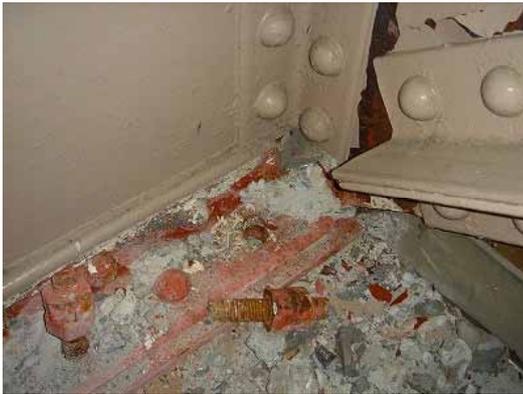
Photo 22 Fracture of Bolts at Column Base

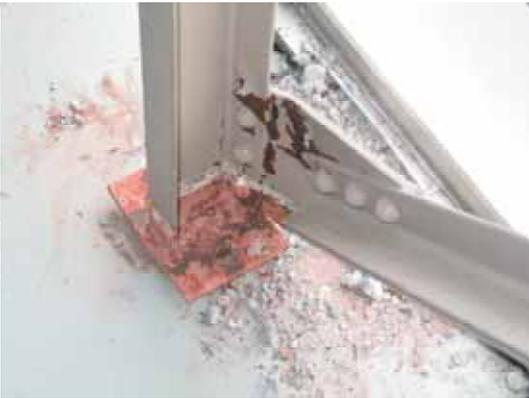
Photo 23 Fracture of Stud Base

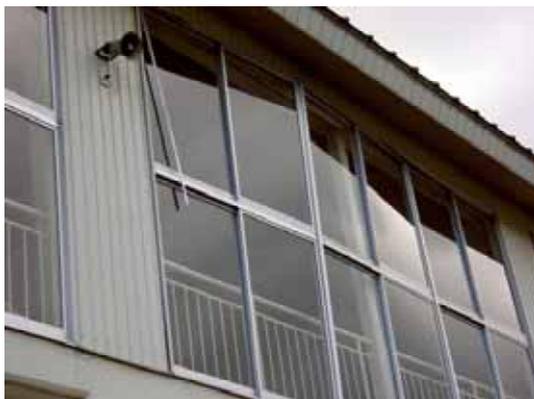
Damages of window sashes and glasses were observed in some gymnasiums as shown in Photos 24 and 25. Damages of falling down of transverse interior wall were observed (Photo 26). Damages of falling down of some ceiling boards were also observed (Photo 27). Damages of falling down of roof board were not observed (Photo 28). Damages of falling down of ceiling board were not observed in the seismic retrofitting gymnasiums (Photo 29).

Photo 24 Damage of Window Sash

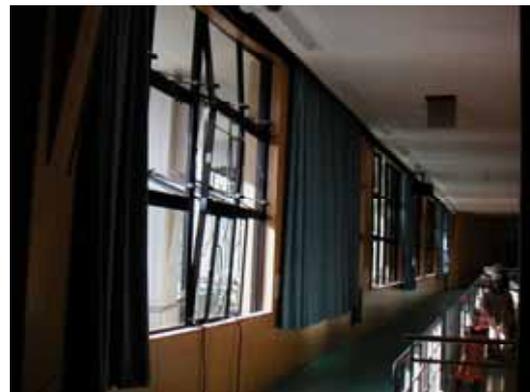
Photo 25 Damage of Window Sash

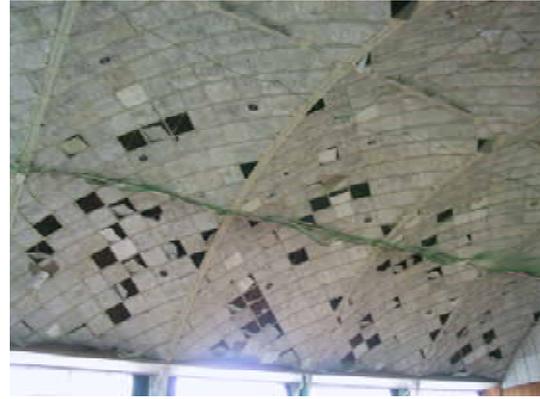
Photo 27 Dropped Ceiling Board

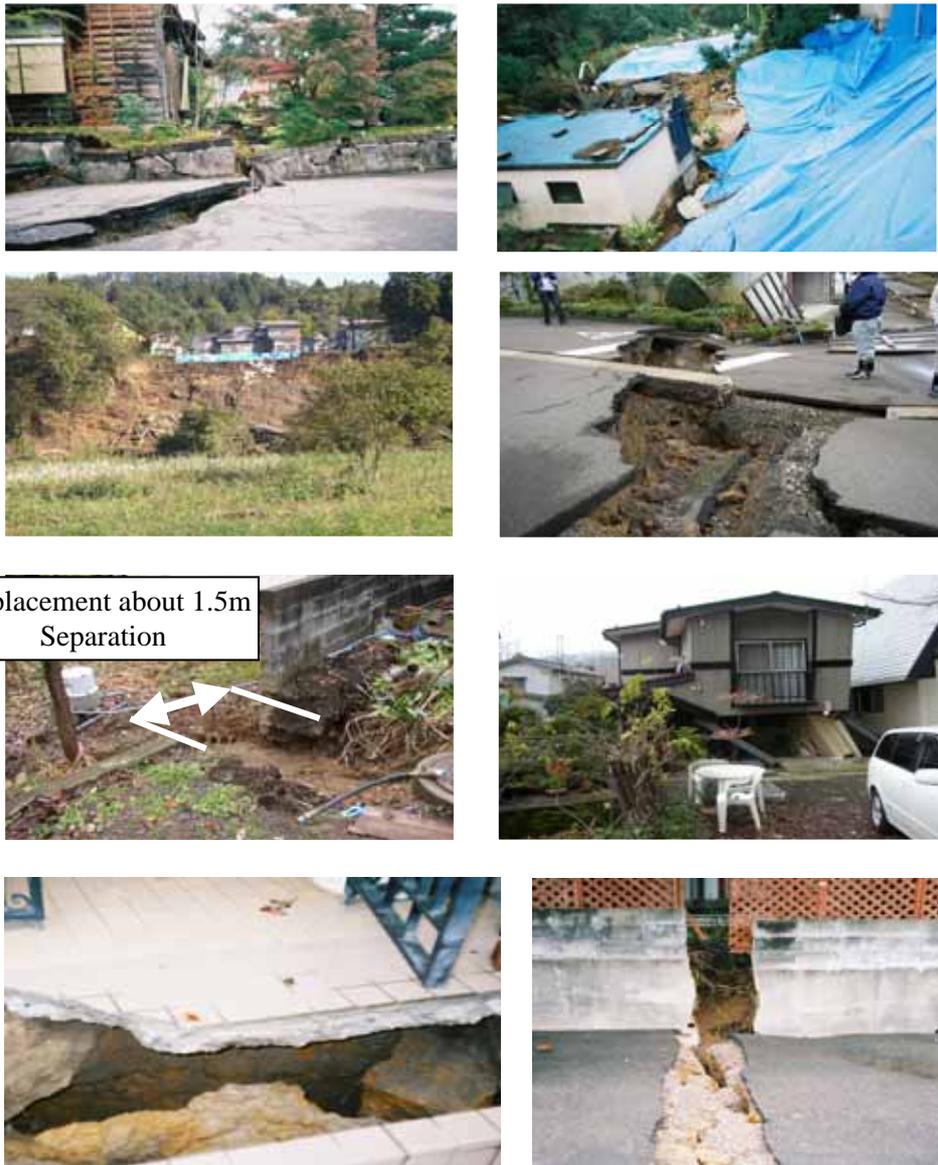
In the Mid Niigata Prefecture earthquake, a lot of landslides and failure of retaining walls on slope ground occurred. Damages that grounds were separated and foundations were broken by the collapse of the slope were observed, as

shown in Photo 30. The severe earthquake motion and the influence of the rainfall to the ground are considered to be the causes of damages.

Photo 30 Damage Examples (Landslide, Ground Crack)

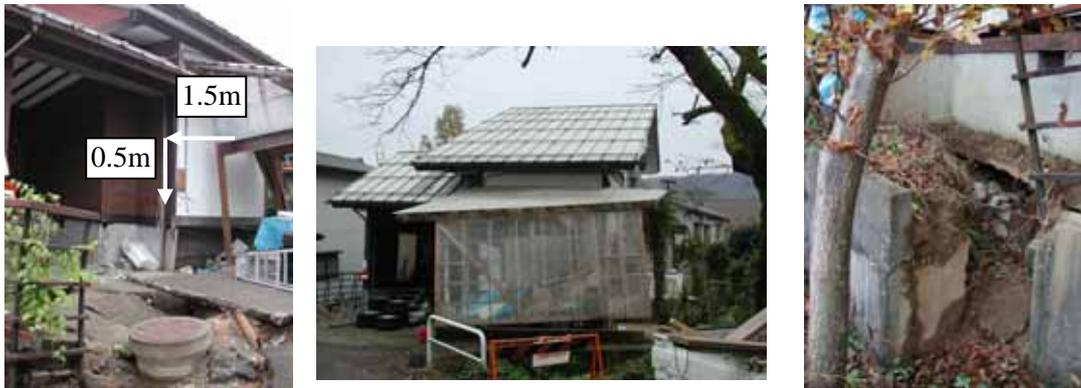
Photo 31 shows the damage situation of the house in the upper part of the slope. The horizontal and vertical displacements were about 1.5m and 0.5m due to slope failure, and the house has settled. The concrete retaining walls in the backyard on the slope were split with

Photo 31 Damage Situation  
(Upper Part of Slope, Youkyutyou in Nagaoka-shi)

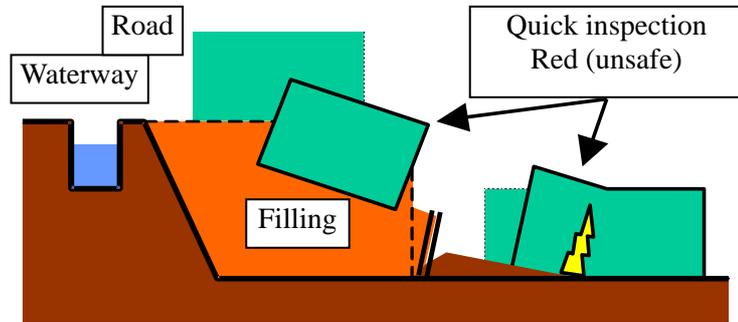
Figure 12 and Photo 32 are the damage situations of the house under the slope. The house on the lower part was pushed along the landslide, and the continuous footing in the house was distorted with 0.5m or more, and several places in the house were broken.

Fig. 12 Damage Situation  
(Youkyutyou in Nagaoka-shi)

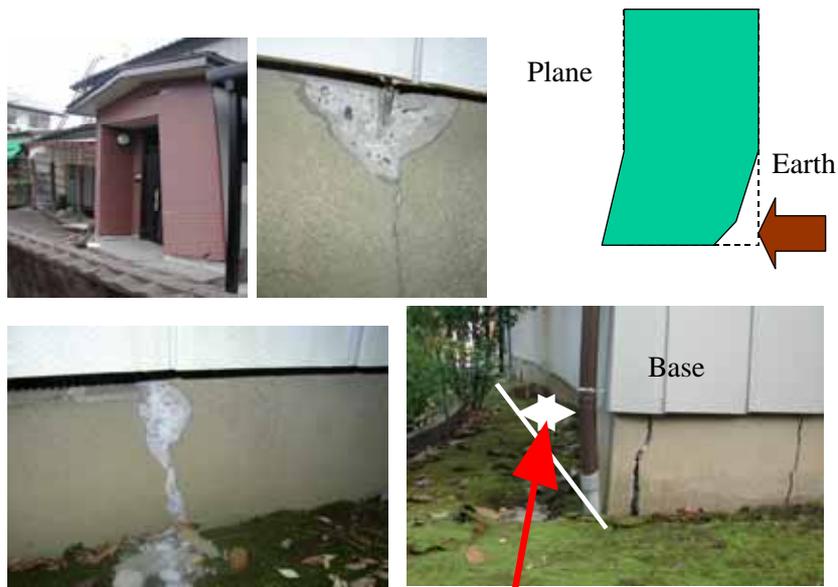
Photo 32 Damage situation  
(Under part of slope, Youkyu-cho, Nagaoka-shi)

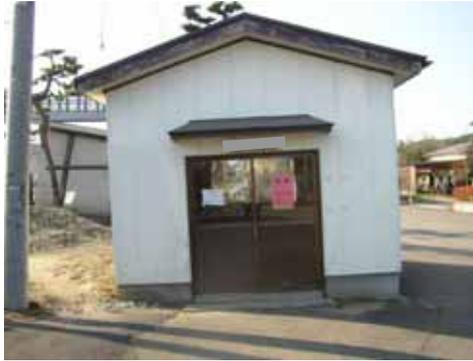
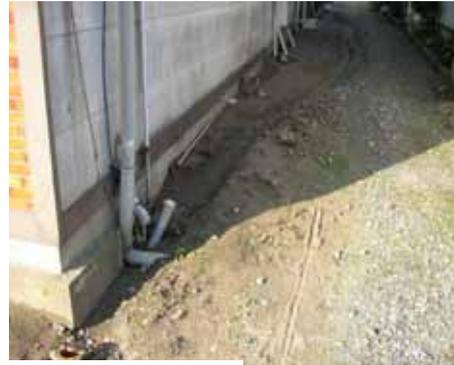
Photos 33 and 34 show the damage situations in Kariwa-village and Nagaoka-shi. The concrete slab was destroyed by a partial upheaval of the ground due to liquefaction. The house was inclined greatly. There was a steel building with three stories whose differential settlement was about 30cm.

Photo 33 Damage Situation  
(Liquefaction, Kariwa-village)

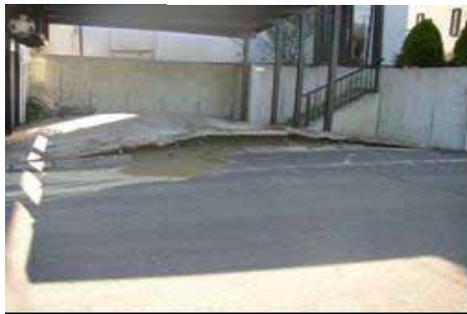
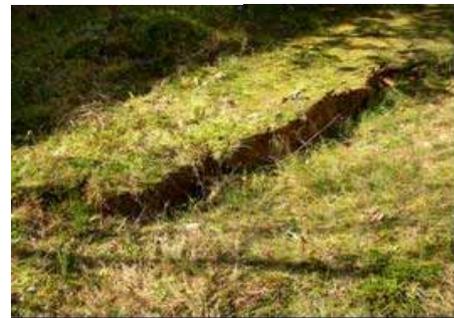
Photo 34 Damage Situation  
(Liquefaction, Nagaoka-shi)

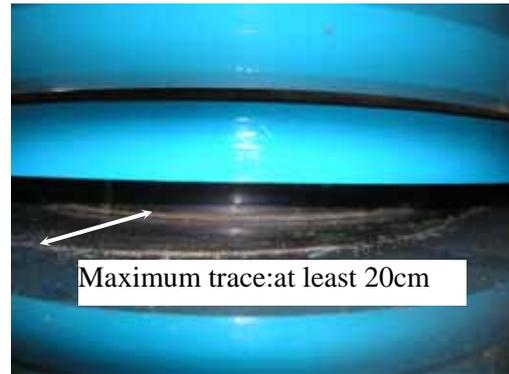
The arrangement of isolators in the building A is shown in Fig. 13. The isolated layer is consisted of 21 sliding bearings and 18 natural rubber bearings. After the earthquake, it was observed that the sliding trace was left on sliding plates and the residual deformation of the rubber bearings was kept. It is estimated that the isolated layer had at least 20 cm displacement as shown in Photo 35. The residual deformation of rubber bearings was 3 cm as shown in Photo 36.

Photo 35 Sliding Trace of Sliding Plate

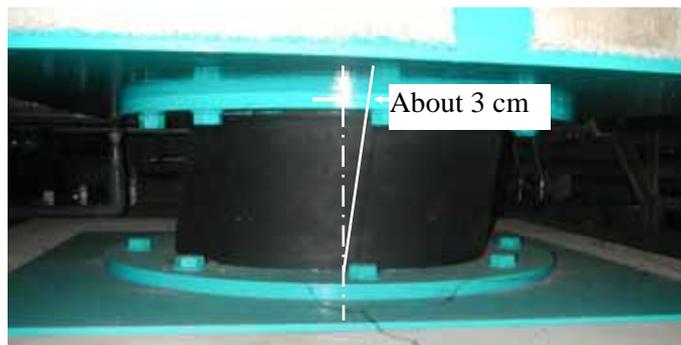
Photo 36 Residual Deformation of Rubber Bearing

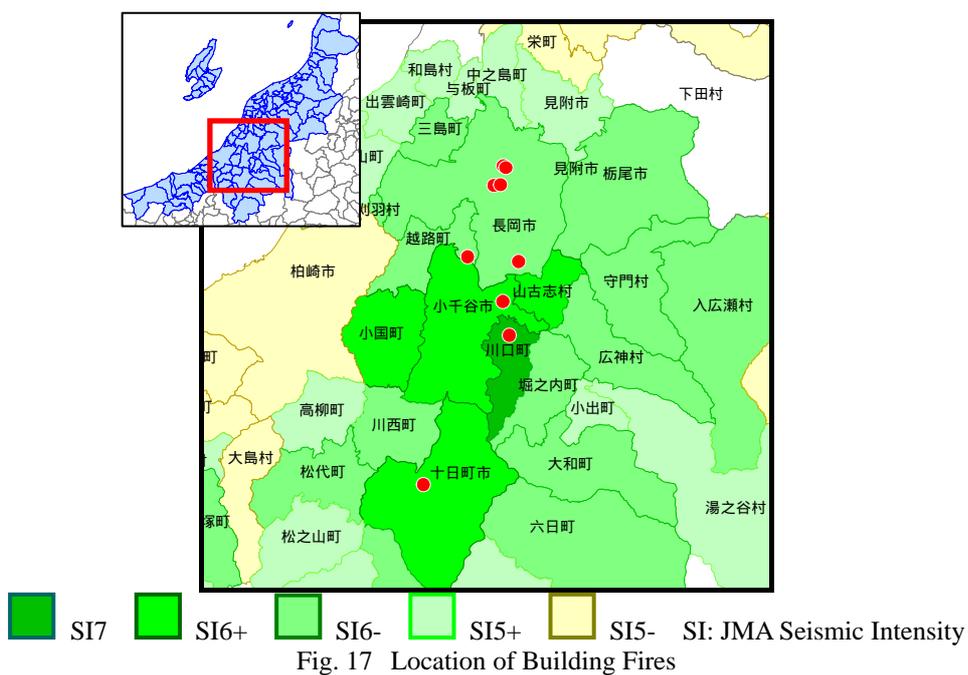
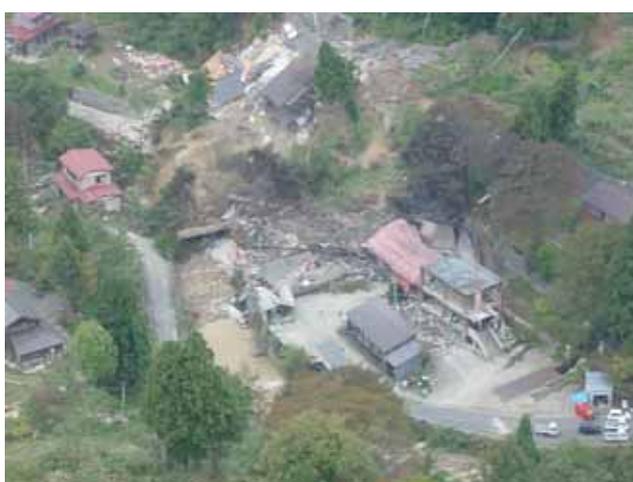
Photo 39 Site of Nigorisawa Fire and Landslide (Six Buildings Burnt Down)

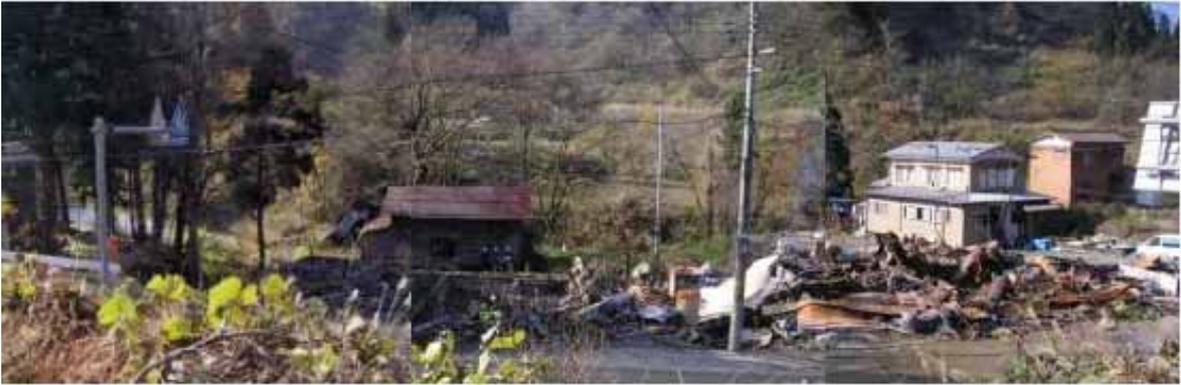
Photo 40 Site of Iwamagi Dwelling Fire (Two Building Burnt Down)

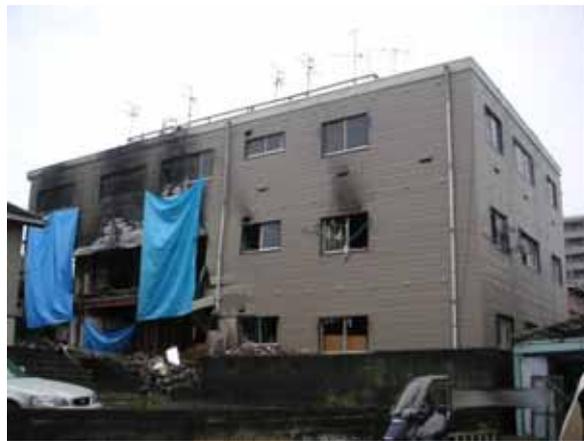
The two gas explosions happened by leaking at gas

pipes in the buildings, not gas ovens or gas fittings, as shown in Photo 41. The mainshock was occurred just time for cooking dinners by using gas ranges. Many people got scald, but no fires occurred by the gas fittings. It is assumed that gas leak and fires were prevented, because microcomputer-controlled gas meters for assurance of safety by automatic shut-off were installed nearly 100% in dwellings of the service area.

Photo 41 Site of Sen-ju Three Story Apartment House Fire
