High Wind Damage to Buildings Caused by Typhoon in 2004

Yasuo Okuda¹, Yukio Tamura², Hiroaki Nishimura³, Hitomitsu Kikitsu¹ and Hisashi Okada¹

ABSTRACT

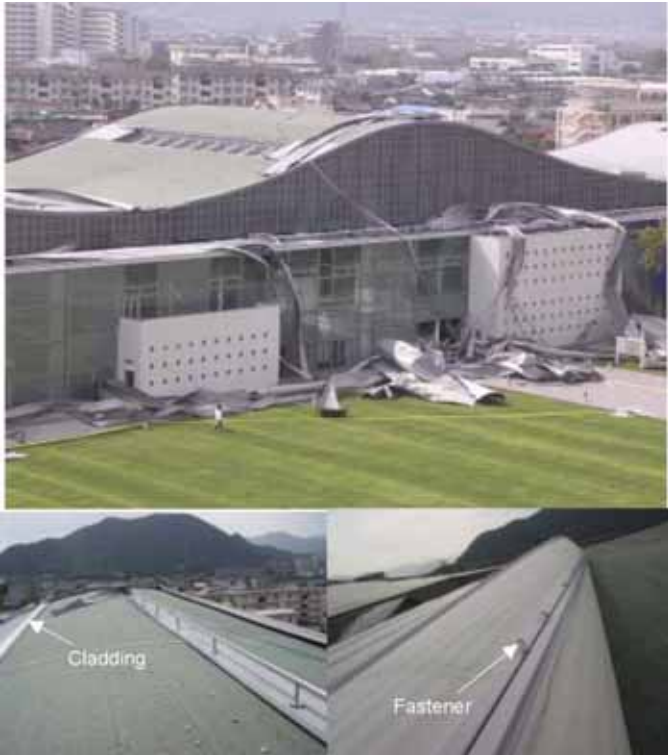
Fig.1 Failure of Roofing Materials of YCAM due to Typhoon 0418

Public facility named Yamaguchi Center for Arts and Media (YCAM) at Yamaguchi Prefecture in the southwestern part of Japan is a new building constructed in March, 2003. The main structure is steel frame with metal roof system which has a unique shape expressing three big waves. The roofing materials cover the roof with the length of 170m and the width of 30m. About half of the whole roofing materials were blown off due to high wind of Typhoon 0418 in September 7, 2004. Maximum 10 minutes mean wind speed of 24.4m/s and maximum instantaneous wind speed of 50.5m/s were observed at the local meteorological observatory. Fig.1 shows the failure observed in YCAM.

As a typical failure, lots of screws were observed to be pulled off from wood-wool cement board located on the edge of roof. On the other hand, screws attached to mortar slab at the center part of roof were tone. It is considered that the failure of roofing materials started from the edge of roof, and then they were subjected to increasing wind force and peeled from the roof one after another. A team of storm investigators concluded that the main cause of the failure is inadequate estimation of the design wind loads and the use of fasten materials whose strength is inadequate. The design wind load was evaluated using a wind force coefficient for a typical

semi-cylindrical roof such as sports gymnasiums. Furthermore, it is found that the wind force could be increased by backpressure of roofing materials through under machinery space.

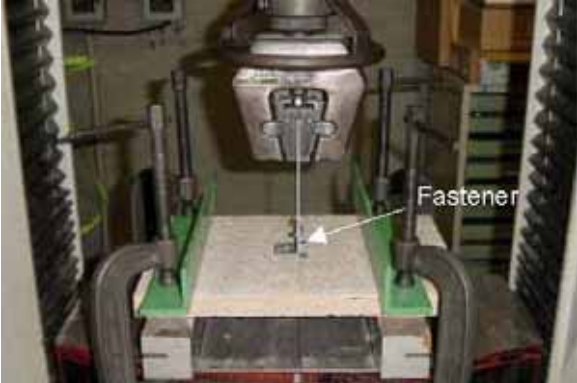
Fig.2 Tensile Test for the Fastener of YCAM

Based on a number of tests to certify the strength of fastener as shown in Fig.2, it was found that the dispersion of the strength of fastener is larger than we expected. Some of them have the value less than the permitted strength of the fastener. It is also found, furthermore, that a remarkable strength reduction in the fastener may be appeared by the stretch of metal roof for daily heat fluctuation suffered by sunshine. Subsequently, the renovation of roof just after damage was assured to satisfy the wind design load considering a sufficient safety margin based on the research results including the wind tunnel experimental result.

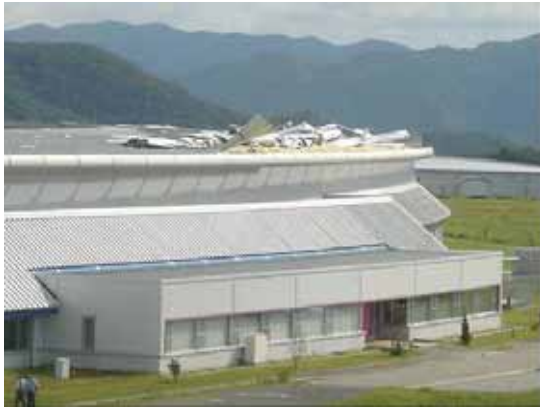
Fig.3 Failure of the roof of SPring 8

The roof of a large-scale experimental facility named SPring-8 was damaged by two Typhoons 0416 (August 30, 2004) and 0418 (September 7, 2004). Fig.3 shows the damage of its roof. The plan of the building is donut-shaped. It is approximately 1,500m in circumference and 30m in width and was constructed in 1997. The roof system consists of two-layer folded steel plates and with thermal insulating materials between them, and the gorge and ridge lines of the folded plates are in the radial direction. The southern part of the roofing material was damaged over an area 270m long-by-10m wide by typhoon 0416, and the eastern part of the roofing material was damaged over an area 100m long-by-10m wide by typhoon 0418.

According to the precise post-disaster investigations, the main cause of the damage was attributed to the fatigue effect on the bolts connecting the roof system to the tight frames due to daily solar heating effects on the upper layer. Fig.4 shows the fracture surface of damaged bolt. Striations and dimples are both observed in the fracture surface of it. Striations are basically observed in fatigue fracture surfaces caused by repeated loads, and dimples are generally observed in the normal fracture surfaces caused by tensile loads. Dimples also took place on the center with striations on both sides.

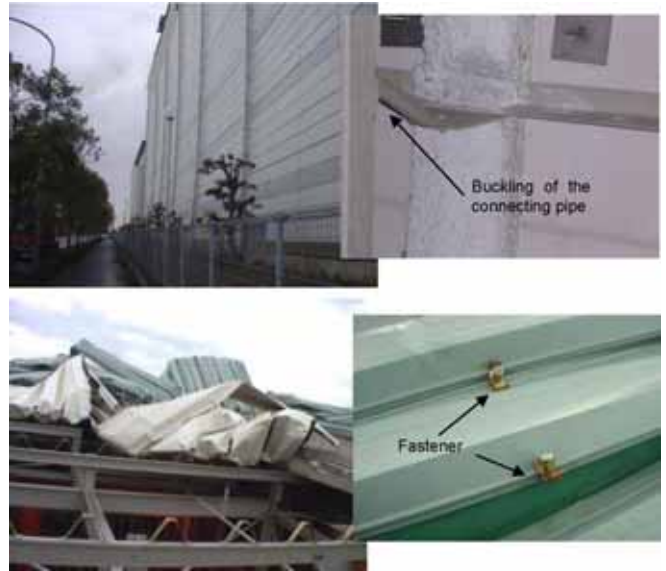
Fig.5 Failure of Large-scale Warehouse at Kobe

A large-scale commercial warehouse at Kobe was damaged due to high wind by Typhoon 0423 in September 27, 2004. The size of this building is 70m in width, 40m in depth and 30m in height. The wall was caved in and the roof was severely damaged due to strong wind pressures as shown in Fig.5. Many stocked goods resulted in suffering heavy losses by water intrusion.

The wall made of ALC (Autoclaved Light-weight Concrete) board, which was supported by light steel frame, was connected to solid rack in the building. The buckling of the connecting steel pipe which seems to have insufficient strength caused this failure. The roof system of a double metal roof deck filled with insulation glass wool was adopted. On this roof system, remarkable differences in temperature

arise between the upper and the lower deck by incident sunshine on the roof. The repeated occurrence of significant difference in stretch of decks affected by fluctuation of temperature may cause the metal fatigue in bolts fastened between the upper and the lower deck.

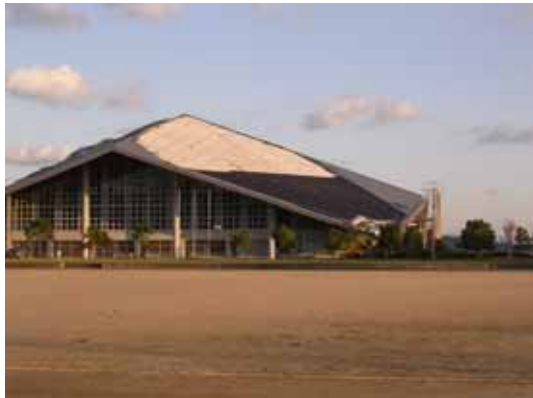
Fig.6 Failure of Public Gymnasium

Okawa Taiikukan is a public gymnasium with ridged roof covered by metal roofing material located at Shikoku in southwestern part of Japan. This building was damaged three times in a year by Typhoons 0406, 0410 and 0423. At first, a quarter of roofing materials were blown off during Typhoon 0406. Subsequently, a few and a half cladding got blown off when Typhoon 0410 and 0423 were passing, respectively. Observed wind speeds were relatively small, i.e. the maximum instantaneous speed of 28.4m/s in Typhoon 0406 and 26.9m/s in Typhoon 0423, respectively. Fig.6 shows the failure of the gymnasium by Typhoon 0423.

Metal roofing materials were fixed to ALC board by using an aluminum anchor that spreads itself two wards inside the ALC board to resist against pulling force. The roofing materials, however, were damaged when high wind attacked to the building. It was observed that lots of anchors were broken without pulled off from the board. It suggests that somewhat

substantial trouble in anchors occurred, which may be affected by an influence of temperature fluctuation. As described above, the effect of temperature causes metal fatigue, since a stretch of roofing material raises shear stresses in the anchor. Considering that this type of public building is generally used as a public shelter for local people, it is important to meet wind resistant performance not only in the structural elements but also in claddings such as roof coverings.

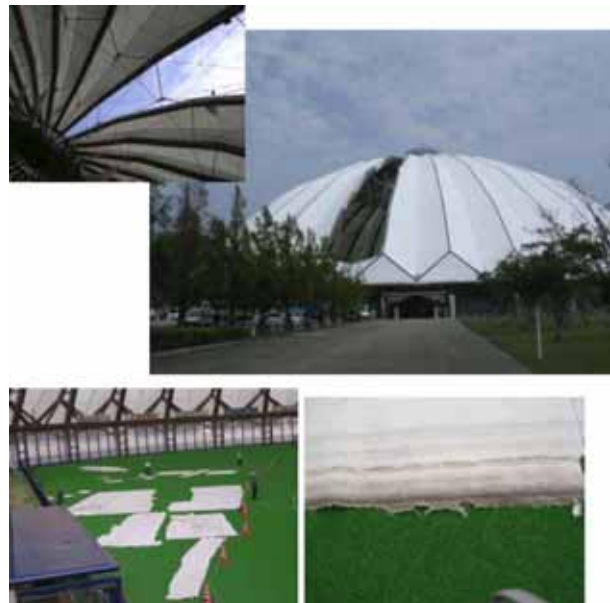
Fig.7 Punctured Membrane Roof of Izumo Dome

When the membranes were severely vibrated induced by high wind during Typhoon 0418, one of 36 sheets of membrane was suddenly punctured as shown in Fig.7. The maximum instantaneous wind speed was observed 38.8m/s at a nearby fire station. Since the punctured membrane was subjected to nearly normal to wind and the breakage started from a point under the cable near the top of the dome, it can be estimated that any flying debris did not attack the punctured area. Fragments of punctured membrane scattered outside and inside of the

building and some parallel lines were observed on the surface of them. It implies that severe friction between the cable and the membrane apparently occurred.

In a long time, sand and dust ridden with wind had been stuck in a gap between the cable and the membrane. Those accumulations may act such as a sandpaper to tear the Teflon coating from the surface of the membrane when the building is vibrated by high wind. When high wind due to Typhoon 0418 hardly shook the building, significant reduction of the strength of the membrane might occur.

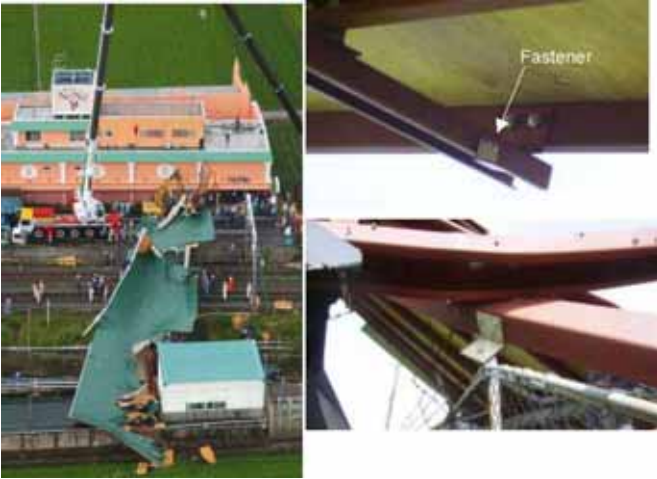
Fig.8 Blown Roofing Material from the Motor Inn

Typhoon 0406 struck Kinki area of Japan in June 21, 2004. A metal roofing covered on a motor inn at Shiga Prefecture was blown off from the building due to high wind and flew on to neighboring railway track of the Shinkansen super express as shown in Fig.8.

The size of the roofing material is 9 meter-by-41 meter and its weight is 7 ton. The Shinkansen service was suspended during 7 hours. The maximum 10 minutes mean wind speed of 16.0m/s and the maximum instantaneous speed of 36.4m/s were observed at the local meteorological observatory. The roof jumped upward and surprisingly passed over the signboard and the antenna on board apart and 10m in height 4m from the roof. Matsui *et al.*⁴⁾ carried out wind tunnel experiment to confirm the phenomenon as shown in Fig.9.

The blown roofing material was constructed on the original roof a few months before the damage in order to repair the rain leakage

remaining the original one. The new roofing material was fixed to the original roof by using small fasteners and screws as shown in Fig.8. It was observed that the original roof was corroded and the number of fasteners was too small, and moreover a few screws did not reach to the beam in the existing roof system. Thus obviously, the strength of holding the roof was insufficient to resist wind pressure. The mean wind speed to start the flight of the roofing material is estimated to be 13.5m/s to 23.5m/s.
