# Damage Investigation and the Preliminary Analyses of Bridge Damage caused by the 2004 Indian Ocean Tsunami

Shigeki Unjoh<sup>1</sup> and Kazuo Endoh<sup>2</sup>

## ABSTRACT

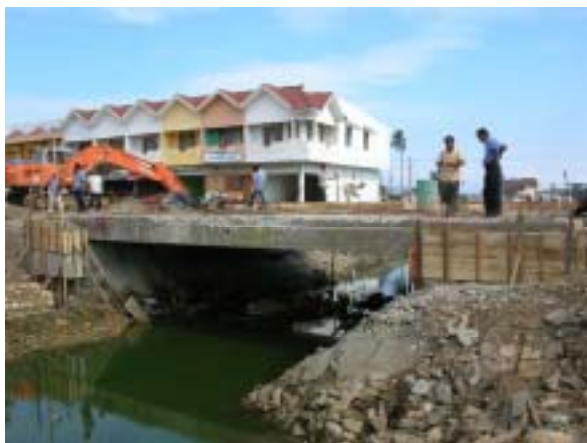
Photos 1 and 2 show one of the significantly damaged bridges. The simply-supported prestressed concrete girder bridge with span length of about 20m was washed out by the tsunami effect. The girder was just set on the top of abutments and there seemed to be no shear connection at the bearing supports. Tsunami height was just as the same height as the ceiling level of the 1st story of the houses. After the earthquake, a temporary bridge was provided to assure the traffic.

At the time of investigation when it was about two months later from the earthquake, the washed-out girder was reused and already settled

on the original location as a permanent repair.

Photo 1 Repair of Washed-out Girder

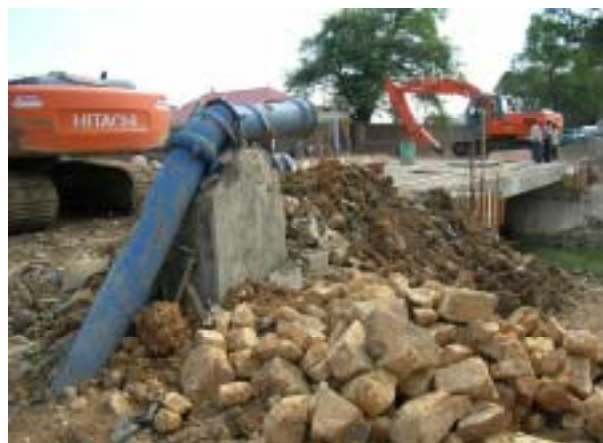
Photo 2 Collapse of Water Pipes Bridge

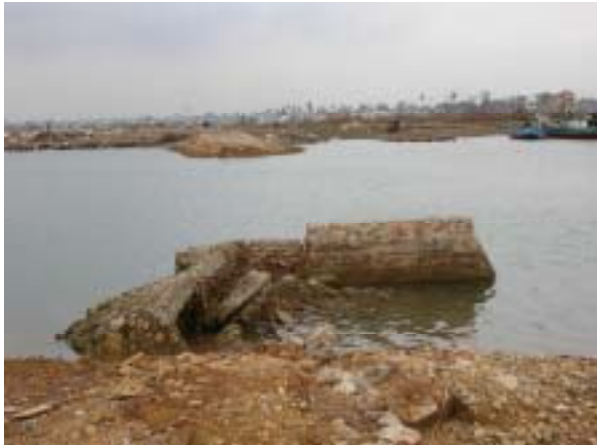
Photos 3 and 4 show the other bridge where the superstructures were completely washed out. It was reported that the bridge had a relatively shallow superstructure made of wooden materials. Substructures were made of masonry materials filled with concrete mortar.

Photo 3 Complete Washout of Bridge  
(reported as Wooden Superstructure)

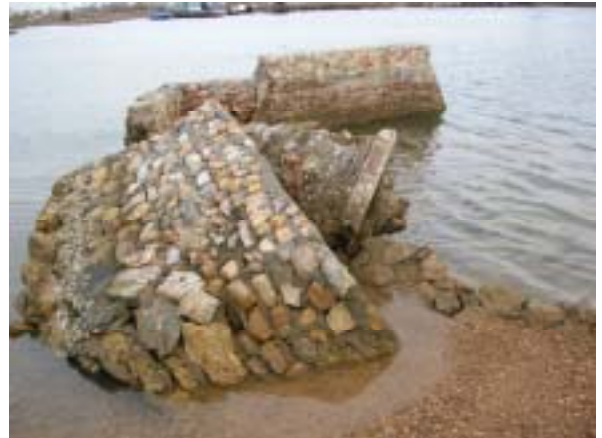
Photo 4 Masonry Substructure and Washout Effect  
of Surrounding Soils

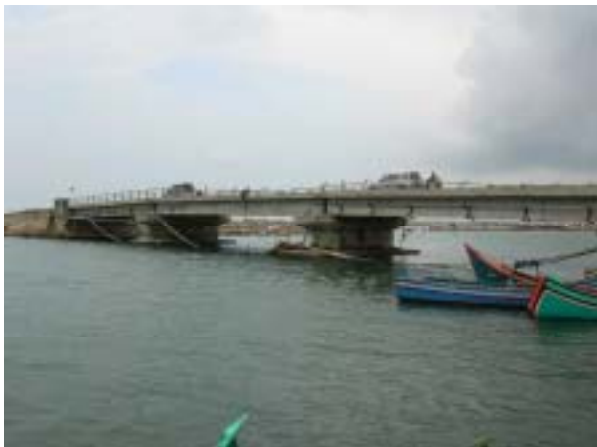
Photos 5 to 8 show the typical damage to a bridge in which the significant lateral displacement was developed by the effect of tsunami wave. The superstructure of the bridge was 3 span simply-supported reinforced concrete girder and was supported by the wall type reinforced concrete piers. The rubber sheet type bearings were used and there was no shear key to laterally connect between girder and substructures. The decks were moved about 50cm laterally but the rotation was developed at the decks then the decks were wedged geometrically between the both abutments. The handrails were partly but heavily damaged and it was estimated that the handrails were broken down by the effect of the hit of boats or driftage. The washout effect at the backfill soils of abutments was also found.

Photo 5 Damaged Bridge

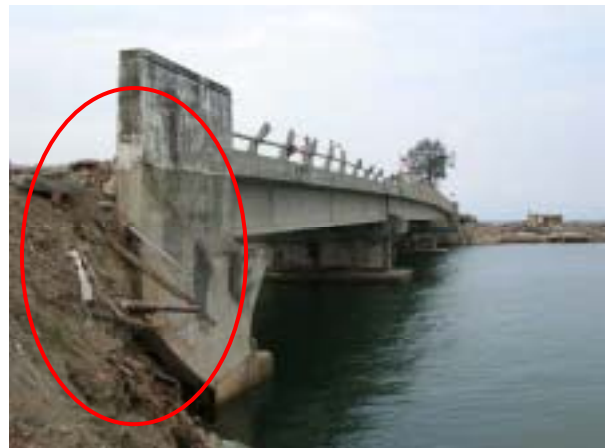
Photo 6 Washout Effect of Backfill Soils

5) Abutment Backfill Soils: There found several damage to abutments where the backfill soils were washed out. To fill the soils as a temporary measure to assure the traffic is relatively easy. But if such damage should be prevented for abutments in which the longer repair work are needed after the earthquake, the bank protection at the abutment is effective.

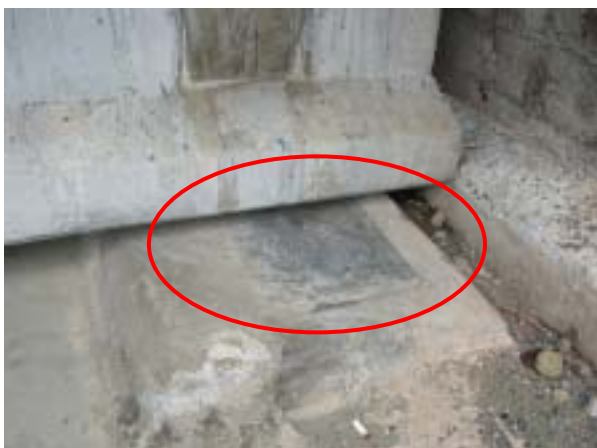
Photo 7 Lateral Displacement of Deck

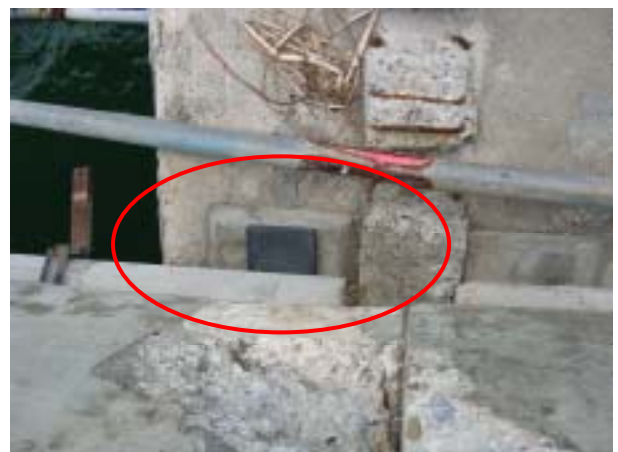
Photo 8 Rubber Sheet Type Bearing  
and Lateral Displacement at Bearing

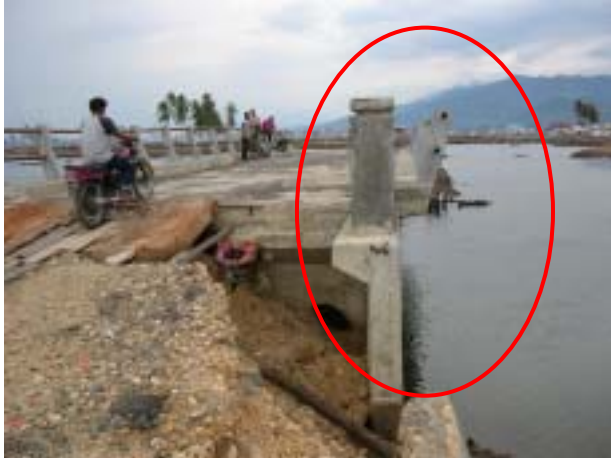
Photos 9 and 10 show another bridge where the significant lateral displacement was developed. The bridge is a simply-supported reinforced concrete girder with span length of about 20m. The deck was moved in the transverse direction about 1m by the tsunami effect. The girder was supported by the rubber sheet type bearing and there was not any shear connection between girder and substructures.

Photo 9 Lateral Displacement of Deck

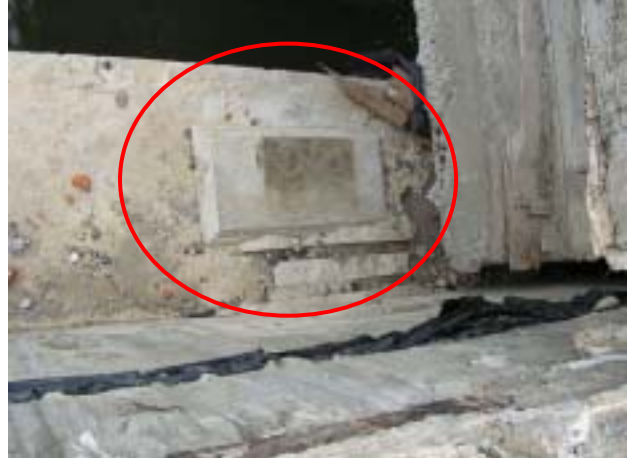
Photo 10 Displacement at Bearing

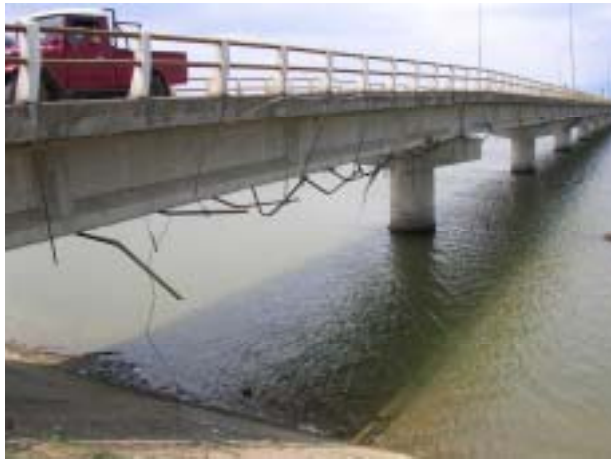
Although several bridges were significantly damaged caused by the tsunami effect, on the other hand, there are several bridges without any significant damage even they seemed to be strongly affected by the tsunami. Photos 11 and 12 show a bridge without any significantly damage by tsunami. The height of tsunami was estimated about several meters over the bridge

deck level. Heavy damage to houses and buildings was found around the bridge. The bridge was a long bridge with 10 span simply-supported concrete girders which were supported by circular reinforced concrete columns. The rubber bearings were used and the concrete block shear keys were provided between girders. Although the attached facilities beside the girders which were estimated as electricity or others were heavily failed but the main body of the bridge was not damaged. Slight damage to the shear keys as cracking was found. It is needed to investigate more including the tsunami height, but it is estimated from the bridge behavior that the shear keys seems to work well to resist against the lateral force caused by tsunami.

Photo 11 Undamaged Bridge by Tsunami

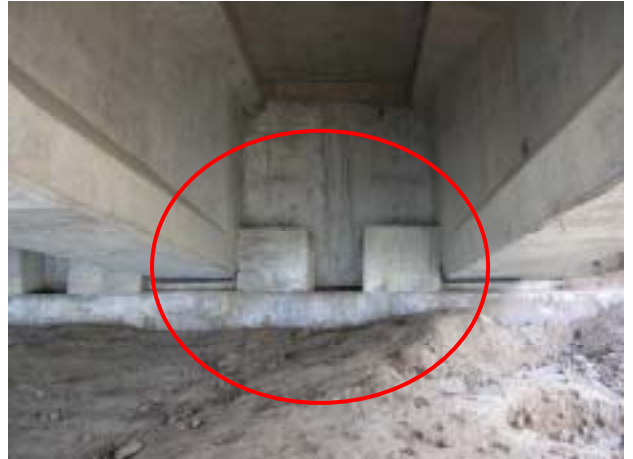
Photo 12 Concrete Block Shear Keys

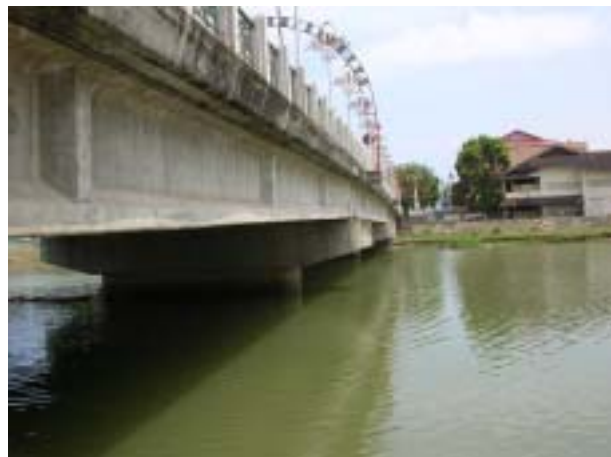
Photos 13 and 14 show another bridge to show the slight damage to shear keys. The bridge was 3 span simply-supported concrete girders and was supported by the rubber bearings and concrete block shear keys. The bridge was not affected by the tsunami. The shear keys were slightly damaged including the concrete cracking and failure. The damage was estimated to be caused by the earthquake ground motions.

Photo 13 Bridge affected by Shaking

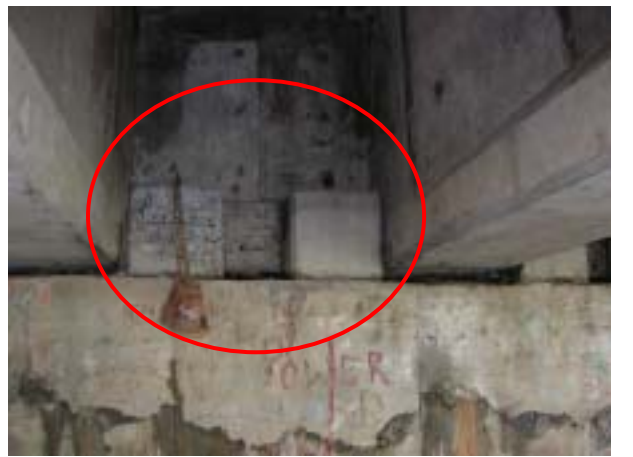
Photo 14 Slight Damage to Shear Keys by Shaking

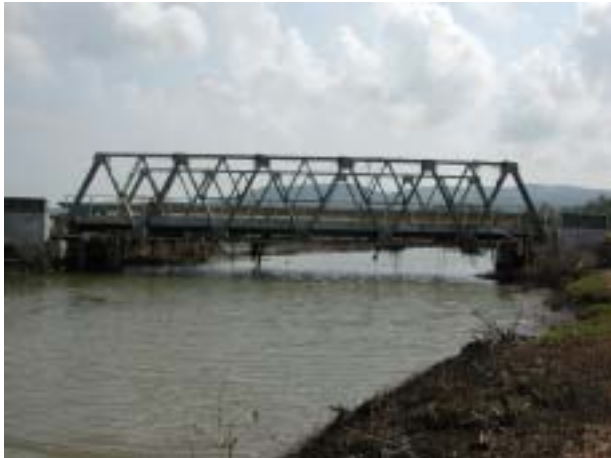
As will be discussed later, many truss bridges with relatively longer spans were washed out in the west coast route from Banda Aceh to Meulaboh. The detailed investigation could not be made for all of the collapsed bridges but some collapsed bridges did not have the connection and shear keys between decks and substructures. Photos 15 and 16 show the behavior of the truss bridge with stiff bearing connections between deck and substructures. Since the bridge is located at the east of Banda Aceh, the tsunami height might not be so significant. But the tsunami height was clearly exceeded over the height of the upper truss member. There found no damage at the bridge. It is needed to investigate more in detail but the stiff bearing connection may be one of the reasons for no damage.

Photo 15 Steel Truss Bridge without Damage

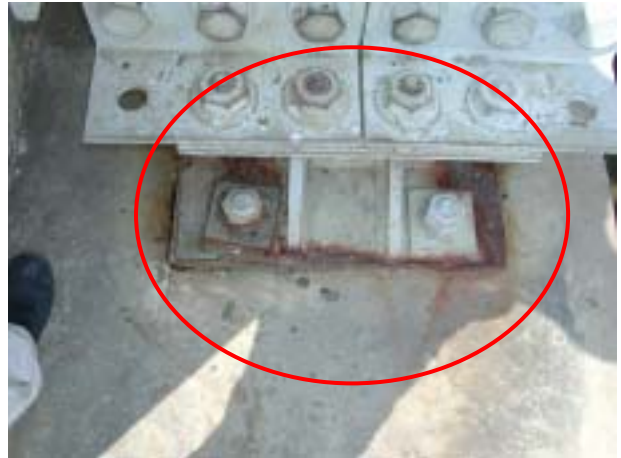
Photo 16 Steel Bearing Supports

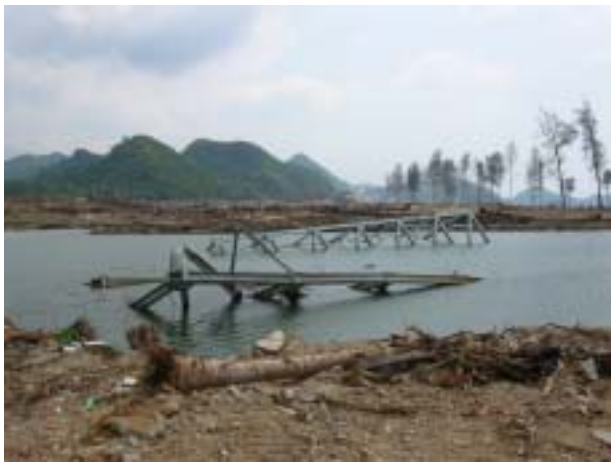
The city of Lhoknga is located at the west of Banda Aceh. The area was significantly affected by the tsunami and the tsunami height is estimated to be over 30m at maximum. Photos 17

to 19 show the complete washout of 2 span simply-supported steel truss bridge, which was supported by the wall type reinforced concrete columns. The decks were supported by the bearings and a bolt was provided to connect deck and substructures. There was no stiff shear connection between deck and substructures except one bolt connection. Since the truss girders were washed out to the upstream side and the bolt to connect between deck and substructure were bended toward the upstream side, it was estimated that the decks were washed out by the tsunami wave in the direction of upstream side. This route is important route to connect between the north and the south, the temporary bridge was provided for emergency measures. It should be noted here that it is estimated the truss type bridge is employed for a relatively longer span bridge in the area.

Photo 17 Washing out of Steel Truss

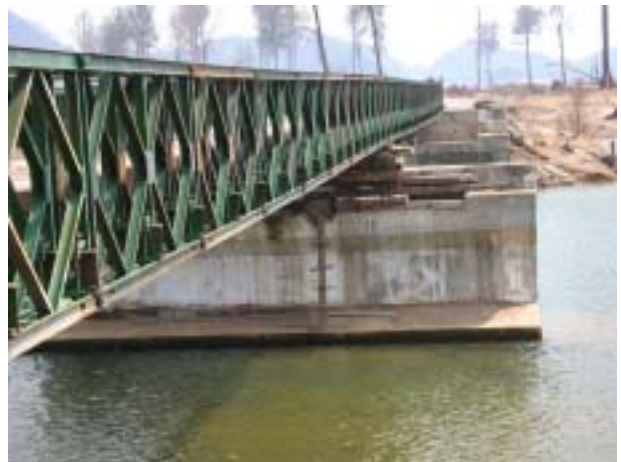
Photo 18 Temporary Bridge

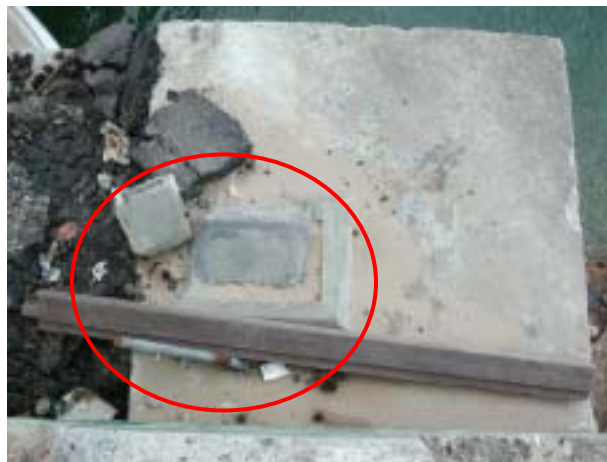
Photo 19 Bearing Support and Bolt to connect between Deck and Substructures

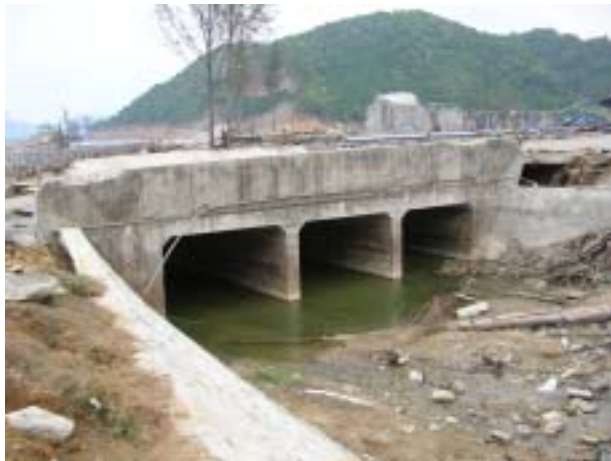
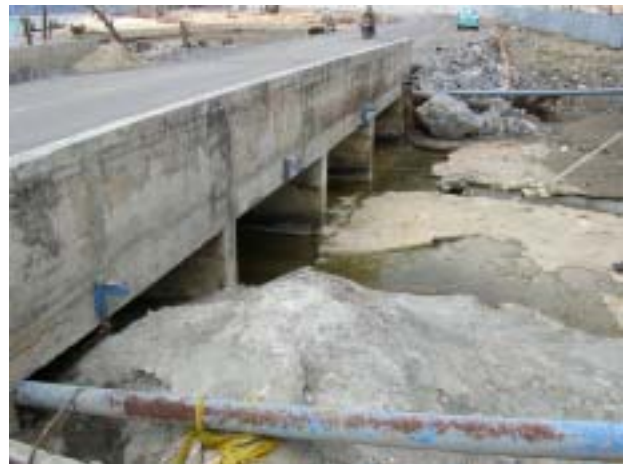
Photos 20 and 21 show the behavior of the reinforced concrete box culvert bridges. The bridge is located in the cement factory which was significantly damaged by the Tsunami. Some damage was found at the sidewall but there was almost no damage at the main body of the bridge.

Photo 20 Concrete Box Culvert Bridge

Photo 21 Concrete Box Culvert Bridge

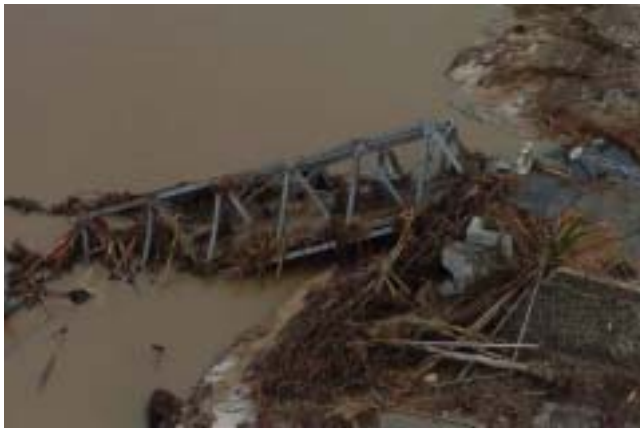
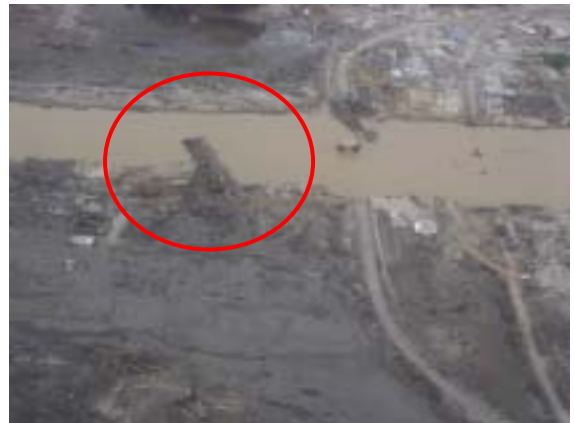
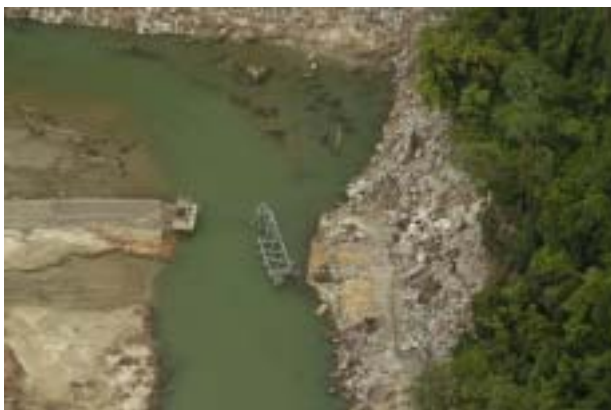
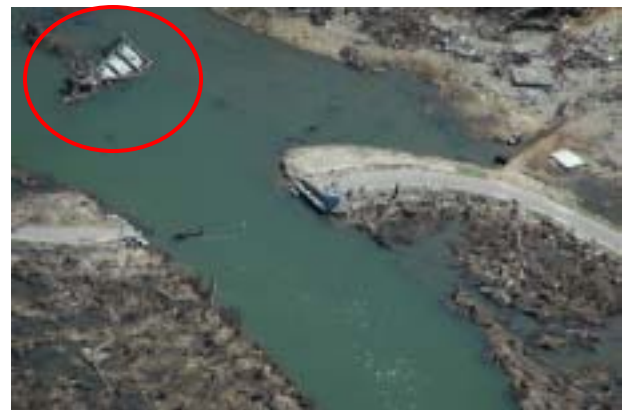
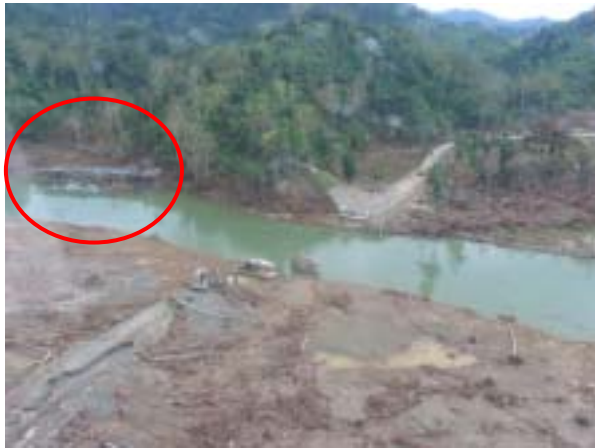
Photos 22 to 26 show the typical washout of the bridges in the route. All photos shown here were taken by UN. There are several steel truss bridges and the deck was completely washed out toward the upstream side. Since the most piers and abutments remained at the original location, it is estimated that the superstructures were

washed out by the effect of tsunami. Photos 27 shows the washout of the roadways which were completely eroded by the tsunami effect. The settlement of land was also estimated along the coast and the erosion of the coastline was quite significant.

Photo 22 Washout of Truss Bridge (1)

Photo 23 Washout of Truss Bridge (2)

Photo 24 Washout of Truss Bridge (3)

Photo 25 Washout of Truss Bridge (4)

Photo 26 Washout of Truss Bridge (5)

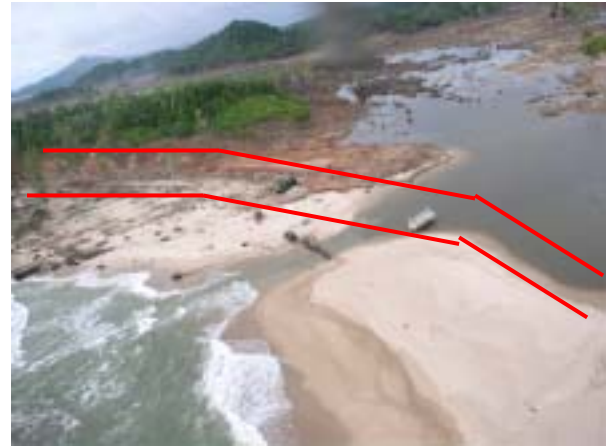
Photo 27 Erosion of Road and Coastline
