# Interpretation of Slope Failure Distribution Triggered by the Northern Pakistan Earthquake on 8 October 2005 using SPOT5 Stereo-imageries

## ABSTRACT

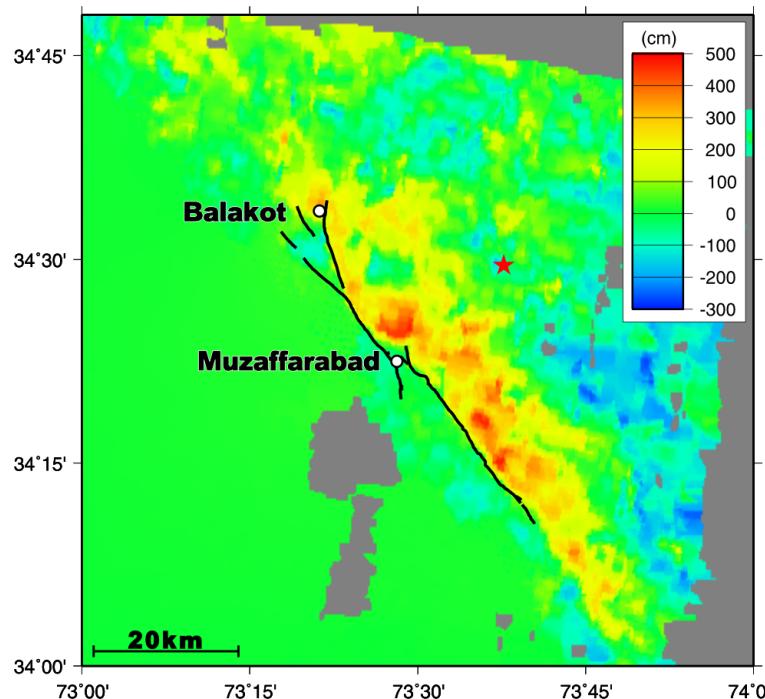
The crustal deformation was spatially mapped with Synthetic Aperture Radar (SAR) data from the European Space Agency's ENVISAT [1], and it was found that the newly deformed area occupies a 90-kilometer-long northwest-southeast trending strip. Heavily damaged area north of Muzaffarabad has the maximum deformation up to six-meter uplift as observed by the satellite.

Fig.1 Detected crustal deformation using ENVISAT/SAR data (wavelength of 5.6 cm, C-Band) [1]. Positive values indicate the movement toward the SAR satellite in the line-of-sight direction (upward and/or E-SE displacement). Solid black lines show Muzaffarabad and Tanda faults [2] and star mark is the epicenter.

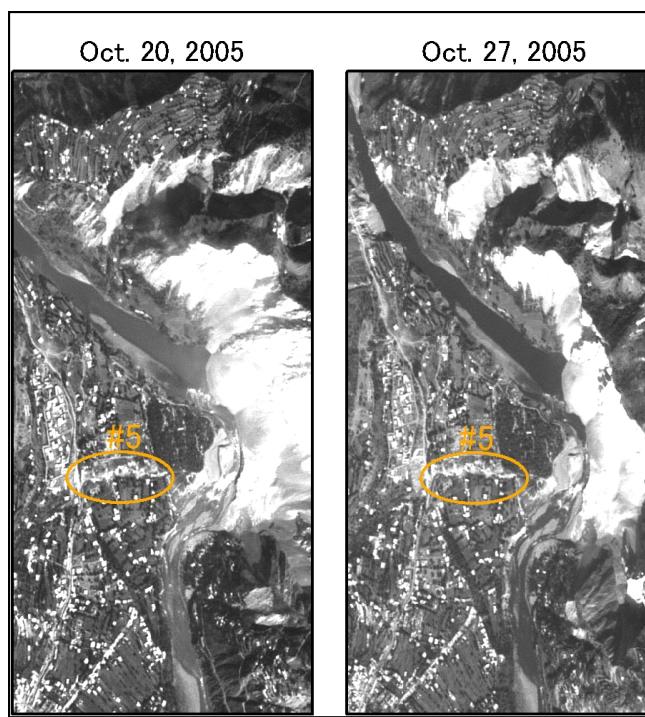
As shown in Fig. 2, these images make stereoscopic vision, and through the stereo-images slope failures were interpreted and delineated on the images. Fig. 2 shows north area of Muzaffarabad. In the figure the circle #5 shows not slope failures but the flexure cliff along the surface rupture of the earthquake fault. Slope failures were interpreted as white-bright slope, especially the right side of the river. In delineating such the slope failure, each slope failure was divided as considering unit slope. However, the interpreted area contains high mountain areas covered with snow, and it was difficult to interpret slope failures in

Fig.2 SPOT5 stereo-imagery in the damaged area of north Muzaffarabad

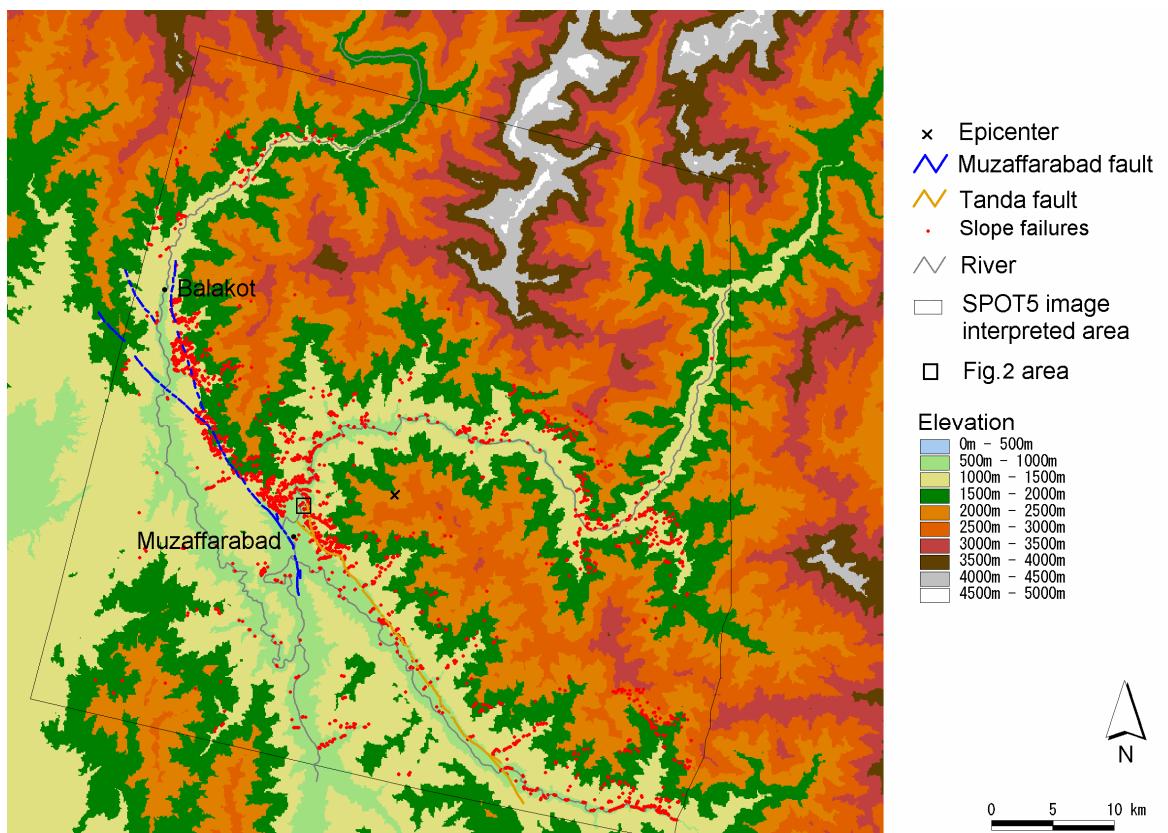
The interpreted slope failures were overlaid on the SRTM data, and shown in Fig. 3. The total count of the slope failures was 2,424. Comparing Fig. 3 with Fig. 1, most of them occurred on the hanging wall side. Furthermore, many slope failures occurred along Muzaffarabad fault and Tanda fault. Fig. 4 shows relation between slope failures and distance from these active faults. It was found that over the one-third of them occurred within one kilometer from the active fault.

Fig. 3 Distribution of slope failures triggered by the earthquake. Elevation data are based on SRTM.

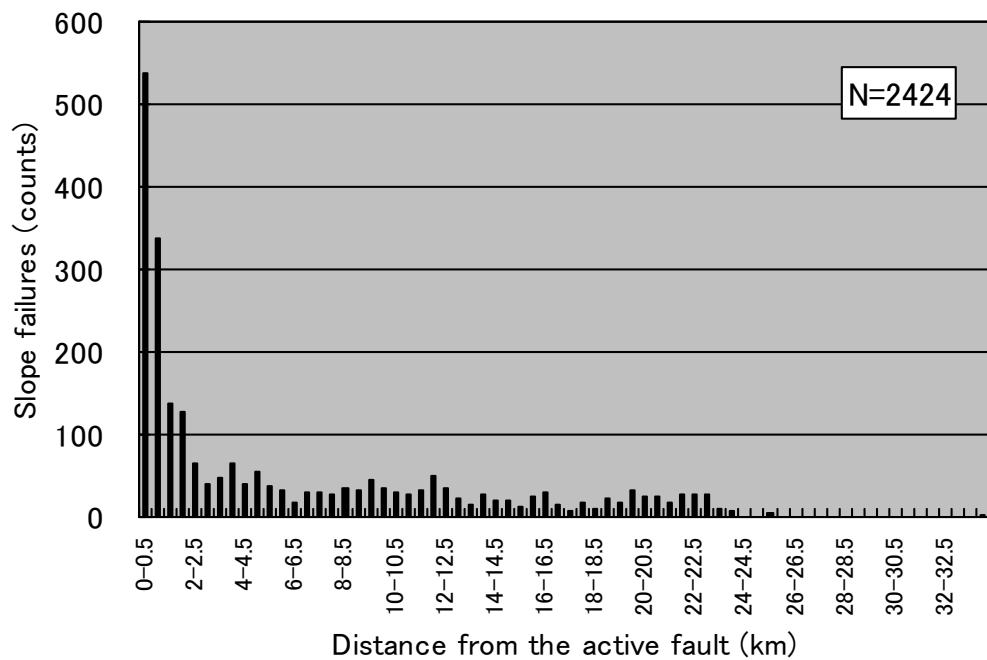
Fig. 4 Slope failures frequency distribution on distance from the active fault

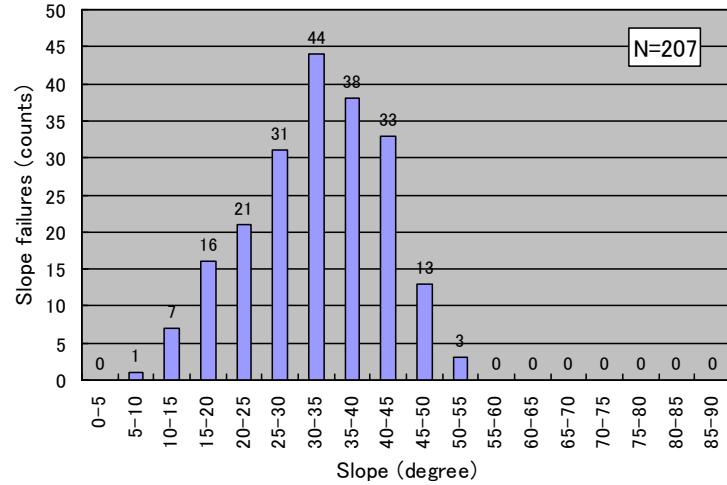
size of 100m by 100m (1 ha in area) and more, namely, 207 counts, were selected. Furthermore, the relation between large-scale slope failures and slope calculated from SRTM was investigated. The result is shown in Fig. 5. The minimum and maximum slope was 8.4 degree and 52.3 degree, respectively. The most failures, 44 counts, occurred at the slope of 30-35 degree, 87 counts failures occurred at the slope of 35 degree and more, and 76 counts occurred at the slope of less than 30 degree. There is a slight tendency that more large-scale slope failures occurred at steeper slope than at gentler slope.

Fig. 5 Large-scale slope failure frequency distribution on slope (degree)

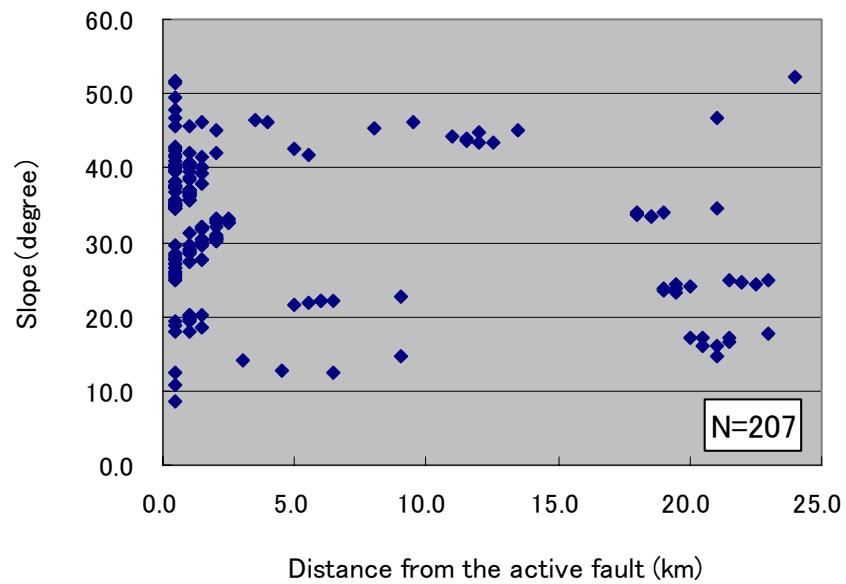
Fig. 6 shows relation of 207 counts failures between slope (degree) and distance from the active faults. It infers that large-scale failures occurred not only at steep slope but also at gentle slope in the near area from the active faults, slope failures of 10-15km from the faults occurred at steeper slope (43.4 - 46.3 degree). However, at the distance of c.a. 18km or further, large-scale slope failures also occurred at the gentler slope (less than 30 degree). It is not concluded that large-scale slope failures occurred at steeper slope when they located at further distance from the active faults.

Fig. 6 Relation between distance from the active fault and slope (degree)

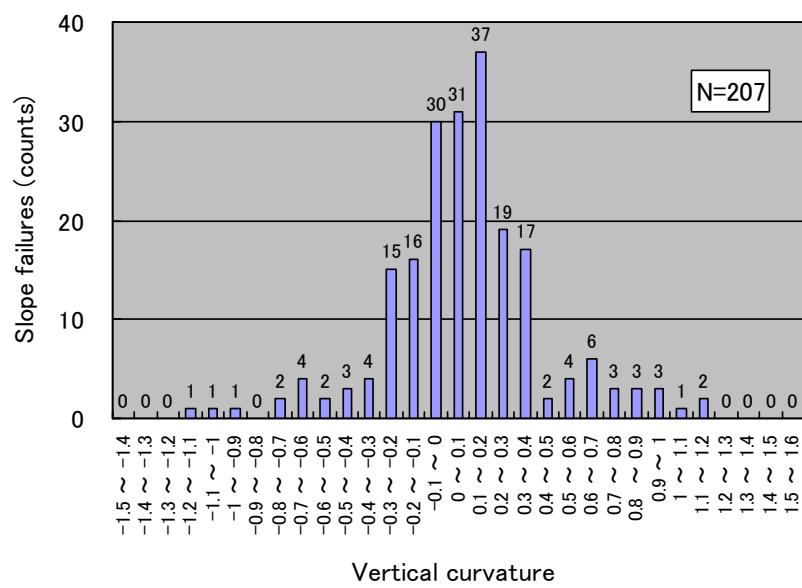
Fig. 7 shows vertical curvature frequency distribution of 207 counts failures. The vertical curvature [3] was calculated from SRTM. It is the index which shows plus and higher values when cross section of topography is more convex, minus and lower values when more concave. Vertical curvature is zero, it means linear slope. The most failures occurred at the curvature of +0.1 - +0.2, 37 counts, 128 counts occurred at the curvature of more than zero (at convex slope), and 79 counts occurred at the curvature of less than zero (at concave slope). From Fig. 7, there is the tendency that more large-scale slope failures occurred at the convex slope than at the concave slope.

Fig. 7 Large-scale slope failures frequency distribution on vertical curvature
