# Outline of the Damage of Transportation Facilities and Geotechnical Structures by the 2009 L'Aquila, Italy Earthquake

## ABSTRACT

This is a reconnaissance report on the damage to transportation facility and geotechnical structures caused by the 2009 L'Aquila, Italy earthquake. Site investigation was conducted by the authors during the period of April 18-21, 2009. Presented is a discussion on the damage of transportation facilities. Geotechnical damage and ground motions are also presented.

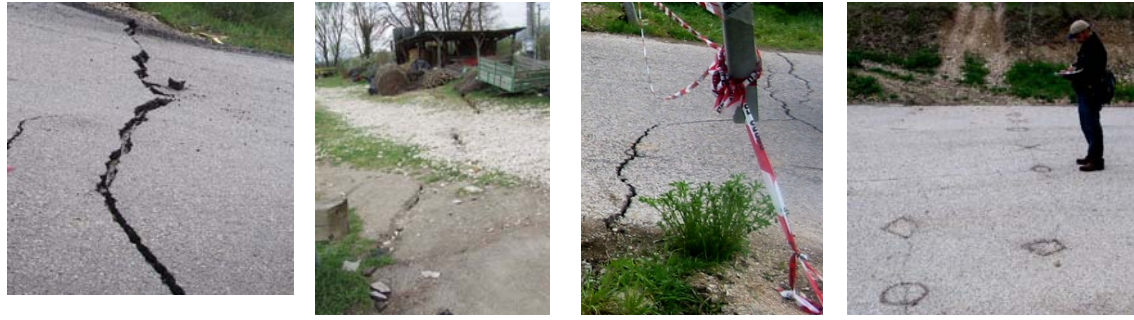
Surface ruptures were observed at Paganica, Lake Sinizzo, and two bridges at Onna and Fossa as shown in **Fig. 3** and **Photo 1**. Surface ruptures were observed at three sites in Paganica. Most fractures at Paganica indicated the opening of surface cracks with a normal displacement. The authors also observed cracks on the road to Lake Sinizzo, which is thought to be the southeast end of the earthquake fault. There were also surface cracks in the vicinity of a bridge near Fossa (refer to Photo 11) as shown in **Fig. 7**. Some cracks were in compression while most of them were in tension.

Photo 1 Surface ruptures in the area of Aterno River to the west of Onna town (refer to Fig. 3 for locations of CL1-CL4))

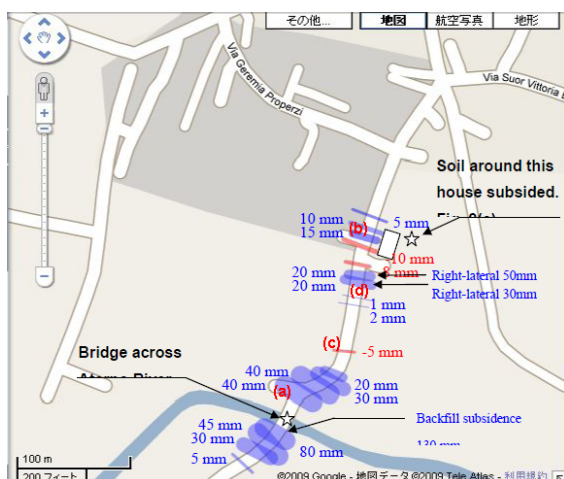
Horizontal movements and cracking were observed in the area of Aterno River to the west of Onna town. The embankments on both sides of Aterno River moved towards the river creating separation cracks as well as some compression cracks in the vicinity of the damaged bridge on Aterno River as shown in [Fig. 7](#) and [Photo 2](#). The cracks and movements on the east side of the river were more intensive as the ground was inclined towards west. Nevertheless, any sand boiling was not observed in the area. It would be quite speculative on the cause of these movements.

Based on InSAR evaluation, ground movements are large in the close vicinity of Aterno River near Onna town. Tectonic movements, ground liquefaction or both might cause the movement in this area. If ground liquefaction is involved, it is likely that there is a thick impermeable silty and clayey layer on top of the liquefiable ground below.

Fig. 7 Cracks in the vicinity of a damaged bridge on Aterno River (Refer to Photo 2)

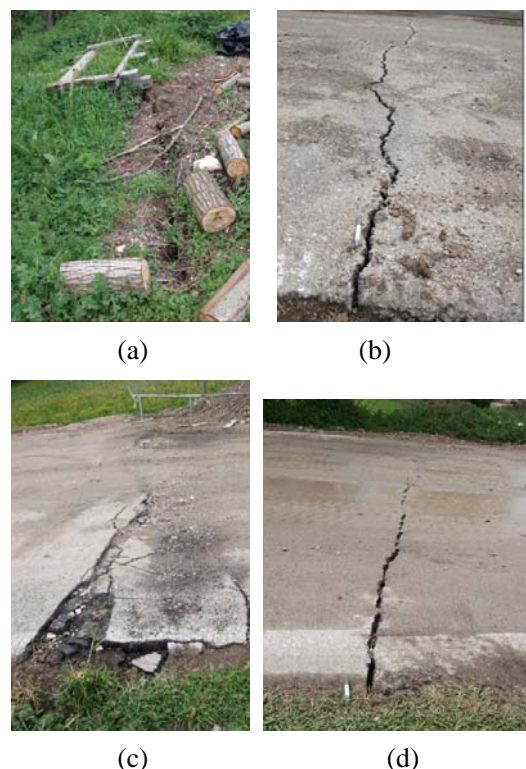
Photo 2 Surface cracks on the east side of Aterno River (Refer to Fig. 7 for locations)

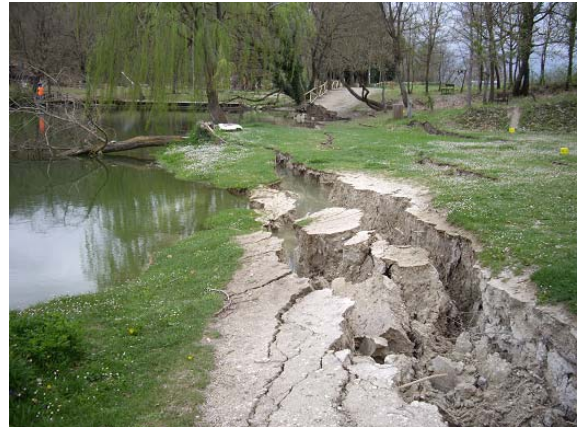
There are a number of sinkholes in the vicinity of L'Aquila featuring the Karst topography of the area. Sinizzo Lake with about 120 m diameter is probably one of the sinkholes. Extensive lateral spreading occurred along the shoreline of Sinizzo Lake as shown in **Photo 3**. Around the north shore, several parallel blocks were bounded by continuous cracks due to large lateral spreading of the surface ground and they moved toward the lake as shown in **Photo 4**. The ground at the west shore moved 22 m towards the lake. Two famous beautiful springs at the north-eastern shore dried up after the earthquake, however a new spring was formed close to the original two springs. The fact that the original ground water flow paths were blocked and a new water flow path was formed due to ground deformation during the earthquake implies that the ground water table was high and close to the ground surface. Based on this evidence, it is considered that the lateral spreading was resulted from yielding of the ground due to intensive earthquake shaking as well as degradation of shear strength of the ground due to generation of the pore water pressure.

Photo 4 Separated blocks due to lateral spreading

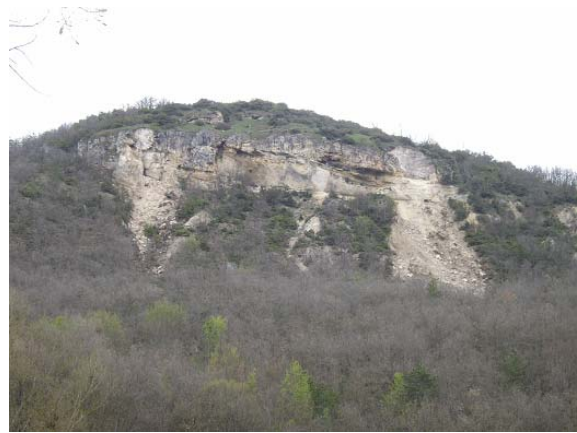
Extensive surface rock sliding on the mountain on east side of the lake was developed as shown in **Photo 5**.

Photo 5 Surface rock sliding on the mountain (east of the Sinizzo Lake)

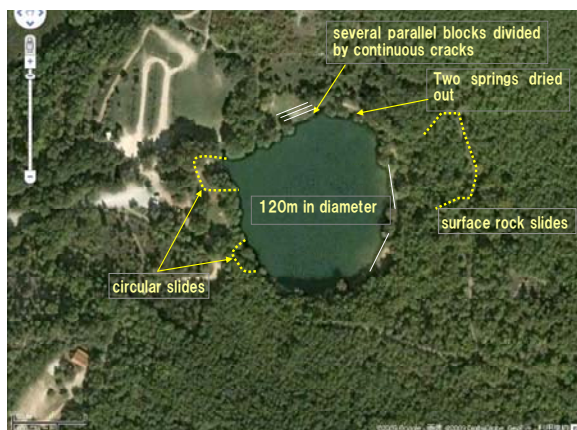
Photo 3 Lateral spreading around Lake Sinizzo (added on Google map)

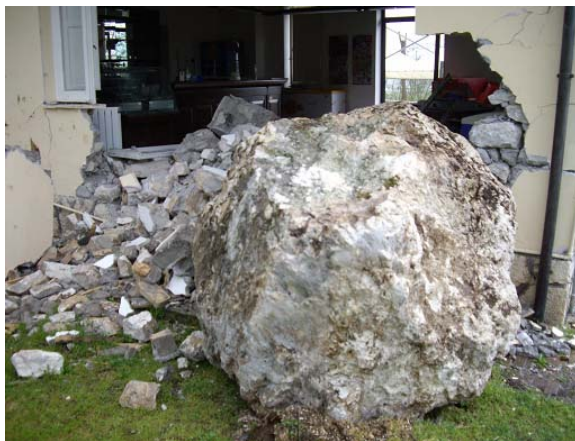
Two large rock falls occurred in Stiffe. The estimated mass and size of one of the rock blocks was 12 t and 1.5m x 1.6m x 1.9m, respectively. This rock block hit and destroyed the wall of a small building in the park near Grotte di Stiffe as shown in **Photo 6**. **Photo 7** shows a broken tree, a shallow dent on the ground and the damaged wall, lined up along the path of the fallen rock block. The velocity and energy at the instance of collision is estimated in view of the jumping distance as 15 m/s and 2,700 kJ, respectively. The collision energy was large enough to destroy the wall of a building. The other fallen rock block reached the bottom of the park.

Photo 6 A 12 ton fallen rock with 1.9m long, 1.6m wide and 1.5m tall

It is important to assess the sources of falling rocks so that stability of neighboring rock masses or isolated rocks remaining on a slope can be evaluated. By assessing the collision energy of possible unstable rock masses, the risk to human lives and properties can be evaluated. It may be effective to prepare a check sheet to record information on the height of rock fall sources, size, geological conditions, protection measures and possible fall path.

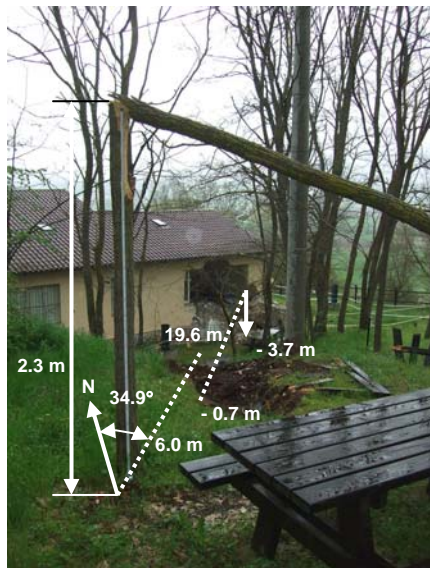
Photo 7 A broken tree, a shallow dent on the ground and a collapsed wall of the building along the path of a fallen rock.

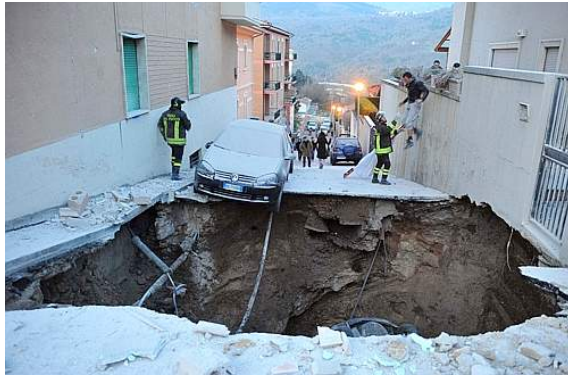
In the old city of L'Aquila, two sinkholes appeared on roads due to the earthquake and a vehicle fell into a sinkhole as shown in **Photo 8**. One of the sinkholes was already back-filled with soils for stabilizing the surrounding ground. However the other sinkhole was only partially back-filled as shown in **Photo 9** and the authors had the chance to investigate it. **Fig. 8** shows the dimensions of the sinkhole. The deepest point from the road surface was measured as 13m near the east edge of the sinkhole. However the cave tended to become deeper towards west. The roof of the cave roughly consists of four horizontal layers. From the bottom to top, they are (1) well cemented calcareous conglomerate, (2) clayey conglomerate, (3) clay, and (4) backfill. It is noted that a sewage conduit was constructed after excavating a 3.7m deep vertical trench reaching to the level of the calcareous conglomerate. This trench excavation has eventually notched the upper surface of the conglomerate roof of the cave, which could further reduce its effective thickness. The scenario mentioned above may have been responsible for the formation of the sinkhole during the earthquake shaking.

Photo 8 Sinkhole immediately after the earthquake (from Web page)

After experiencing the intense shaking, there are probably a number of unstable thin roofed caves remaining underground in the old city of L'Aquila. Thorough sounding of the condition of foundation rock mass may be important for a safe and rational rehabilitation of the city. Among many techniques available, the surface wave tomography may be effective and it may yield shear wave velocities of ground, which are directly related to its mechanical properties.

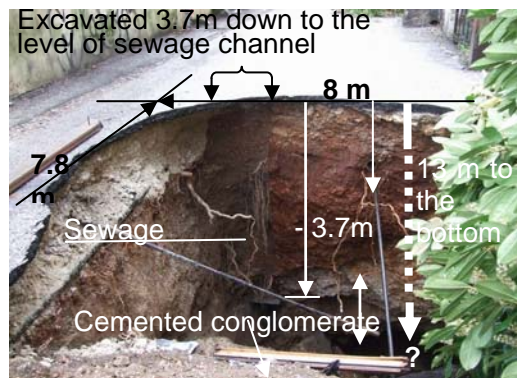
Photo 9 Sinkhole in a road, old city of L'Aquila (refer to Fig. 8)

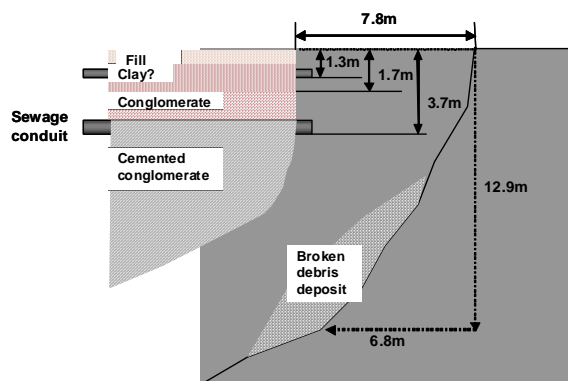
Fig. 8 Section of a sinkhole (Refer to Photo 9)

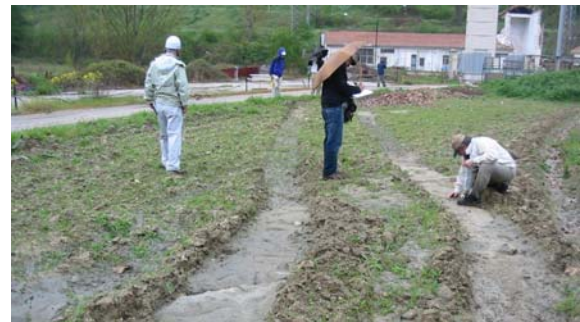
investigations, the authors found sand boils along Aterno River in the area called Martini, which is just south of the hill on which the old downtown of L'Aquila City is located. The river meanders in the area and it is likely to have resulted in sandy deposits at those meanders. At Martini district liquefaction created many NE-SW trending fractures parallel to the river embankment and they opened up as shown in Photo 10. Sand boiling as thick as 150 mm was observed in various locations. The movement of ground was towards SE direction. Table 2 and Fig. 9 show some physical properties and grain size distribution of sand boils, respectively, based on laboratory tests at Tokai University, Japan and Pamukkale University, Turkey. Boiled sand is almost homogenous and its grain size distribution falls within the easily-liquefiable bounds according to Japan Port and Harbour Research Institute classification (1997).

The liquefaction induced lateral spreading. The sum of crack openings from the adjacent field towards the river embankment ranged between 250-350mm. There were several depot-like structures and bridges for railways and roadways in the area where soil liquefaction was observed. However there was no visible damage on the structures probably because the foundations were resting on deep stiff soils.

Photo 10 Liquefaction at Martini district of L'Aquila

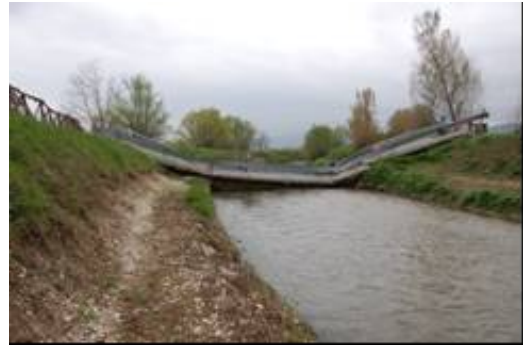
A 35 m long 5 m wide three-span continuous reinforced concrete bridge collapsed as shown in [Photos 11 and 12](#). It was located at the crossing of SR261 on Aterno River for approaching Fossa Town. Four reinforced concrete pile-bent columns with a hexagonal section failed at a height slightly above the river surface, and they shifted sideways and penetrated the deck slab as shown in [Photos 13 and 14](#). A column had six 17 mm diameter round main bars at each corner of the hexagonal section as shown in [Photo 15](#). Several 9 mm diameter round bars were also set to fix the top of columns to the reinforced concrete girders. 6 mm diameter round hoops were provided at about 300 mm interval. The strength of concrete in columns was most likely less than 20 MPa. [Photo 16](#) shows a broken pile-bent as well as a girder next to the bent at the right downstream column. Plastic hinge did not form in the column because of the low reinforcement. It seems that damage of the column which was induced prior to the earthquake progressed during the earthquake. Steel bars exposed due to very thin covering concrete were extensively corroded prior to the earthquake. Both left and right river dykes were protected by stone masonries at inside facing to river flow. The river dykes suffered almost no damage due to the earthquake. This feature of damage reminds us of a similar damage of the Struve Through Bridge in the 1989 Loma Prieta Earthquake, California, USA (Lew, 1990).

Photo 11 Collapse of a three span continuous bridge near Fossa Station

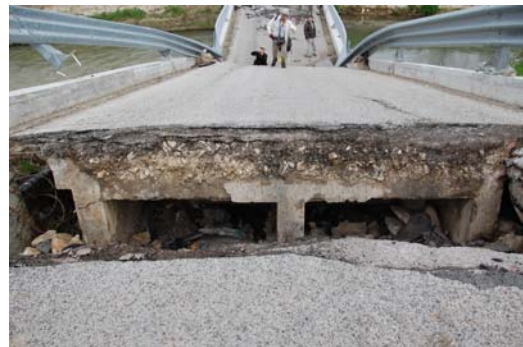
Photo 12 Section of the fallen deck

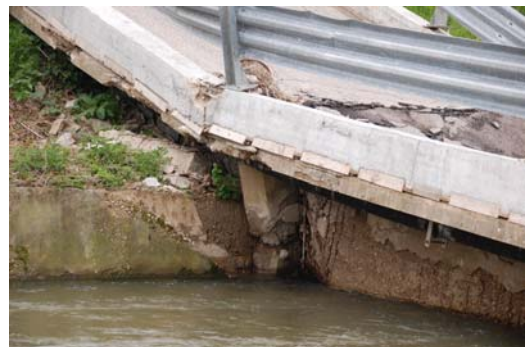
Photo 13 Damage of pile-bent pier

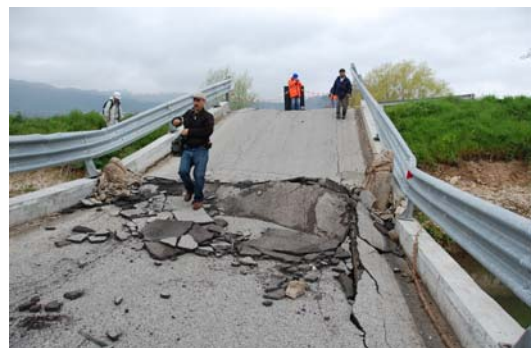
Photo 14 Pile-bent piers which punching sheared the deck slab

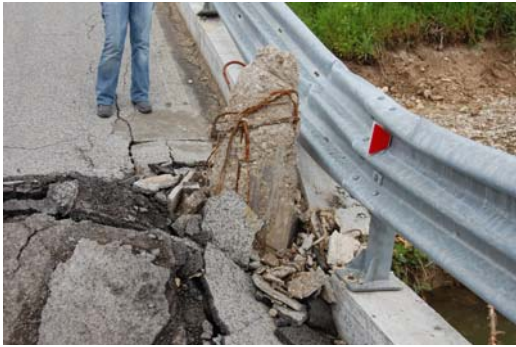
Photo 15 Top of a pile-bent pier

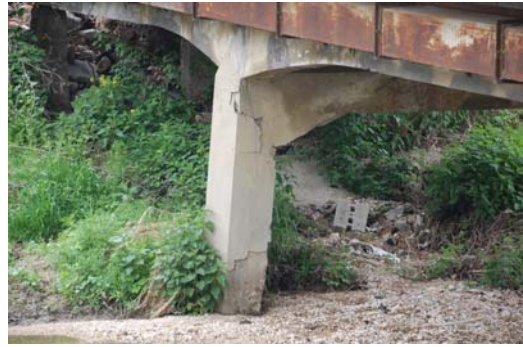
Photo 18 Damage of a frame reinforced concrete pier

A 20 m long 4 m wide three-span continuous bridge located in the suburbs of Onna Village suffered damage at the top of frame piers as shown in [Photos 17 and 18](#). Plastic hinge did not form at the beam-column connection. The damage which was developed prior to the earthquake progressed during the earthquake. Embankment right behind the abutment settled and a cast-iron water pipe attached on the bridge suffered damage at the connection between the bridge and the embankment. Several cracks occurred on the river dyke due to soil sliding.

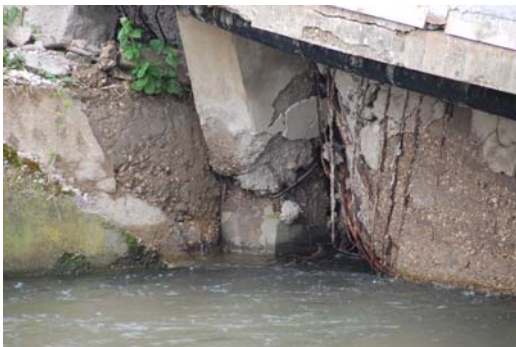
Photo 16 Failure of a pile-bent pier

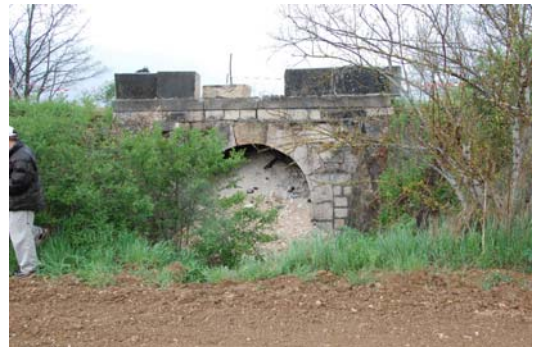
A 2 m long, 2.5 m tall stone masonry arch culvert collapsed and was temporarily repaired by filling crushed lime stone into the culvert as shown in [Photos 19 and 20](#). How the arch culvert suffered damage was not known because it was already repaired. However it is likely that a part of stone masonry arch members lost the equilibrium and collapsed during the earthquake. Because the embedment of the arch was shallow without covering masonries on the arch, the arch members had less stability.

Photo 19 Emergency repair of a stone masonry arc culvert (SR261)

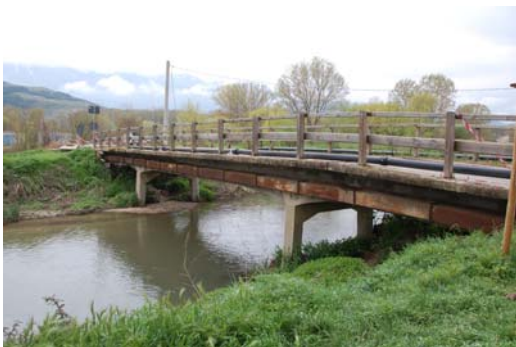
Photo 17 A 20 m long bridge near Onna Village

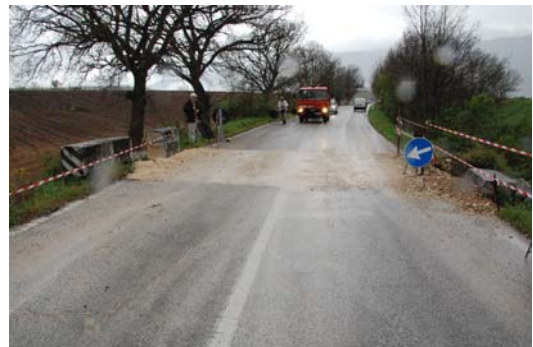
Photo 20 Road temporarily repaired by filling crashed limestone

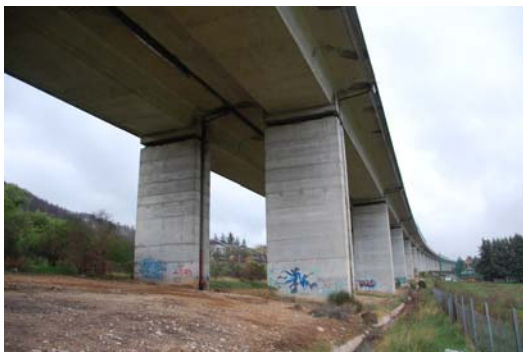
A part of the A24 viaduct in L'Aquila as shown in **Photo 21** also suffered damage. The viaduct is a 37 m long simply supported PC box-girder bridges supported by 11-20 m tall reinforced concrete columns. It is supported by steel fixed (sliding) and movable (roller) bearings or elastomeric bearings. The viaduct was separated in the upper and lower bound bridges. Vertical gaps as large as 200 mm were seen at numerous expansions as shown in **Photo 22**. A number of decks drifted by nearly 200 mm in the longitudinal and transverse directions as shown in **Photo 23**. The bearings where gaps occurred at expansion joints or decks drifted could hardly be investigated, but it is likely that the gaps at expansions were developed by failure of bearings. Drift of the decks is generally developed due to residual deformation of elastomeric bearings. A part of the covering concrete spalled as shown in **Photo 24** at the bottom of a pier. It is likely that the pier nearly yielded. **Photo 25** shows damage of a shear connector at the end of a deck.

Photo 21 A viaduct of A24 in L'Aquila

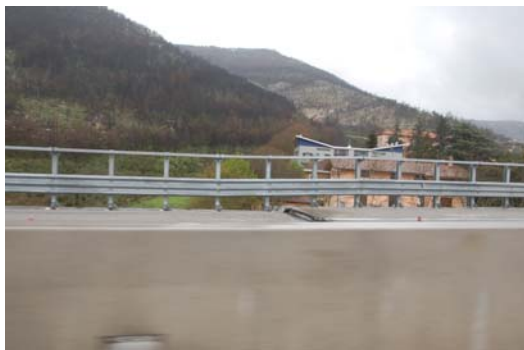
Photo 22 Gap at an expansion joint

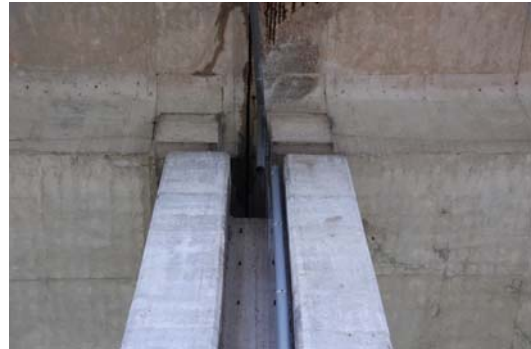
Photo 23 Residual drift of two bridges in the longitudinal direction

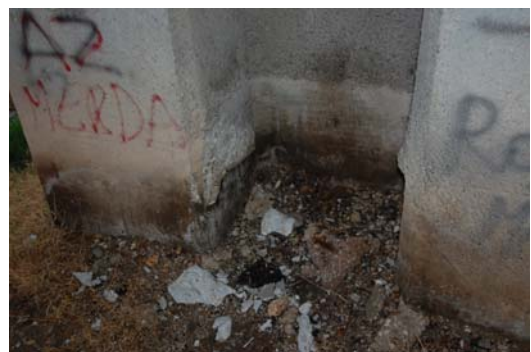
Photo 24 Spalling of a part of covering concrete

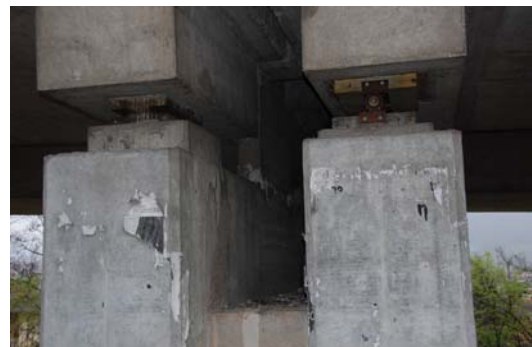
Photo 25 Damage of a shear connector

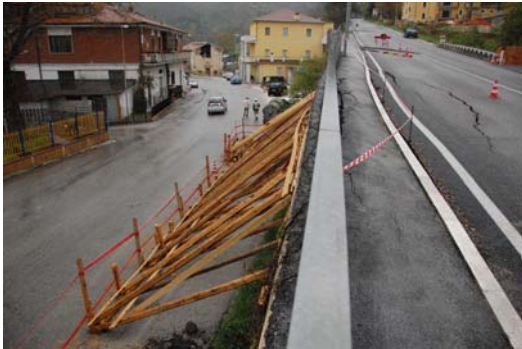
Settlement of road surface occurred at a number of locations in the lowland along Aterno River. One of the two lanes of SS17 at the intersection with SR615 was partly restricted for traffic because the road embankment locally subsided by 350mm and the upper part of the stone masonry retaining wall leaned as shown in **Photos 26 and 27**. The retaining wall was propped by wood bars for resisting the earth pressure. The detour lane was being constructed adjacent to the affected lane.

Photo 26 Subsidence of a road embankment at the intersection of Route SS17 and Route SR615

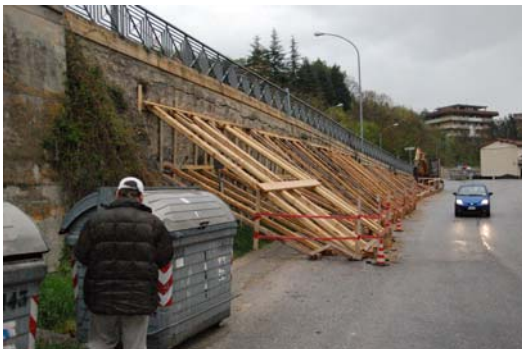
Photo 27 Emergent repairing of damaged embankment
