# Damage to Dams due to the Iwate-Miyagi Nairiku Earthquake in 2008

## ABSTRACT

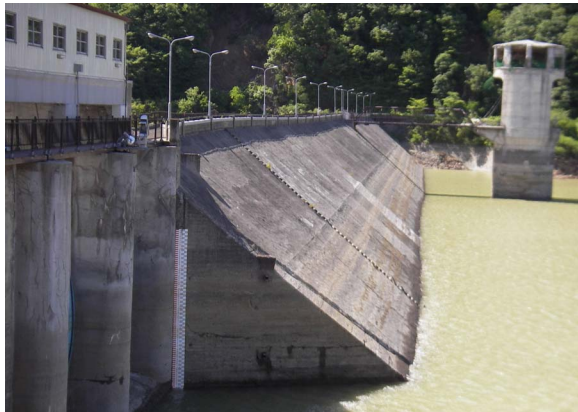
Ishibuchi Dam is a concrete faced rockfill dam (CFRD) with a dam height of 53m completed in 1953, and managed by Tohoku Regional Bureau, MLIT. Figure 3 is the cross section and longitudinal section of the dam. The upstream concrete face maintains the watertightness of dam body of this type of dam. No severe damage was found in the concrete face and its joints shown in Photo. 1.

Photo.1 Concrete faced upstream slope on which no damage was found (Ishibuchi Dam) (Photographed by Public Works Research Institute (PWRI) on June 15, 2008)

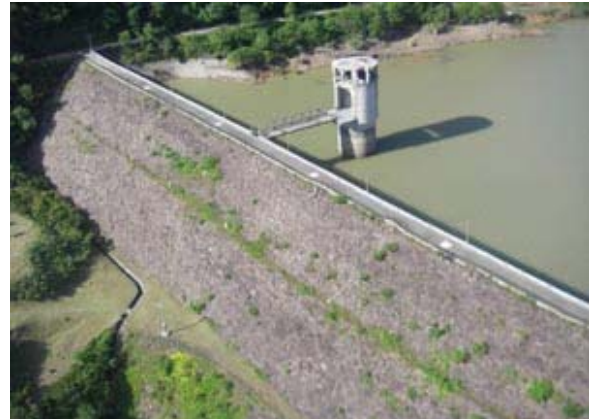
At the crest of the dam, the pavement was waved and cracked shown in Photos. 2 and 3. And gaps appeared on the boundary between the

Photo.2 Overview of the crest and downstream slope (Ishibuchi Dam) (Photographed by PWRI on June 15, 2008)

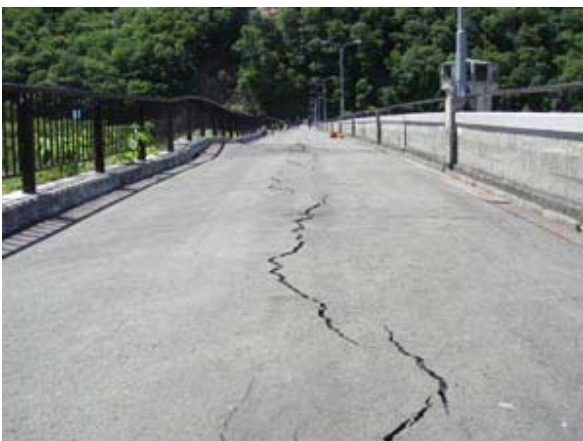
Photo.3 Cracks and waving of the crest pavement (Ishibuchi Dam) (Photographed by PWRI on June 15, 2008)

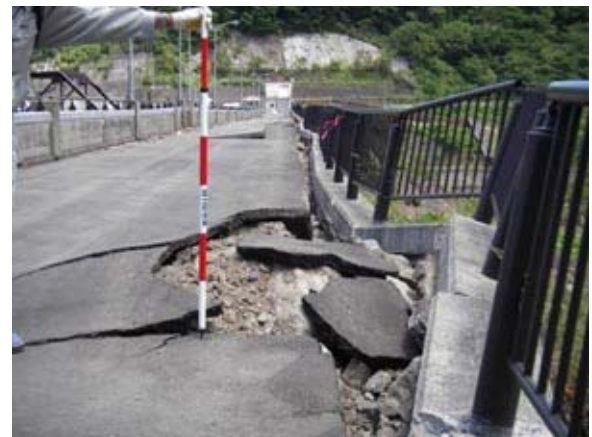
railing and pavement on the shoulder of the slope at the crest. On the downstream slope surface of the dam, projections were observed on the rock materials at the protruding parts of the wave on the crest pavement shown in Photos. 4 and 5, but damage of this kind was limited to high elevations. This dam was constructed by the dumped rock construction method as shown in Photo. 6 taken during construction. The piers for the railroad from where trucks dropped rock materials were left buried in the dam body. It is hypothesized that the whole dam body settled due to the earthquake, while the areas near the buried piers only settled a little. The maximum differential settlement is supposed to be about 50cm.

Photo.4 Gaps between the railing and pavement on the crest (Ishibuchi Dam) (Photographed by PWRI on June 15, 2008)

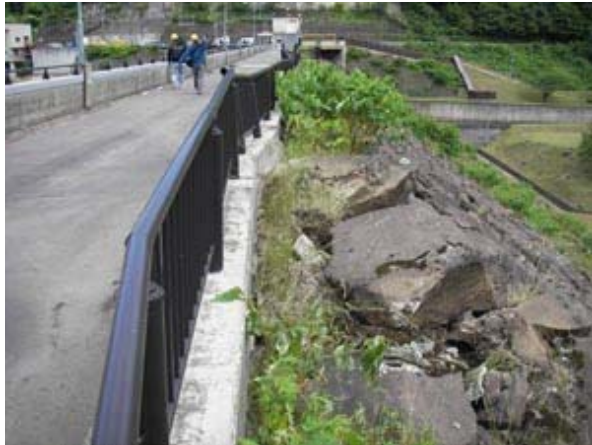
Photo.5 Projection of the riprap rocks around the top of the downstream slope (Ishibuchi Dam) (Photographed by PWRI on June 15, 2008)

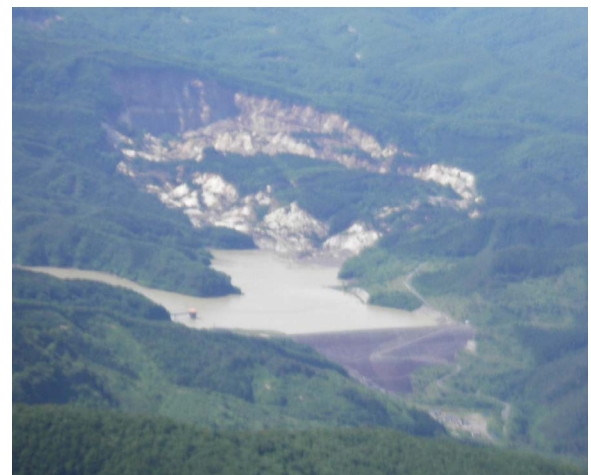
Huge landslides occurred around the reservoir on the left bank upstream from the dam. The largest landslide was 1.3km long, 0.8km wide, and approximately 67 million  $m^3$  in volume as shown in Photo. 7 of an aerial photograph. Approximately 1.5 million  $m^3$  of this landslide soil flowed into the reservoir. This corresponds to about 10% of the reservoir capacity of 14.13 million  $m^3$ .

Photo.7 Huge landslides around the reservoir of Aratozawa Dam (Photographed by PWRI on June 15, 2008)

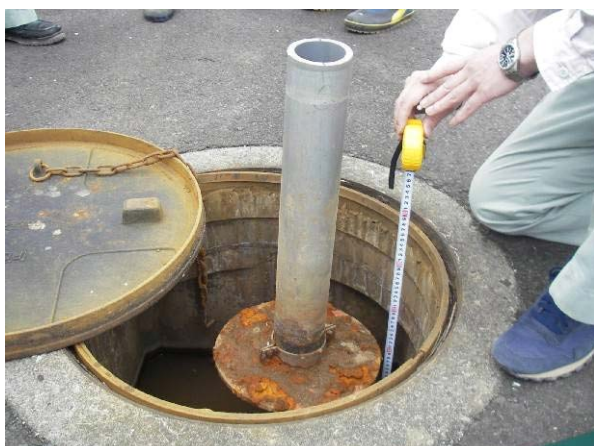
measured at the upstream slope shoulder of the dam crest. The surveying target was installed on the rock zone surface. Because the pipe of a crossarm gauge protruded about 40cm shown in Photo. 8, it is hypothesized that the large settlement occurred at the core zone in the center of the crest rather than at the rock zone. Regardless of the large settlement, no conspicuous cracks were found on the crest pavement surface shown in Photo. 9. In addition, no deformation of the riprap on the upstream

Photo.8 The pipe of a crossarm gauge protruded, as a result of the settlement of the dam body (Aratozawa Dam) (Photographed by PWRI on June 16, 2008)

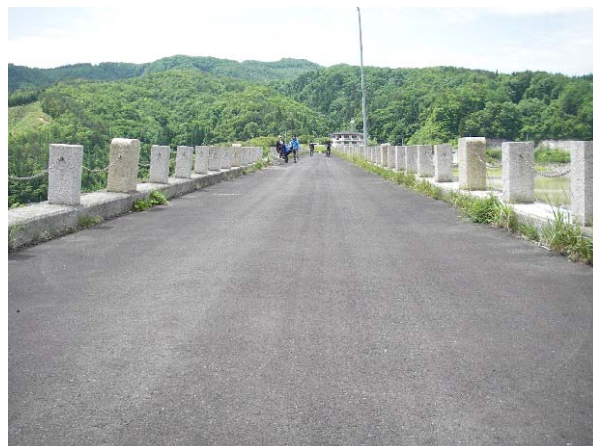
Photo.9 Few cracks in the crest pavement in spite of the dam body settlement (Aratozawa Dam) (Photographed by PWRI on June 16, 2008)

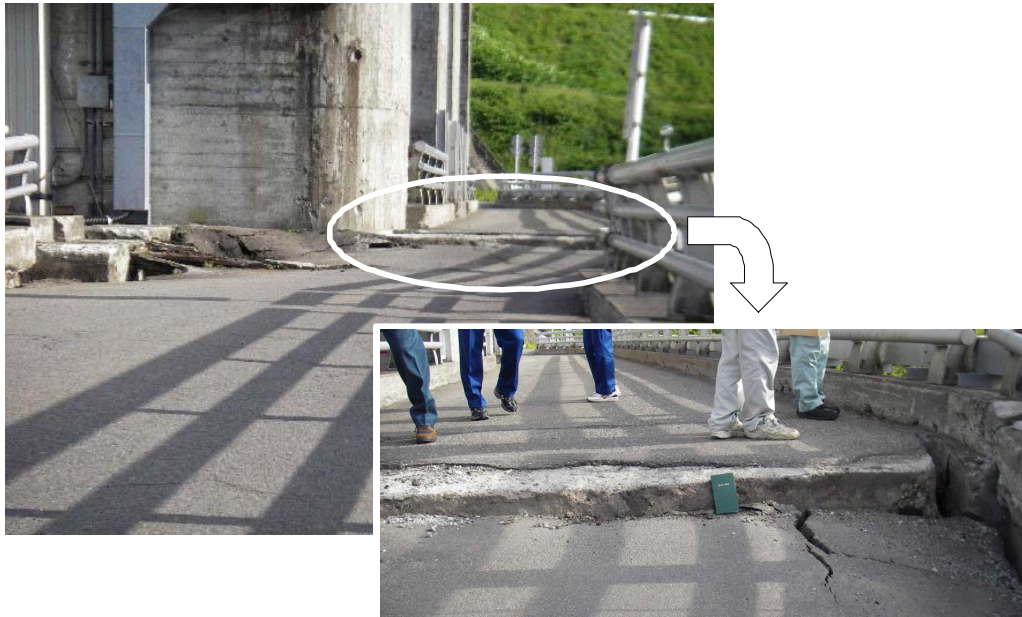
No cracks were confirmed on the pavement at the crest. Crest settlement of about maximum 14cm was observed, and at the connection of the spillway and the rockfill dam body, a level difference of about 15cm formed shown in Photo. 10. No deformation was confirmed on the upstream facing and the downstream rock slope surface.

Photo.10 Level difference occurred at the connection of the spillway concrete and the rockfill dam body as a result of the settlement of the dam body (Minase Dam) (Photographed by PWRI on June 15, 2008)

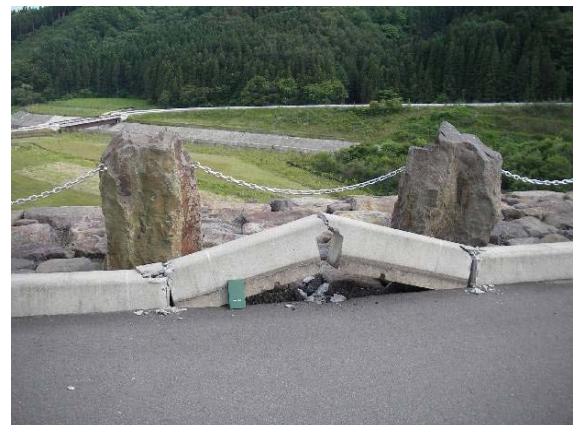
Photo.11 The damaged curbstone on the crest shoulder (Koda Dam) (Photographed by PWRI on June 16, 2008)

but the horizontal displacement in the dam axis direction was a little large at a maximum of about 13cm. And the curbstones on the crest were partially damaged by compression as shown in Photo. 11. No conspicuous cracks were, however, found on the crest pavement. And the riprap on the upstream and downstream sides was free of any deformation.
