# Damage to Buildings by EF5 Tornado in Iowa, U.S. on May 25, 2008

Hitomitsu Kikitsu<sup>1</sup> and Partha P Sarkar<sup>2</sup>

## ABSTRACT

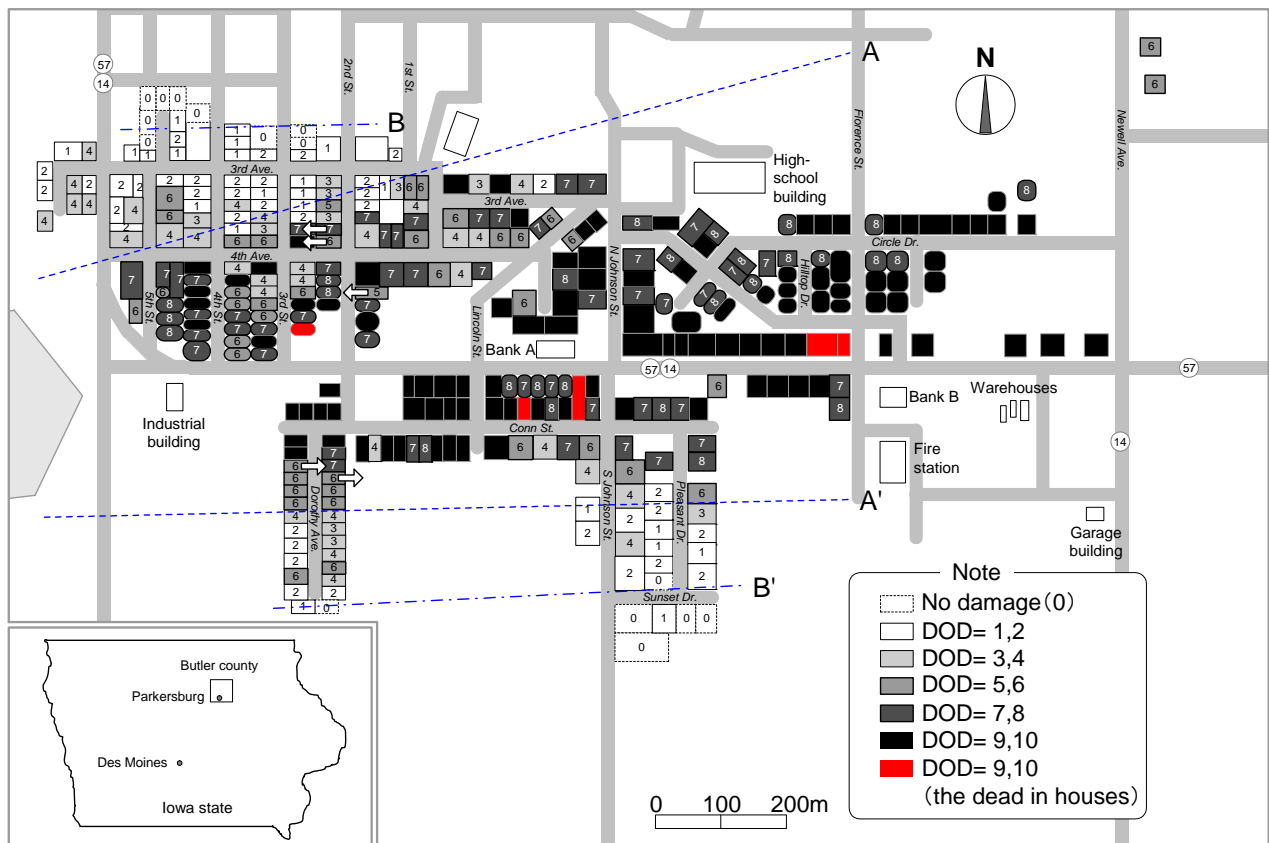
Figure 1 Distribution of damage to buildings in Parkersburg, IA

A rough map of Parkersburg showing the locations of the damaged buildings is given in Figure 1. Damage state of each house correspond to the degree of damage or DOD regulated for one- or two-family residences as shown in Table 1<sup>4)</sup>. The damage state is defined as DOD of 1 to 10 in EF scale. DOD of 1 to 4 indicate damage states in which non-structural components are mainly damaged, while DOD of 5 and more indicate damage states related to structural components including destruction of entire structure.

The most severe damage area, where almost all the houses were collapsed, is along highway 57th, Conn street, N Johnson street, and Circle street. Therefore, it can be estimated that the center of tornado vortex passed through highway 57th. According to the local newspaper, the casualties occurred in several

Generally, it can be noted that the boundary between severely damaged area and quite less damaged one is more distinguishable in tornado-induced damage than in the case of typhoon-induced damage<sup>5)</sup>. Based on that, line A – A' (Fig. 1) can be approximate boundary between structural components' related damage and non-structural components' related damage. Also line B – B' can be approximate threshold of visible damage to buildings. This result shows that houses suffering structural damage range in width of approximately 400 – 600m, and that houses suffering mostly non structural damage range in width of approximately 200m in both sides.

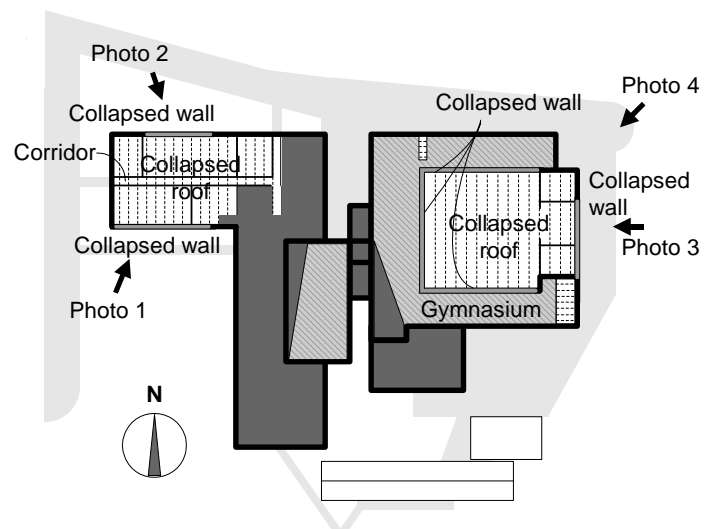
Damage to the high school building is shown below. The walls were made out of one external layer of brick and mortar and one internal layer of unreinforced concrete masonry unit (or CMU) and mortar, placed side by side while spanning between reinforced concrete columns. The roof was flat and it was supported by light steel truss spanning between the walls. It is observed that walls of the classrooms along the west side (Photos 1, 2) and those along the east side (Photos 3 – 4) were completely destroyed. Photo 5 shows the exposed steel reinforcement of the collapsed column that was part of a wall along the east side. Extensive roof damage of the school gymnasium can be seen in Photos 2, 3 and lots of broken glass were found scattered all around. The clock in Photo 1 shows the time of destruction when it stopped at 4:55 pm (CST).

Figure 2 Damage to high-school building

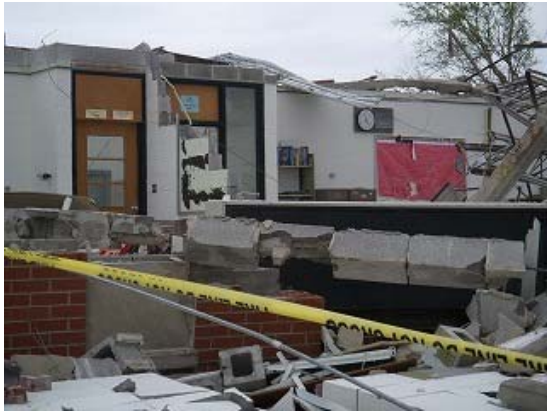
Photo 1 Collapse of wall of classroom

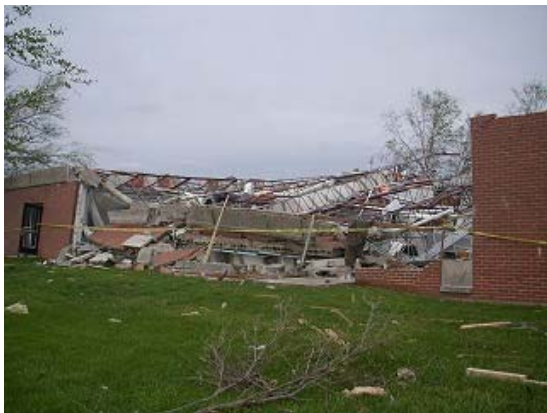
Photo 2 Collapse of wall and roof of classroom

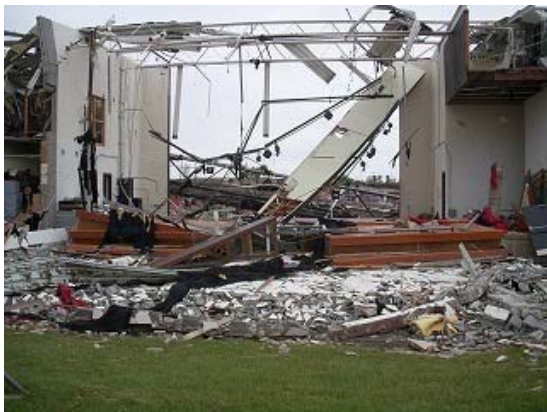
Photo 3 Collapse of wall and roof

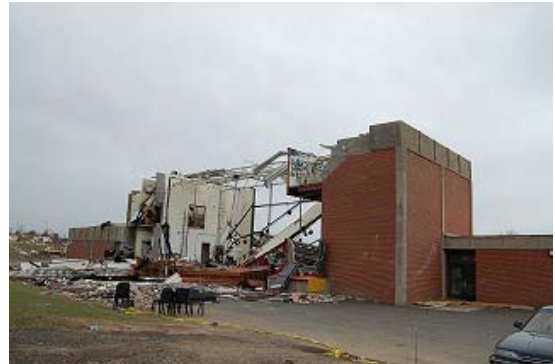
Photo 4 View of collapsed wall

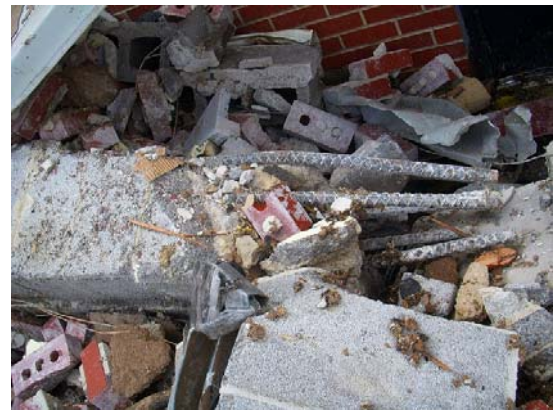
Photo 5 Failure of structural elements reinforced with bars

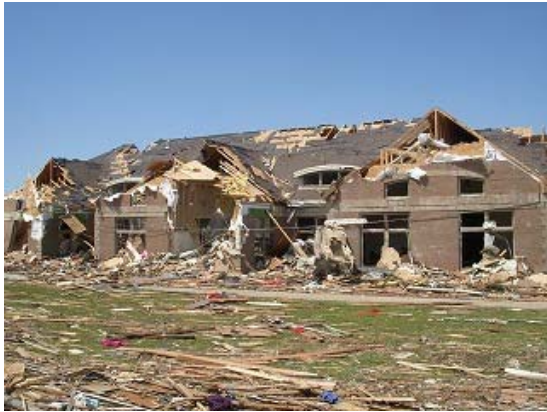
Damage to Bank A and Bank B buildings is shown in Photos 6, 7, and Photo 8, respectively. These were regular timber constructions with a brick veneer. The structural damage to Bank A building such as collapse of a wall resulted in much more devastation than that of Bank B building. It is surprising to note that although Bank A building, in spite of its location right along the tornado path, was the only building that stood and was not completely demolished. It should be noted that this was a newer construction.

Photo 6 View of damage from the south (Bank A)

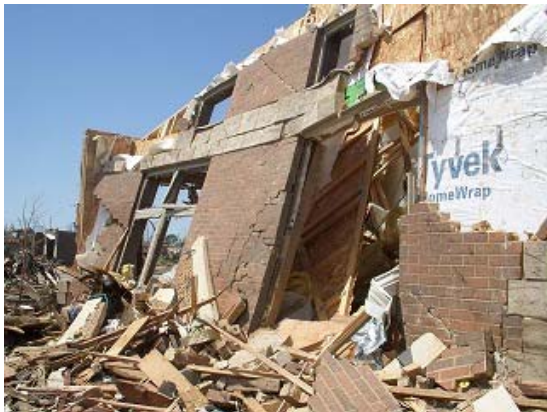
Photo 7 View of south west corner showing collapse of a portion of south wall (Bank A)

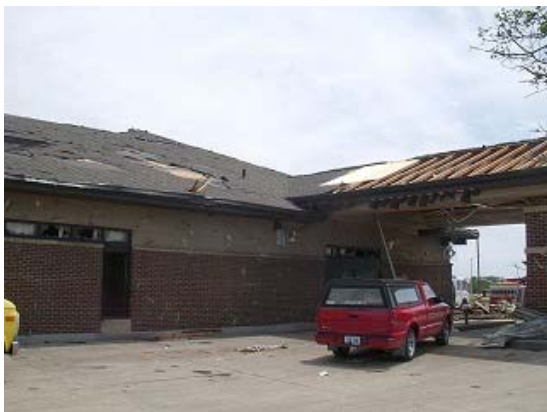
Photo 8 Damage to roof canopy (Bank B)

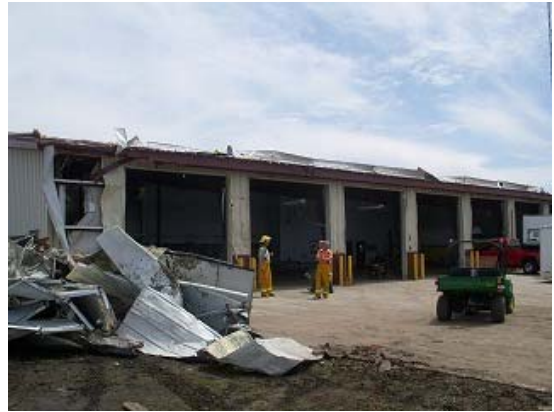
Damage to a fire station is shown in Photos 9 – 10 below. The fire station sustained minor damage but all seven out of its eight overhead shutters on the western side were completely lost (Photo 9). This is a typical metal building

Photo 9 West side of fire-station

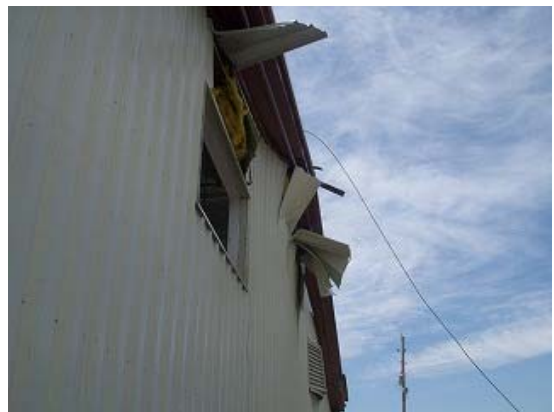
Photo 10 North side of fire-station

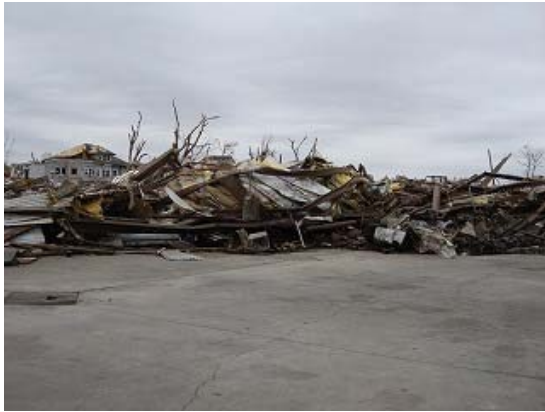
An industrial steel framed building with gable roof and a large roof span took the first hit from the tornado as it was located at the south-western corner of the town where the tornado first approached Parkersburg. The entire building was destroyed and only the concrete slab remained. The twisted steel frame and corrugated sheet metal are seen in Photo 11 and failed steel components and sheared welded joints are seen in Photo 12. All the columns of the building were sheared from their base.

Photo 11 Destroyed structural elements

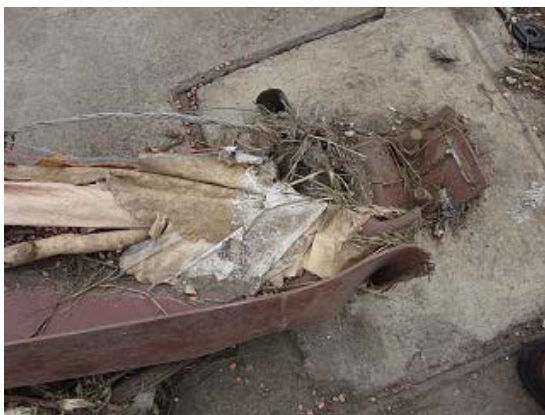
Photo 12 Failed steel component

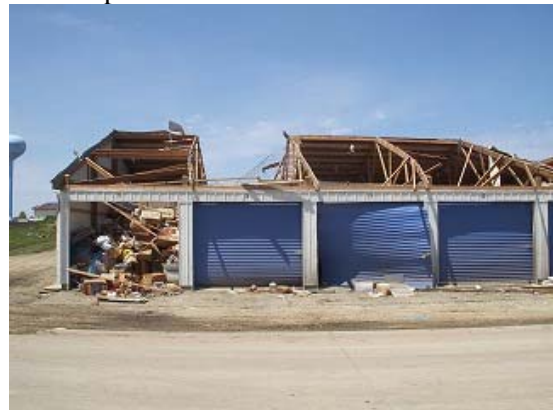
There were three warehouses (A, B and C) on Figure 1. Each of three warehouses has individual compartment rooms attached with shutters, which are arranged in line in both east and west sides. Damage to Warehouse A is shown in Photos 13 – 15. This one is located on the eastern-most end of the three warehouses that were built side by side and is the largest amongst the three warehouses. The end-most roof truss of this warehouse on the north side (Photo 15) and most of the roof on the east side are lost (Photo 13).

Photo 13 Damaged shutters and roof frames

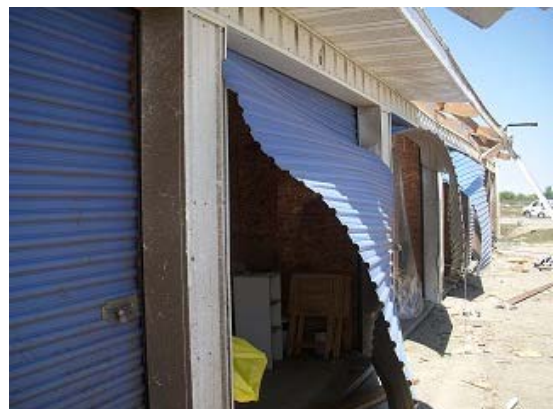
This warehouse sustained much more damage to its roof and shutters compared to the garage. This could be because it was closer to the path of the tornado than the garage. It is evident that a few of the shutters in the warehouse were pulled outward that is consistent with the loading produced by suction in the tornado vortex (Photo 14).

Photo 14 Pulled-out shutters

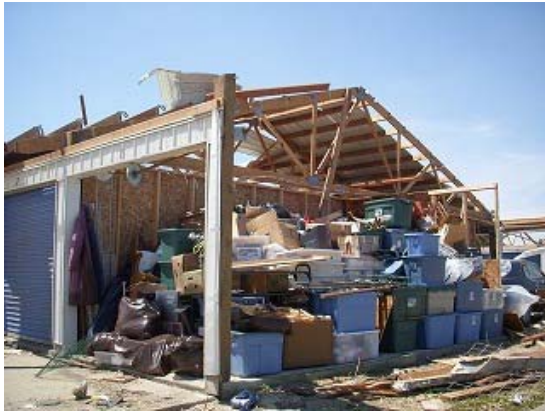
Photo 15 Loss of roof truss and wall

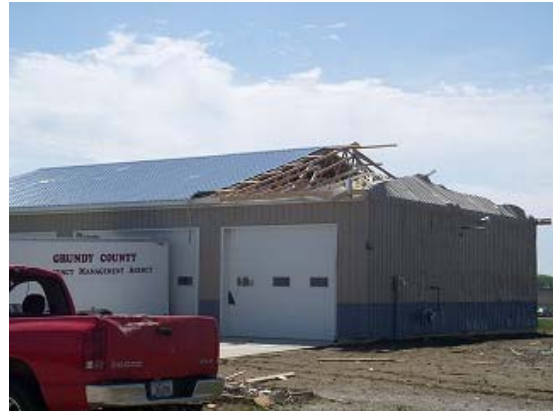
Damage to a vehicle garage is shown in Photos 16 – 17. The roof cover on the west side of the vehicle garage is lost. This building has a gable roof with its ridge oriented along the east-west direction. It is observed in Photo 16 that the damage to the roof and its gable end occurred at the west end which was the leading edge of the rotating flow. The overhead shutters that were on the north side performed very well, as seen in the photo. Photo 17 shows flying debris impact on the west wall.

Photo 16 Damage in west and north side

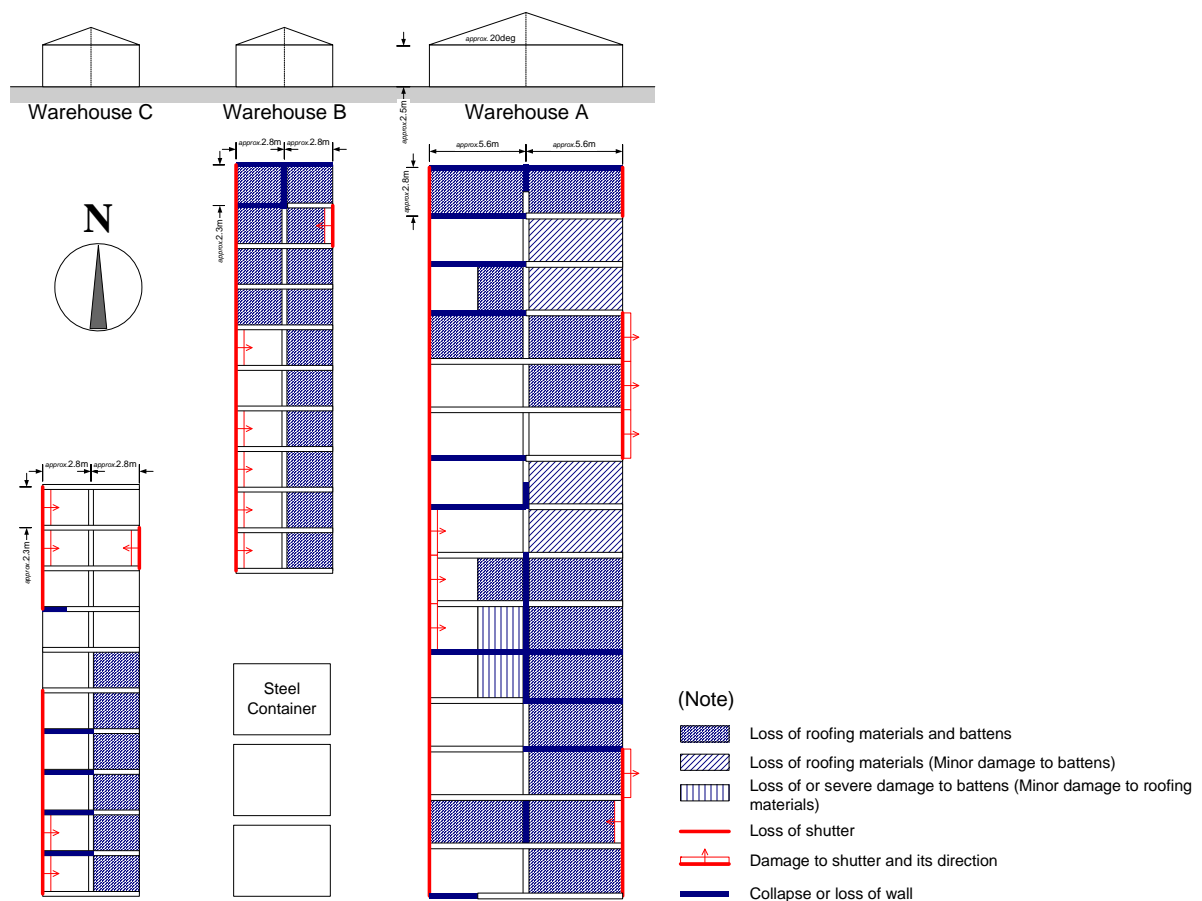
Figure 3 shows distribution of damage to roof

cover, shutter and wall of all the three warehouses in plan view. This shows marked contrast of damage states between east and west sides in each warehouse: there are severe damage to roofing systems and not so much damage to shutters in east side of each warehouse, while there are severe damage to shutters in west side of each one. Moreover, with respect to damage to shutters, almost all the damaged shutters in east sides were pulled outward as shown in Photo 14, while all the damaged ones in west side were pushed inward.

Figure 3 Plan view of damage to warehouses

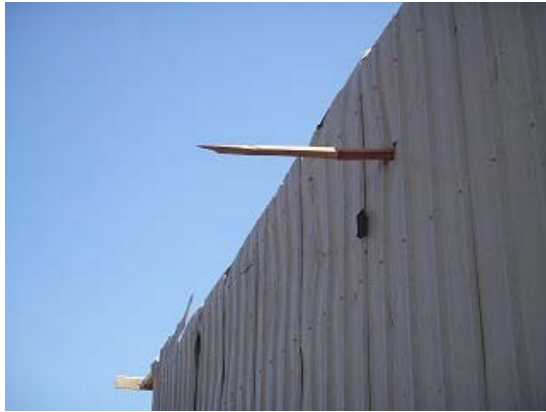
Photo 17 Flying debris impact on the west wall

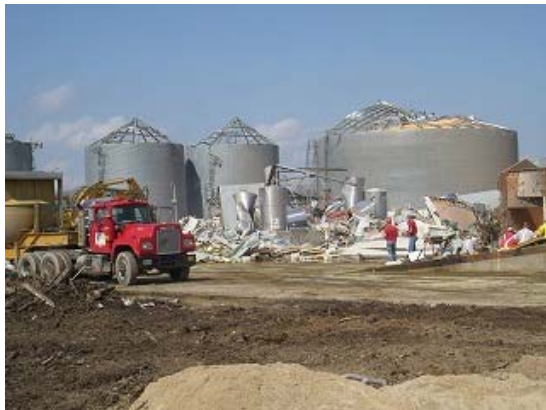
Damage to grain bins and tanks is shown below. This grain bin complex is located approximately two miles east of the most damaged area of Parkersburg along the tornado path. All the grain bin structures lost its dome-shaped roof (Photo 18). Severe buckling of the cylindrical shell (Photo 19) and overturning of the smaller tanks (Photo 20) could be observed. The buckling of the shell usually occurred in the top third or in the upper half portion of the structure. It was unclear whether these grain bins or tanks were empty or full or partially full.

Photo 18 Loss of dome-shaped roof

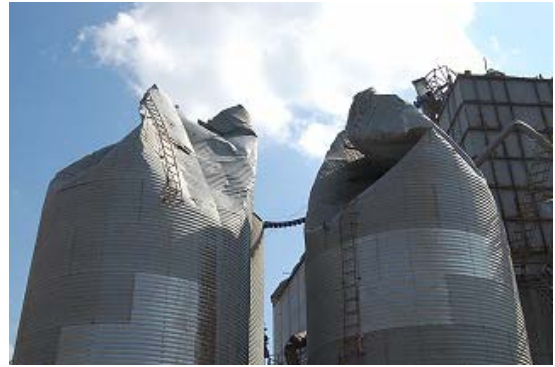
Photo 19 Severe buckling of the cylindrical shells

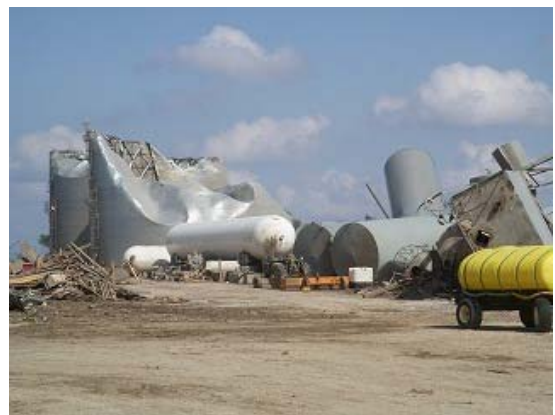
Photo 20 Overturning of smaller tanks

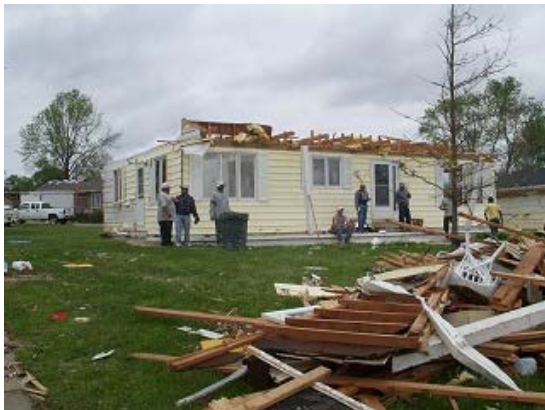
While most walls of buildings, as shown in Photos 21 – 23, are still intact, the roof is partially or completely lost. In addition, Photo 23 shows partial or complete collapse of one wall.

Photo 21 Complete loss of the roof

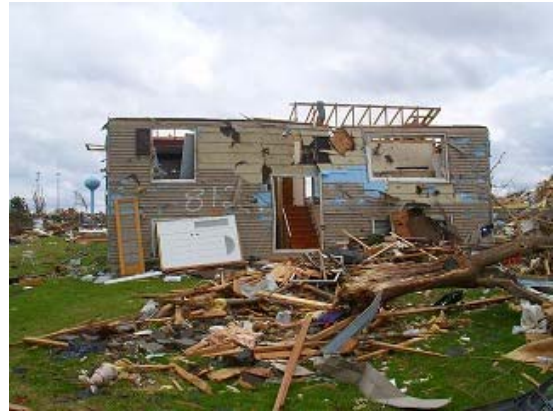
Photo 22 Complete loss of roof

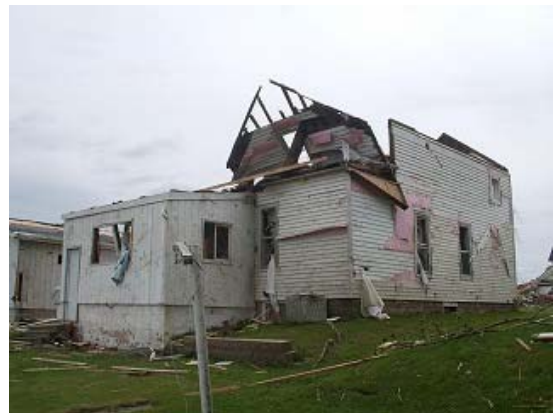
Photo 23 Loss of roof and overturn of the wall

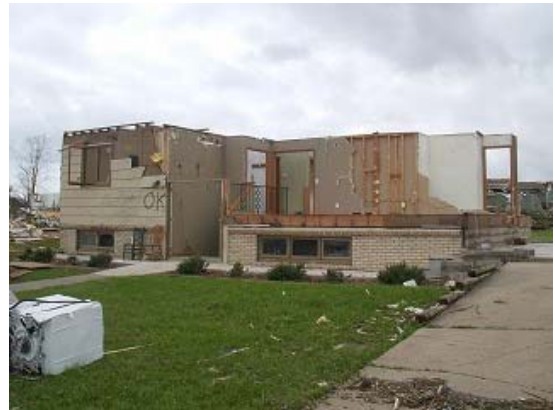
Photo 24 Partial loss of walls

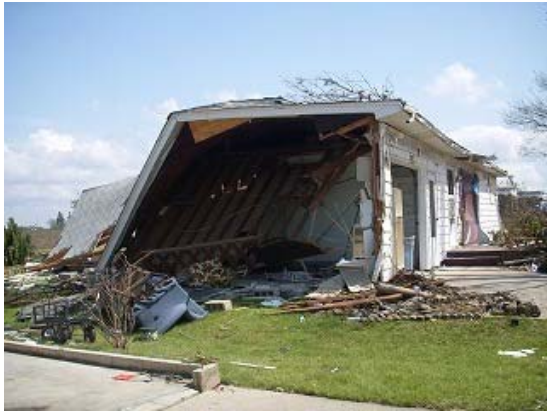
There were many damaged houses in which most walls (external or internal) had collapsed and the roof is completely destroyed. Photo 25 shows collapse of walls on three sides of the house resulting in the vertical collapse of the entire roof structure. In some cases, for example as seen in Photo 26, one room with interior walls remained intact.

Photo 25 Collapse of walls

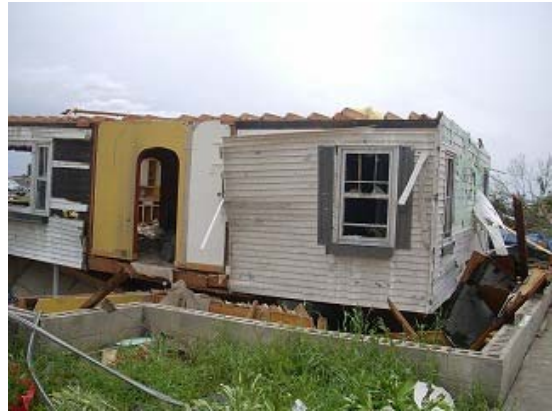
Photo 27 Lateral shifting of entire house

The entire house in Photo 27 is seen shifted off to the west direction. Another view of this house is shown in Photo 28. Entire house in Photo 29 is observed to be shifted in the east direction. This is consistent with the counterclockwise rotational direction of the wind where winds to the south of the path are in the east direction causing damage to buildings in Photo 29 and winds to the north of the path are in the west direction causing damage to building in Photo 27.

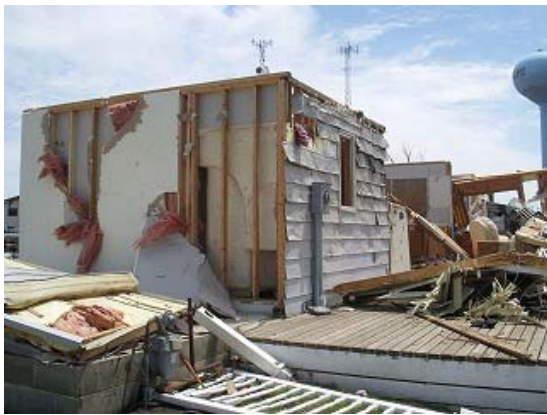
Photo 26 Intact small room

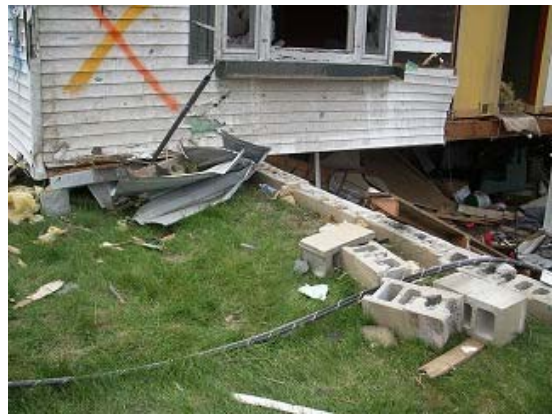
Photo 28 Collapse of continuous footing

This post disaster survey also revealed that new construction method in all the seriously damaged houses chose continuous footing made from reinforced concrete as shown in Photo 35, because continuous footing that were damage and exposed, as shown in Photo 28, showed inadequate reinforcement.

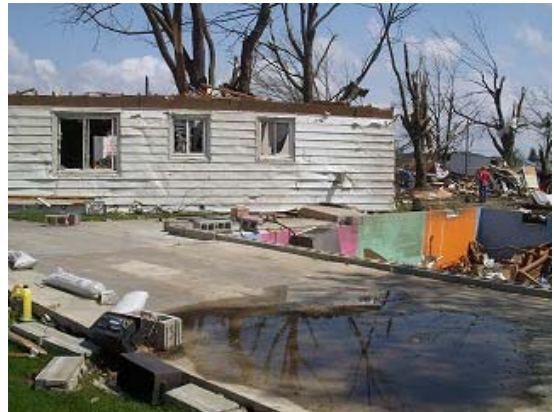
Photo 29 Lateral shifting of entire house

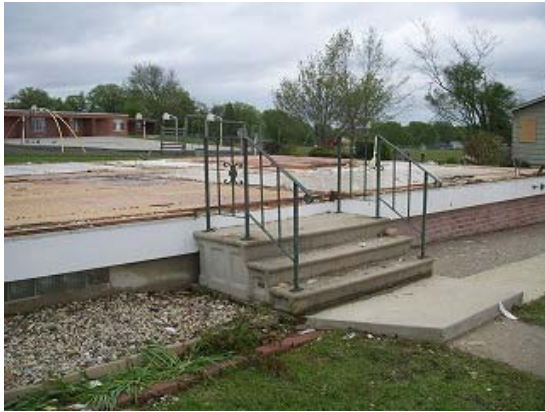
Loss of entire house can be categorized into two damage modes — one where the floor slab remains on the foundation (Photo 30) and the other where the floor slab is swept clean (Photo 31).

Photo 30 Loss of entire house

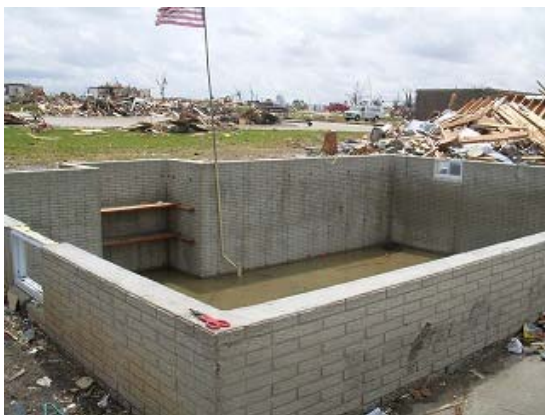
Photo 31 Loss of entire house and swept-clean floor slab

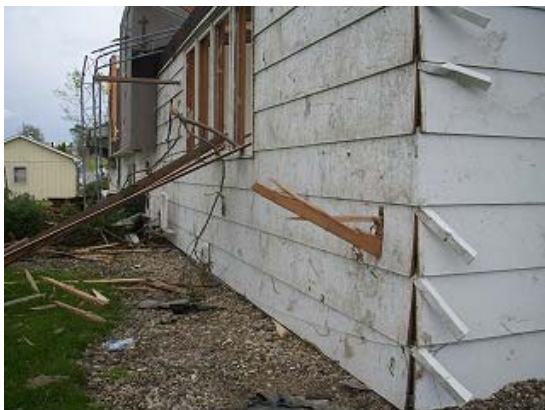
Moreover, in partially damaged houses, impact of flying debris on walls or glasses could be seen in Photo 32. Most of the debris is timber structural component from failed homes (Photo 33).

Photo 32 Damage of wall by wind-borne debris impact

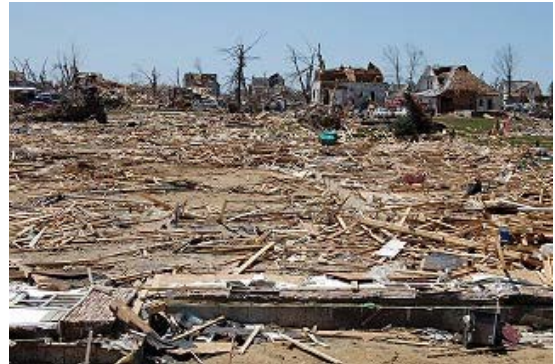
Photo 33 Scattered timber components

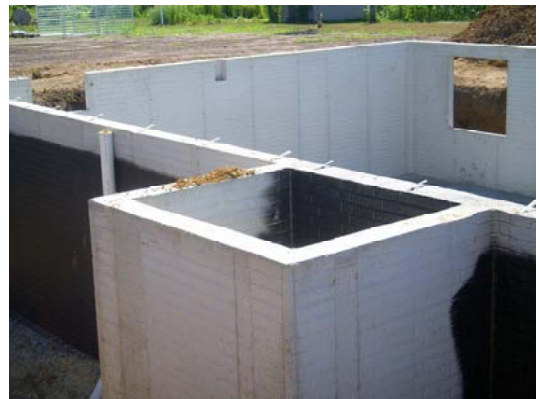
Photo 35 New construction of continuous footing and basement
