Damage Investigation of Maturube Bridge during the 2008 Iwate-Miyagi-Nairiku Earthquake

ABSTRACT

2. DAMAEG INVESTIGATION OF MATSURUBE BRIDGE

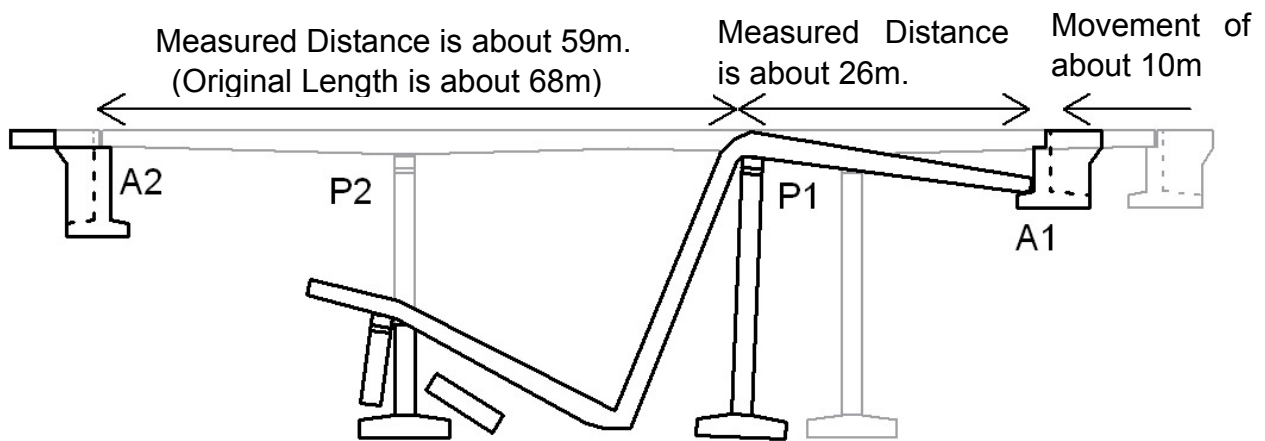
Fig. 3 Measured Distance Changes between Substructures

The distance between the locations of substructures was measured by using simple method at the site. Although it is necessary to measure more accurate manner, **Fig.3** shows the measured values. The distance between A1 abutment and A2 abutment shortened to about 85m. Since the original distance was about 95m, so the distance shortened by about 10m. The distance between A1 abutment and adjacent P1 pier was about 26m. Original distance was 27m, so some shortening was found. On the other hand, the distance between P1 pier and A2 abutment was 59m. Since original distance was about 68m, therefore, about 9m shortened. The distance between A1 abutment and P1 pier was not so much change but the distance change between P1 pier and A2 abutment was about 10m. That means that the A1 abutment and P1 Pier moved toward P2 pier and A2 abutment.

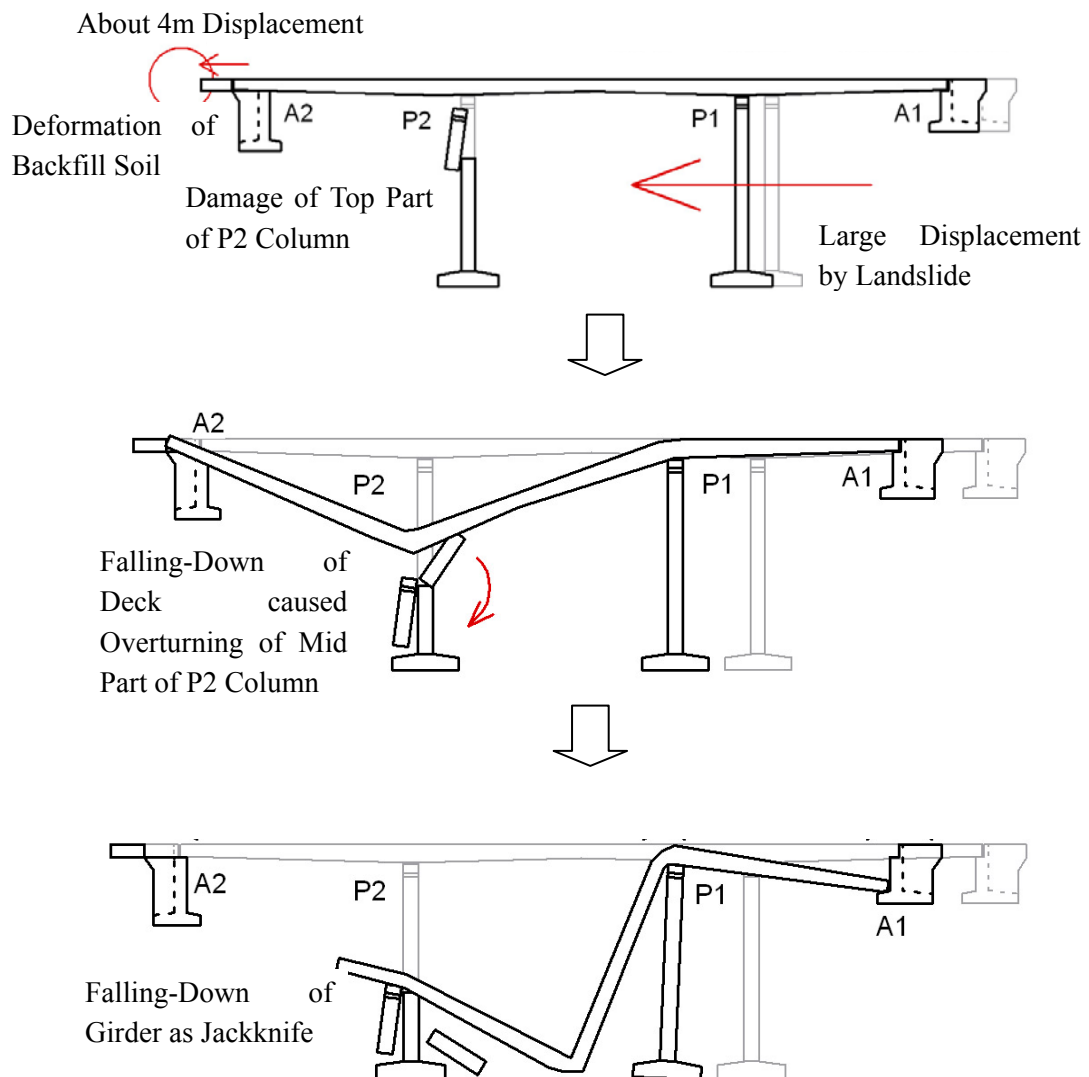
Fig. 4 Estimated Sequences of the Bridge Collapse

- 1) The failure and slide of the mountain slope was developed by the earthquake shaking and the abutment and pier which were supported by the slope moved with the landslide.

- 2) In particular, considering the evidence of the heavy damage and cracks at the backside soil of A1 abutment, A1 abutment and P1 pier moved to the direction of A2 abutment. At the same time, the superstructure was pushed to the direction of A2 abutment and P2 pier. That resulted in the collapse of P2 pier and damage to the parapet wall of A2 abutment, then the superstructure fell down like a jackknife.

- 3) P1 pier was separated into 3 parts. The column had two termination sections of longitudinal re-bars at mid-height. It was estimated that the terminated section became relative weak sections when the column was subjected to the extreme large displacement. The upper section with termination of longitudinal re-bars of P2 pier firstly failed because of the large displacement of superstructure, the top part fell down to the A2 abutment side. Then the superstructure was broken and settled down because of dead weight with losing the support from P1 pier and the continuous displacement from the slope, finally the superstructure fell down as a jackknife. When the falling down of the superstructure to the ground, the middle part of column of P2 pier was overturned to the P1 side with the falling superstructure.

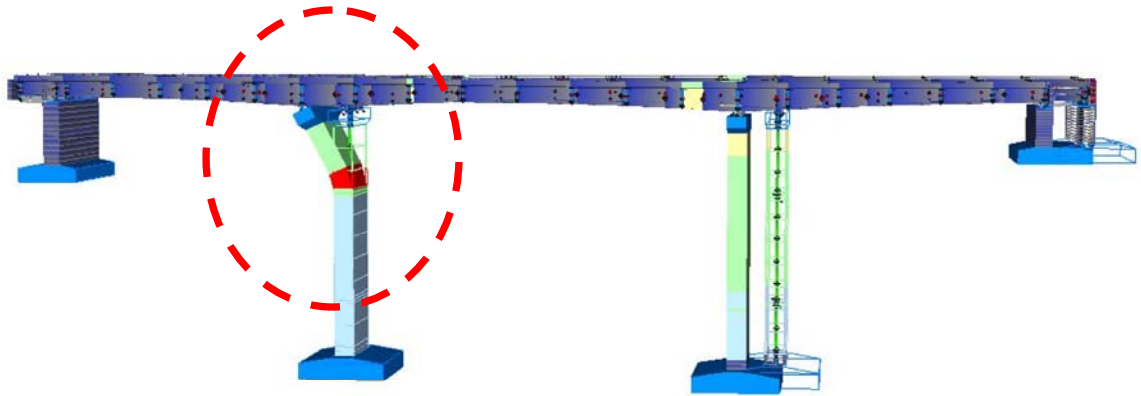
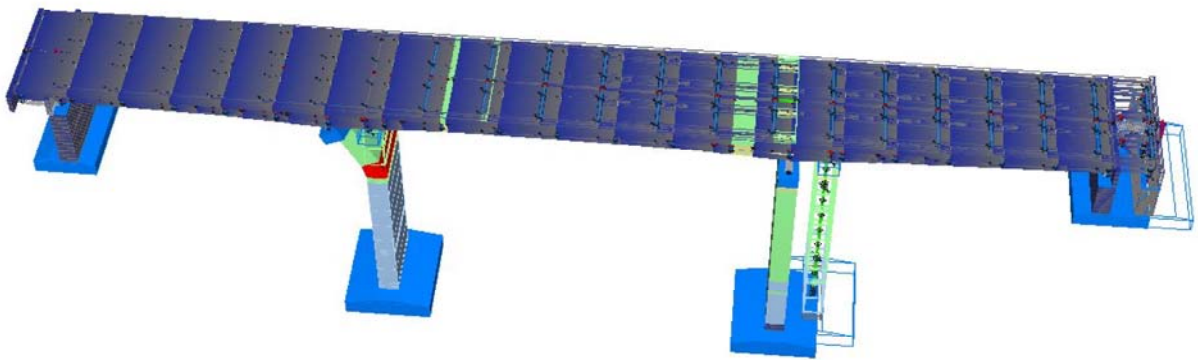
Fig.6 shows the preliminary results obtained from the pushover analyses. Upper section of the termination of longitudinal re-bars was found to be failed firstly and the top part of P2 pier pushed to the direction of A2 abutment. It is estimated from the analyses that the failure and falling down of the top part of the P2 pier was caused by the large displacement of the superstructure. The failure of the parapet wall of A2

(a) Failure of Top Part of P2 Pier caused by the Displacement

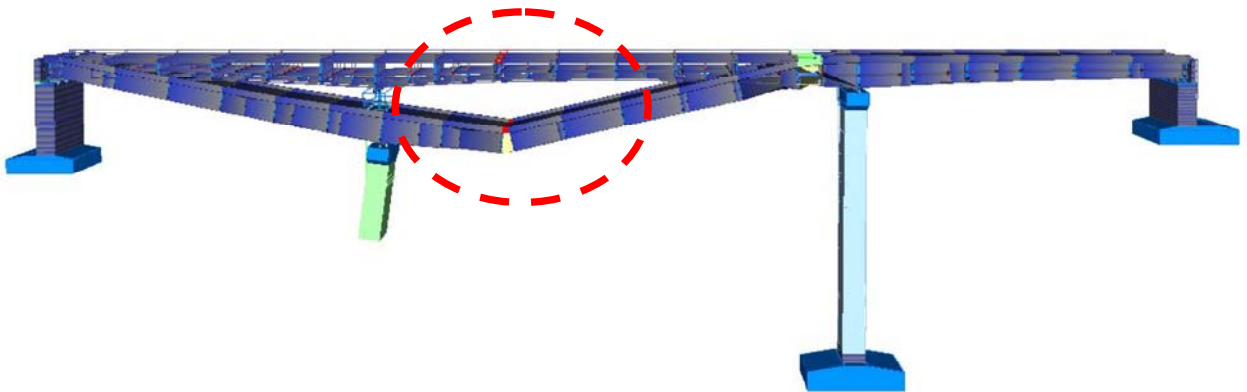
abutment also found because of the push-into of the end of the superstructure. Therefore, the failure mode in the first stage was almost reproduced by the simulation analysis.

(b) Possibility of Jackknife Failure of Girder with Losing Vertical Support by P2 Pier

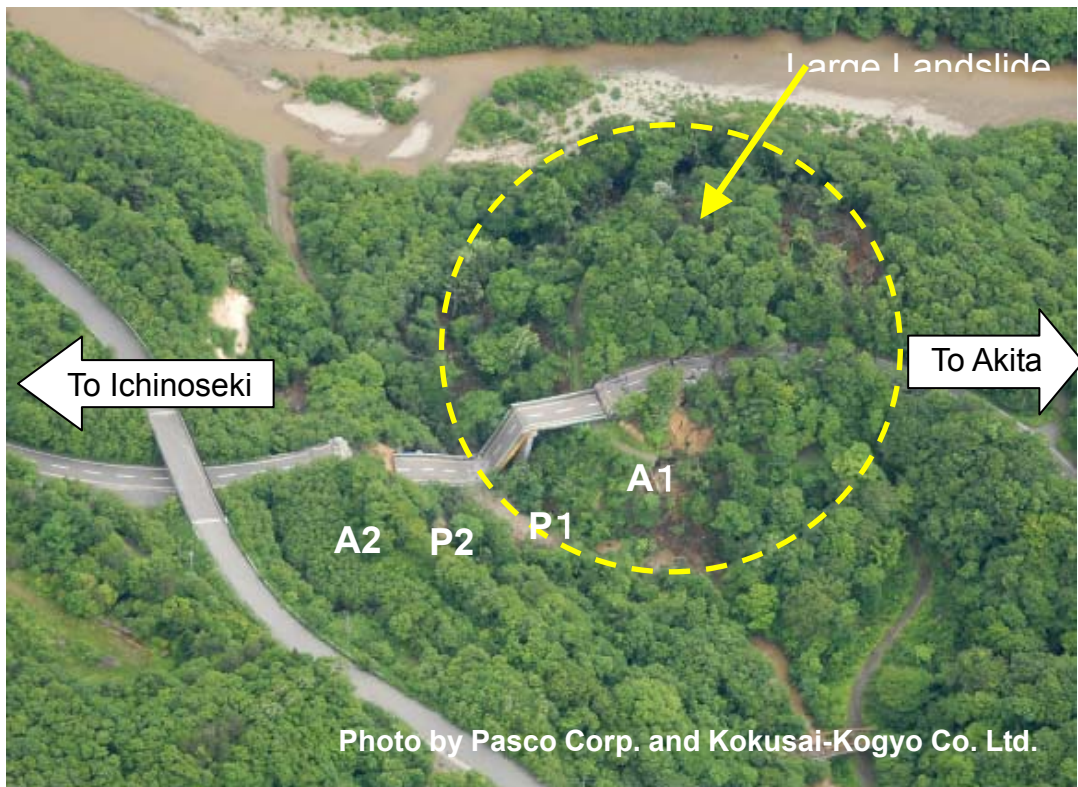
Photo 1 shows an aerial photo of the collapsed bridge. The photo was taken and provided by the Pasco Corporation and the Kokusai Kogyo Co., Ltd. It is understood that P2 pier was collapsed and a part of superstructure between A2 and P1 fell down to the ground. Deck end at A1 abutment also fell down from the seat of the A1 abutment. Looking at the mountain area at the back of A1 abutment, some large cracks and slope deformation were recognized. It was estimated that the landslide in the part of mountain slope occurred and that the slope moved to the bridge and affected on the collapse.

Photo 1 Aerial Photo of Maturube Bridge

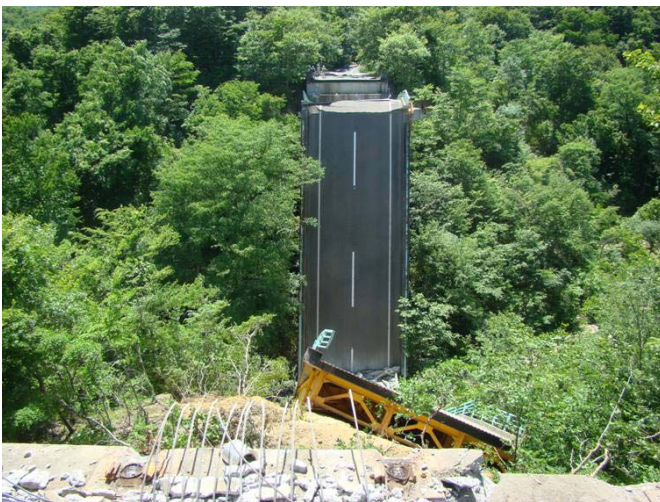
As wrote in the above, the superstructure between A2 abutment and P1 pier fell down to the ground as a jackknife. Deck end also fell down from the seat of the A1 abutment. At P1 pier, the steel girders were broken and overturned laterally because of the falling down of the superstructure between A2 abutment and P1 pier.

Photo 2 Collapse of Superstructure

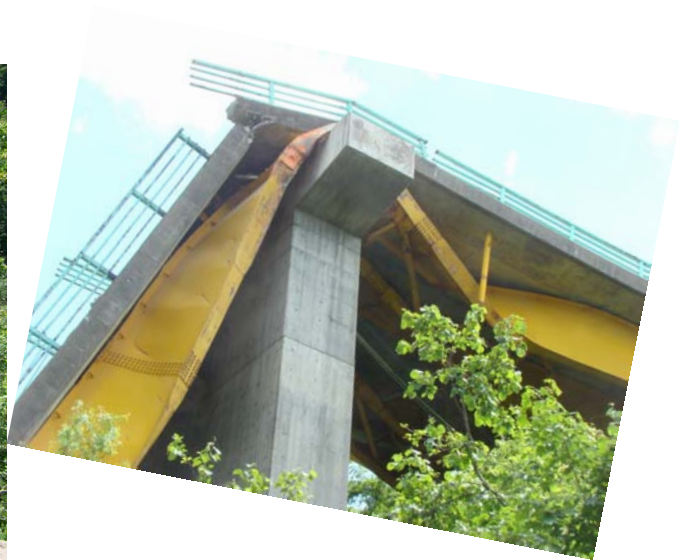
Small cracks were observed at the mid-height section of the column, they were possibly at the section of the concrete placement joint. But the columns itself was not damaged remarkably. The pier was inclined so that the pier top is close to A1 abutment and the

Photo 3 Damage of Girder on P1 Pier

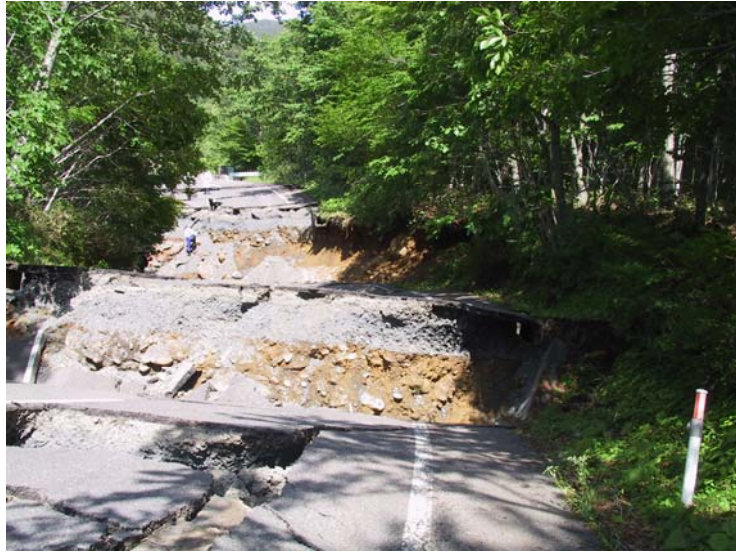
Road surface at the backward of A1 abutment failed heavily and large cracks and slips of the soils were developed. Significant cracks from parapet wall to the abutment wall were also found at the side of abutment.

Photo 4 Large Cracks and Slips of Backfill Soils at A1 Abutment

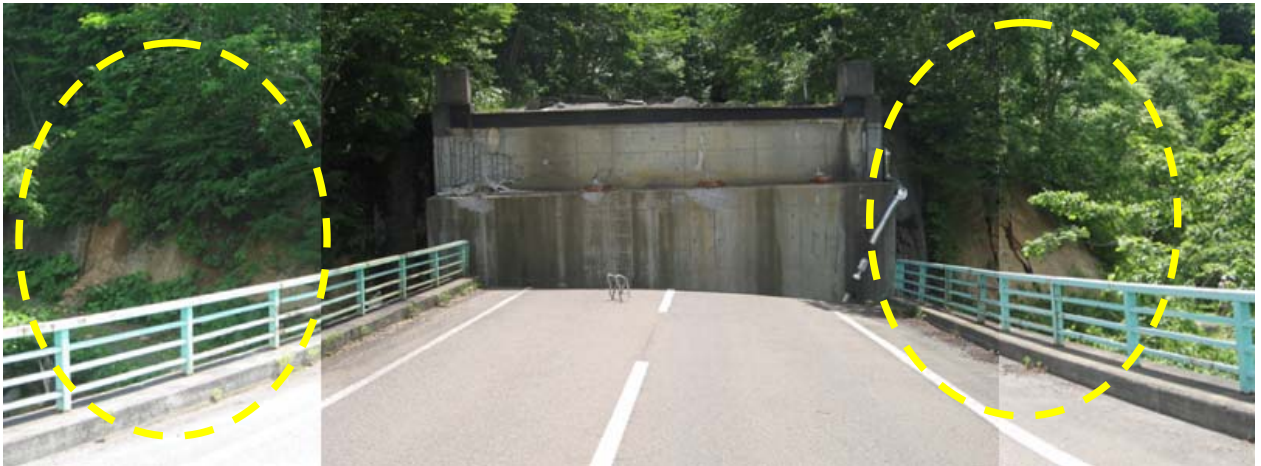
Photo 5 Crack at Slopes in the Back of A1 Abutment

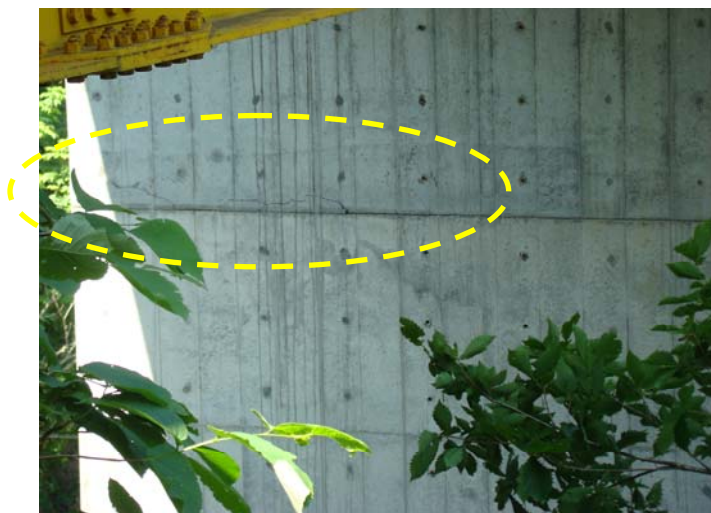
Photo 6 Crack at the Pier P1 (Around Joint of Concrete Placement)

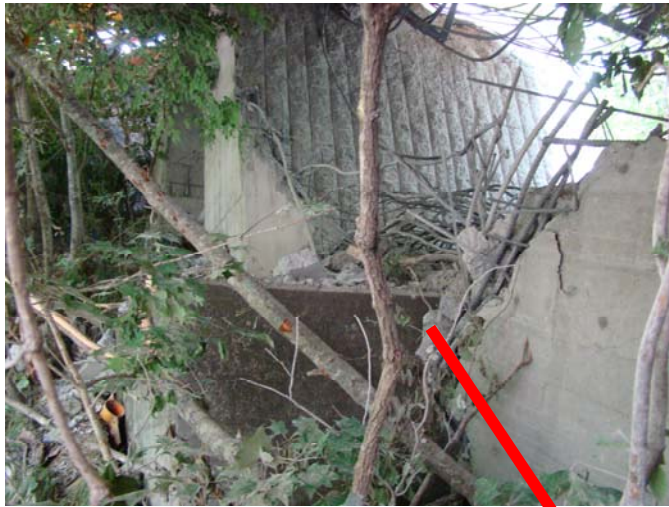
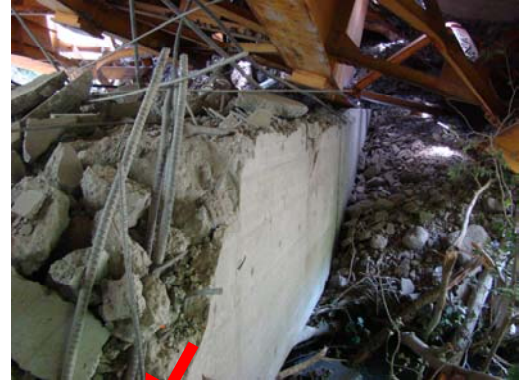
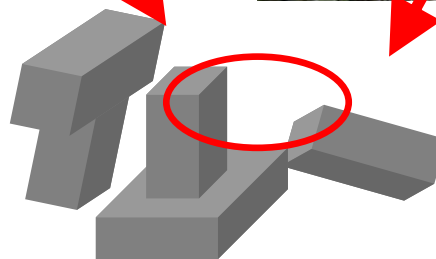
P2 pier failed in the particular failure mode. The column was broken and separated into 3 parts. Two parts fell down just around the bottom of original column. Top part of the column just fell down in the A2 abutment side and stood just along the bottom part column. The middle part of column fell down and overturned in the opposite A1 abutment side. The bottom part still remained at the original position.

Photo 7 Damage of P2 Pier

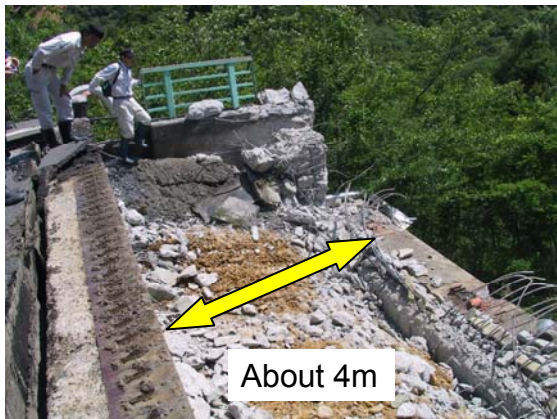
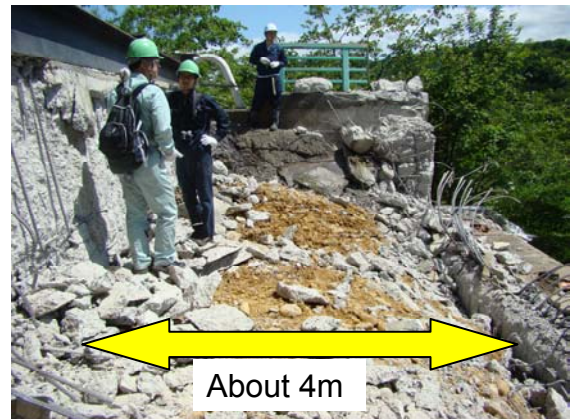
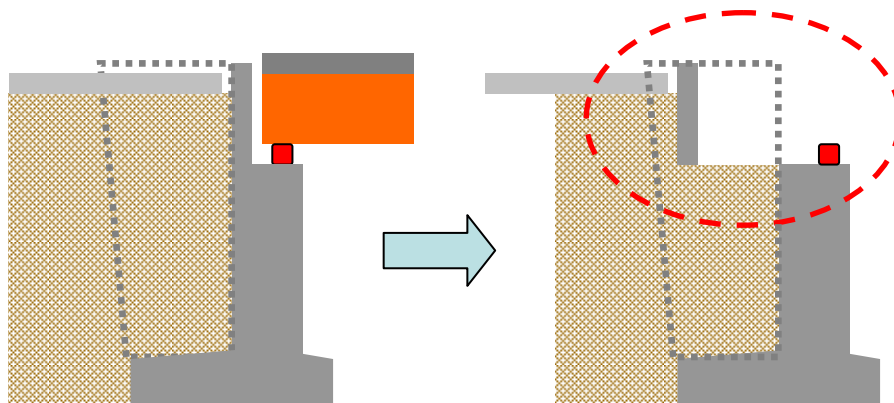
The particular failure mode was also found at the A2 abutment. Parapet wall was failed and pushed into the backfill soil. The push-into distance was about 4m. The evidence to show the impact between the deck end and the parapet wall was recognized at the surface of the parapet wall and the end section of the steel girders.

Photo 8 Damaged of A2 Abutment (Failure of Parapet Wall)

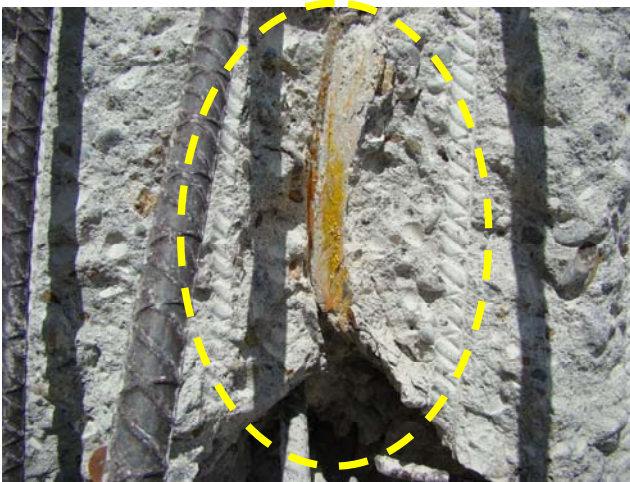
(a) Surface of Parapet Wall

Photo 9 Evidence of Impact between Parapet Wall and Girder End

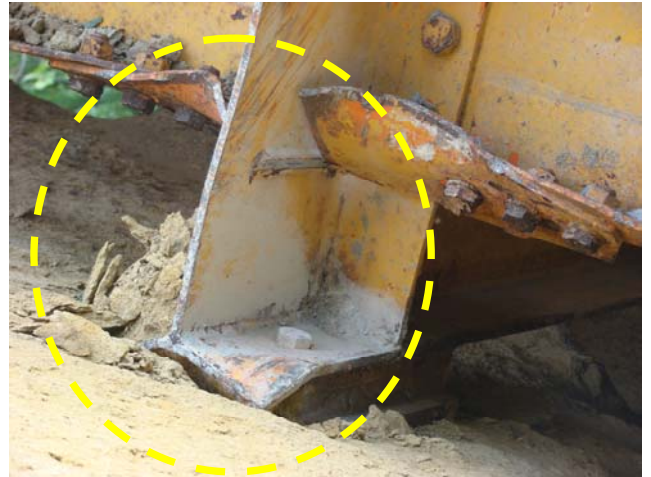
(b) Girder End
