The Lessons Learned from Wenchuan Earthquake on Highway Bridges

W. Phillip Yen¹, Genda Chen², Mark Yashinski³,

ABSTRACT

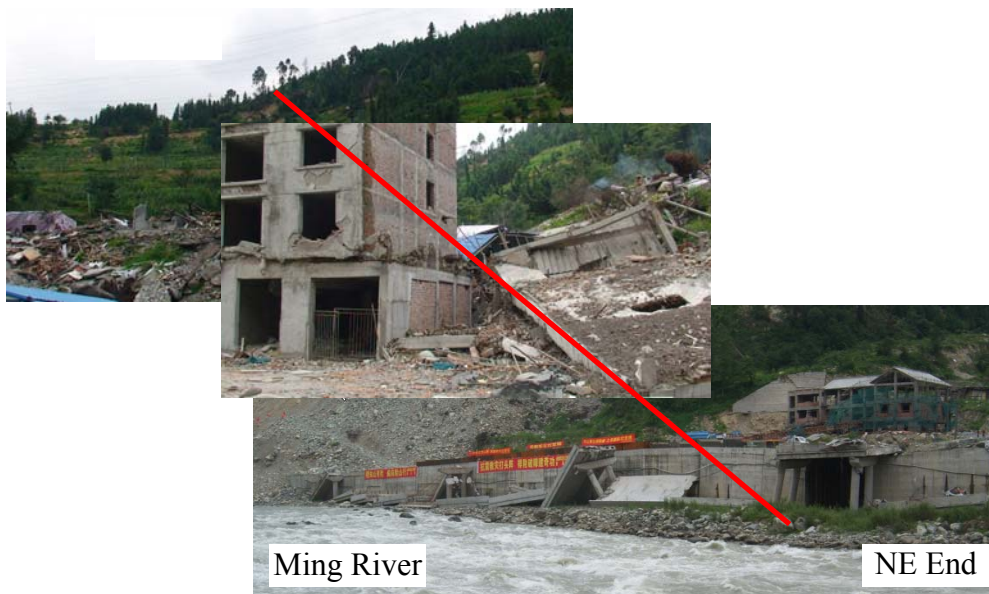
The epicenter of the May 12 Wenchuan earthquake is located near Yingxiu in Wenchuan County, Sichuan Province. The surface rupture of the center fault in the Longmen-Shan fault zone was observed in Yingxiu as illustrated in Figure 5. The thrust fault appeared to cross the Ming River in right angle. As shown in Figure 5, the earthquake left behind a distinct dislocation on the river bed at the northeast (NE) end of the surface rupture. The northwest (NW) side of the fault on the upstream of the River moves upward against the southeast (SE) side of the fault. The fact that one deck panel along the expressway elevated bridge was still supported by one pier in Figure 3 indicated the sudden push by a near-field pulsing effect.

Figure 3: Surface Rupture of the Earthquake Fault

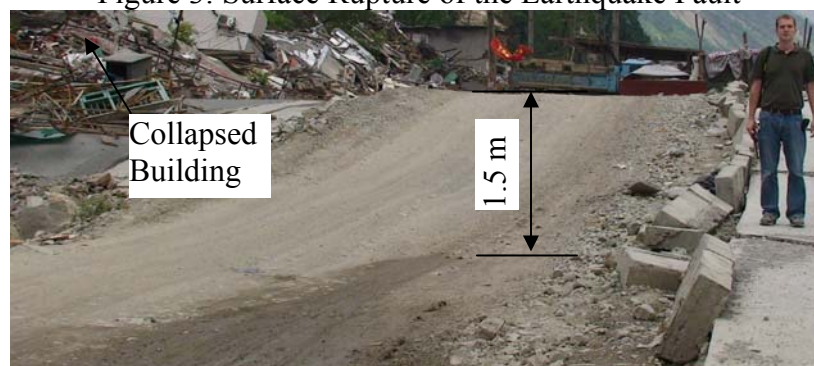
sudden change was also evidenced as shown in Figure 5 on the slope of the mountain behind the building. A closer look at the old Dujiangyan-Wenchuan highway in front of the building indicated that the vertical dislocation is approximately 1.5 m as illustrated in Figure 4.

Figure 4: Surface Rupture along the Old Highway near the Collapsed Building

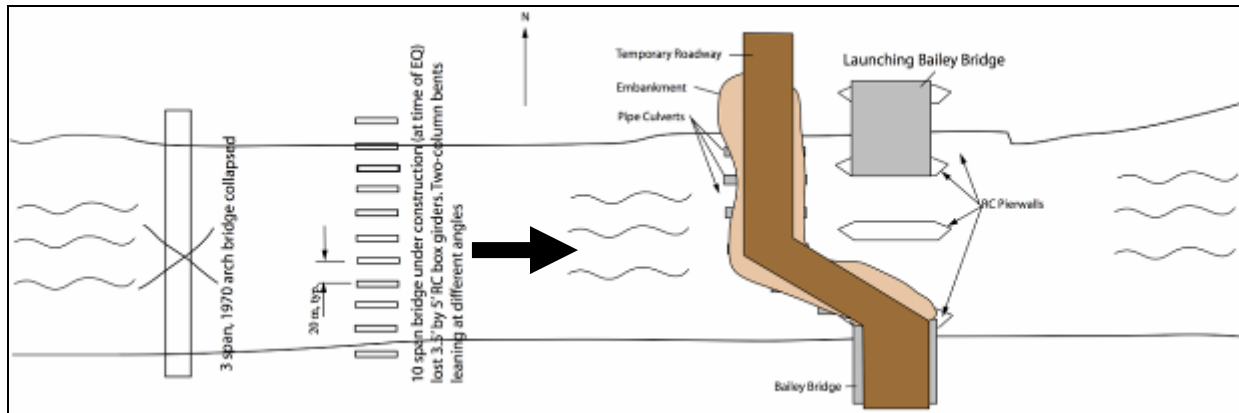
On the other side of the Ming River was a five-story building with a construction joint between two similar parts. The right side of the building as shown in Figure 5 was completely collapsed while the left side of the building only lost the second story and suffered structural damage in walls. A

Three bridges crossed a river (river's name was not known) near Nanba Town as shown in Figure 5. The west structure was a concrete and masonry three-span arch bridge built in the 1970s. The old arch bridge completely collapsed during the earthquake as shown in Figure 6. Immediately downstream of the arch bridge was a 10-span river crossing (on a 10° skew) that was under construction during the earthquake, as shown in Figure 7. Each 6 m long span was simply supported on two-column bents and seat-type abutments with 560 mm seats. As shown in Figure 8, each span consisted of eight precast box girders with a cross section of 1067 mm by 1520 mm. Each girder was supported on two 200 mm round elastomeric bearings at each end. The girders were in place but the concrete deck had not yet been poured at the time of the earthquake as seen from Figure 5.

Figure 5: Three Bridges at Nanba Town

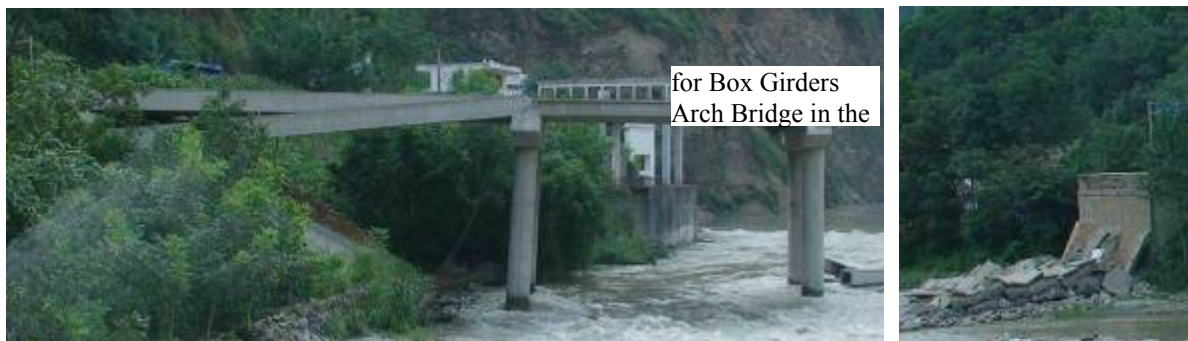
such, the three-span arch bridge must have been damaged by ground shaking, perhaps exacerbated by soil movement. Liquefaction, lateral spreading, or other soil movement may have been also responsible for the distortion of the two column bents. The reconnaissance team was not able to discern what type of foundation system the bents were supported on, but apparently they were not sufficiently embedded into good material.

Figure 6: Collapse of the Old Three-Arch Bridge

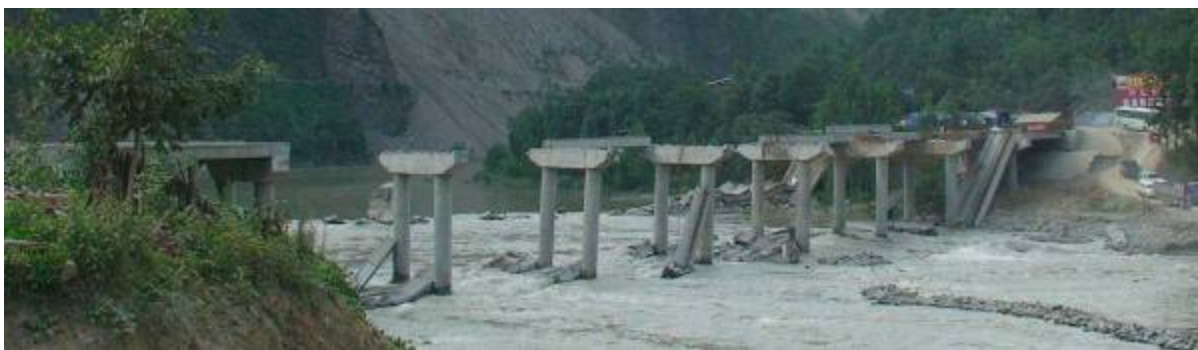
As shown in Figures 7 and 8, most of the box girders of the new bridge dropped into the river and the two-column bents were distorted. The end box girders were transversely displaced by approximately 760 mm. The deck hadn't been poured, there wasn't any real transverse bracing or shear keys, and girders were on a slight skew, all of which contributed to the damage. Also, many of the bents were leaning or distorted, but with no damage visible above the waterline.

Figure 7: Damage Scenario of the 10-span Bridge under Construction during the Earthquake

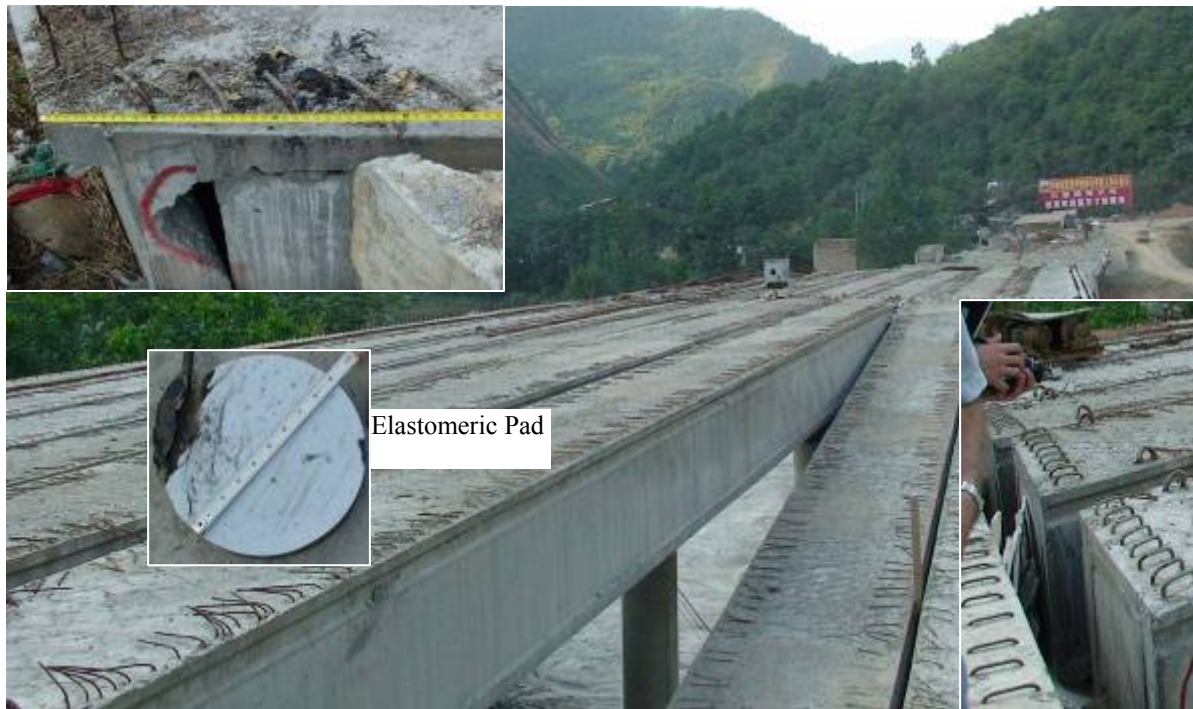
Figure 8: Damage to the 10-Span Bridge under Construction

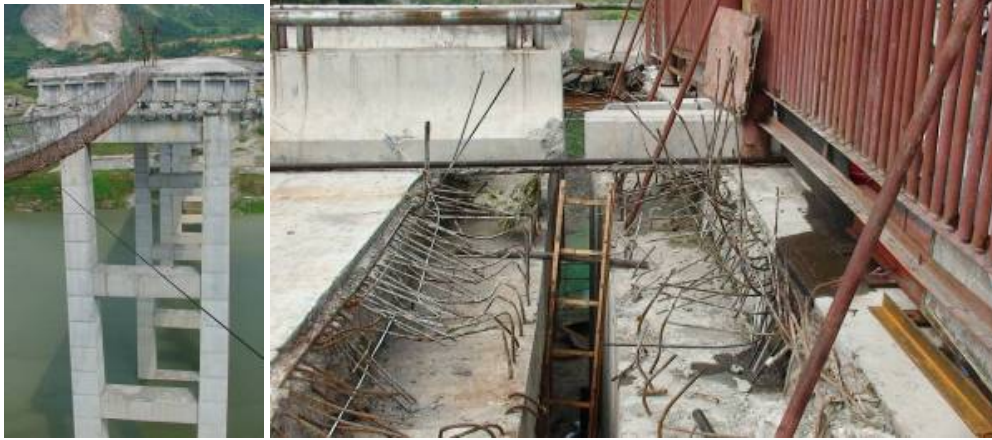
As shown in Figure 13, the approach span near the tunnel is a two-span, RC girder structure with 50 m span length each. The bridge deck is supported on five RC girders and two-column bents with several cross struts. As indicated in Figure 13, the bridge deck is continuous but the girders are simply supported on the bents. The main bridge is a continuous, non-prismatic, three-span structure supported on two intermediate wall piers with 125 m, 220m, and 125m length, respectively. The superstructure is a single-cell box girder structure. The depth of girders varies to a maximum depth of 4.0 ~ 4.5 m.

The construction of the bridge was near completion except for the installation of expansion joints at the time of the earthquake. The most severe damage was to the end span of a five-span T-girder segment that became unseated at the expansion joint end, fractured in the continuous deck at the other end due to gravity load, and fell off the supporting bent caps during the earthquake. The bent seats were approximately 300 mm in length but the bridge experienced at least 500 mm of longitudinal movement due to earthquake shaking. Since the columns of each bent are approximately 105 m tall, the accumulated displacement at the bent cap was likely significant during the earthquake. There were other indications of large longitudinal movement. The barrier rails were overlapped by about 300 mm at the southeast expansion joint. The barrier also displaced transversely for approximately 250 mm. Divers found cracks at the bottom of the main span columns due to earthquake shaking. Shear key failure was also observed as shown in Figure 50. After the earthquake, the bridge deck was jacked back into place with hydraulic jacks.

Figure 13: Drop-off Span and Construction Details between Two Spans

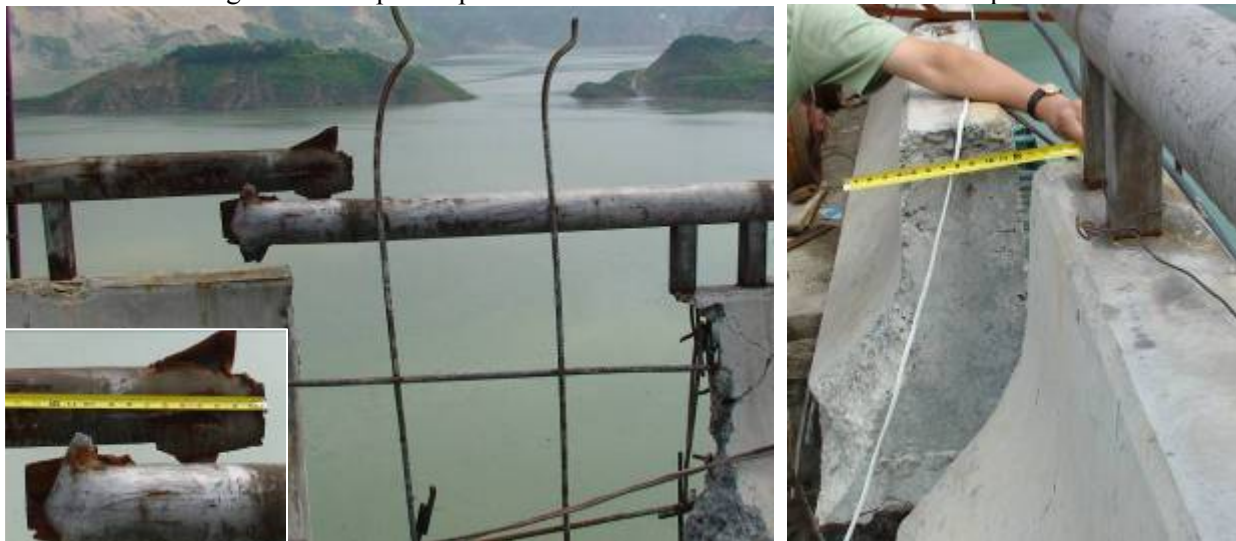
Figure 14: Longitudinal and Transverse Offset of Bridge Deck

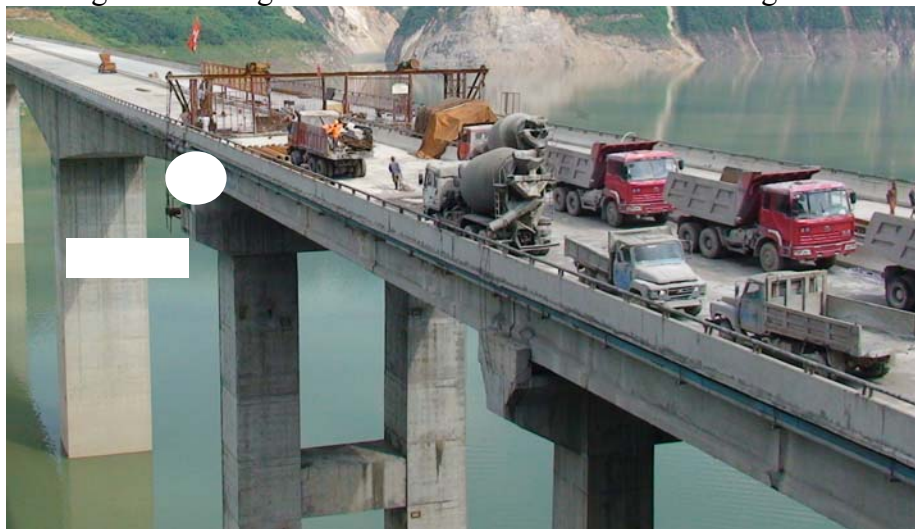
Figure 15: Shear Key Failure

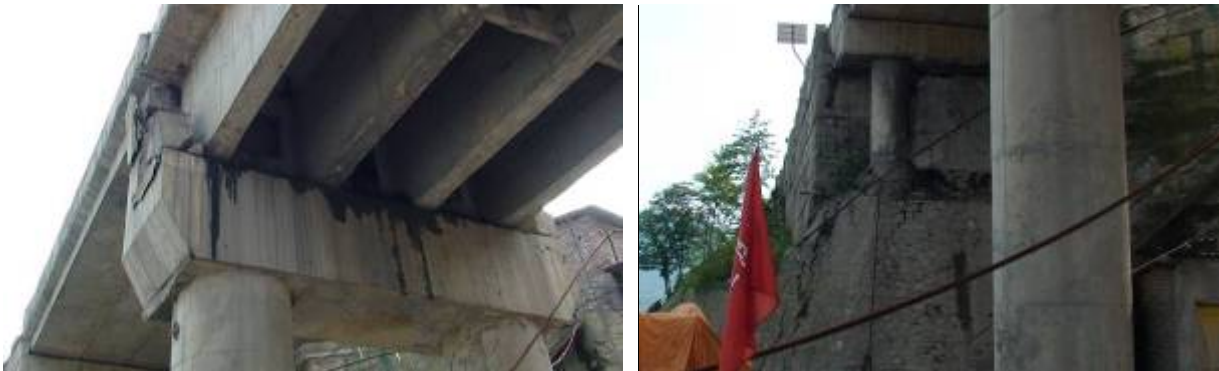
The end of the Miaozhiping Bridge near the tunnel is divided into two parallel elevated structures in order to guide two ways of traffic in alignment with the twin tunnels as indicated in Figure 16. Over the southeast approach is a four-span RC girder bridge built in 2004. The bridge supports the old highway from Dujiangyan to Wenchuan and Juzhaigou. The old highway was built along the mountain terrain, perpendicular to the Zhipingpu Highway at Zhipingpu Town. The bridge showed shear key failures and embankment cracking as shown in Figure 17.

Figure 17: Damage to Shear Key and Embankment of the Overpass

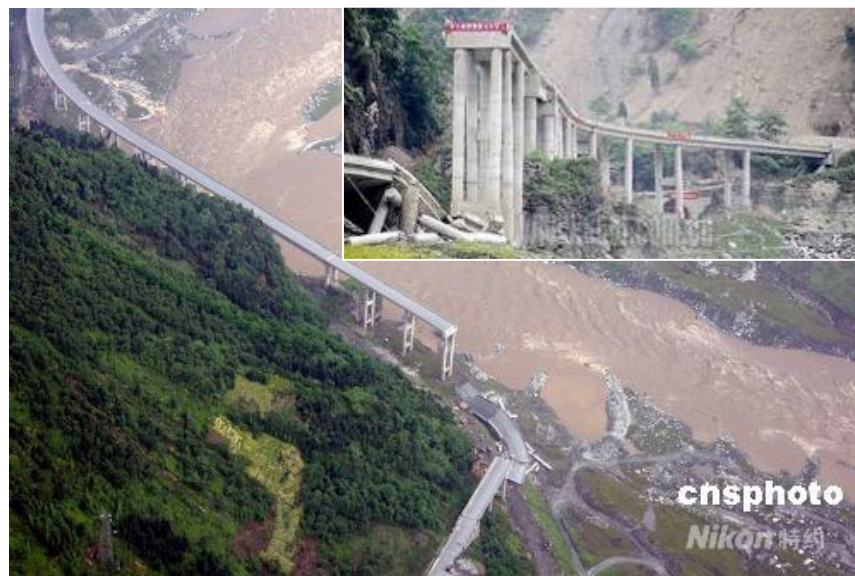
During the earthquake, the more highly curved section of the bridge completely collapsed as illustrated in Figure 20. The rest of the bridge suffered varying degrees of damage, including shear cracks and failure at columns and struts, shear key failure, and bearing failure as shown in Figures 21-24 for Bents 3, 9, 15, and 18, respectively. At Bent 3, typical damage occurred between the strut and columns in the form of spalling and cracks. At Bent 9 with expansion joints, the superstructure had significant transverse displacement, knocking off the shear key. At Bent 15, the bridge section was completely collapsed due likely to the shear and flexural failure of columns. At Bent 18, in addition to cracks between column and strut, significant spalling occurred underneath the bridge deck.

At the curve part of the bridge, the bridge is likely subjected to higher deformation and stress under the earthquake, resulting in collapse. Even for the straight part of the bridge, due to tall columns, the damage in various sections under the earthquake results in tilting of the columns that would push the superstructure almost off their support at

Similar to the previously described Xiaoyudong Bridge, this bridge could have been damaged by surface faulting though there is no clear surface fault feature that the reconnaissance team has ever found near the bridge site. Considering the complex vibration system of the irregular structure with varying column heights and lack of continuity between the substructure and superstructure, severe shaking alone could result in collapse. Still, the bridge is very close to the fault and several photos (taken immediately after the earthquake) show what looks to be a surface fault under the bridge. During the field reconnaissance after nearly three months later, all signs of the fault were gone and the bridge was lying on the ground.

Figure 20: Post-Earthquake Damage

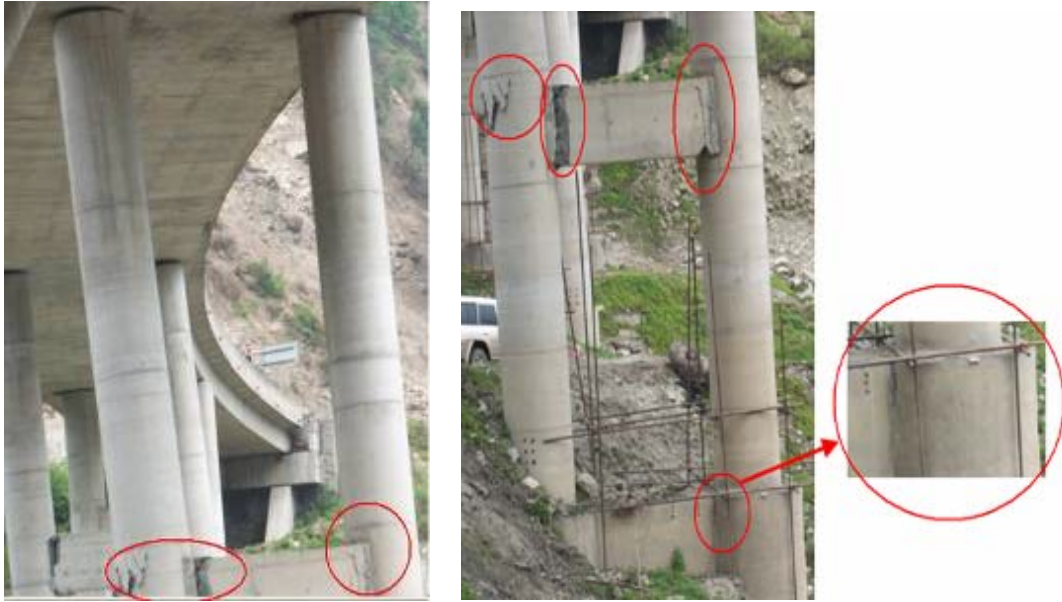
Figure 21: Damage at Bent 3

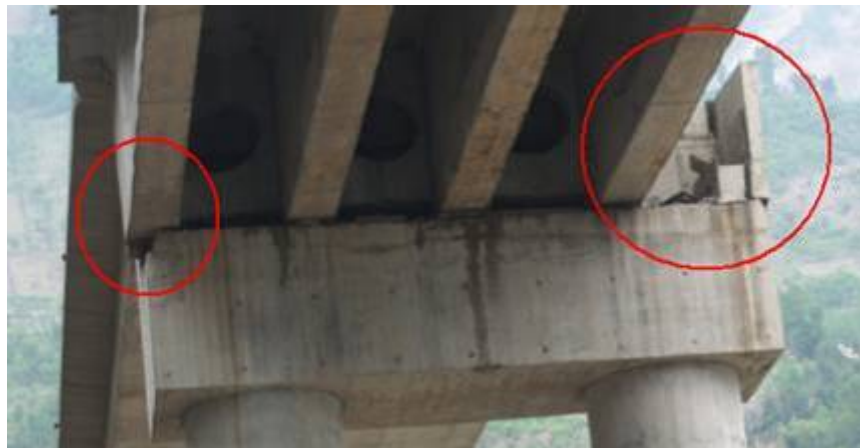
Figure 22: Damage at Bent 9

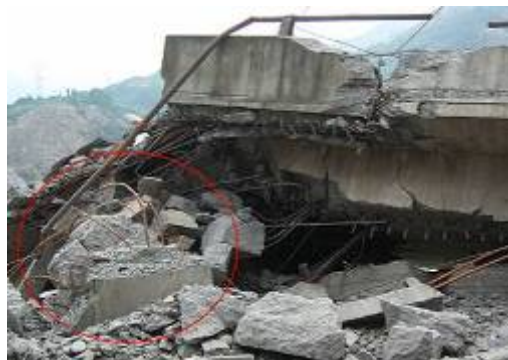
(a) Column Shear and Flexural Failure

Figure 23: Earthquake Damage at Bent 15

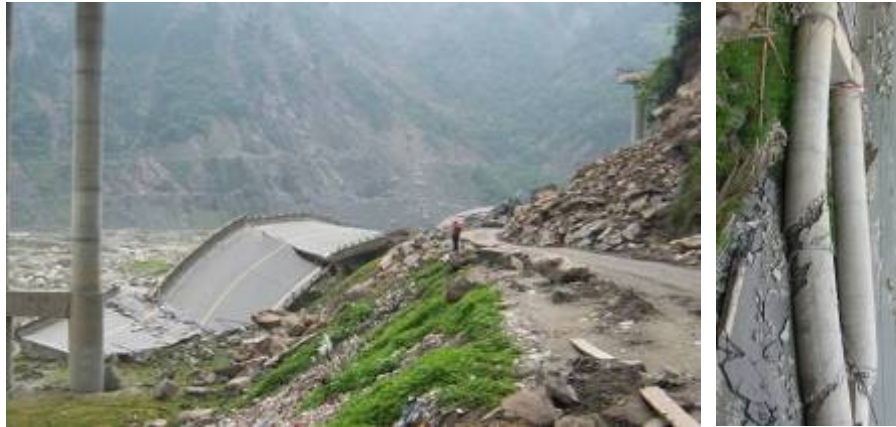
(b) Column Shear Failure and Section 5 Collapse

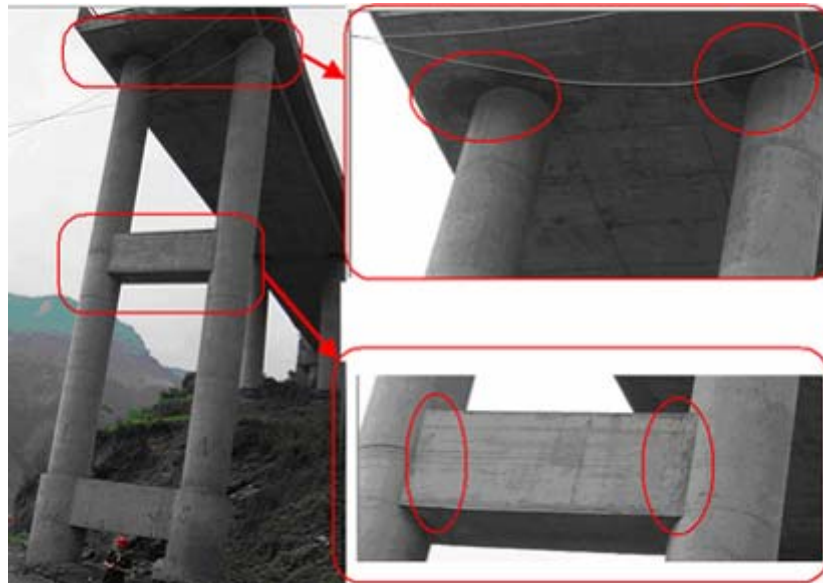
Figure24: Damage at Bent 18

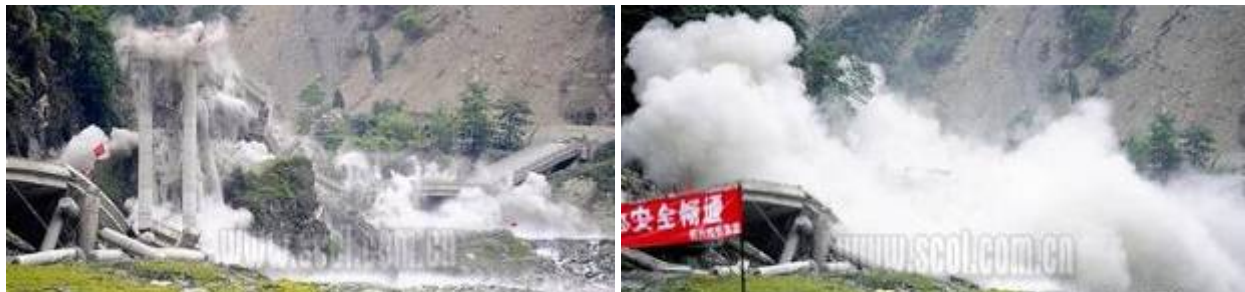
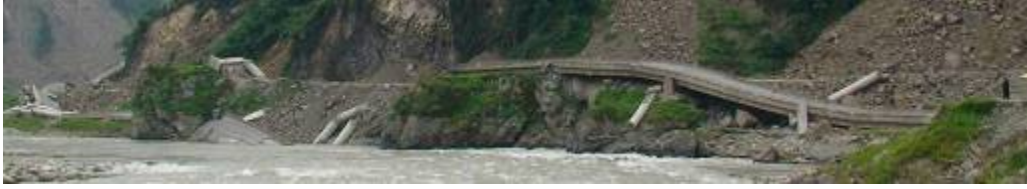
Figure 25: Post-Earthquake Demolition of Baihua Bridge

several locations. A detour had been graded along the side of the damaged bridge. Considering the high risk of a further collapse during an aftershock, endangering people using the detour, the rest of the bridge was demolished with dynamite as illustrated in Figure 25.
