## Damage of Bridges during 2011 Great East Japan Earthquake

### ABSTRACT

This paper presents damage of road and railway bridges during the Great East Japan earthquake and tsunami on March 11, 2011 based on a JSCE damage investigation. Ground motion induced damage and tsunami induced damage of both road and railways bridges are presented.

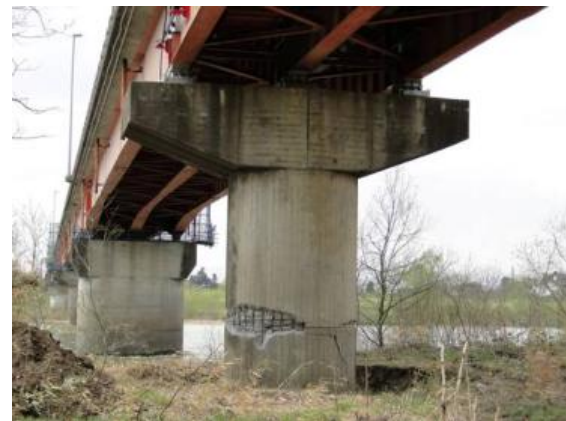
Photo 1 Shear failure of a column due to termination of longitudinal bars with insufficient development (Fuji Bridge) (courtesy of Dr. Hoshikuma, J., PWRI)

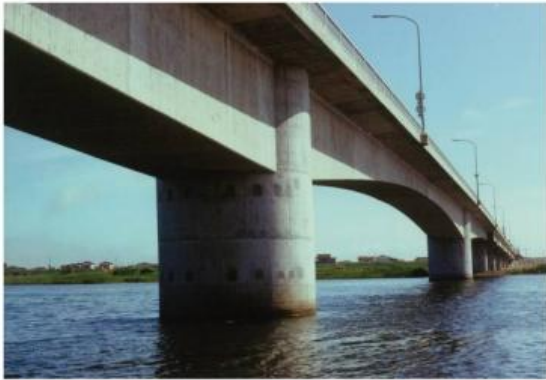
Photo 2 Yuriage Bridge

Yuriage Bridge as shown in Photo 2 suffered extensive damage at reinforced concrete hollow and solid columns, supports of prestressed concrete girders, and steel pin and roller bearings during 1978 Miyagi-ken-oki earthquake. Since the damaged columns were repaired and strengthened by reinforced concrete jacketing, they did not suffer damage this time. However pin and roller bearings suffered damage again in

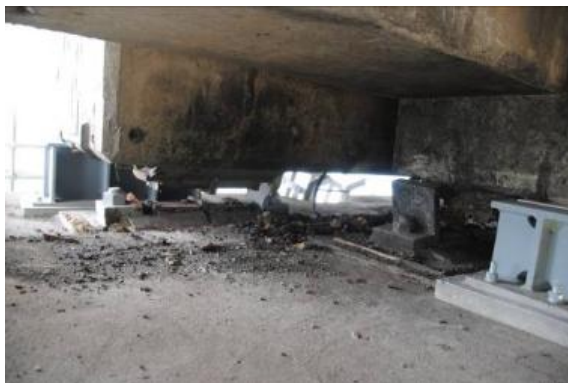
Photo 3 Damage of pin and roller bearings

the similar way as shown in Photo 3. It is obvious that pin and roller bearings are vulnerable to seismic action, because the stress builds up until failure by allowing virtually no relative displacement at pin bearings and relative displacement accommodated in roller bearings is insufficient to realistic relative displacement developed under a strong excitation.

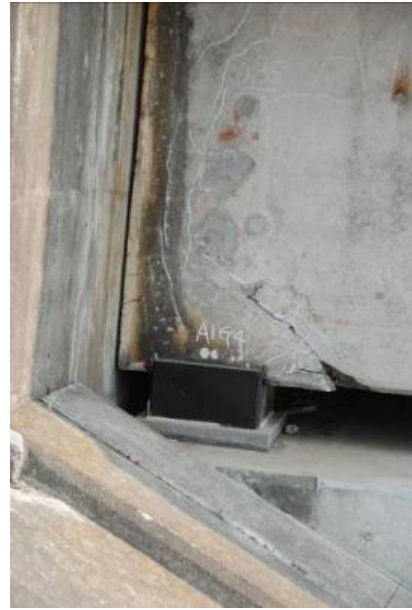
Photo 4 Damage of PC girders near the support

Furthermore, the same supports of prestressed concrete girder which suffered damage in 1978 Miyagi-ken-oki earthquake suffered again as shown in Photo 4. Taking account of likely concentration of seismic force at this region and the importance of anchorage of PC cables, more rigorous repair had have to be conducted after 1978 Miyagi-ken-oki earthquake.

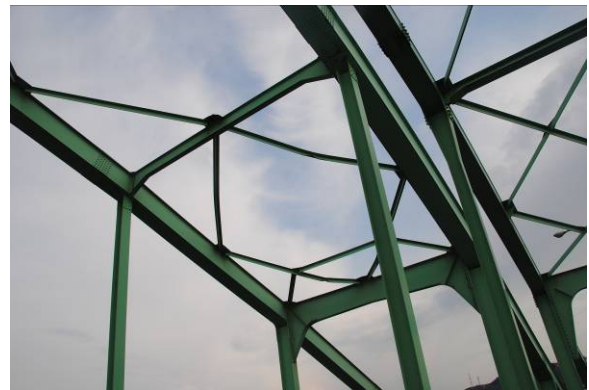
Photo 5 Buckled truss braces

Tennoh Bridge built in 1959 suffered extensive damage during 1978 Miyagi-ken-oki earthquake. This bridge suffered extensive damage again during this earthquake at the same members; truss braces and pin and roller bearings as shown in Photo 5.

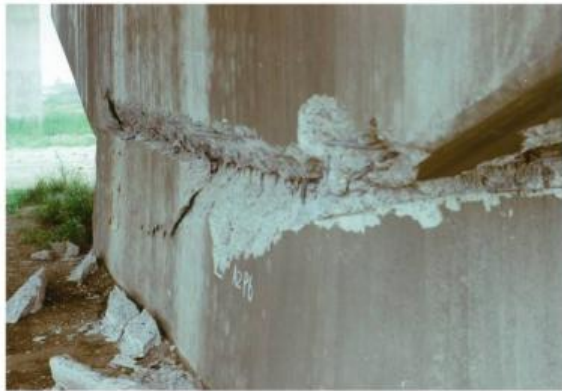
Photo 6 Damage of a pier during 1978 Miyagi-ken-oki earthquake (Sendai Bridge)

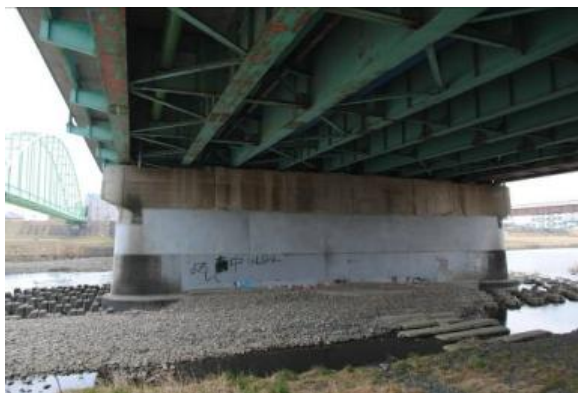
Photo 7 Retrofitted pier of Sendai Bridge which did not suffer damage during 2011 Great East Japan earthquake

On the other hand, damage of bridges which were already retrofitted suffered virtually no damage. For example, Sendai Bridge which is a symbolic bridge in Sendai suffered extensive damage at columns and bearings as shown in Photo 6 during 1978 Miyagi-ken-oki earthquake. However this bridge suffered no damage during this earthquake, because columns were retrofitted as shown in Photo 7 and steel bearings were replaced with elastomeric bearings.

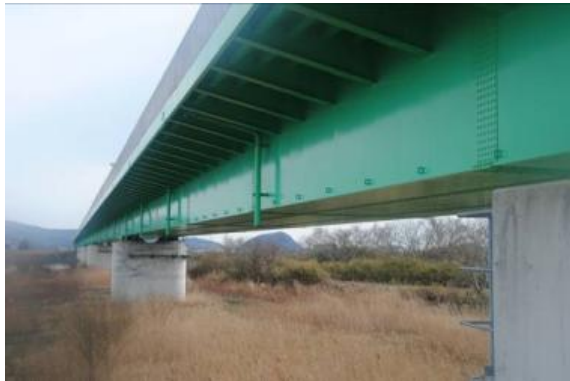
Photo 8 Shin-Tenno Bridge

For example, Photo 8 shows Shin-Tenno Bridge which was constructed in 2002 suffered no damage. This bridge was located 150 m upstream of Tenno Bridge which suffered damage during 1978 Miyagi-ken-oki earthquake and suffered damage again at almost the same components. Photo 9 shows an end of girder at the left bank where it was supported by elastomeric bearings. New cable restrainers which satisfy the requirements by the post-1990 design code are set. No damage occurred in this bridge.

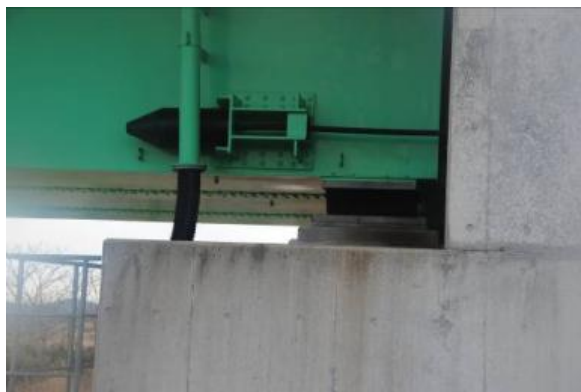
Elastomeric bearings including lead rubber bearings and high damping rubber bearings performed much better than vulnerable steel bearings. However it should be noticed that elastomeric bearings ruptured in several bridges. For example, at Sendai-Tobu viaduct as shown in Photo 10, several elastomeric bearings ruptured

Photo 9 An end of deck supported by elastomeric bearings and unseating prevention devices

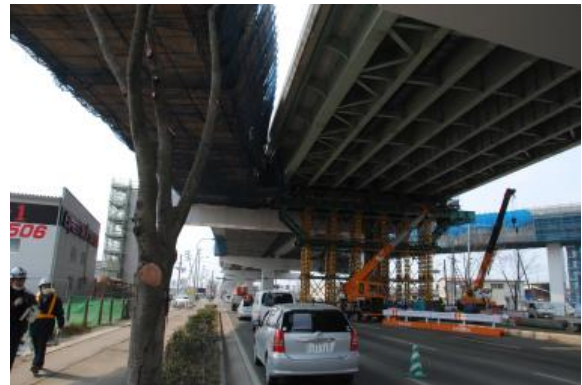
Photo 10 Piers where elastomeric bearings ruptured (Sendai-Tobu viaduct)

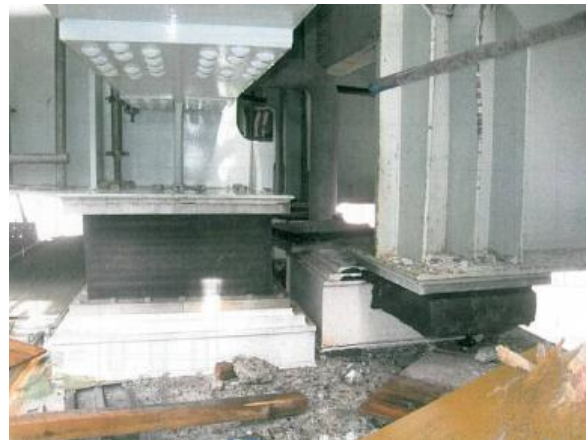
such that the deck offset in the transverse direction and settled aside the ruptured bearings as shown in Photo 11. Rubber layers detached from steel plates as well as rupture inside rubber layers as shown in Photo 12. Since extensive number of elastomeric bearings including high damping rubber bearings and lead rubber bearings are used, the damage should be critically investigated. It is pointed out that one of the possible reasons for the damage is that the interaction between adjacent bridges with different natural periods was not properly considered in design of elastomeric bearings. Since an expansion joint constrained relative displacement between adjacent decks in the transverse direction, it is likely that larger displacement demand of an adjacent deck is imposed to the elastomeric bearings which were designed based on smaller displacement demand [Quan and Kawashima 2009].

Photo 11 Transverse offset of a girder due to rupture of elastomeric bearings

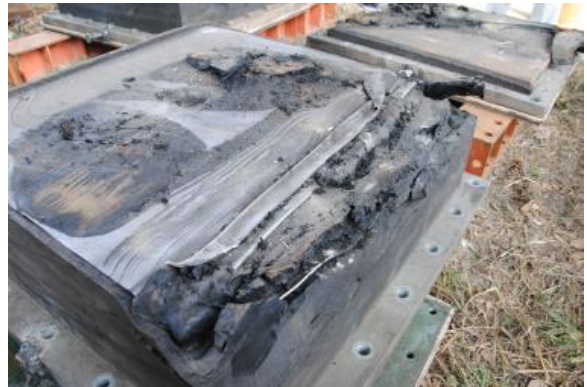
Photo 12 One of elastomeric bearings ruptured

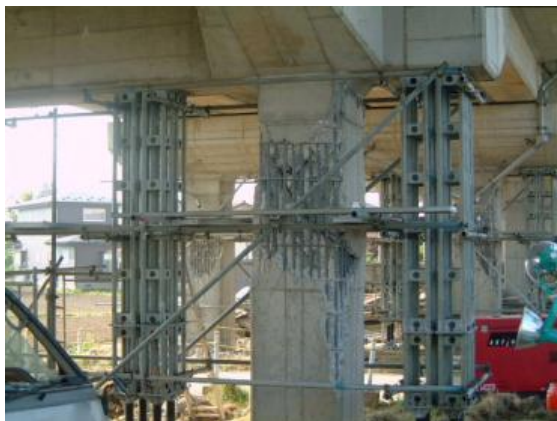
Photo 14 Shear failure of RC columns at Odaki viaducts after 2003 Sanriku-Minami earthquake

No. 3 Odaki viaducts in Iwate-ken failed in shear as shown in Photo 14 during 2003 Sanriku-Minami earthquake. The viaducts were retrofitted so that they had sufficient shear capacity under the first retrofit program after 2004 Niigata-ken Chuetsu earthquake. The retrofitted columns of the viaducts performed well with almost no damage during 2011 Great East Japan earthquake as shown in Photo 15.

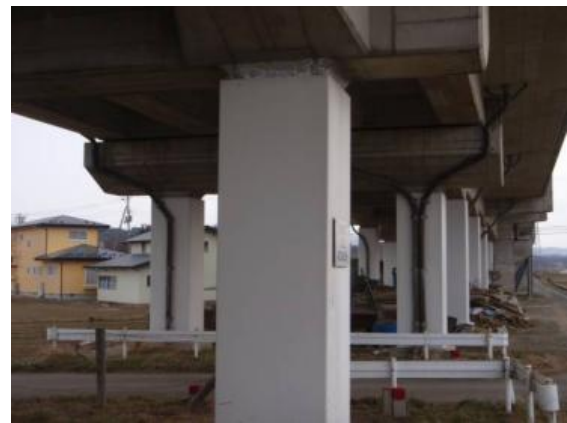
Photo 15 No. 3 Odaki viaducts which were retrofitted after 2003 Sanriku-Minami earthquake performed well during 2011 Great East Japan earthquake

it is reasonable to considered that the response acceleration of No. 3 Odaki viaducts was nearly the same between 2003 Sanriku-Minami earthquake and 2011 Great East Japan earthquake. It is considered that the seismic retrofit for No. 3 Odaki viaducts was effective for preventing significant damage during this earthquake.

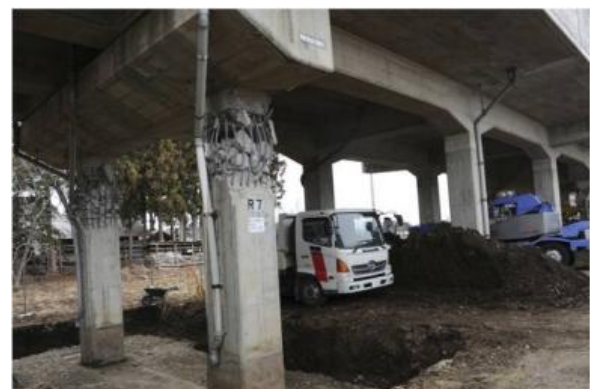
Photo 16 Damage of R7 column, No. 1 Nakasone viaduct during 2011 Great East Japan earthquake

During 2011 Great East Japan earthquake, side columns suffered extensive damage as shown in Photo 16. All columns lost even the bearing capacity for vertical load. It was fortunate enough not to totally collapse because the viaduct was supported by eight columns. Side columns in other viaducts also suffered extensive damage. Shear failure occurred at the upper part of columns as shown in Photo 17. The damage was so extensive that original shear cracks could not be identified because of crash and spill out of the core concrete.

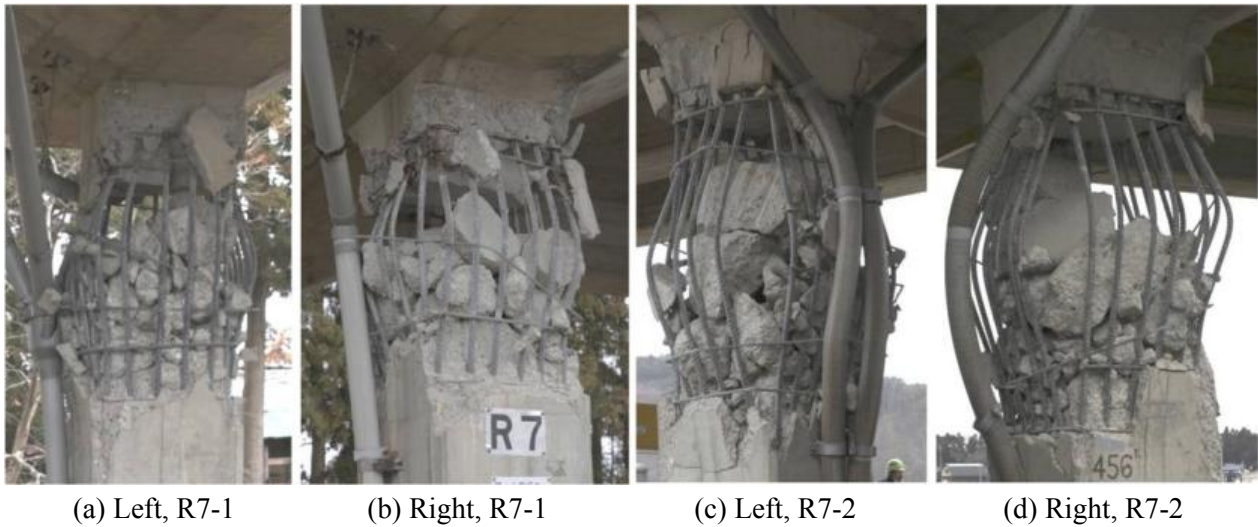
Photo 17 Close view of damage of R7-1 and R7-2 columns

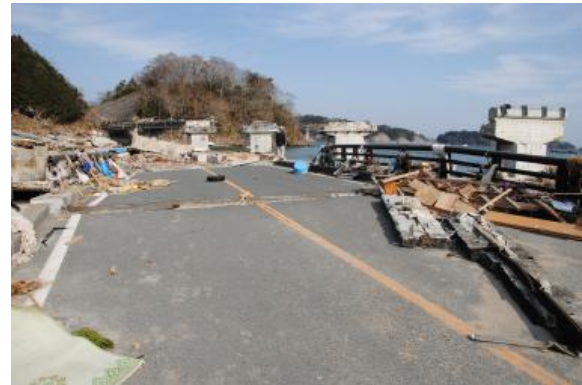
Photo 18 Damage of Utatsu Bridge

Utatsu Bridge at Minami-sanriku Town over Irimae Bay suffered extensive damage by tsunami as shown in Photo 18. It consisted of 3 types of superstructures with spans ranging from 14.4m to 40.7m, as shown in Fig. 6. The superstructures from S3 to S10 were completely washed away from their supports in the transverse direction due to tsunami while the superstructures S1, S2, S11 and S12 were not

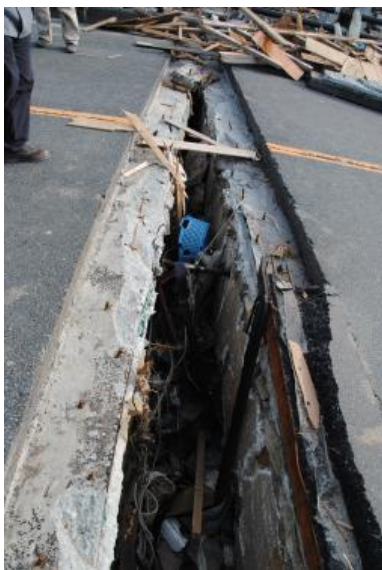
Photo 19 Effective restrainers to tie together adjacent decks

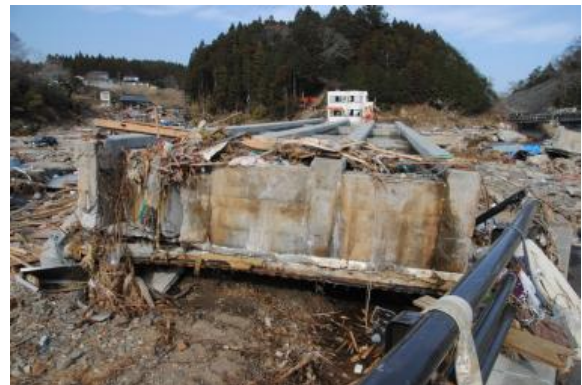
Photo 20 An overturned superstructure

washed away. The outflow displacements of S3~S10 are shown in Fig. 7. It should be noted that the spans located at the center such as S5-S7 and S8 were flowed 28 m and 41 m away from the original position, while the spans located at the sides such as S1, S2, S11 and S12 were not washed away. It is noted that S3, S4 and S4, and S5, S6 and S7 which flowed out together because they were tied by cable restrainers for preventing excessive superstructure response under a large seismic excitation as shown in Photo 19. S8, S9 and S10 overturned during being floated as shown in Photo 20.

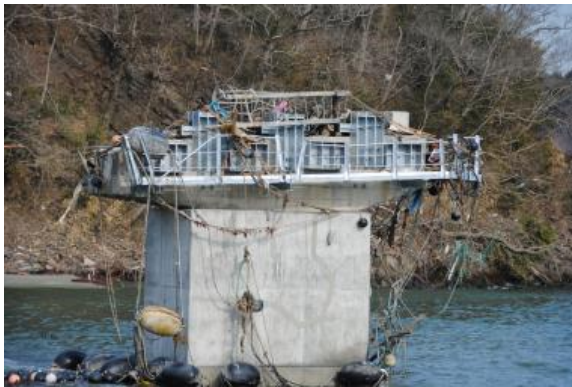
Photo 21 Steel devices for extending seat length (short device) and steel stoppers for preventing excessive longitudinal deck response due to ground motions (tall device)

superstructures were washed away. Two types of steel devices were set as an unseating prevention device in this column; one is the devices aiming of increasing seat length required by the recent code, and the other is the devices which were set

for preventing excessive deck displacement in the longitudinal direction. It is important to know that none of those devices tilted or were detached from the pier which must have happened if the decks were simply washed away laterally. It is likely that the decks were uplifted by tsunami buoyancy force and then they were washed away. Steel plate bearings used in this bridge was very simple as shown in Photo 22 such that both uplift and lateral force capacities were limited.

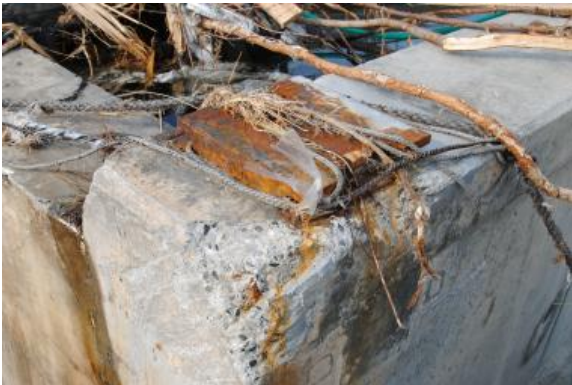
Photo 22 Failure of a RC side stopper, and four steel stoppers for preventing excessive longitudinal deck response which were not damaged

due to a transverse force which applied from the deck. It is likely that due to tsunami force the deck uplifted at the sea side first being supported only at the land side, which resulted in larger tsunami force. Thus the side stopper at the land side collapsed due to excessive concentration of tsunami force.

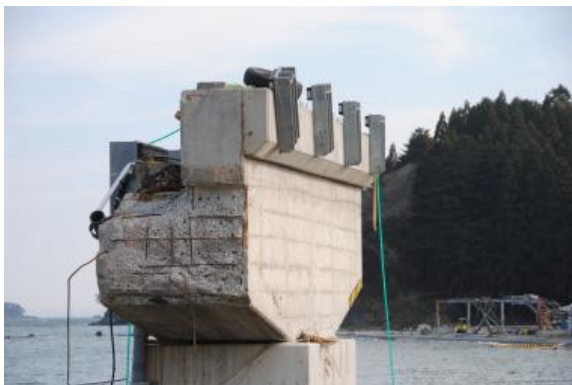
Photo 23 An upper steel bearing after damaged

This is also the case at a column shown in Photo 23 in which four stoppers did not tilt. But a RC side stopper at the land side collapsed probably
