# Port Damage from Tsunami of the Great East Japan Earthquake

Takashi Tomita<sup>1</sup>, Gyeong-Seon Yeom<sup>2</sup>, Daisuke Tatsumi<sup>2</sup>, Osamu Okamoto<sup>3</sup> and Hiroyasu Kawai<sup>4</sup>

This paper presents tsunami damage in ports caused by a tsunami of the Great East Japan Earthquake. The tsunami higher than tsunamis for plan and design of tsunami disaster mitigation structures such as tsunami breakwaters, seawalls and etc. caused destruction in some structures. Furthermore, the tsunami higher than the expected tsunamis for tsunami disaster mitigation plan in communities overflowed the tsunami disaster mitigation structures, and therefore caused devastating inundation in the communities. The tsunami whose inundation was deep on land changed big vessels and oil tanks into tsunami debris.

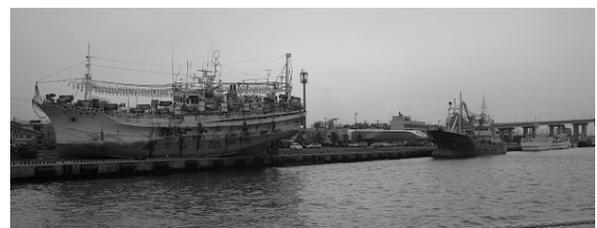
Fig. 3 Landed boats

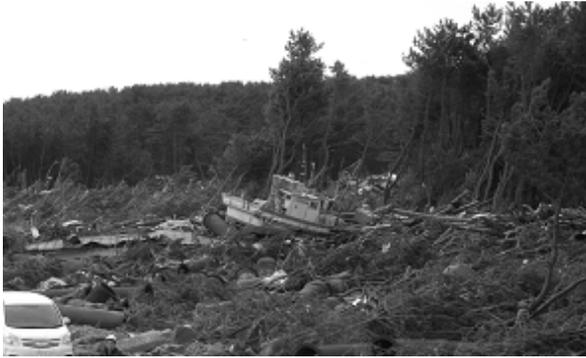
Fig. 4 Boats trapped by a coastal green belt

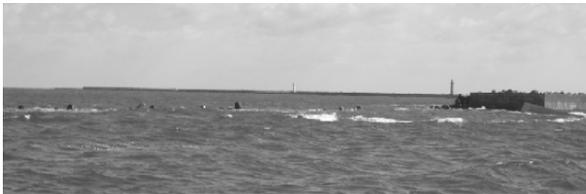
North breakwater caissons of 1,870 m out of the total length of 3,500 m were slipped out and submerged, being affected by tsunami, as shown in Figure 5. In the figure many caissons connecting to a caisson in the right side of the figure are submerged and parts of wave-absorbing blocks installed in front of caissons can be seen above the sea surface. Significant seabed scours were measured around a corner of a reclaimed island quay as well as at the mouths of the breakwaters.

Fig. 5 Damaged north breakwater in Hachinohe Port

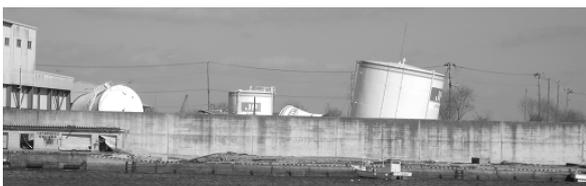
In Kuji Port [2], the tsunami causing inundation depth of 4.4 m overtopped a line of tide protection wall of 3.6 m high, and flooded residential area. Furthermore, the tsunami causing 4.3 m inundation depth in the port area push oil tanks over sideways as shown in Figure 6. In Kesenuma, oil tanks became tsunami debris, which were landed on different places from the original positions.

Fig. 6 Damaged oil tanks in Kuji Port

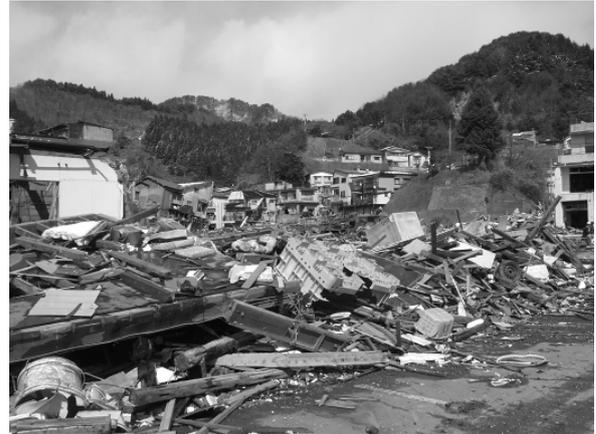
In Kamaishi Port [4], the tsunami of 6.9 to 8.1 m in terms of inundation height floated and crushed wooden houses, as shown in Figure 7. Reinforced concrete (RC) buildings and large-scale grain silos were damaged but not collapsed. A number of vehicles together with destroyed houses were observed floated out on the road, as shown in Figure 8.

Fig. 7 Destruction of houses in Kamaishi

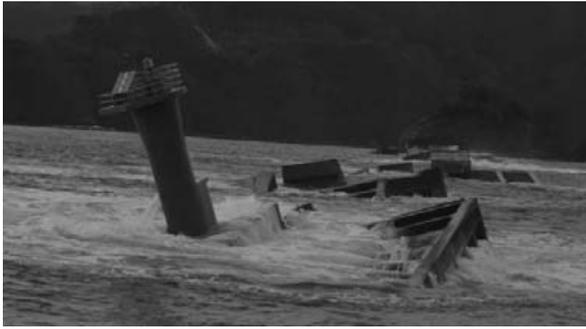
Offshore breakwater in Kamaishi Port was also damaged by the tsunami as shown in Figure 9. Caissons were slipped and submerged. Much difference in terms of water level between front and back of the breakwater may produce strong water pressure and fast current flowing in gaps between caissons to slide caissons [6].

Fig. 9 Damaged offshore breakwater in Kamaishi Port

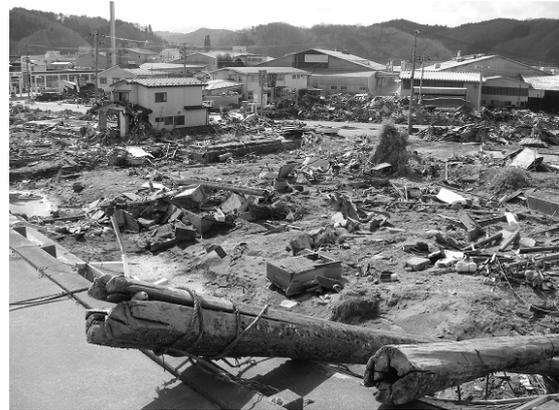
In the Miyako bay including Miyako Port, almost same tsunami inundation heights were measured, as shown in Figure 10. The tsunami of 10 m overtopped a protection dike and inundated residential areas as shown in Figure 11. Vessels were landed on wharfs in the port. Logs and cars were also floated and impacted houses, as shown in Figure 12.

Fig. 11 Destruction of residential area behind protection dike

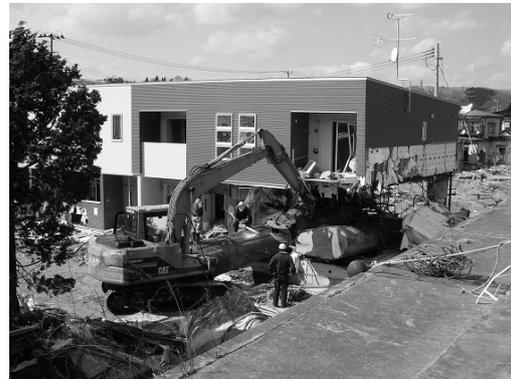
Fig. 12 Debris impact

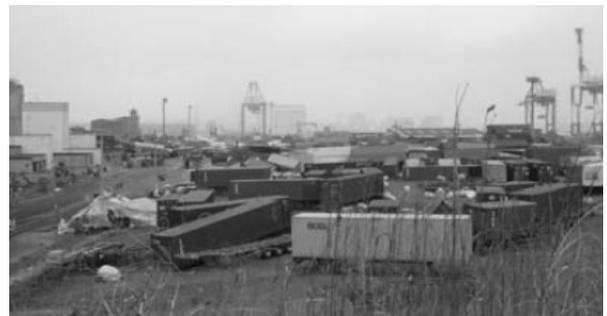
Tsunami debris are not only vessels, automobiles, oil tanks, logs but also shipping containers. In the Sendai-Shiogama port, many containers were scattered by the tsunami impact, as shown in Figure 13. In the Hachinohe port, many containers were taken away the sea.

Fig. 13 Scattered shipping containers in Sendai-Shiogama Port
