Corrosion of 30 Years Old Weathering Steel Bridges

Kenji Ikeda¹⁾, Takashi Sato²⁾, Kazunori Watanabe³⁾, Shizuo Kato⁴⁾, Toshiya Sugawara⁵⁾

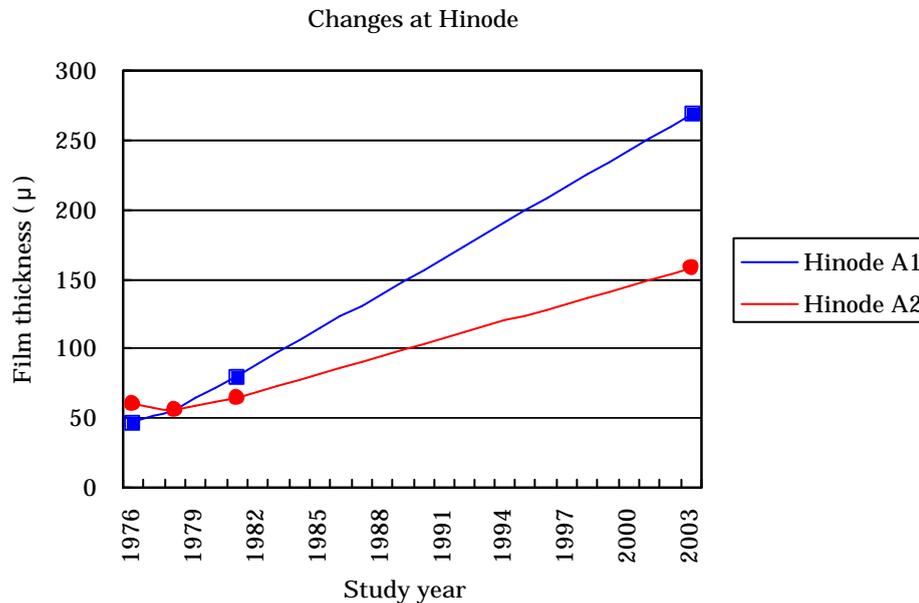
Figure 3 Temporal changes in film thickness

Investigations at A2 found a thickness increase of 6.5 μ/year from 1976 through 1981, and 8.6 μ/year after 1981. Investigations at A1 found increases of 0.8 to 4.3 μ/year. Our study found thickness of 158 μ at A1 and 268 μ at A2. This is probably due to the bridge's proximity to the frontage road and the low clearance (Figure 4). Use of

anti-icing agents began to increase from the 1980s, and we suggest that anti-icing agents were spattered on the overbridge by passing cars. Investigations on salt deposition were made in 2001 and 2003. Deposition was 562 mg/cm^2 in 2001 and 620 mg/cm^2 in 2003, i.e., salt deposition increased. It is judged that surface rust has not yet reached a stable state.

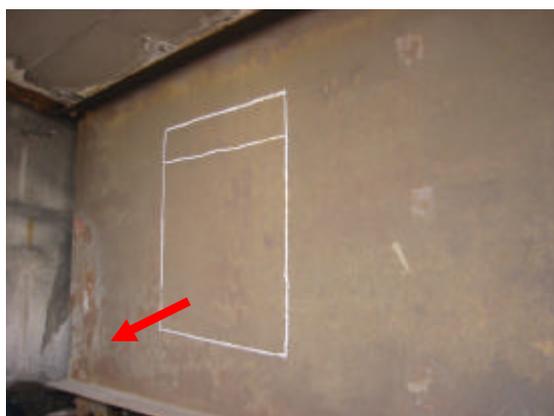
Figure 6 shows the corrosion characteristics of Hinode Overbridge. Figure 6(a) shows corrosion at the girder end section that resulted from water leakage from the expansion joint. This corrosion seems to be progressing. Figure 6(b) shows layer-by-layer rust exfoliation on the upper surface of the main girder bottom flange. Corrosion is probably progressing due to deposits such as salt-containing dust on the upper surface of the flange.

Figure 6(a) Corrosion at the girder end section

2) It is necessary to take measures against water leakage from the expansion joint and deck.

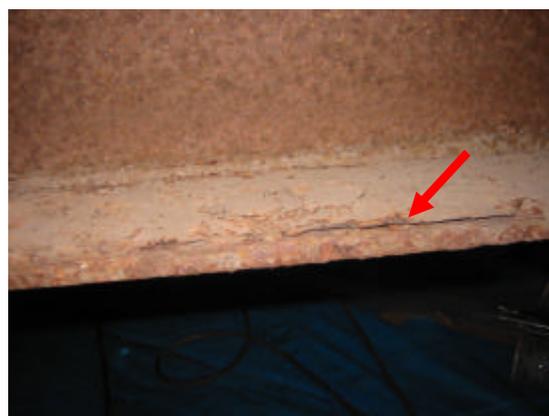
Figure 6(b) Layer-by-layer rust exfoliation on the flange upper surface

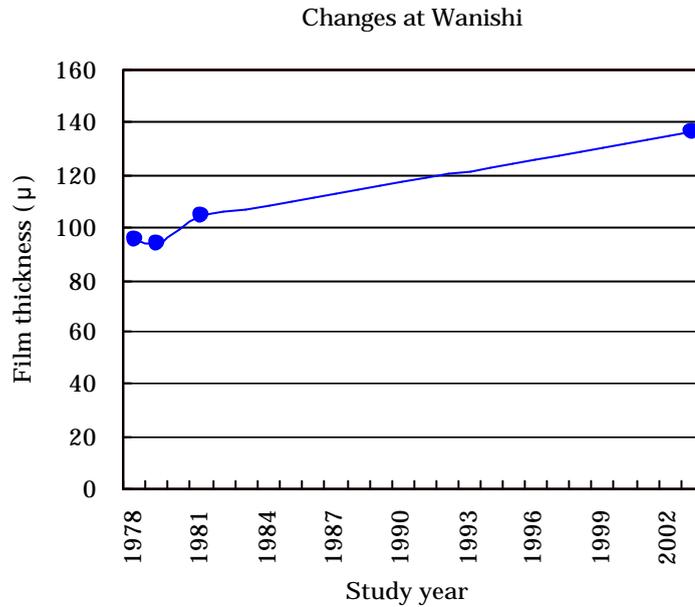
Figure 7 Temporal changes in film thickness at Wanishi Overbridge

Figure 7 shows temporal changes in film thickness at this bridge. The film thickness investigation found that the film thickness has been gradually increasing. The thickness increase was $3.1 \mu/\text{year}$ between 1978 and 1981. Since 1981, the thickness increase has stabilized at $1.4 \mu/\text{year}$. The surface condition is favorable. Compared to the other bridges studied, the salt deposition was small, which is favorable for corrosion-resistant steel. Figure 8 shows the temporal changes in appearance.

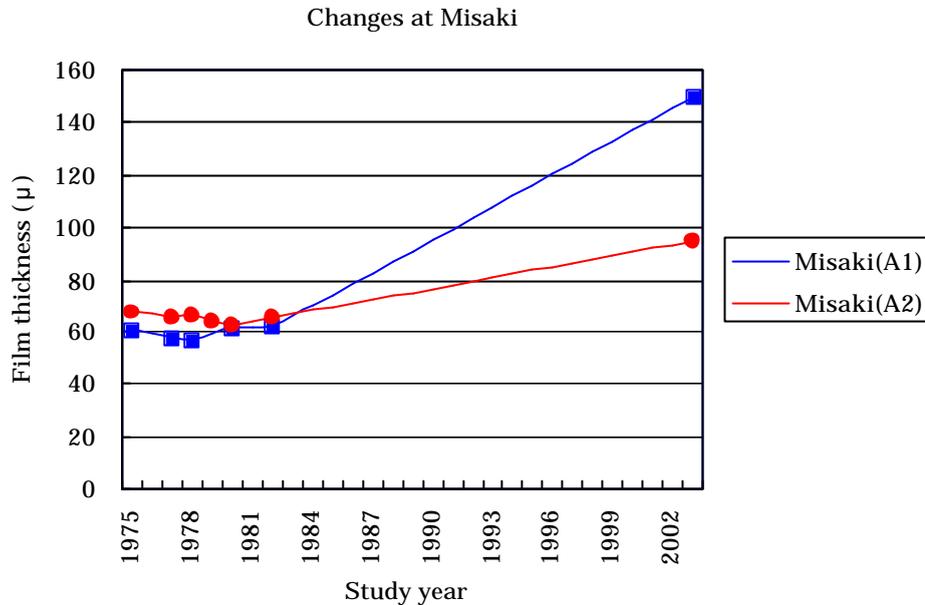
Figure 9 Temporal changes in film thickness at Misaki Overbridge

Figure 9 shows the temporal changes in film thickness at this bridge. The investigation from 1975 to 1982 found the thickness to fluctuate around the value of 60 μ . Since 1982, the thickness increase has been 5 μ /year. At the surface, stabilizer remains at some parts and rust is present at other parts. This suggests that stable rust is still being formed. Corrosion here is characterized by marked corrosion resulting from water leakage from the expansion joint, as with the other bridges.

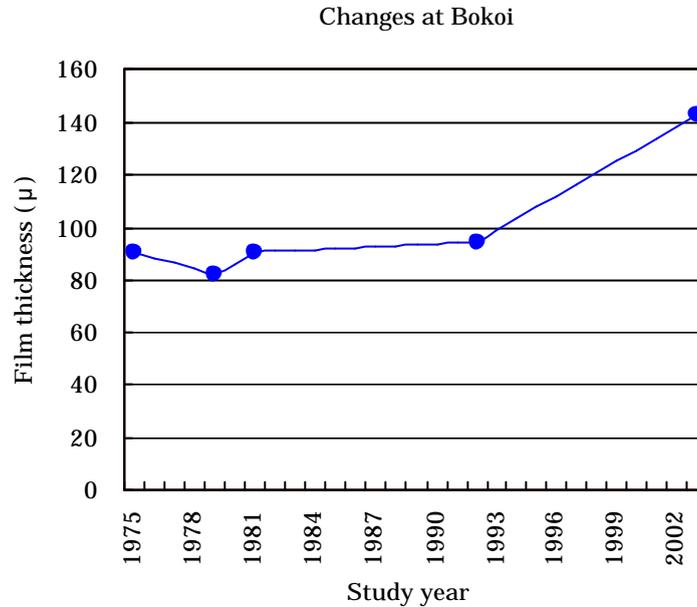
Figure 11 Temporal changes in film thickness at Bokoi Overbridge

Figure 11 shows the temporal changes in film thickness at this bridge. The investigation from 1975 to 1982 found that the film thickness fluctuated between 80 and 90 μ (0.4 μ /year). Since 1982 the film thickness increase has been 2.4 μ /year. Stable rust seems to have formed on the surface, but it does not seem thick enough to serve as a protective film. Corrosion is characterized by marked corrosion resulting from water leakage from the expansion joint, as with the other bridges.
