Nondestructive Inspection of the Suspender Ropes in a Suspension Bridge

Hiroaki HOASHI¹⁾, Takeshi SUGIMOTO²⁾

Two suspender ropes at Innoshima Bridge which elapsed 16 years after completion were removed and inspected to verify the state of interior corrosion. As the result, corrosion was found to be progressing inside the suspenders comparing with its surface, and the circumstances associated with the corrosion could be elucidated.

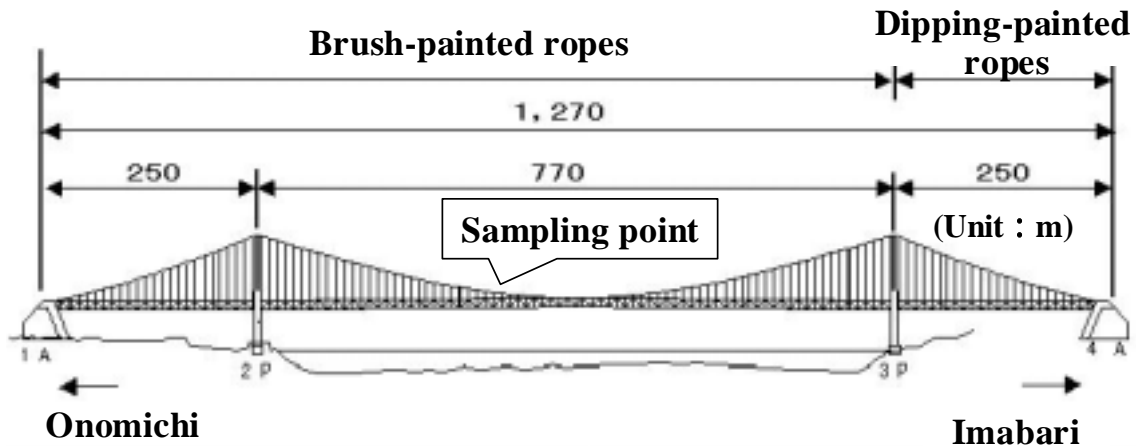
Fig 2 Sampling Point of Suspender (Innoshima Bridge)

From the 400 locations (100 panel points) subjected to close visual inspection in 1998, the approximate center of the center span was selected as the rope sampling point, for the reason that external corrosion was severe there and that suspender ropes in the center are shorter (approximately 14 m in length) and easy to replace. Two suspender ropes were removed from this point (see **Fig 2**).

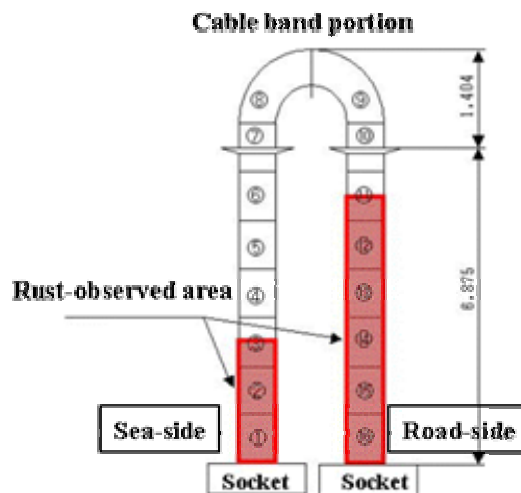
Fig 3 Development Picture of Suspender Rope

Each removed suspender rope (14 m in length) was divided into 16 sections, and each section was disassembled into strands to inspect the interior of the rope visually. Rust was observed in the range shown in **Fig 3**. Close inspection revealed the following:

- ① The rope sections near the sockets remained intact though corrosion in these sections had been anticipated from overseas reports on corrosion.
- ② The core and inner strands corroded along the entire circumferential surfaces as shown in **Photo 1**.
- ③ Although the exterior side of each outer layer strand that has been protected by paint remained intact, corrosion was present on the interior side that had been in contact with the inner layer strands.
- ④ The strands of the cable band portion remained intact since the rope was entirely caulked.

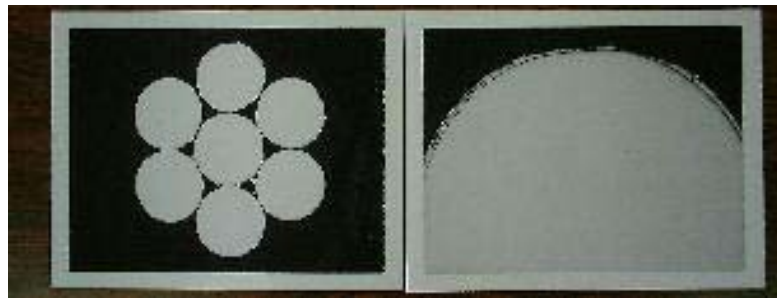
(a) Intact Core Strand Portion

The plating on the intact core strand section is partly reduced in thickness, presumably due to friction between strands when they were twisted to form the rope. The corroded core strand cross-section shows the occurrence of corrosion on the exterior side (in contact with the surrounding inner layer strands).

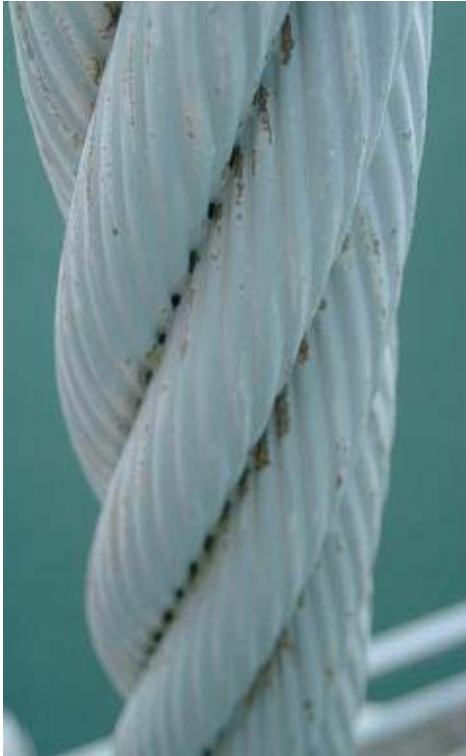
(a) Brush-Painted

- (1) Brush-painted ropes (**Photo 3(a)**)
 - ① There were areas in which the surface coat and base coat have almost completely been lost.
 - ② In the grooves between strands, there were areas with multiple holes, with paint film completely lost.
- (2) Dipping-painted ropes (**Photo 3(b)**)
 - ① Paint film remained in larger areas, and there were fewer quantities of holes in the grooves than on brush-painted ropes.

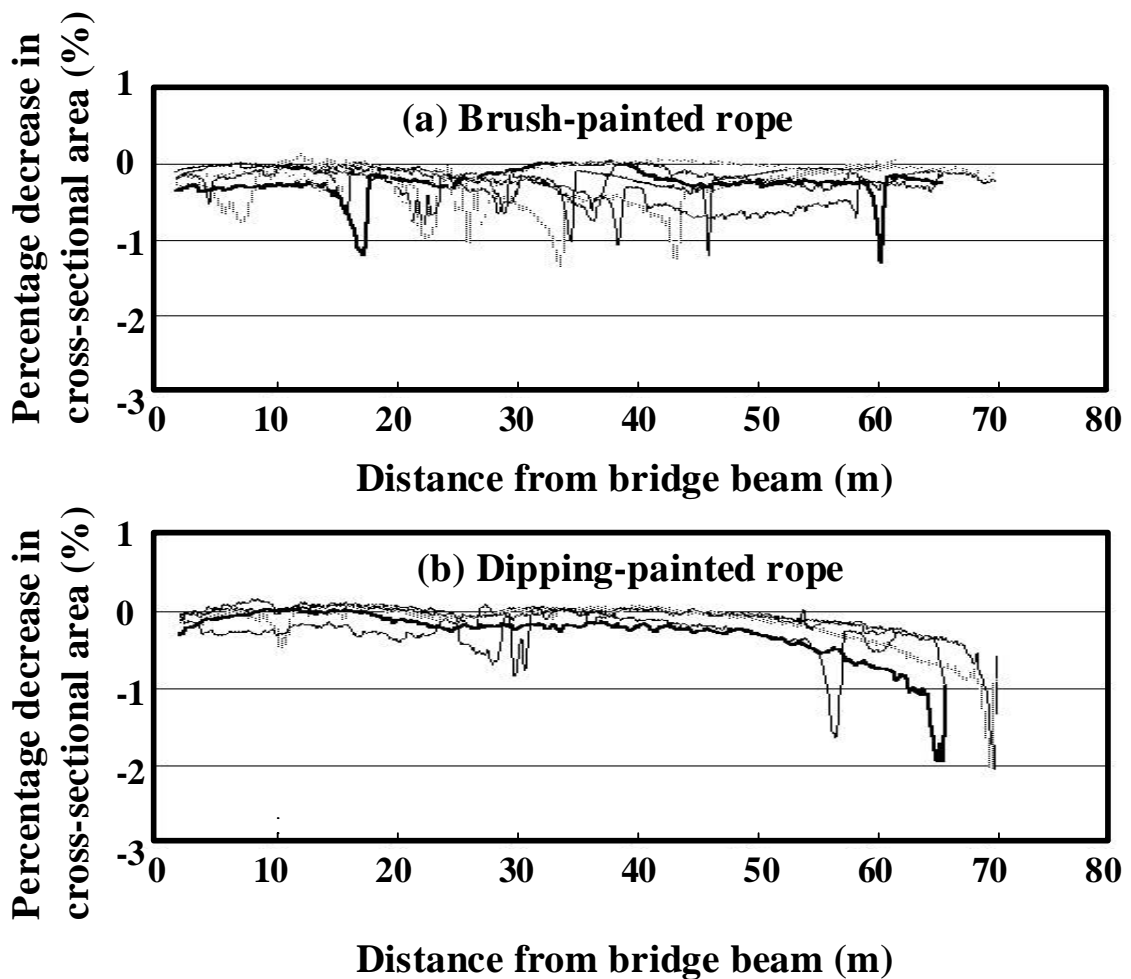
Fig 6 Result of Non-destructive Inspection

To evaluate the extent of corrosion, the magnetic flux in each suspender rope measured by the continuous-measurement was compared with the average magnetic flux (standard value) measured suspender ropes which had been replaced in 1999. **Fig 6** shows the results.

- ① Cross-sectional area reduction was detected at two to five positions in each rope.
- ② The maximum decrease percentage in cross-sectional area was approximately 1.5%.
- ③ No positional trend could be identified regarding reduction of cross-sectional area.
- ④ There was no correlation between external appearance and cross-sectional area reduction of rope.

- ① Reduction of cross-sectional area was detected in the entire upper section of each rope.
- ② The maximum decrease percentage in cross-sectional area was approximately 2%.
- ③ There was no correlation between external appearance and cross-sectional area reduction of rope.
