Anti-subsidence Measure Using King-post Cables against Subsidence in A PC Box Girder with Central Hinge

Takeshi SUZUKI¹⁾, Shigeru MATSUMOTO²⁾, Kousuke WAKATSUKI³⁾,
Hideki MANABE⁴⁾

Abstract: Four dyvidag bridges with hinge on the Hanshin Expressway Network were found subsiding in the central hinge region. Displacement was most significant in the Kireuriwari Viaduct of the Osaka Matsubara Route which exhibited a subsidence of more than 30 cm from the initial level. Anti-subsidence measure was investigated as a part of the major repair work on this route in fiscal 2003. Through comparative studies between a composite truss, external cables installed inside the box girder and other proposals, a king post cable structure was chosen because of its advantages in terms of local and structural conditions of the bridge. This method was to install new struts to the underside of the main girder and lay external cables eccentrically. This report covers detailed design of the king post cable reinforcement technique.

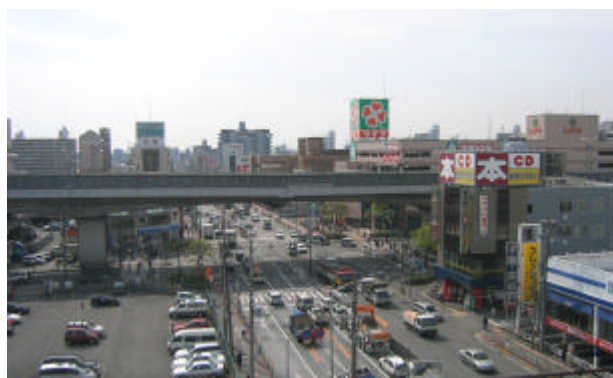
Photo.1 View of the entire Kireuriwari Viaduct

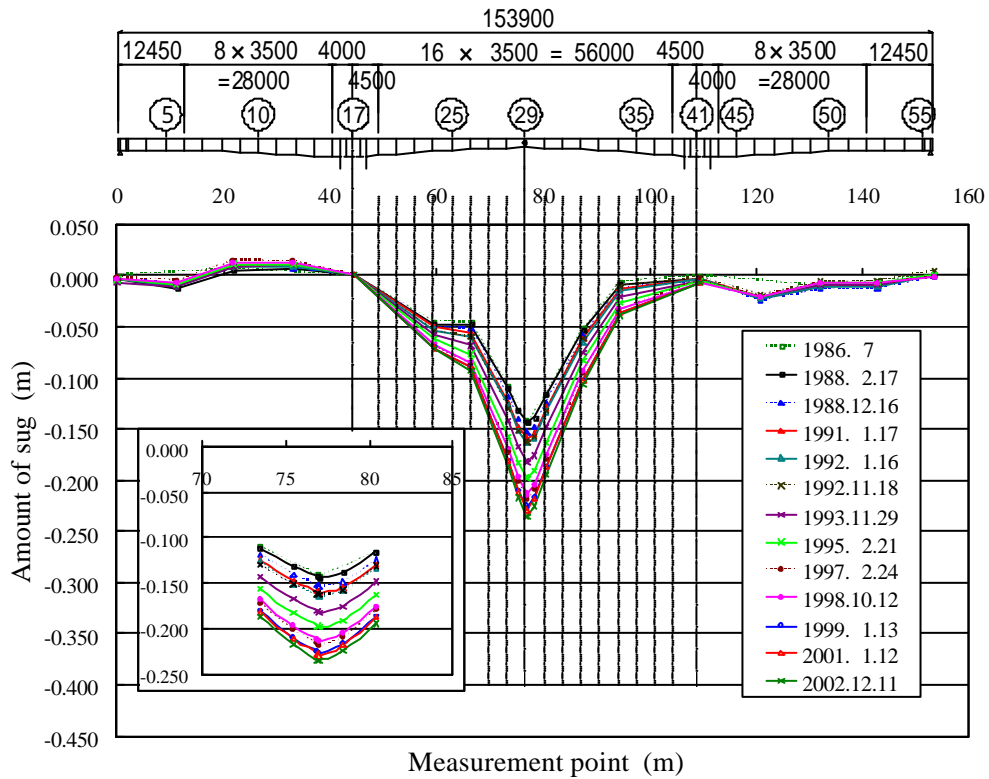
Figure.3 shows the amounts of sag in the main girder. The bridge began to bend sharply at around 10 m from the center of the span, with minor displacement in the side spans. The overlays for serviceability recovery in 1986 and 1993 caused deflections of 4 mm and 7 mm

Fig. 3 Measurement results: cumulative amounts of sag (the inbound lane)

mm, respectively, in the central hinge region. None of the piers exhibited major subsidence. Cumulative amount of sag in the central hinge region measured in December 2002 was 236 mm from the design longitudinal alignment. On the other hand, according to the records, this bridge was given an additional elevation of 85.4 mm at construction. Therefore, the actual cumulative amount of sag reached 321 mm. Although there was some influence of temperature variations between measurements, recent data revealed that the rate of sagging was increasing by about 2 mm to 9 mm each year.

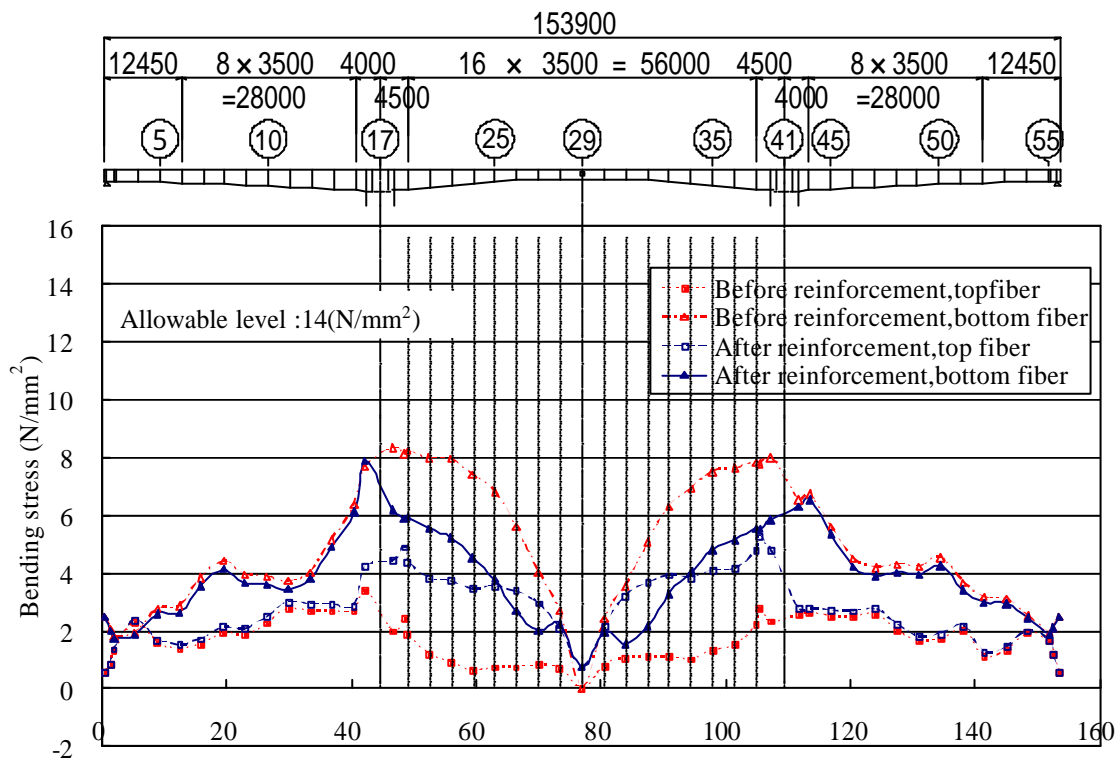
Figure. 5 shows combined stress under dead load. The current reinforcement was found favorable in terms of stress, with compressive stress due to bending in the central span decreased to around 2.0 to 6.0 N/mm^2 . A sag correction of 47 mm was estimated in the central hinge region.

Fig. 5 Combined stress under dead load

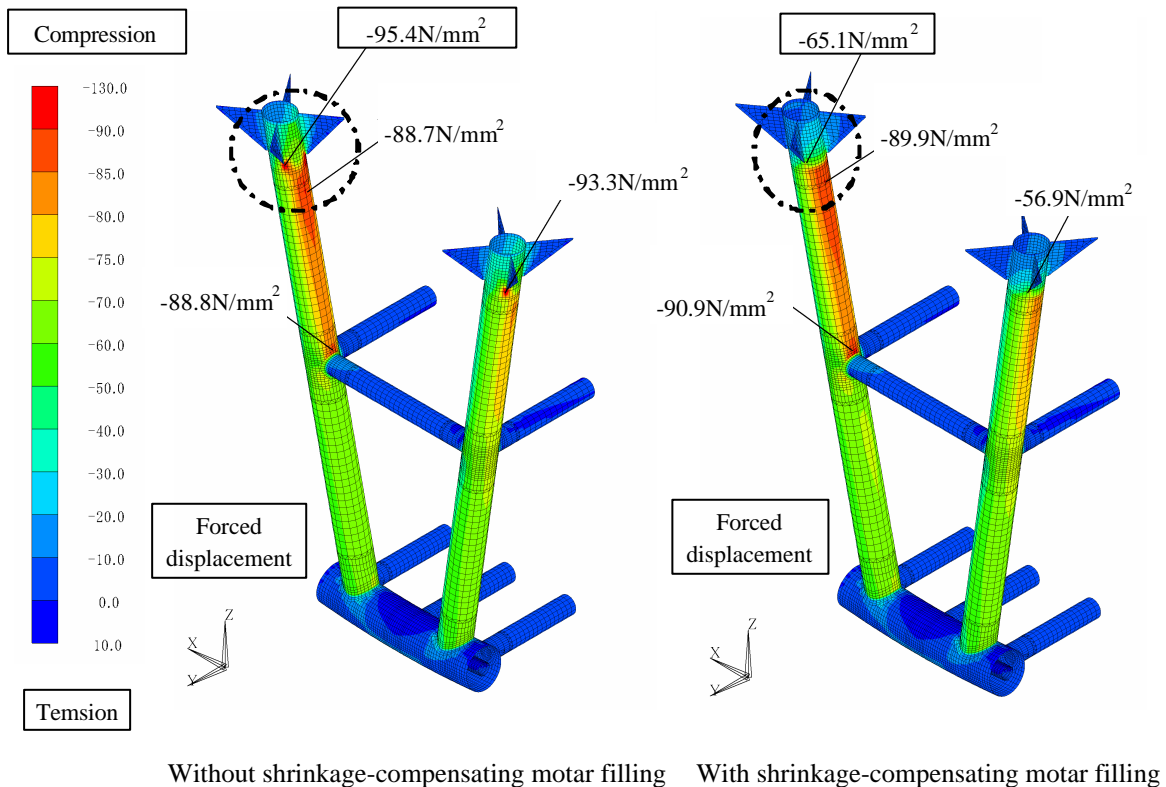
Figure .6shows the 3D FEM analysis results under design load, with relative displacements taken into account. As shown in the case without filling (left) and the case with filling (right), minor principal stress at the tips of the ribs was improved by filling with mortar from -95.4 N/mm^2 to -65.1 N/mm^2 , or to 68%, indicating successful dispersion of stress. Although stress amplitude under live load was only 2.0% of that under full design load by the overall frame analysis, full penetration weld joints were adopted for the steel pipes for assured safety against fatigue in the struts.

Fig. 6 3D FEM analysis on the struts

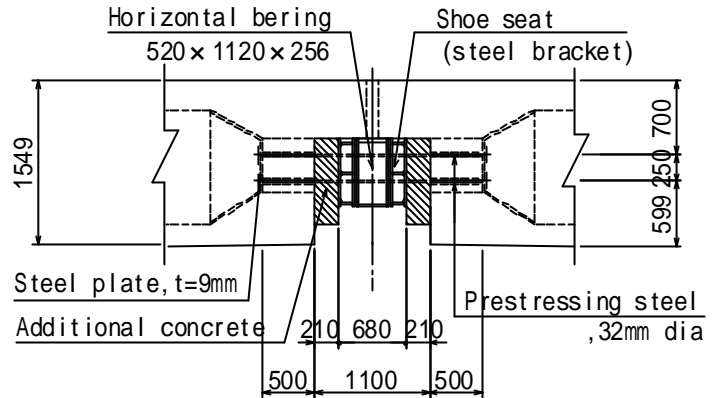
Fig. 7 Details of the central hinge region (side view)

Axial force acting on these horizontal bearings was about 6350 kN/shoe under design load (temperature change and variation), suggesting that the existing cross beams were insufficient to obtain adequate flexural and punching shear capacities. Therefore, they were reinforced with additional concrete and bonded steel plates as shown in Fig. 7.

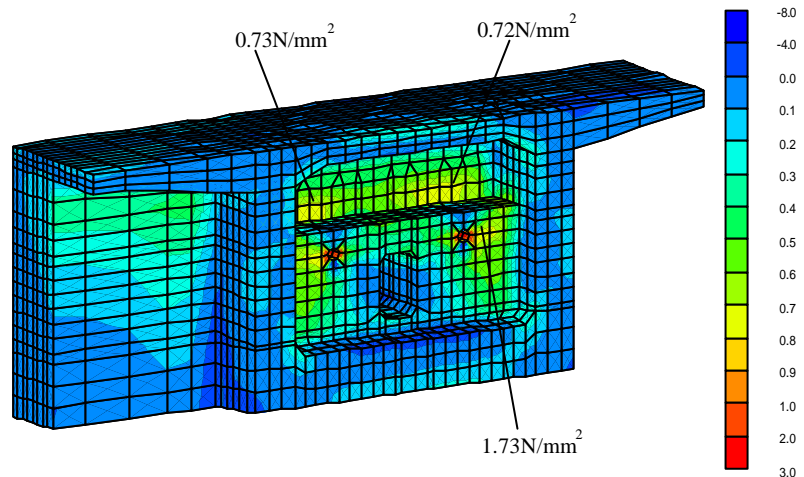
was investigated by the 3D FEM analysis. Major principal stress was $\sigma_{\max} = 1.73 \text{ N/mm}^2$ in the vicinity of the anchors, exhibiting no deleterious tensile stress. Reinforcing bars were added to cope with the tension. Figure. 8 shows the 3D FEM analysis results on the king post cable deviation zones.

Fig. 8 3D FEM analysis results on the king post cable deviation zone

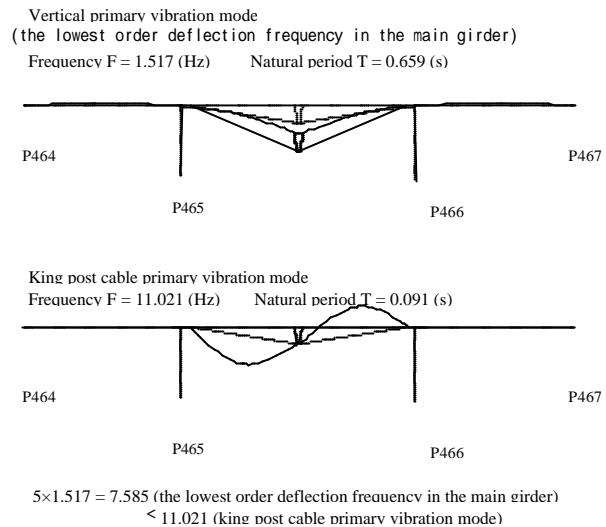
frame model, taking shear stiffness due to the tension in the king post cables into account. As shown in Fig. 9, the frequency of the external cables (f_c) was larger than five times the frequency of the main girder (f_h) ($5f_h < f_c$), suggesting that no deleterious vibration accompanied by resonance would occur⁶⁾. It was decided to install vibration controllers at spacings of less than 10^7 to increase safety against resonance which was already assured by the analysis results even without them.

Fig. 9 Natural vibration analysis results
