# Detailed Investigation of PC Cable-stayed Bridge Damaged in the 1999 Taiwan Earthquake

Kenji KOSA<sup>1)</sup> and Kenji TASAKI<sup>2)</sup>

## ABSTRACT

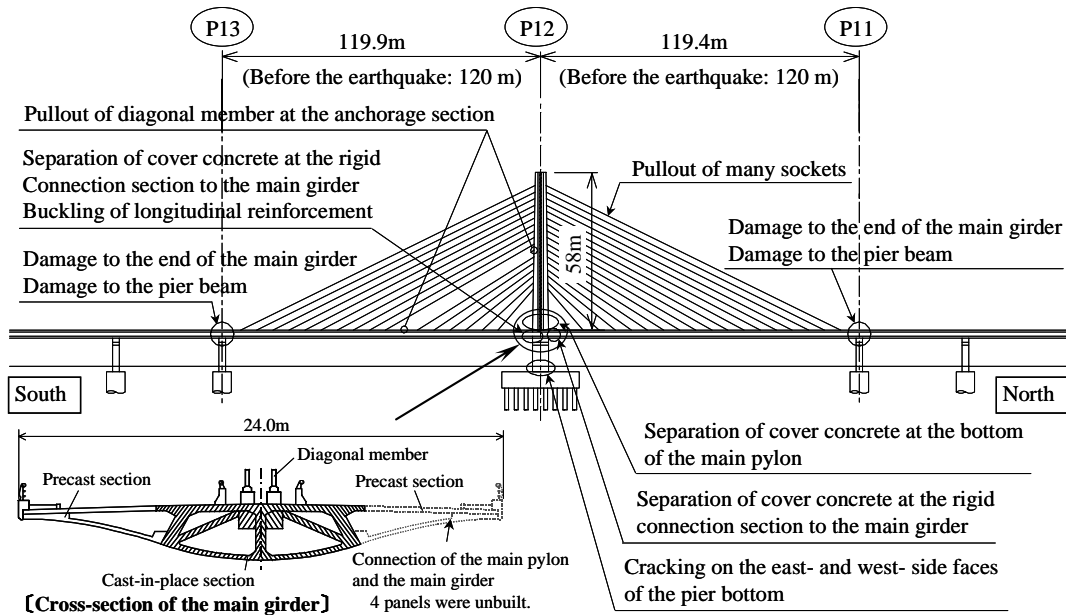
Fig. 2 Damage to the Ji-Ji-Da Bridge and measurement results

The damage was widespread extending over the main girder, the main pylon, the pier, as well as the cable, as shown in Fig. 2. For example, the cover concrete fell from the faces of the perpendicular direction at the bottom of the main pylon, and the ends of the main girder detached from each adjoining girder and swayed to the perpendicular direction. Also, the cover concrete was separated and the main reinforcement buckled in the main girder on the south side at the rigid connection section with the main pylon. From these damages, it is considered that a large seismic force acted in both the axial direction and the perpendicular direction of the bridge.

As to the cables, one cable on the south side, the 11<sup>th</sup> from the top, was pulled out from the anchorage section of the main pylon. Many sockets were also pulled out from the anchorage section. This means that large tension was caused to the diagonal cables during the earthquake. On the other hand, according to our first field measurement immediately after the earthquake, the span length before the earthquake, 120 m, did not changed virtually after the earthquake.

As to the progress of retrofit as of November 2002, Ji-Ji-Da Bridge was already open for service, but the pullout cable was still left as it was and a bent support was still in place. However, the bottom of the main pylon had been repaired with concrete jacketing and the bottom of the pier with steel jacketing.

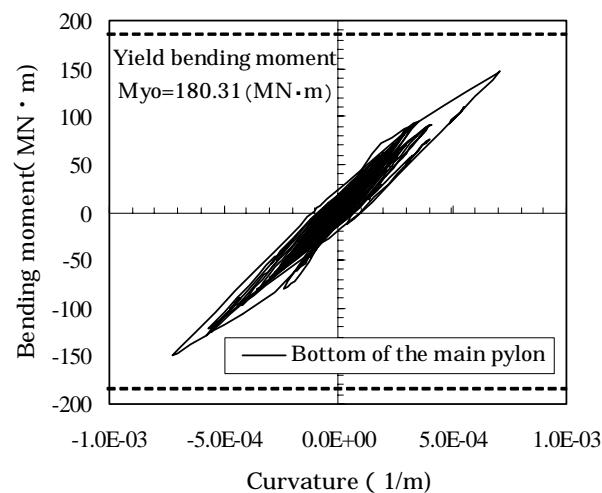
Fig. 12 Response hysteresis at the bottom of the main pylon (perpendicular direction)  
(Results of the input of the TCU078 original waveform)

Figure 12 shows the response history (bending moment vs. curvature relationship) of the perpendicular direction at the bottom of the main pylon when the TCU078 original waveforms were input. According to this figure, the maximum response bending moment at the bottom of the main pylon does not reach the yield bending moment. However, according to our field observation immediately after the earthquake, the main reinforcement in the perpendicular direction buckled and the cover concrete fell at the bottom of the pylon, which is the evidence that this area reached the nonlinear range by exceeding the yield point. This means that if the TCU078 original waveforms are input, the actual damage occurred cannot be reproduced.

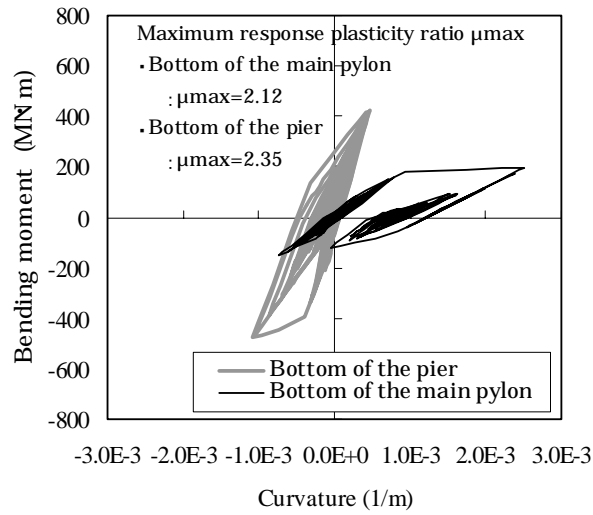
Fig. 14 Response hysteresis at the bottom of the main pylon and at the bottom of the pier

Figure 14 shows the response history (bending moment vs. curvature relationship) in the perpendicular direction at the bottom of the main pylon and the bottom of the pier. According to the analysis results, the maximum response plasticity ratio,  $\mu_{max}$ , at the pier bottom and the pylon bottom was 2.35 and 2.12, respectively, both reaching the yield strength. As to the pier bottom, this ratio is relatively in good agreement with the actual damage at the pier bottom where bending cracks occurred in the section up to 4 m from the bottom but cover concrete was not separated from the pier. As to the pylon bottom, however, the cover concrete fell from the east side face of the pylon bottom and hence it is presumed that the actual linear response was larger than the analytical results, although a relatively good agreement is seen between the analytical results and the tendency of the damage.

One of the reasons for this is the effect of the high axial force that is working on the main pylon. According to past researches on the nonlinear response of RC members having high axial force, it is known that the deformation capacity decreases because the horizontal displacement accompanies a large additional bending<sup>7)</sup>. The axial stress working on the bottom of the pylon is  $7.35 \text{ N/mm}^2$  under the dead load as shown in Table 2, which is approximately 7 times as high as the axial stress working on ordinary RC piers. Although the additional bending due to the horizontal displacement of the main pylon was duly considered in the analysis by the geometrical nonlinearity, a decrease in the strength due to the additional bending was not considered in the nonlinear history model of the pylon bottom, which may resulted in the underestimation of the axial stress than the actual response.

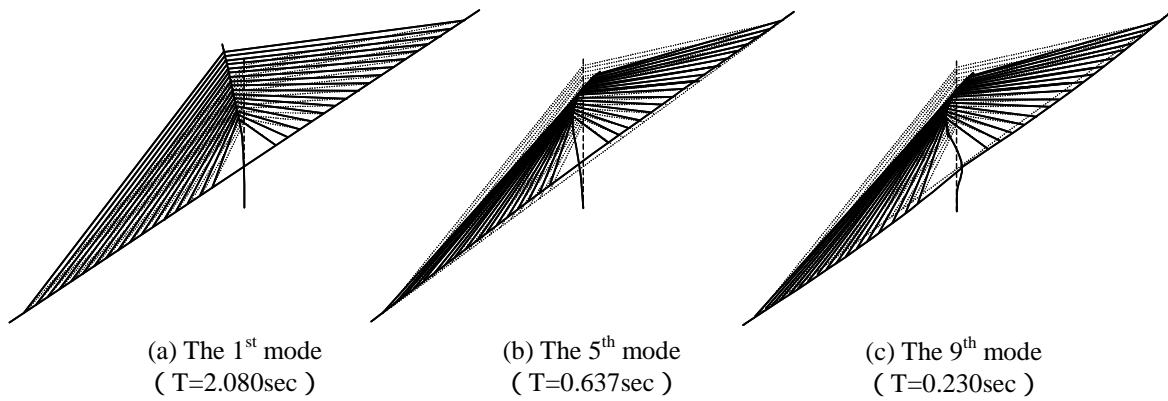
Fig. 15 Predominant mode in the direction perpendicular to the bridge axis

The reason that damage occurred not only at the pier bottom but also at the pylon bottom is probably due to the effect of high level modes of the main pylon. Primary modes in the perpendicular direction derived from the analysis of eigenvalues are shown in Fig. 15. In addition to the primary mode, the 5<sup>th</sup> mode and the 9<sup>th</sup> mode are predominant. As seen from the distribution of the maximum bending moment in the perpendicular direction of the main pylon and the pier shown in Fig. 16, the distribution of bending moment at the time of the maximum response at the pylon bottom differs from that at the pier bottom by the effect of high level modes.

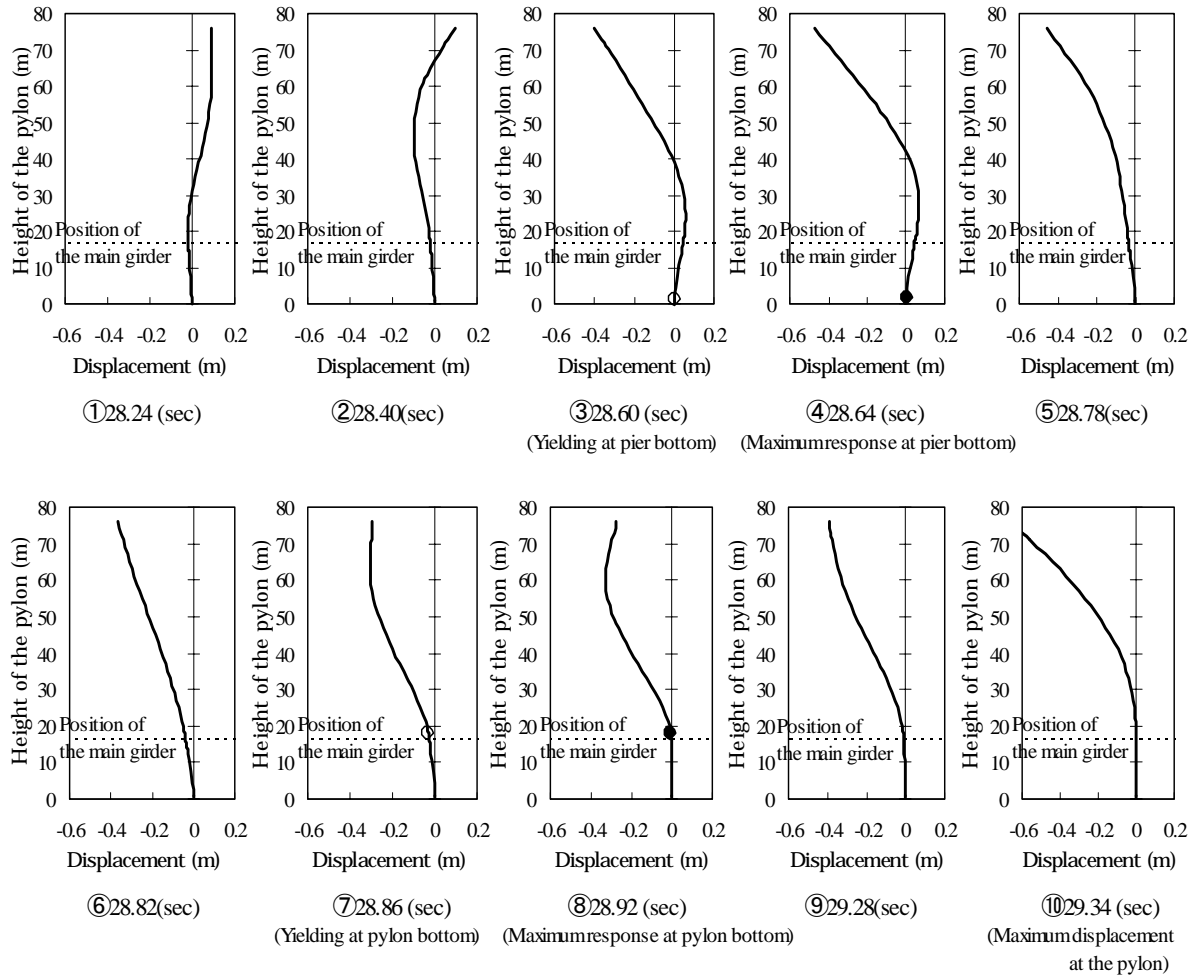
Fig. 17 Development of displacement at the main pylon and the pier

Here, to grasp the effect of the high level modes, developments of deformation at the main pylon was tracked at each time step. The deformations of the pylon seen around the time of 28.2 - 29.3 seconds which are the time of the maximum response of the pylon are shown in Fig. 17.

At 28.24- 28.40 seconds, the responses of the pylon bottom and the pier bottom were still elastic, but they were already showing the deformation of high level modes. At around 28.60- 28.64 seconds, the pier bottom reached yielding by the 5<sup>th</sup> mode deformation, and immediately after that the maximum response was obtained. At this time, the pylon bottom did not yet reach yielding. At 28.78- 28.82 seconds, the pier bottom exhibited the deformation of the primary mode in the nonlinear range. Then at 28.86- 28.92 seconds, the pylon bottom reached yielding by the deformation of the 9<sup>th</sup> mode, and immediately after that the maximum response was obtained. At 29.28- 29.34 seconds, both the main pylon and the pier was in the nonlinear state, at which the deformation of the primary mode was predominant and the top of the pylon reached the maximum displacement.

As seen, the pier bottom failed by the deformation of the 5<sup>th</sup> mode and the pylon bottom by that of the 9<sup>th</sup> mode, and then the nonlinear response advanced.

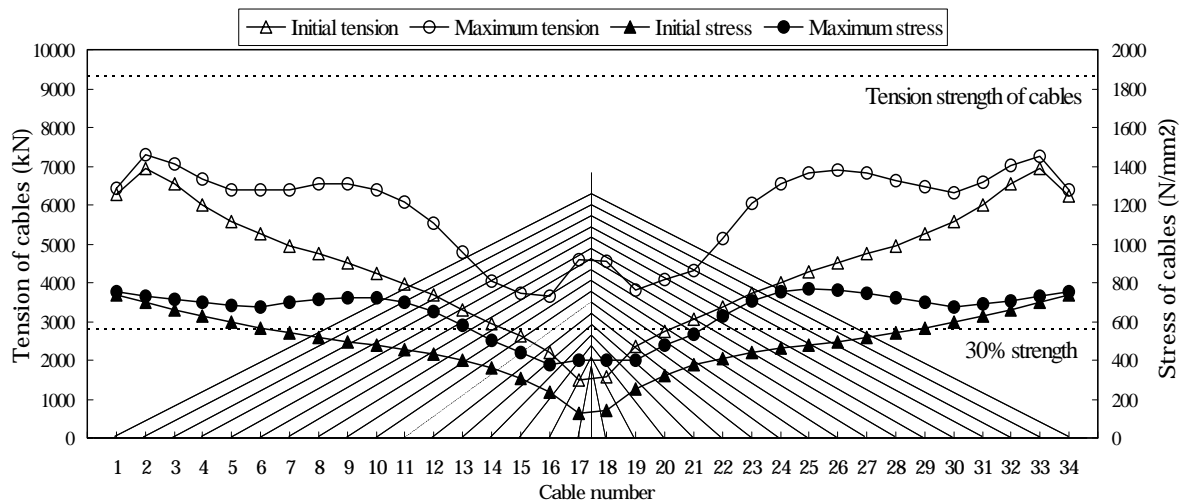
Fig. 18 Distribution of the maximum tension of the diagonal cables

Fig. 18 shows the distribution of the maximum tension force of the diagonal cables. The initial tension, the maximum tension, and the tensile stress of the cables, numbering from 1 to 34, are shown in the figure. The difference between the maximum tension and the initial tension is the fluctuating tension associating with the seismic response. As this is a cable-stayed bridge, cables are pulled from the main pylon towards the both sides. Hence, the initial tension becomes larger as the anchorage position becomes distant from the pylon because of the effect of the cable weight and the anchoring angle. Also, as the pylon and the main girder are rigidly connected, the initial tension of cables located near the pylon is small relatively. At the time of the earthquake, construction of this bridge was almost over leaving a part of the precast section of the main girder and the deck construction. And, it is considered that an initial tension of  $486 \text{ N/mm}^2$  on average, which is approximately 26% of the tensile strength, was introduced to the cables at the time of construction. The cross section of the cable consists of PC steel multi-strand wires having diameters of 12.7 mm, 15.2 mm, and 7 mm, and the tensile strength is  $1,860 \text{ N/mm}^2$  which is equivalent to SWPR7B.

The largest maximum stress of the cables was  $720 \text{ N/mm}^2$  which was taken around the pullout 11<sup>th</sup> cable. But, this value is about 40% smaller compared with the design tensile strength of the cable, which is  $1,860 \text{ N/mm}^2$ . With this maximum stress value, it seems structurally impossible for the cables to be pulled out from the anchorage section.

However, when we had a talk with the bridge administrators in Taiwan in November 2002, they told us that the cable anchorage section had actually been constructed at the strength about 30% of the design tensile strength due to some construction reasons. In our analysis, the maximum tensile stress of the cables was derived as about 40% of the design tensile strength. If the actual strength of the cable anchorage was about 30% of the design tensile strength as the Taiwan administrators say, it can be said that there was the possibility that all the cables except the 14<sup>th</sup> through 21<sup>st</sup> might have been pulled out from the anchorage section. From these results, it is said that the cause of the cable pullout was the insufficient strength of cable anchorage.
