The Collapse Mechanism and the Temporary Restoration of Omori Bridge Damaged by the Storm Surge of Typhoon No.18 in 2004

Shinya OKADA*, Hiroshi MITAMURA**, Hiroyuki ISHIKAWA***

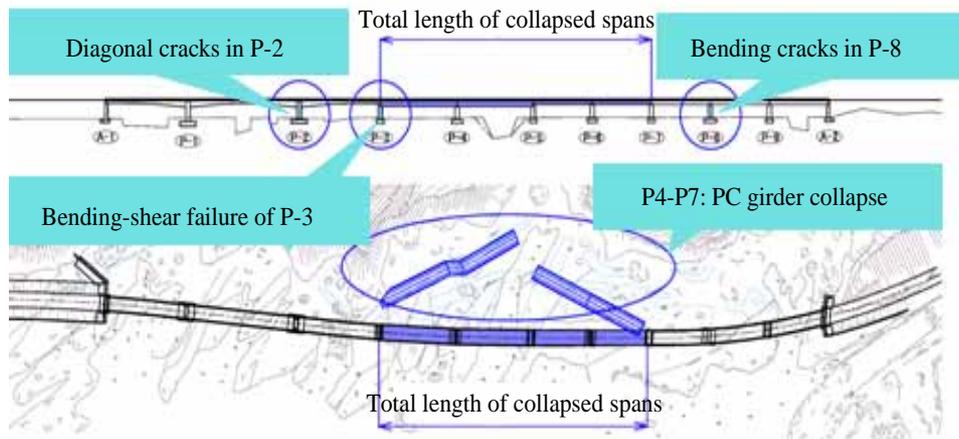
Figure 3: Damaged portions of bridge

- (1) collapse of four spans of PC girders (Photo 3),
- (2) diagonal cracks about 0.7 mm in width on pier P2,
- (3) bending-shear failure of pier P3, which has a tilt of about 30 cm (Photo 4), and
- (4) bending cracks about 2.0 mm in width on pier P8.

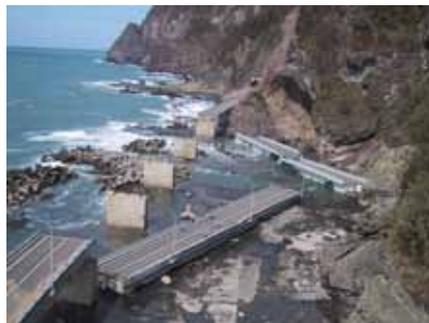
Photo 2: Collapsed bridge

The major damage to Omori Bridge is as follows (Figure 3 and Photo 2):

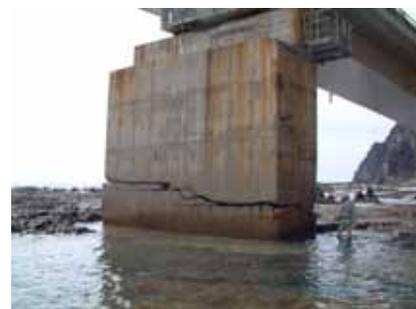
Photo 4: Damage to pier P-3

During the fall of the main girders, it is thought that the doglegged girders hit the adjacent girders on the Otaru and Hakodate (Iwanai) sides and that this impact damaged piers P2, P3, and P8 (Figure 7).

The substructure was repaired based on the initial design criteria in *The Design Manual for Highway Bridge Substructures* issued in 1968 (seismic design was based on the seismic coefficient method). The repair work included the steel jacketing of pier P2, (2) reinforced concrete lining to pier P3 (Photo 7), and (3) crack grouting to pier P8.

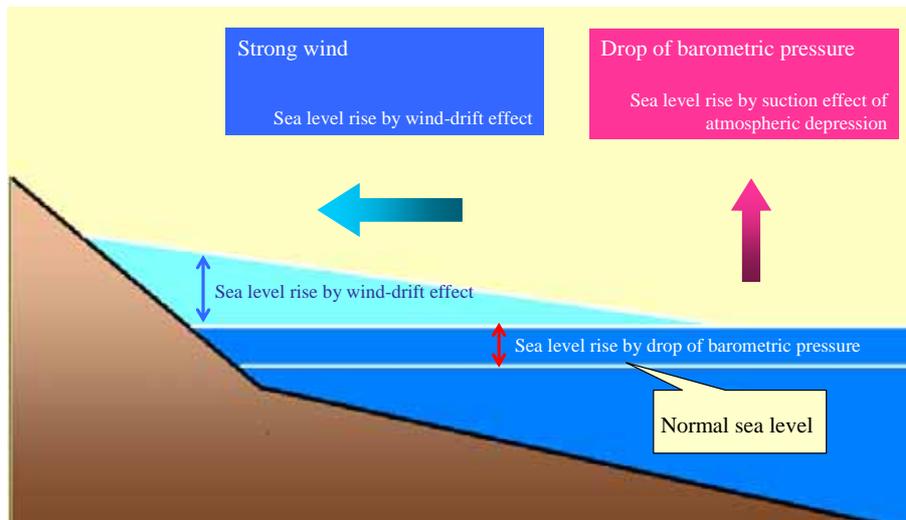
Figure 4: Model showing mechanism of sea level rise

A barometric pressure of 989 hpa and a maximum average wind velocity of 34.1 m/s were recorded at 1:40 p.m. on September 8 by a telemeter near Omori Bridge. The sea level rise at the time, caused by the drop in barometric pressure and strong winds from the sea, is estimated to be 94.8 cm (Figure 4). Also estimated are a significant wave height of 7.6 m and a wave period of 12 sec.

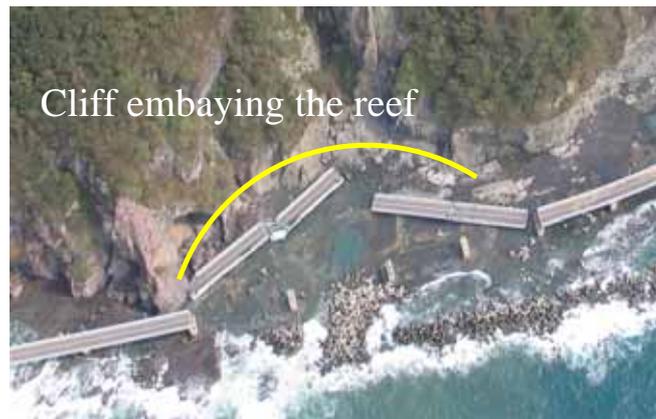
Photo 5: Aerial photo of site

7.2 Particular topography: Because of the reef below the bridge and the sheer cliff that embays the reef (Photo 5), the waves reflected from the cliff concentrated around the bridge. The wave-dissipating concrete blocks created a pool on the reef, causing a further rise of sea level.

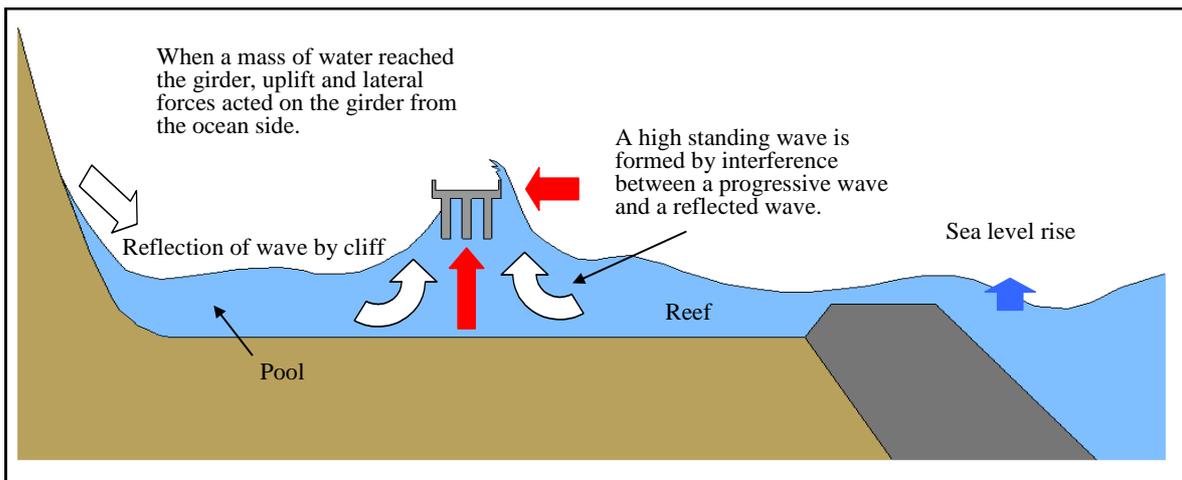
Figure 5: Collapse of bridge by wave action

7.3 Standing wave: As the sea level rose, the progressive waves rose higher on the reef. Standing waves of higher height were produced as a result of interference between the progressive waves and waves reflected by the cliff. The girders were subjected to buoyancy and uplift pressure (Figure 5).

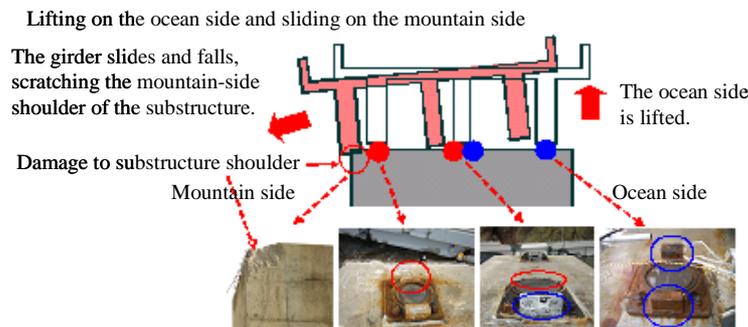
Figure 6: Inferred process of bridge collapse

Bearings on the ocean side of the piers were damaged by uplift force, and those on the mountain side of the piers were damaged by lateral force. Damage was also found at the mountain-side shoulder of the substructure. It is inferred from the above observation that the fall of the bridge proceeded in the following manner. The ocean side of the girder was first lifted, and then the girder itself was laterally displaced toward the mountain side while scratching the shoe surface (Figure 6).
